Mitigation Project Name St. Clair Creek  
 DMS ID 95015  
 River Basin Tar-Pamlico  
 Cataloging Unit 03020104

Subject: Task 11: Response Letter to DMS review comments regarding the Draft Year 5 Monitoring Report for the St. Clair Creek Restoration Project (#95015)  
Beaufort County, North Carolina, Cape Fear Basin – CU#03020104  
DMS No. 95015, Baker No. 125116

# **St. Clair Creek Restoration Project Year 5 FINAL Monitoring Report**

Beaufort County, North Carolina

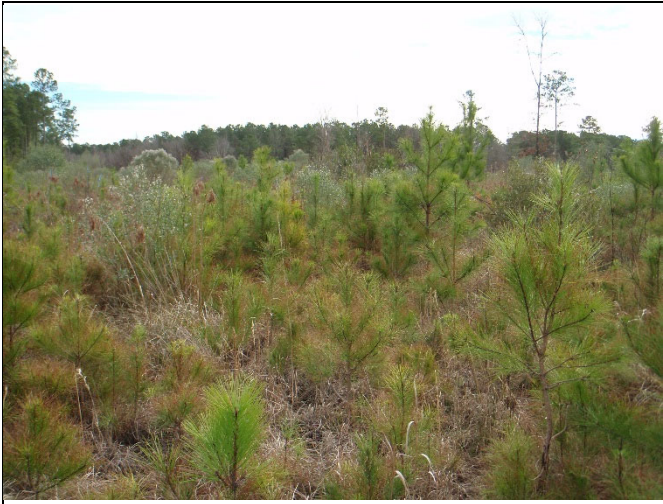
Following Year 5 monitoring, *Pinus taeda* (loblolly pine) seedlings and short saplings were found scattered throughout the riparian buffer of the UT2 restoration area as well as in smaller portions of UT3. It should be noted that the pines do not appear to be suppressing planted species survival or growth as vegetation density appears strong throughout the project, even in areas with pine presence. However, due to IRT concerns, these pines will be treated and heavily thinned during 2019 using hand/power tools and/or chemical applications. The Site will continue to be closely observed for pine growth throughout the remaining monitoring period. Several photographs of the scattered pines can be found in the Vegetation Problem Area Photolog in Appendix B.

Table 6b. Vegetation Problem Areas				
St. Clair Creek Restoration Project: DMS Project ID No. 95015				
Feature Issue	Station Number	Suspected Cause	Resolution	Photo Number
Loblolly Pine ( <i>Pinus taeda</i> )	Scattered throughout buffer on UT-2	Post-restoraton seed source	Will be treated in 2019 with power tools and/or chemical application.	Photos 1-4 in VPA Photolog

Loblolly Pines on UT2

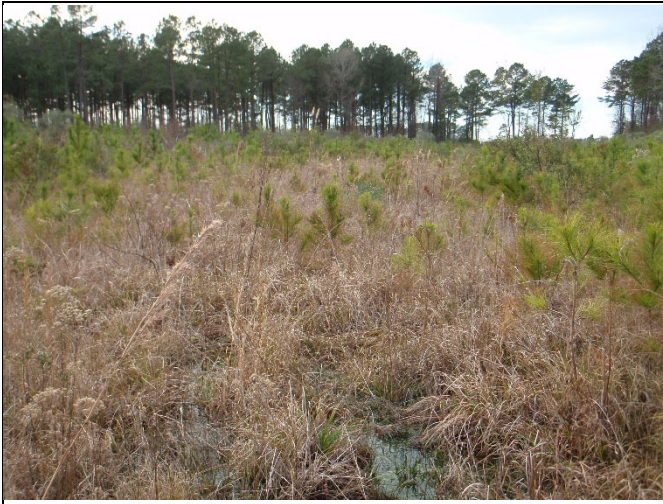
Loblolly Pines on UT2

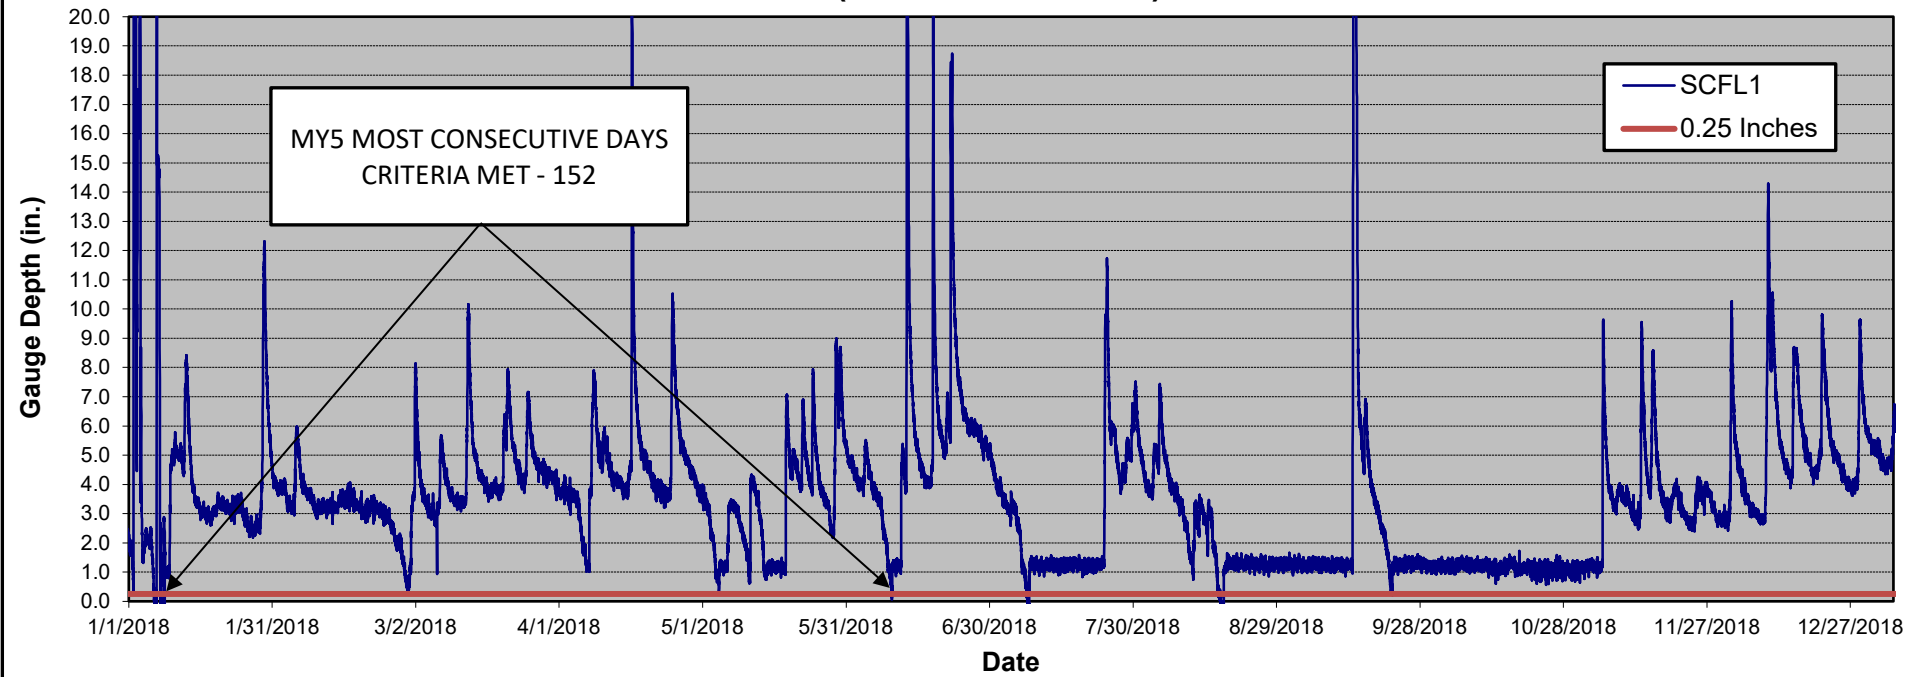
### St. Clair Creek Flow Gauge SCFL1 (Downstream UT2)

\*0.25 inches denotes level at which flow occurs along the UT2 valley thalweg

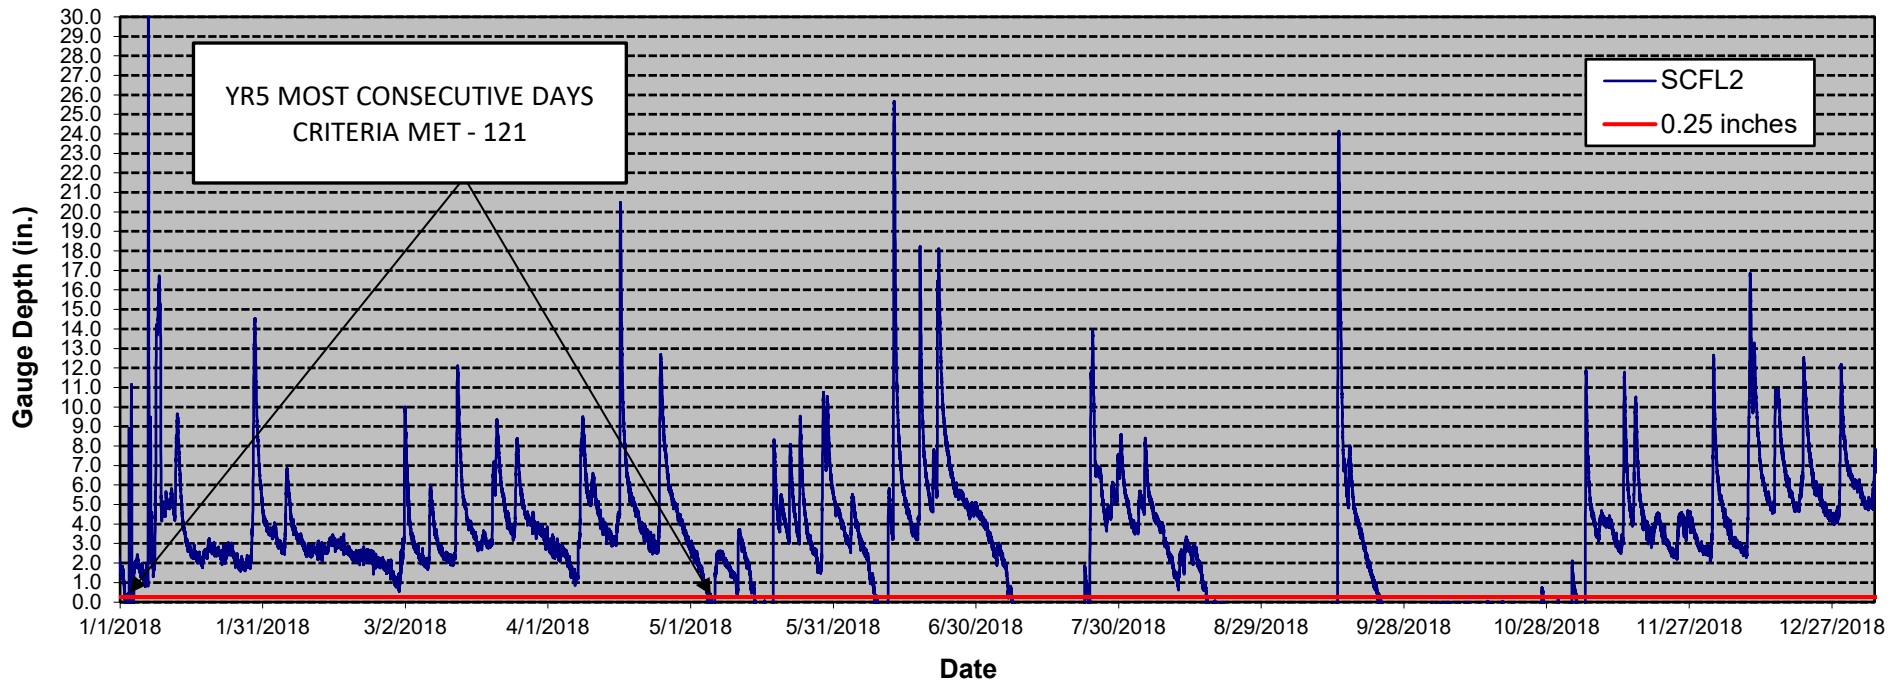
### St. Clair Creek Flow Gauge SCFL2 (Downstream UT2)

\*0.25 inches denotes level at which flow occurs along the UT2 valley thalweg

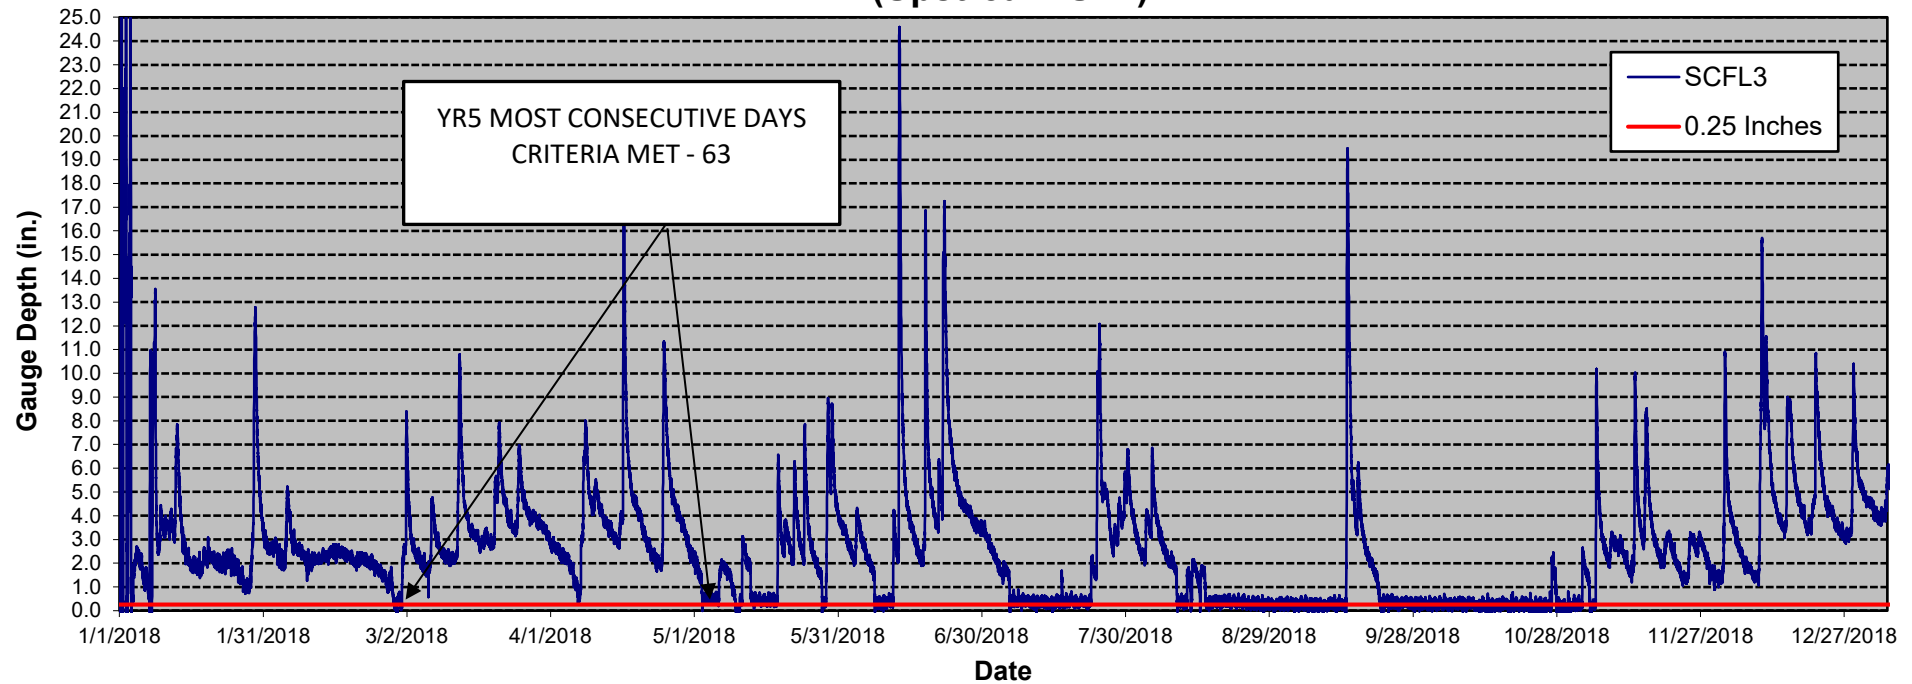
### St. Clair Creek Flow Gauge SCFL3 (Upstream UT2)

\*0.25 inches denotes level at which flow occurs along the UT2 valley thalweg

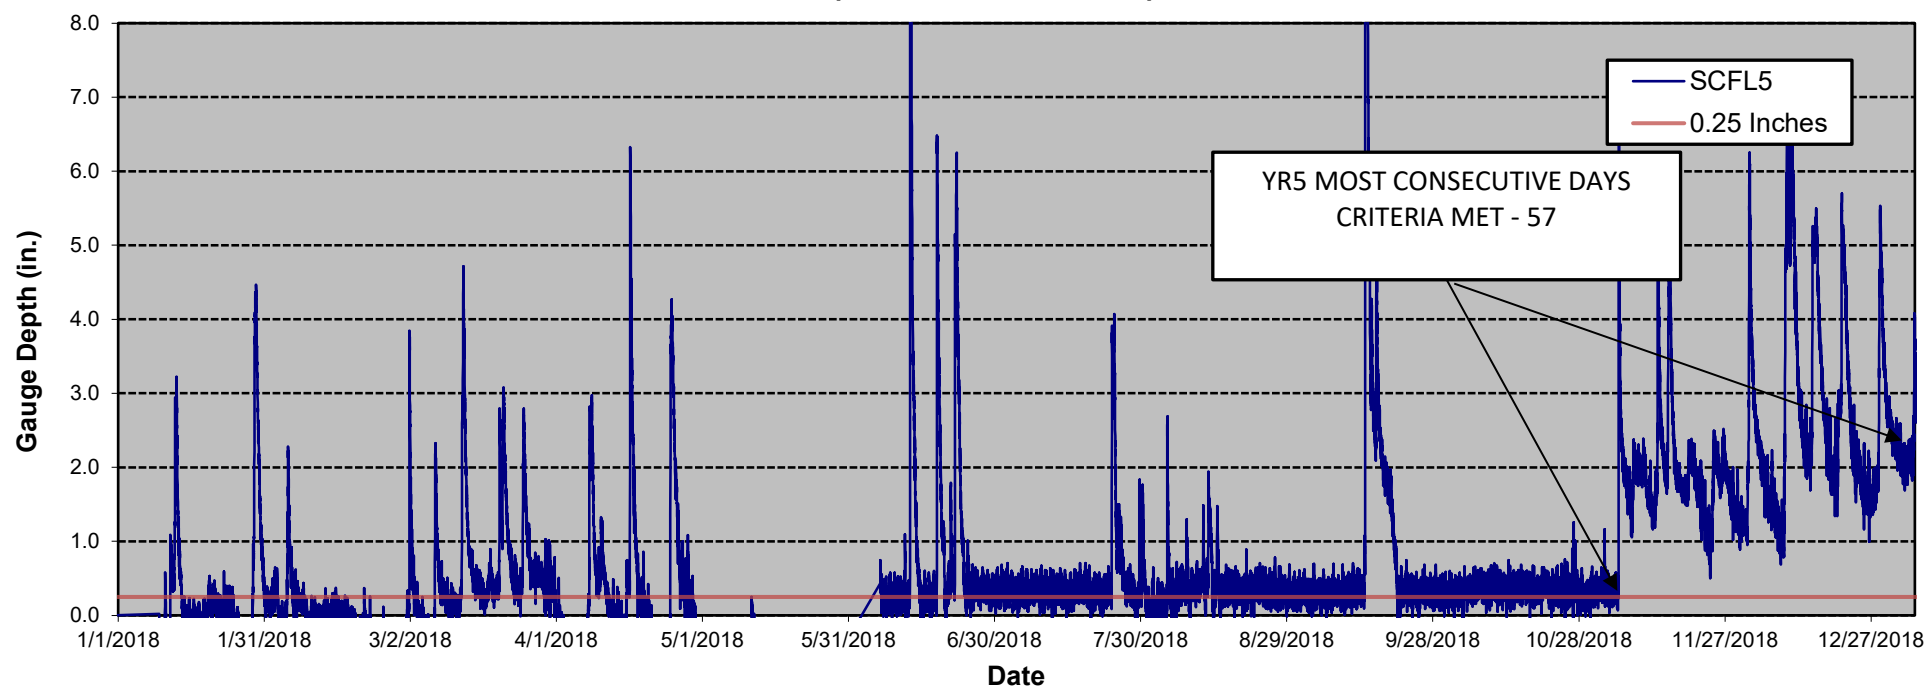
### St. Clair Creek Flow Gauge SCFL5 (Downstream UT3)

\*0.25 inches denotes level at which flow occurs along the UT3 valley thalweg

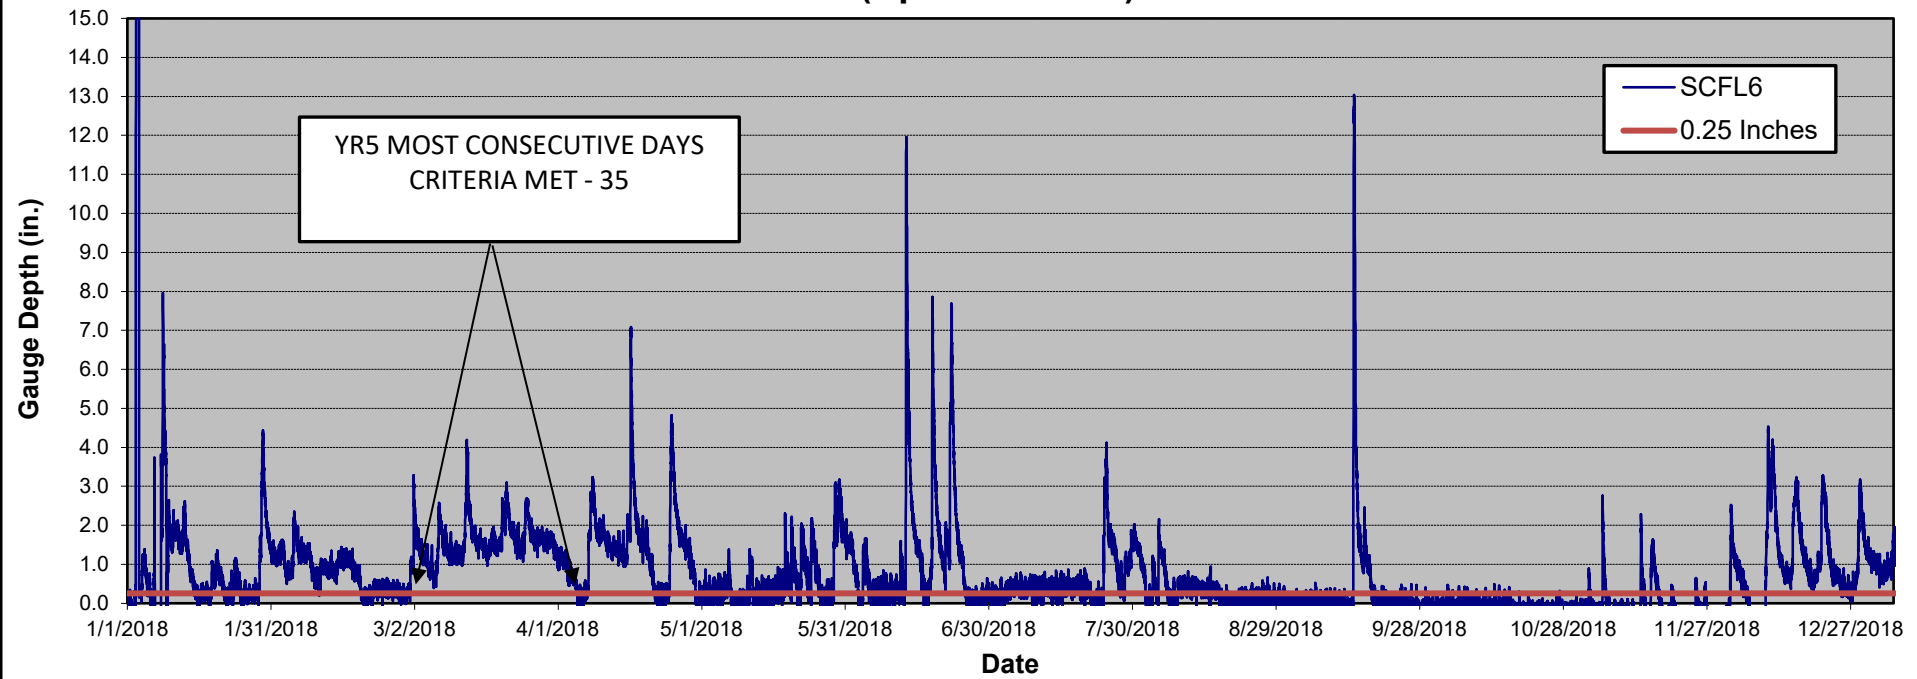
### St. Clair Creek Flow Gauge SCFL6 (Upstream UT3)

\*0.25 inches denotes level at which flow occurs along the UT3 valley thalweg

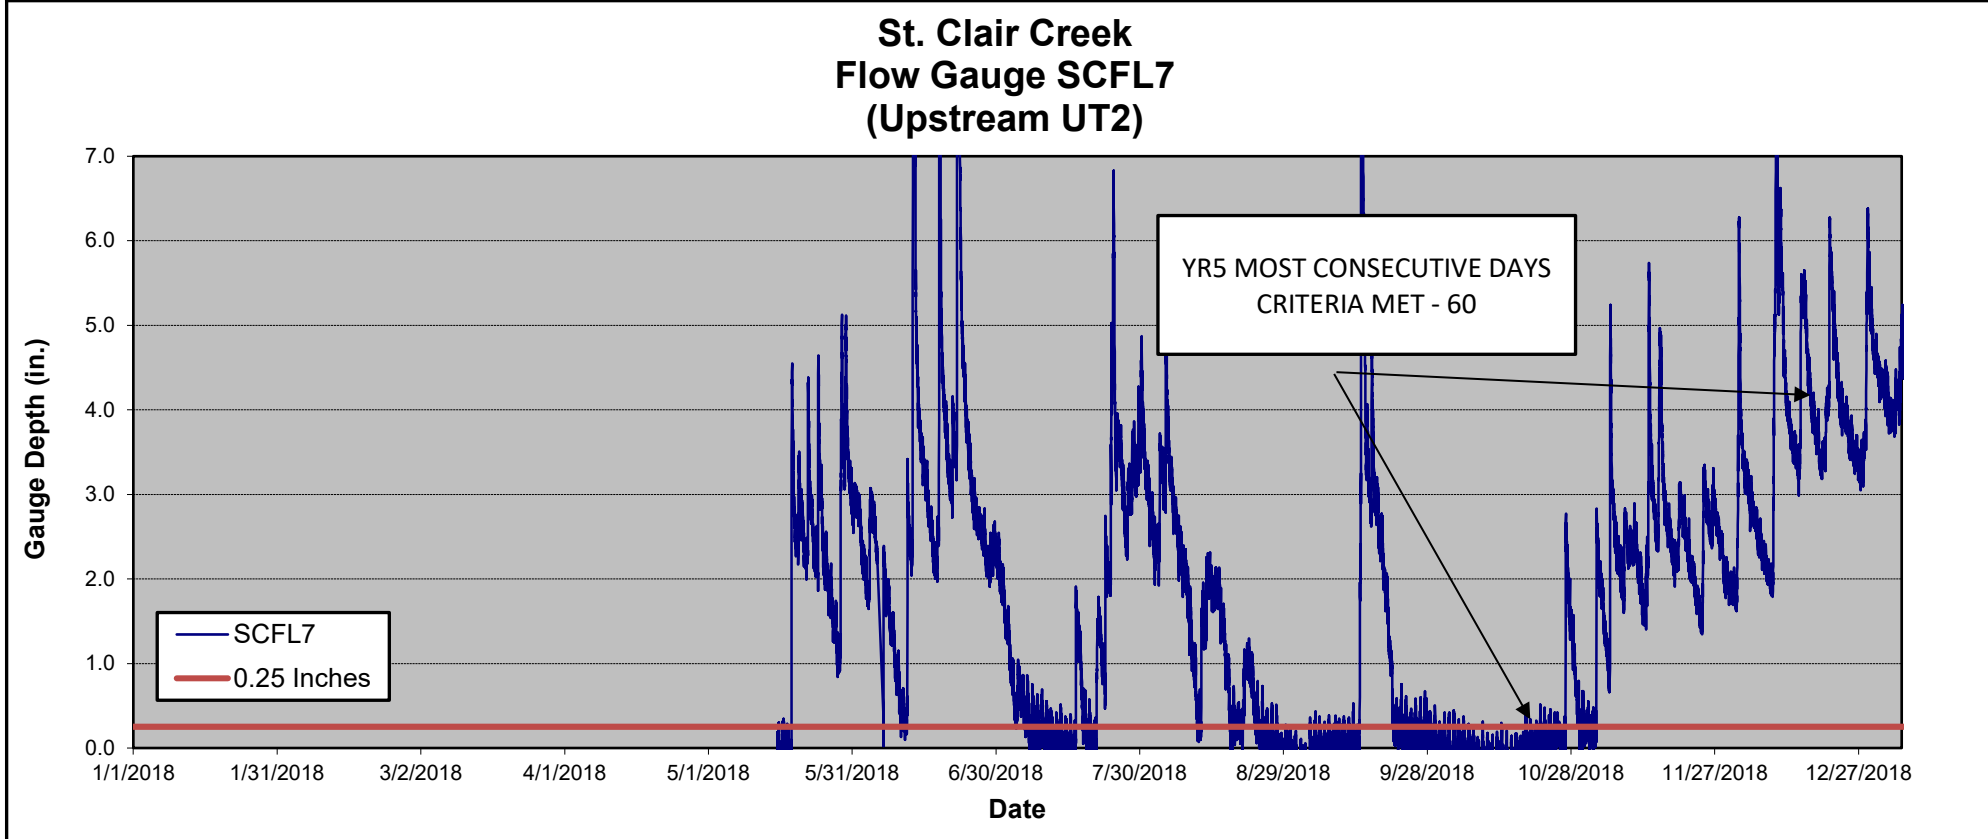
\*0.25 inches denotes level at which flow occurs along the UT2 valley thalweg

Note: Flow gauge 7 was installed June 6th 2018
