Monitoring Year 4 FINAL Monitoring Report
Stewarts Creek Tributaries Stream Restoration Project
Surry County, North Carolina
Yadkin River Basin, Hydrologic Unit Code (HUC) 03040101

May, September 2023 – November 2023

December 2023

NCDEQ Contract No. 7183
DMS ID No. 100023
RFP#16-006993 (Issued 9/16/2016)
USACE Action ID No. SAW-2017-01508
DWR ID No. 20171043

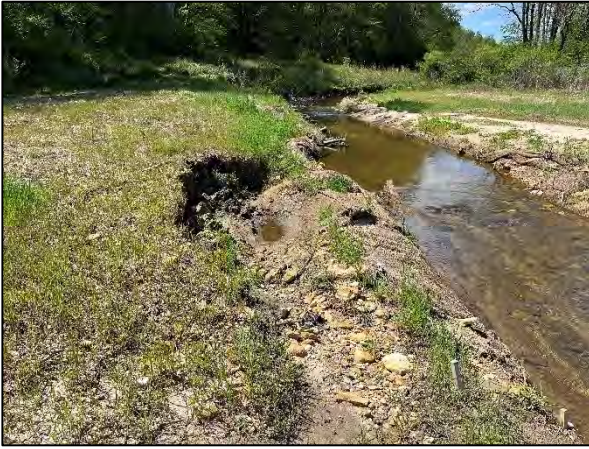
CPA-1, upstream section, facing upstream (4/20/2023)

The only area of channel instability noted in MY4 is the previously mentioned CPA-1, located within the upstream repaired section of Moores Fork Reach 2. The problem area is two separate sections of bank toe erosion, an upstream section on the right bank (50') and a downstream section on the left bank (125'). In both sections, where toe wood was installed as part of the 2022 AMP, the section of streambank immediately downstream of the toe wood eroded immediately after construction was complete but before vegetation had a chance to establish. These areas have been monitored throughout 2023 and have not worsened since the initial event. EPR is planning to reshape the stream channel and install additional toe wood through both of these sections in winter 2023-2024 to match the intended design from the 2022 AMP. No cross sections or vegetation plots will be relocated by these repairs, and as little vegetation will be disturbed as possible. Any disturbed areas will be reseeded and planted with bare root trees from the approved AMP planting list.

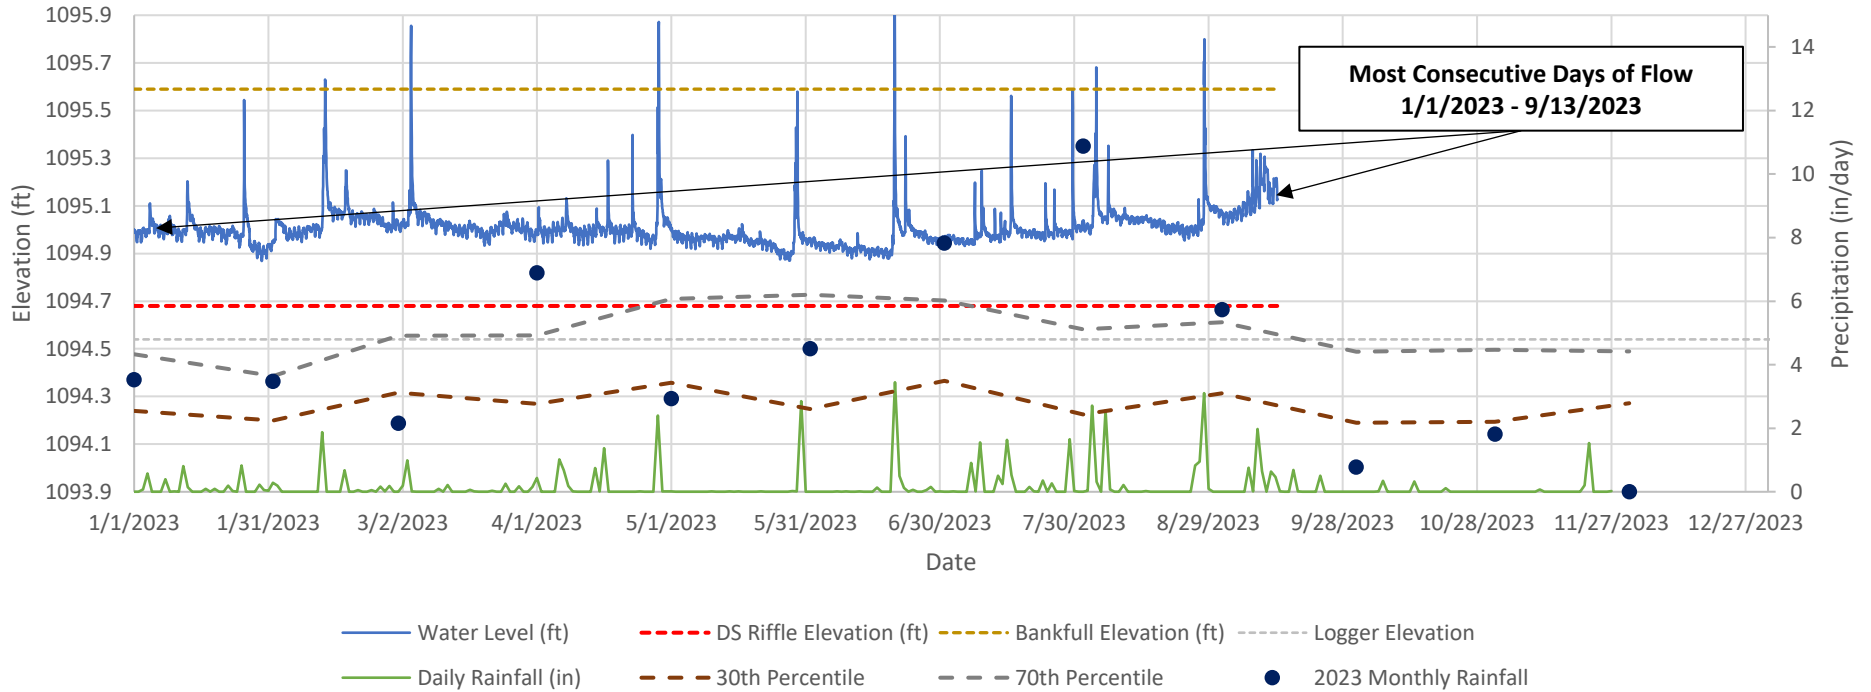
***Note:** SCTSG5 suffered gauge malfunctions from 7/25/2023 - 10/25/2023 in MY4. Corrupted data was not included in stream gauge plots.
SCTSG3 suffered gauge malfunctions from 9/13/2023 - 10/25/2023 in MY4. Corrupted data was not included in stream gauge plots.

*This gauge was dead from 9/14/23-10/25/23 and was replaced on 10/26/23.

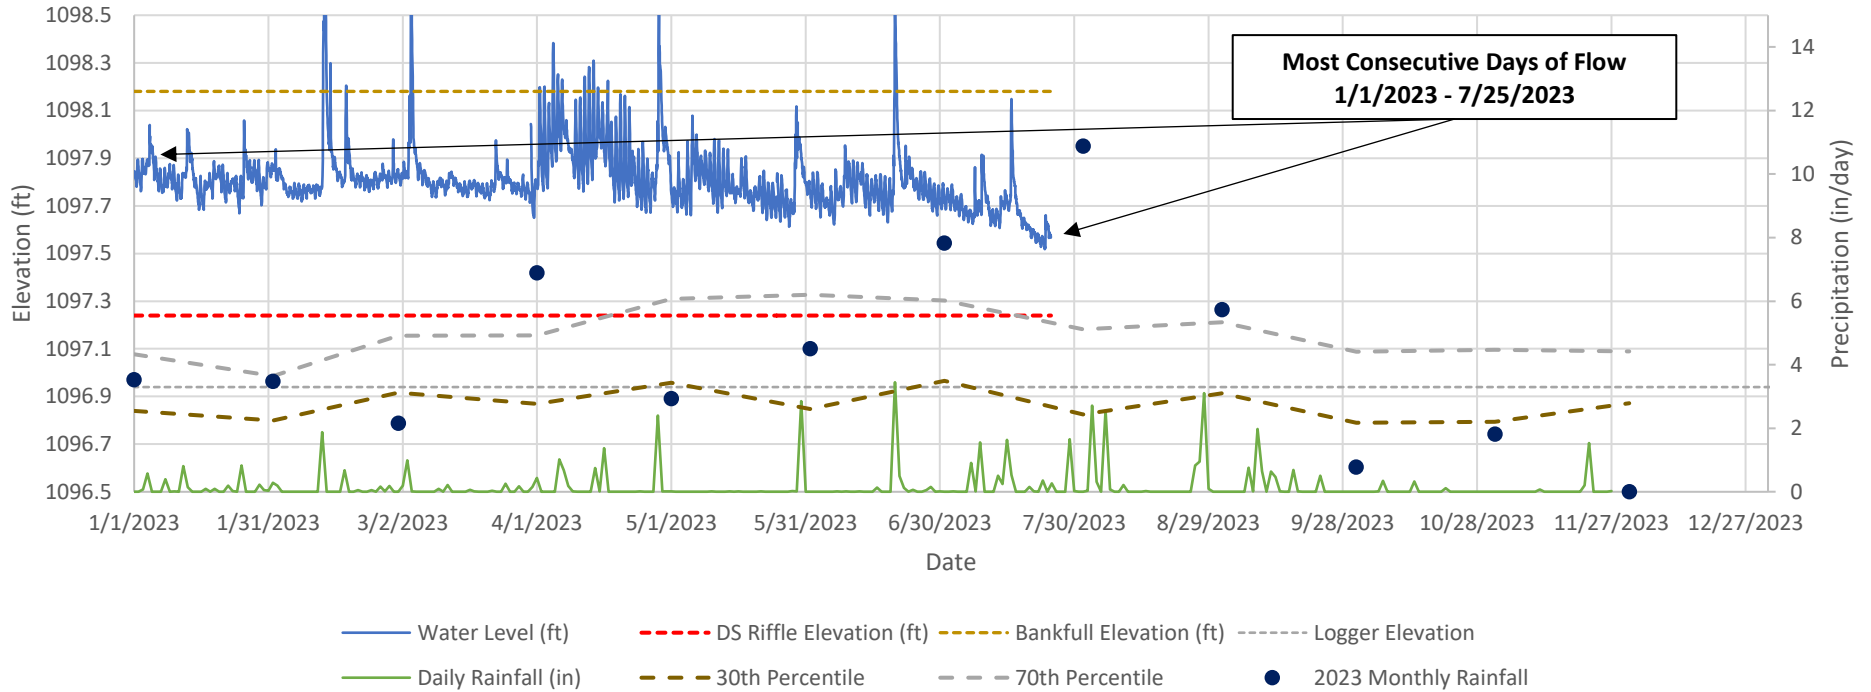
SCTSG5

*Rainfall data from HOBO Tipping Bucket Rain Gauge located at the Red Barn Mitigation Bank, 3.5 miles SE.
 *Stream gauge 5 died starting on 7/25/23-10/25/23 causing no data to be recorded. A new battery was put in on 10/26/23.
 *Rainfall data was supplemented from AGACIS Mount Airy 2 West from 06/14/2023-06/27/2023, 05/30/2023, 04/28/2023, 10/7/2023-11/28/2023.
