**Monitoring Year 1 FINAL Monitoring Report**  
**Stewarts Creek Tributaries Stream Restoration Project**  
**Surry County, North Carolina**  
**Yadkin River Basin, Hydrologic Unit Code (HUC) 03040101**

**Data Collection Period:**  
September 2020 – November 2020

**Submission Date:**  
December 2020

**Ecosystem Planning and Restoration**  
1150 SE Maynard Road, Suite 140  
Cary, NC 27511

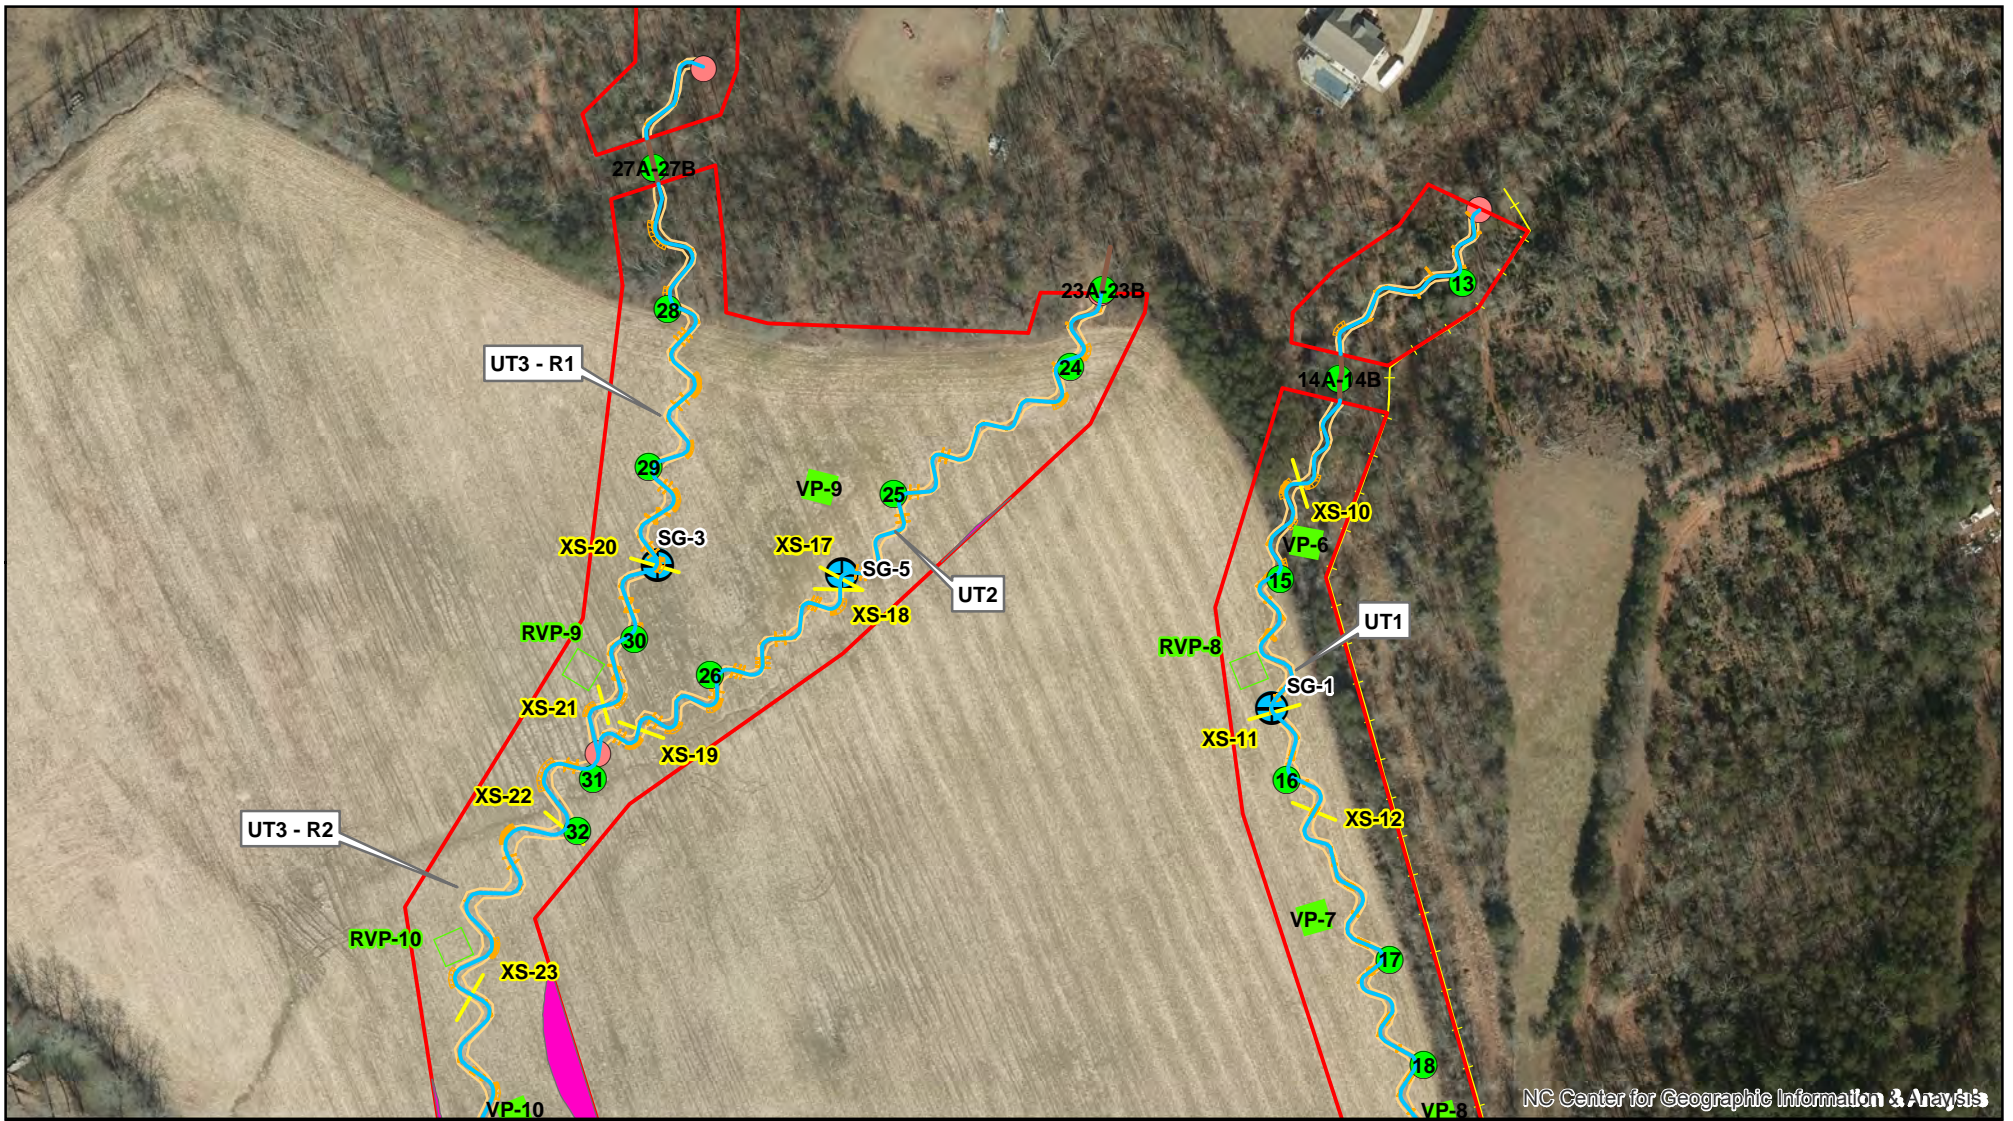
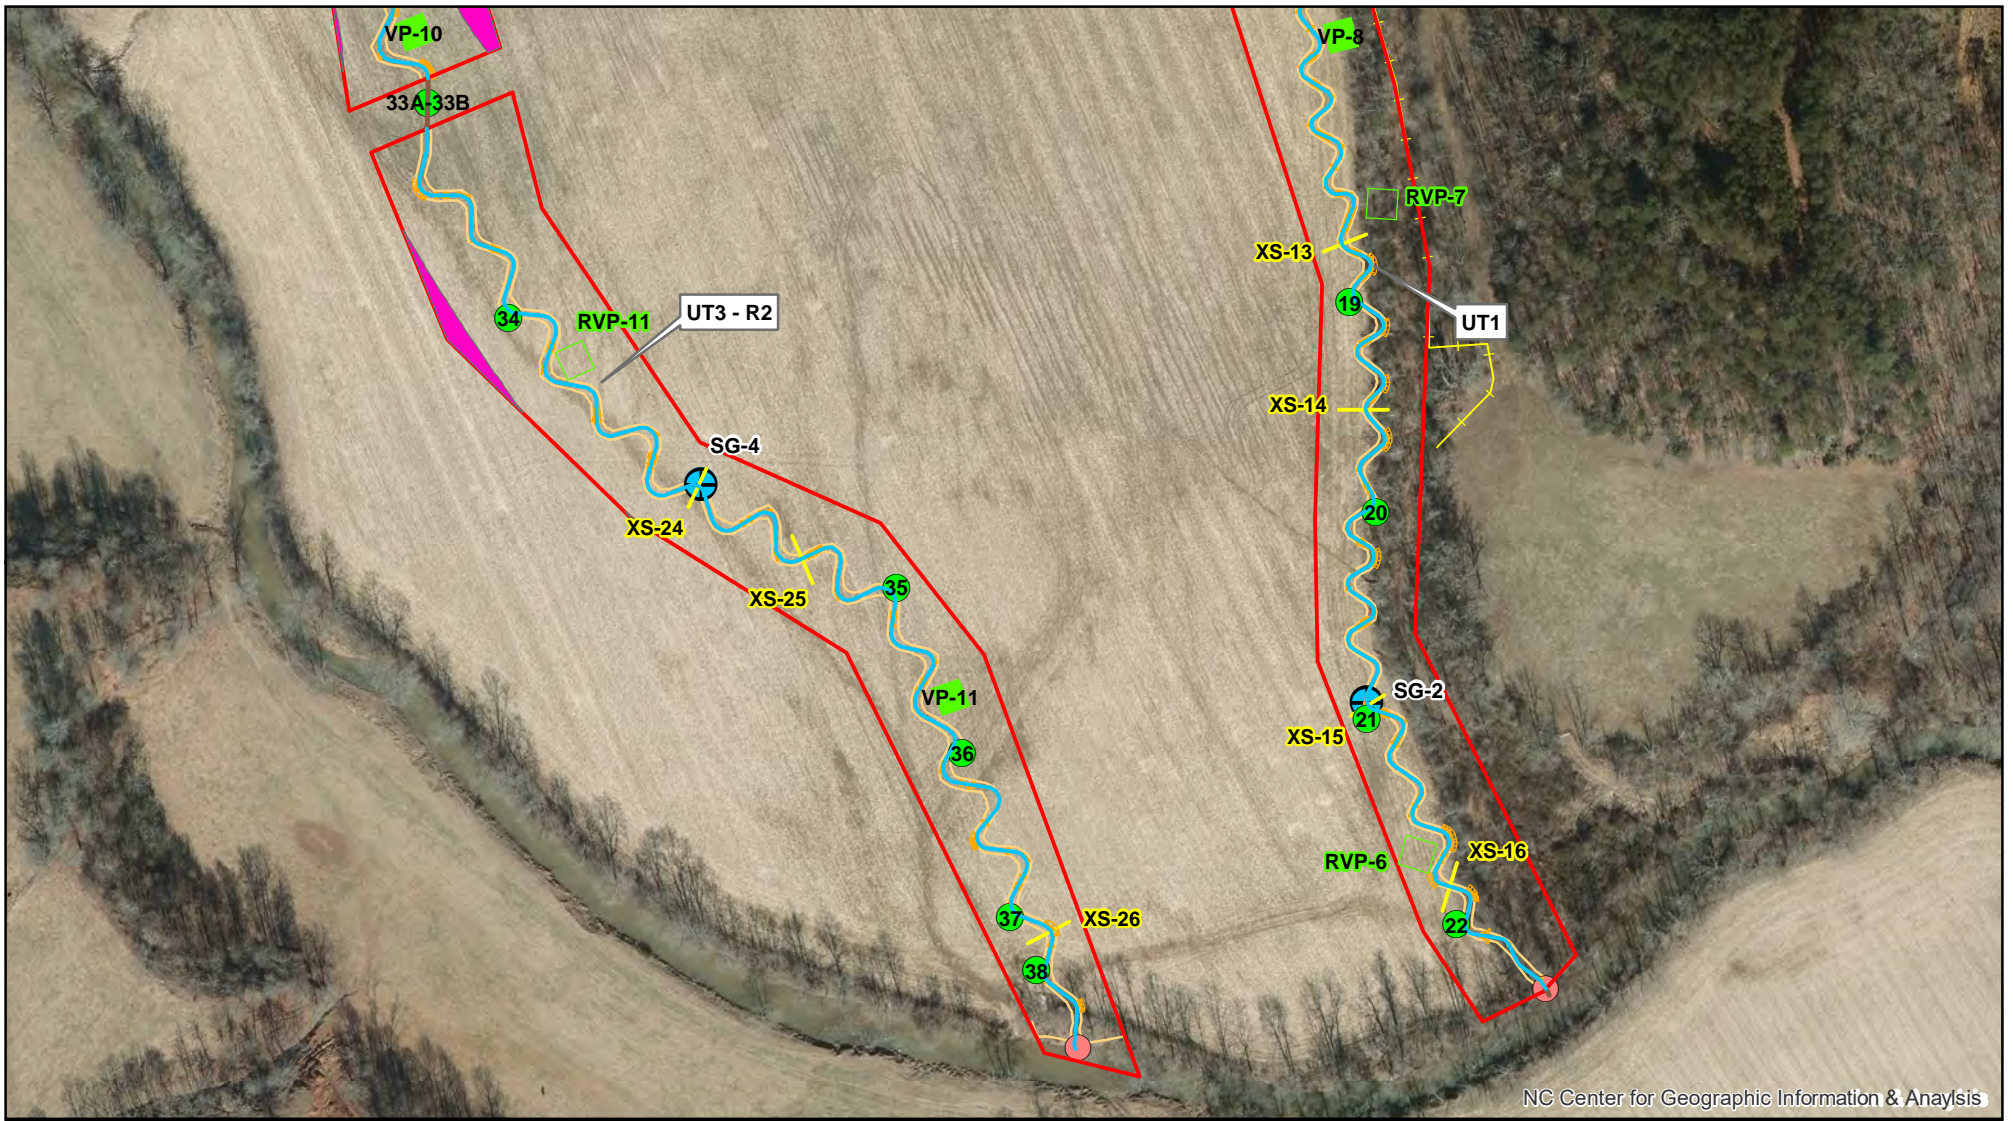
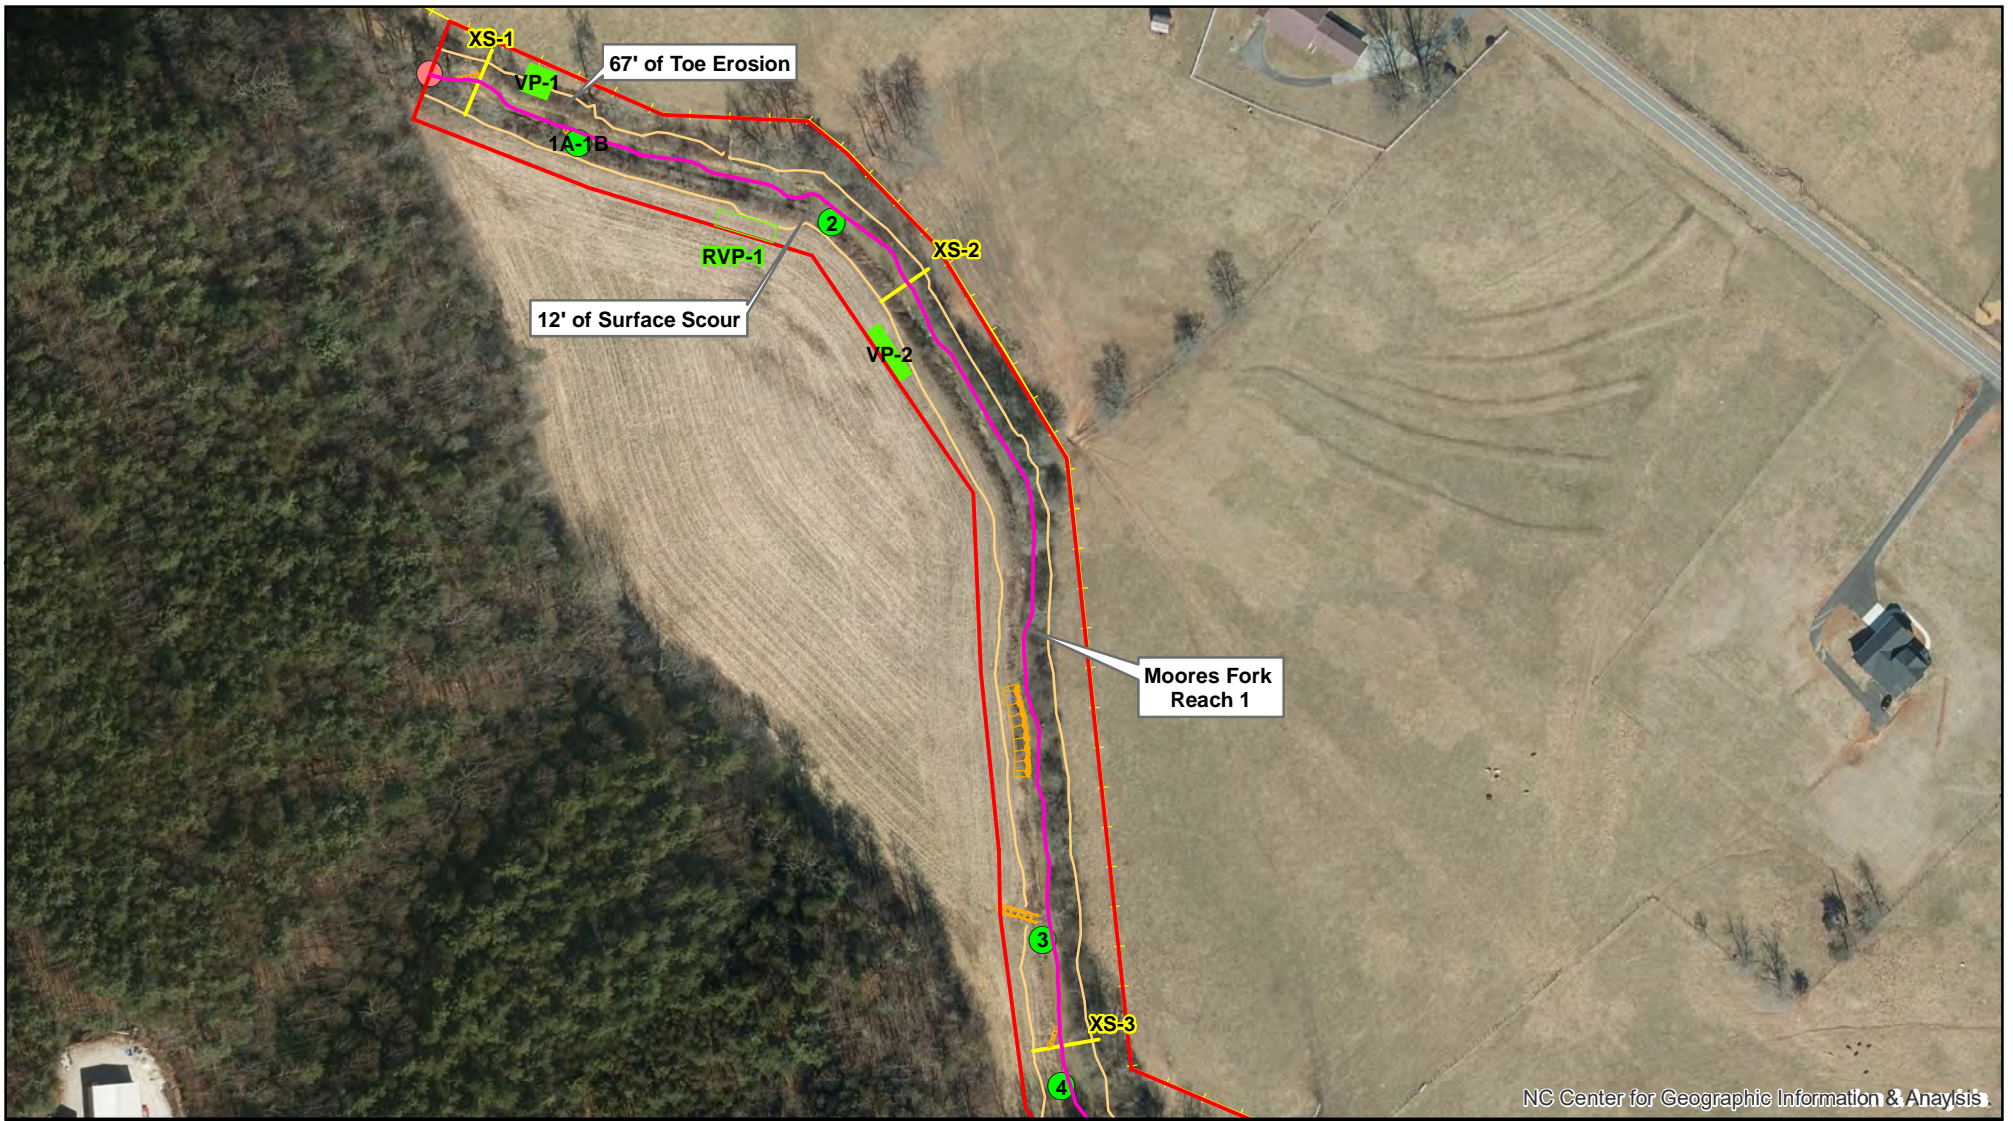
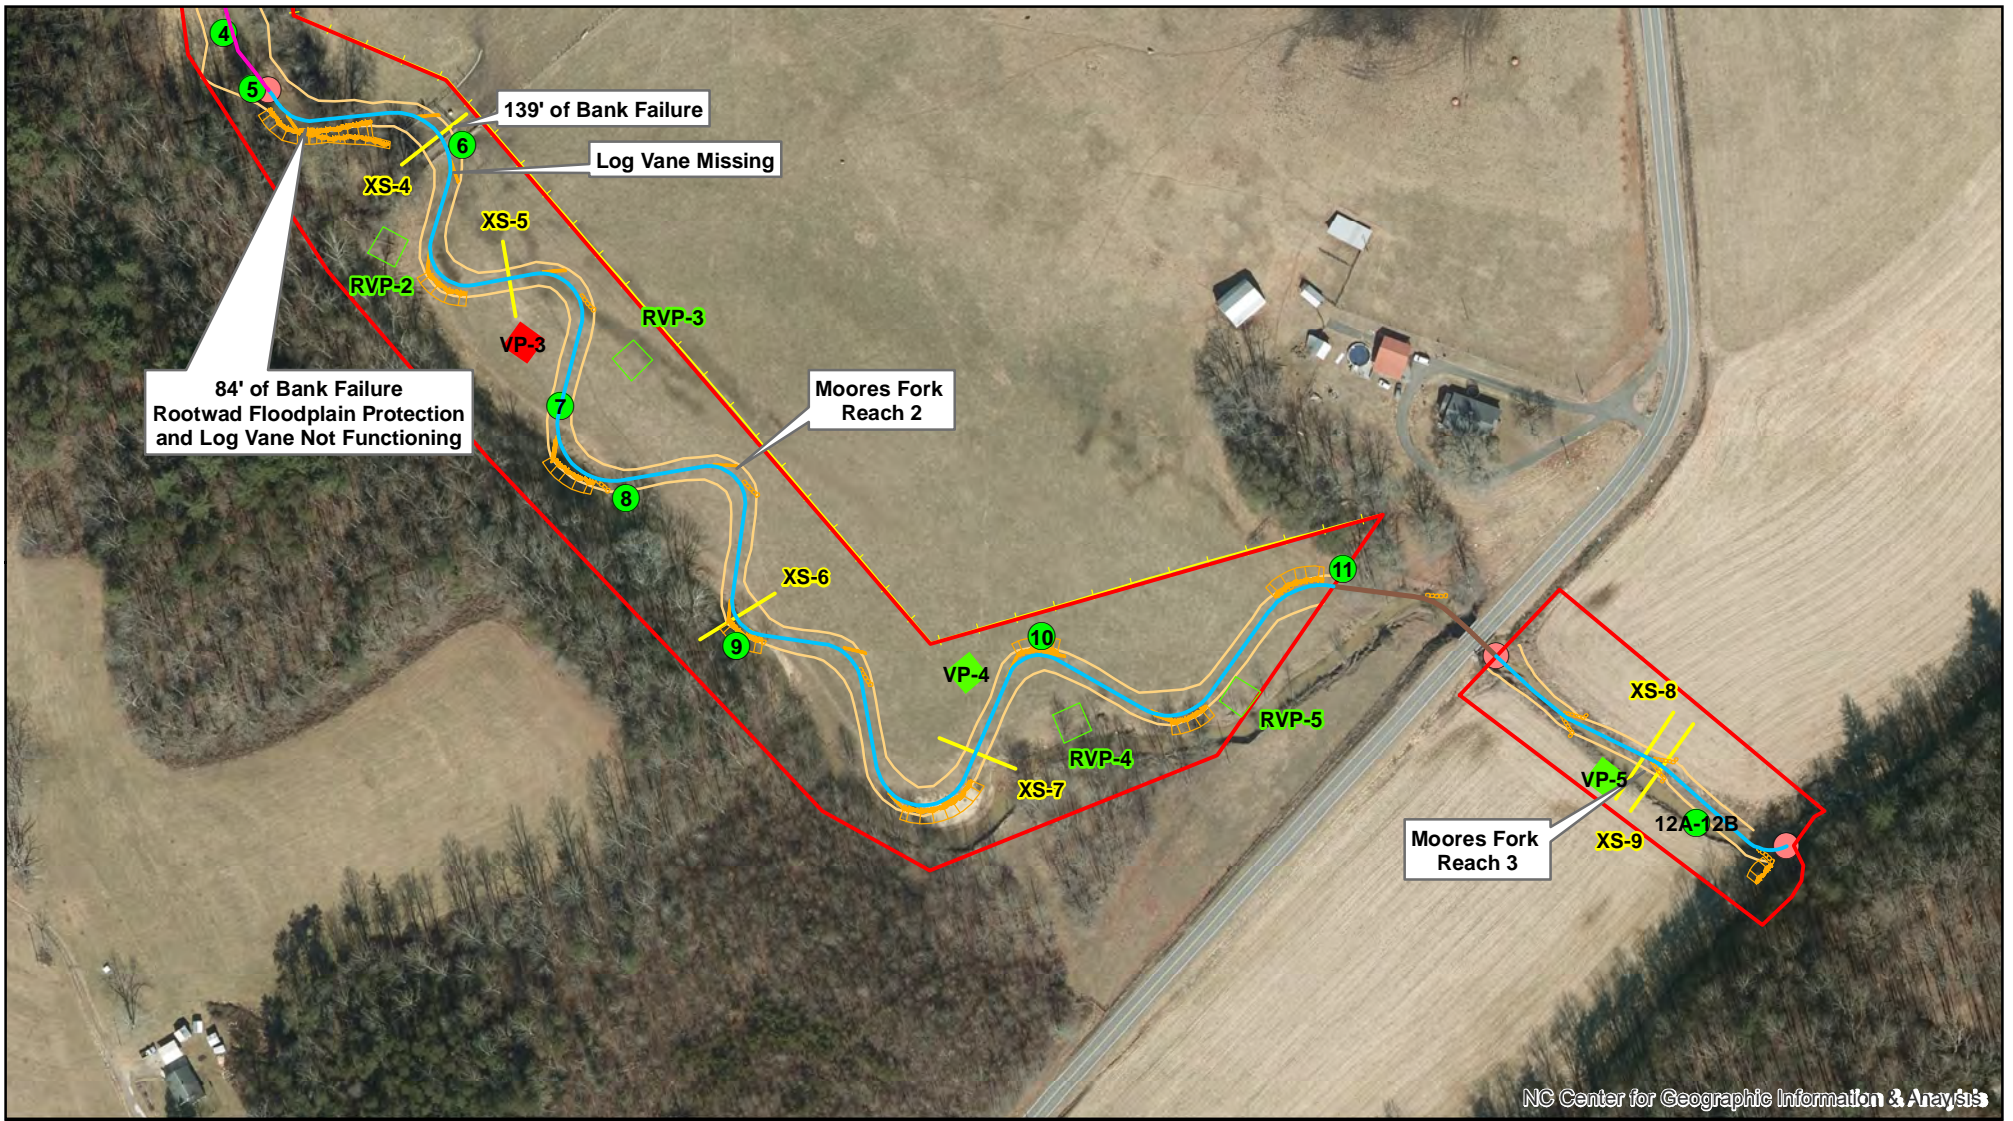
**STEWARTS CREEK TRIBUTARIES**  
**STREAM RESTORATION PROJECT**  
 CURRENT CONDITION PLAN VIEW: ASSET MAP  
 MY1: 2020

No vegetation problem areas were noted in MY1 vegetation plots. Riparian herbaceous vegetation that was established after construction appears to be flourishing throughout the Site. There are areas of corn encroachment (0.2 acres) in the easement at the UTs shown in the CCPV (Figures 1B–1E). These areas and any other potential bare areas have been addressed through additional posts and signage made clear to the landowners and will be replanted in Winter of 2020/2021. Additionally, no invasive species vegetation were noted within the conservation easement.
