**Monitoring Year 3 FINAL Monitoring Report**  
**Stewarts Creek Tributaries Stream Restoration Project**  
**Surry County, North Carolina**  
**Yadkin River Basin, Hydrologic Unit Code (HUC) 03040101**

**Data Collection Period:**  
October 2022 – January 2023

**Submission Date:**  
February 2023

NCDEQ Contract No. 7183  
DMS ID No. 100023  
RFP# 16-006993 (Issued 9/16/2016)  
USACE Action ID No. SAW-2017-01508  
DWR ID No. 20171043

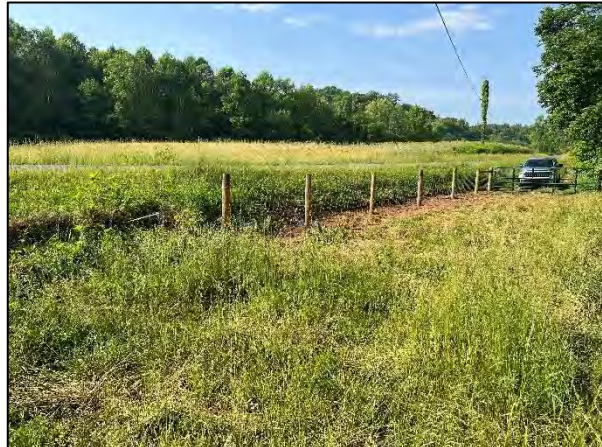
Moores Fork Additional Fencing Off Race Track Road  
MY3 (5/20/2022)

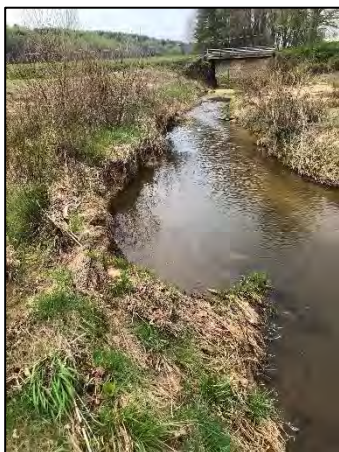
Moores Fork Reach 3, Sta. 49+00  
RB Erosion – MY3 (4/13/2022)

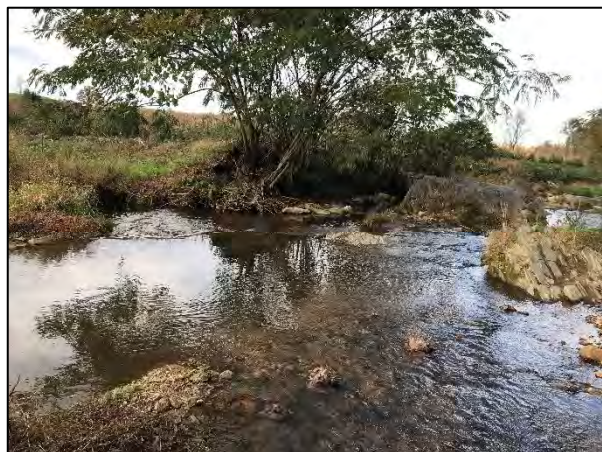
Moores Fork Reach 3, Sta. 51+25  
LB Erosion – MY2 (11/4/2021)
