STILLHOUSE CREEK STREAM RESTORATION – Project # 363
First Annual Monitoring Report –Final
February 2008

CONDUCTED FOR THE NORTH CAROLINA DEPARTMENT OF ENVIRONMENT
AND NATURAL RESOURCES

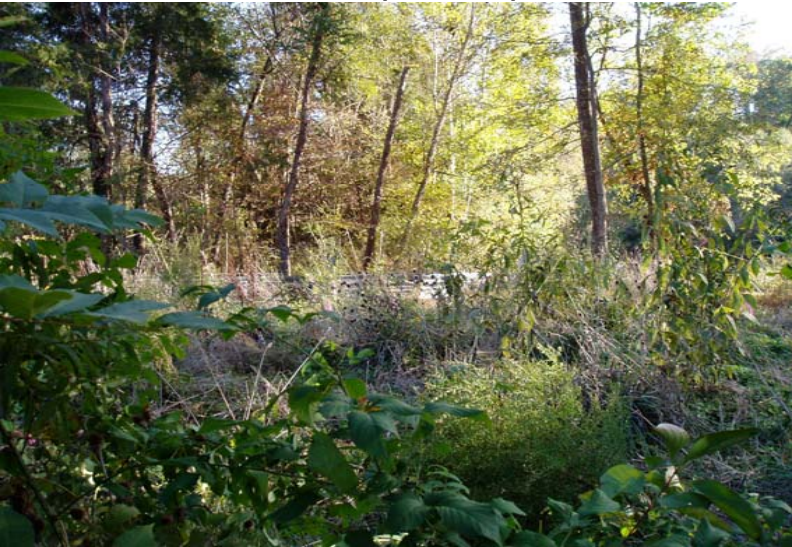
Plot 3 (10/31/07)

In Reach 3 (Figure A1) the terrace across from vegetation monitoring plot 3 (Stations 715-830) has sufficient planted stem survival, but vigor is low. This may be due to poor soils or soil compaction that occurred prior to or during construction. The right top of bank area near cross-sections 4 and 5 (Stations 1000-1060) has a low survival of planted woody vegetation. Although, sedges and other non-woody vegetation are well-established in this area, it should be monitored in case remedial action is needed in the future. No remediation is recommended at this time.
