STILLHOUSE CREEK STREAM RESTORATION – Project # 363
2009 FINAL MONITORING REPORT – YEAR 3
January 2010

STILLHOUSE CREEK STREAM RESTORATION – PROJECT #363
2009 FINAL MONITORING REPORT – YEAR 3

CONDUCTED FOR THE NORTH CAROLINA DEPARTMENT OF ENVIRONMENT
AND NATURAL RESOURCES

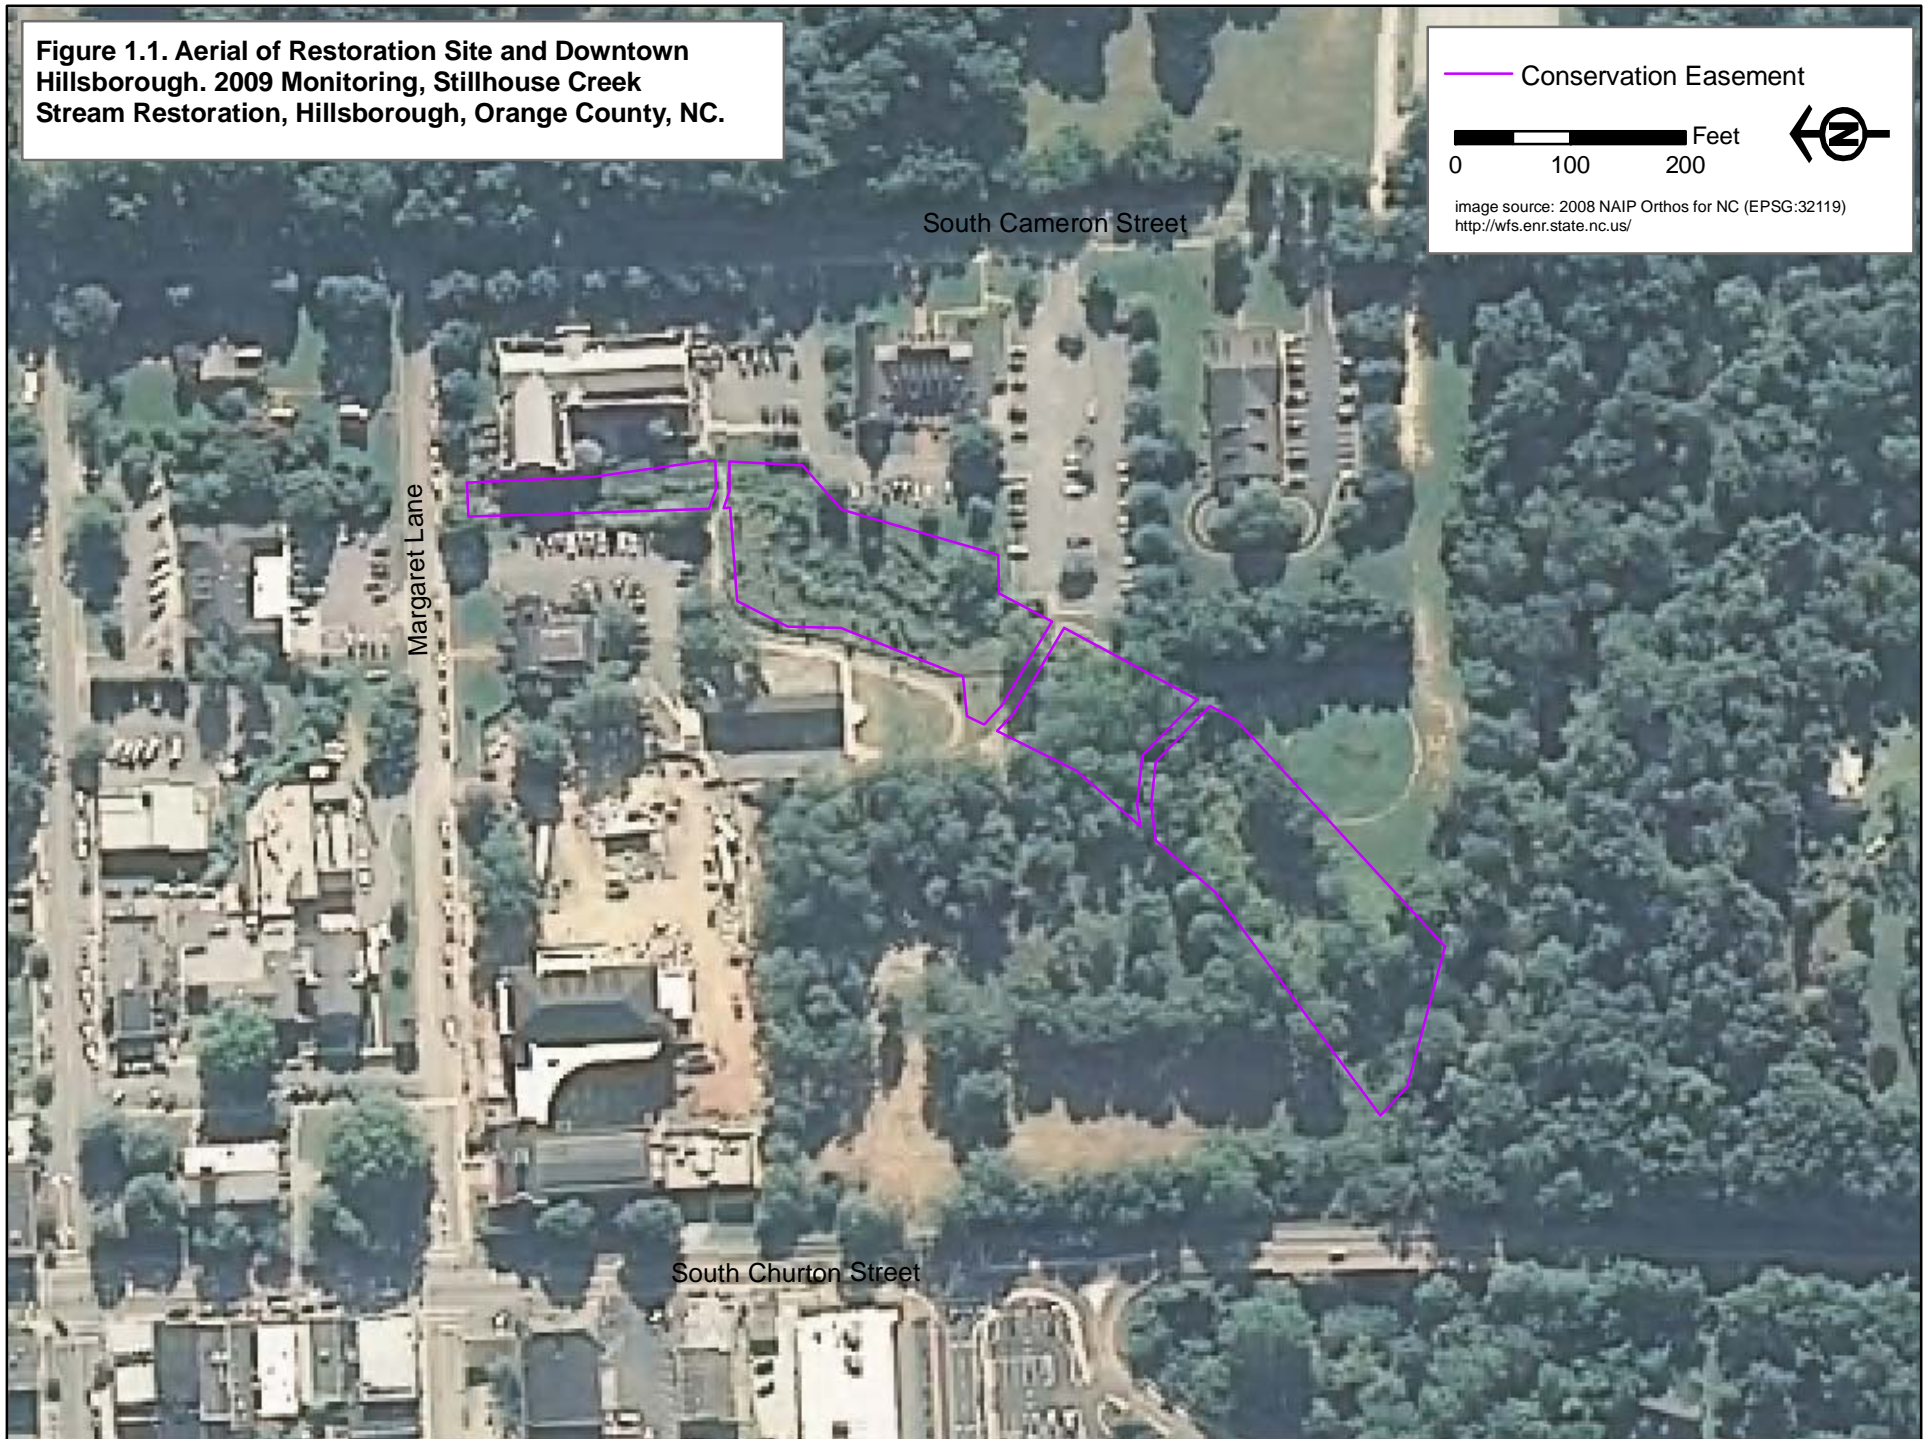
**Figure 2.0. Current Conditions Plan View
2009 Monitoring, Stillhouse Creek Stream
Restoration, Hillsborough, Orange County, NC**

Vegetation Problem Areas
 ■ Debris in Buffer
 ■ Low Planted Stem Success
 ■ High Invasive Vegetation Density
