# Stonebridge Stream Mitigation Project

## Year 1 Monitoring Report

December 2006

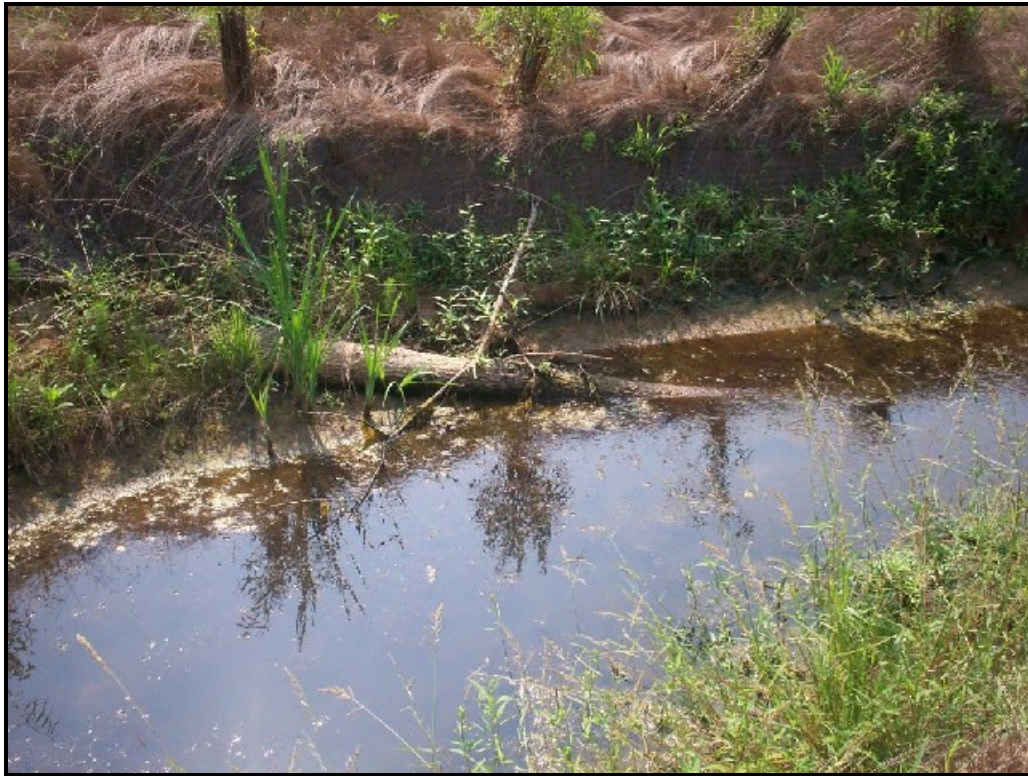
**Photo 1. Log vane structure-looking downstream.**

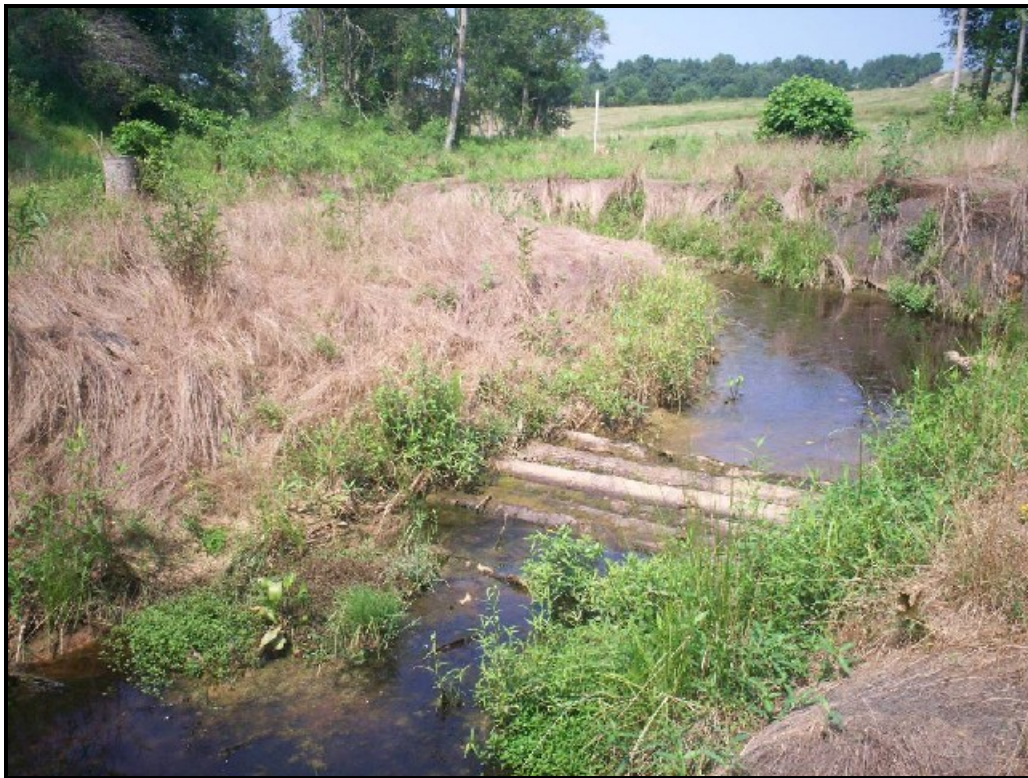
**Photo 2. Log ramp structure-looking upstream.**

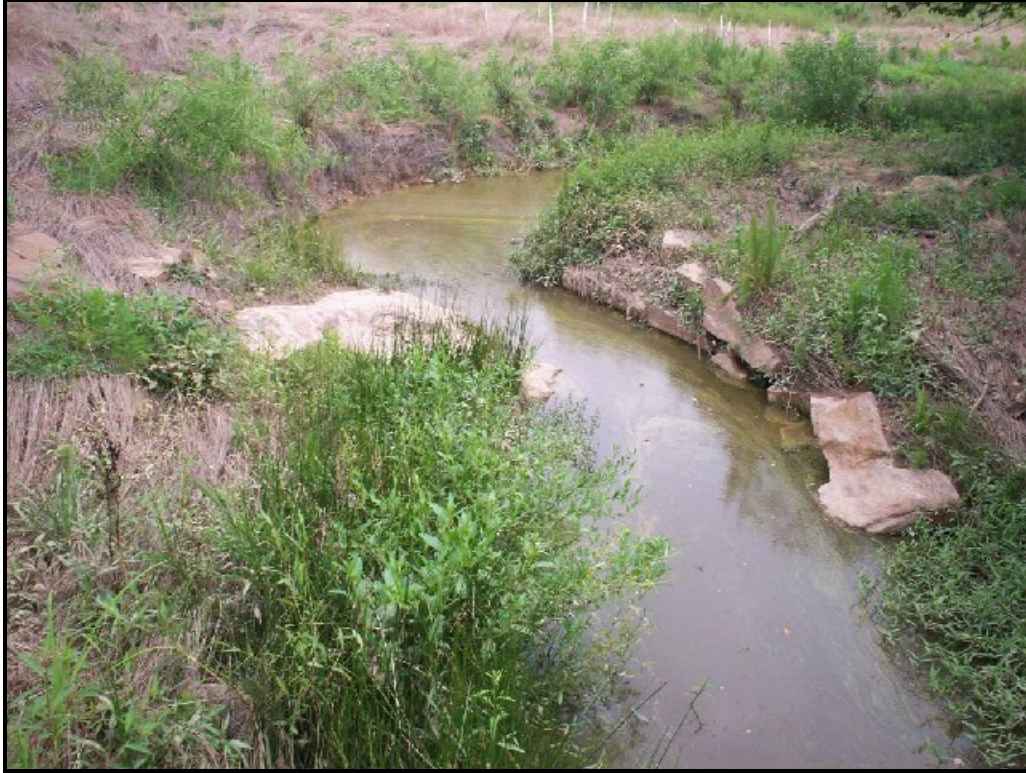
**Photo 5. Stream channel; rock bank stabilization, looking upstream.**

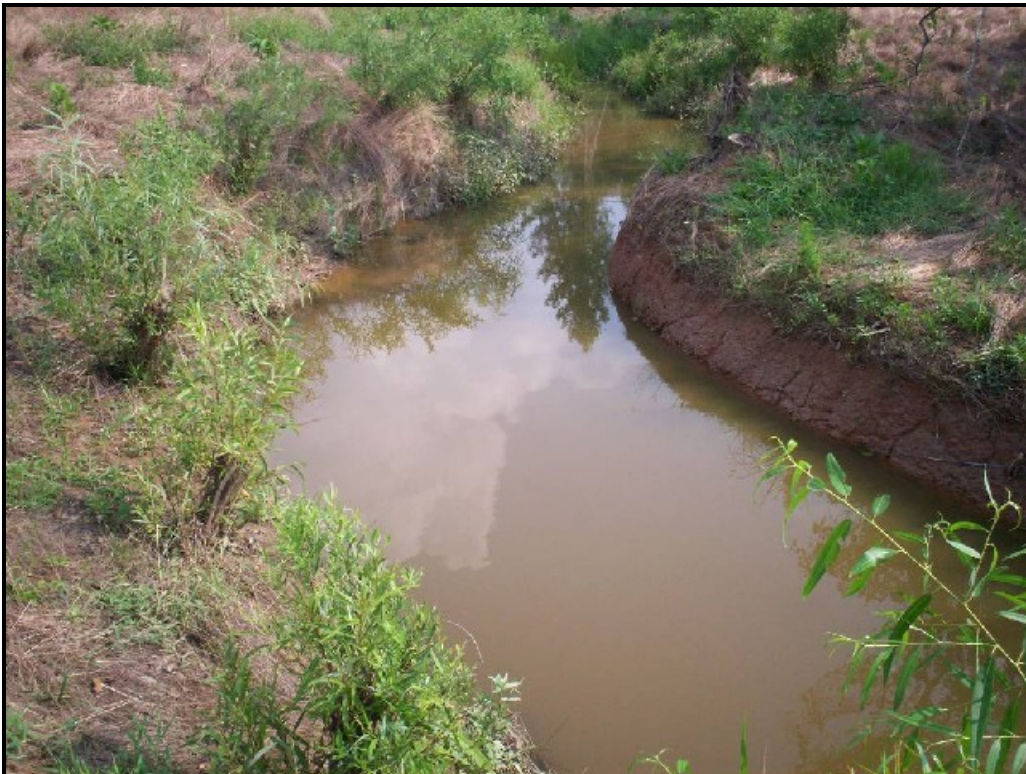
**Photo 6. Stream channel; looking downstream, notice live stake bundles on left bank.**

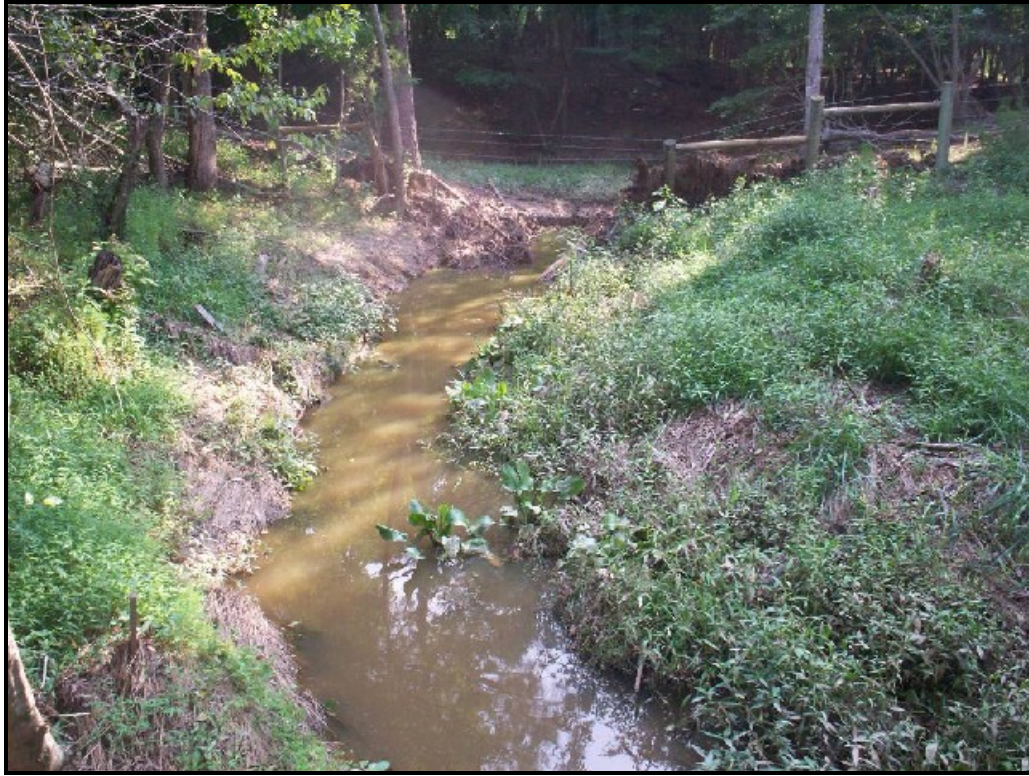
**Photo 7. End of the project-looking downstream.**
