**Stonebridge Mitigation Project  
Moore County, North Carolina**

**Year 2 Monitoring Report**

**November 2007**

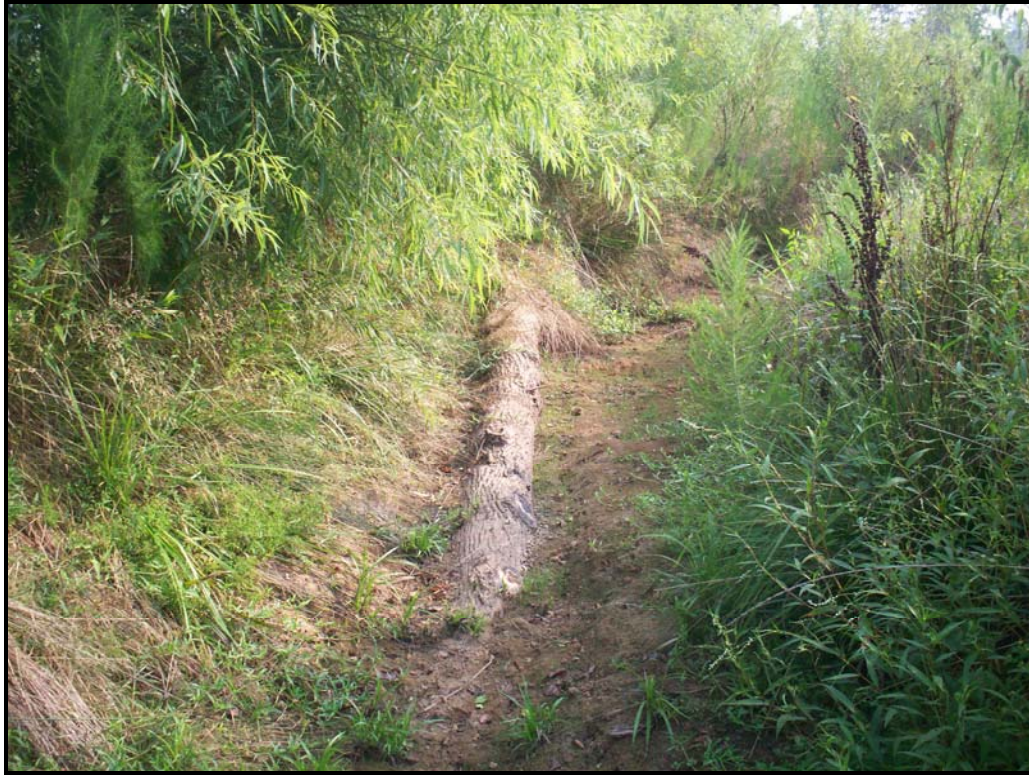
**Photo 1. Log vane structure at STA 26+00 -looking downstream.**

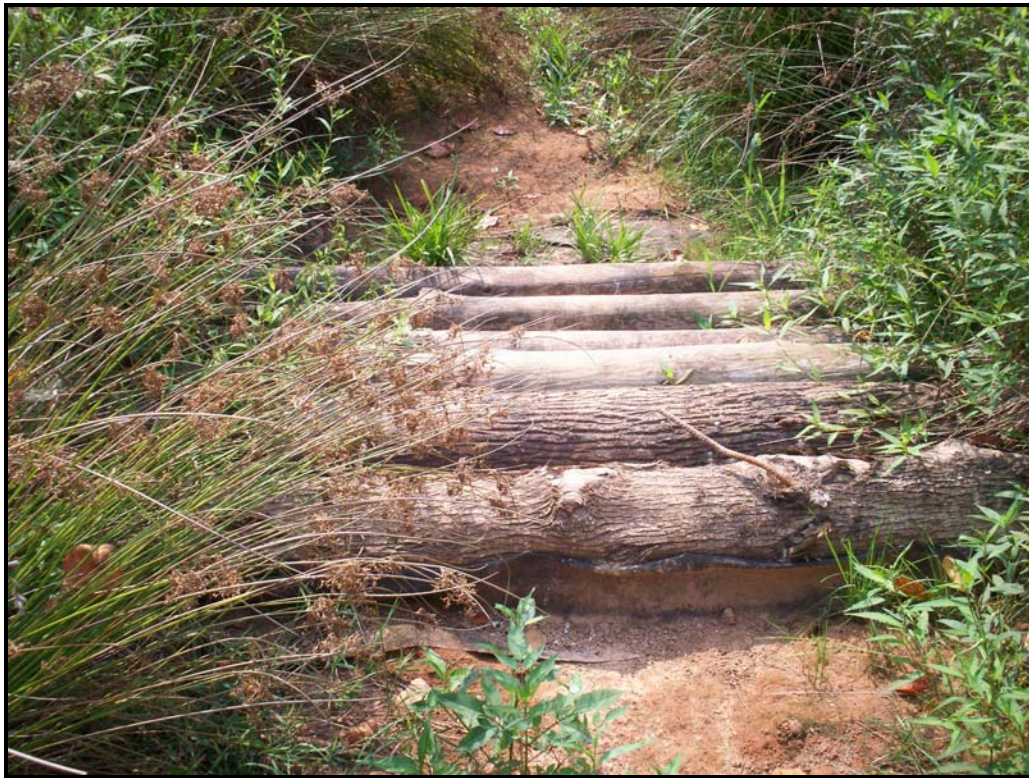
**Photo 2. Log ramp structure at station 10+90 - looking downstream.**

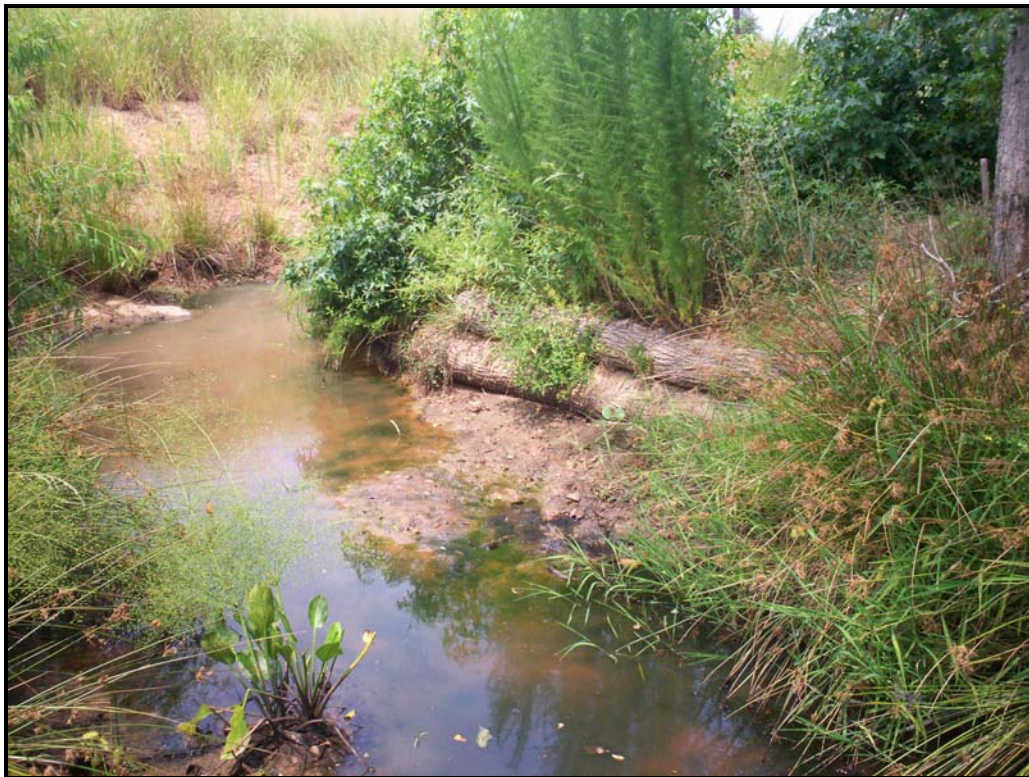
**Photo 4. Log Toe at station 49+10 –looking downstream.**

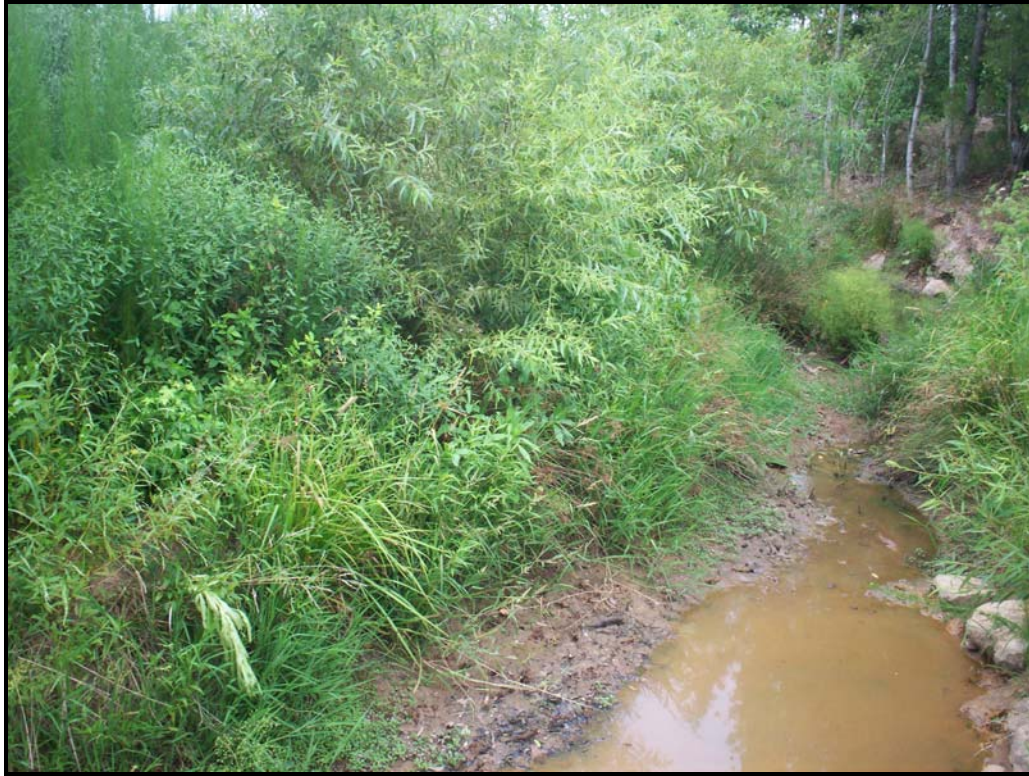
**Photo 5. Stream channel with well vegetated banks-looking downstream at STA 48+75.**

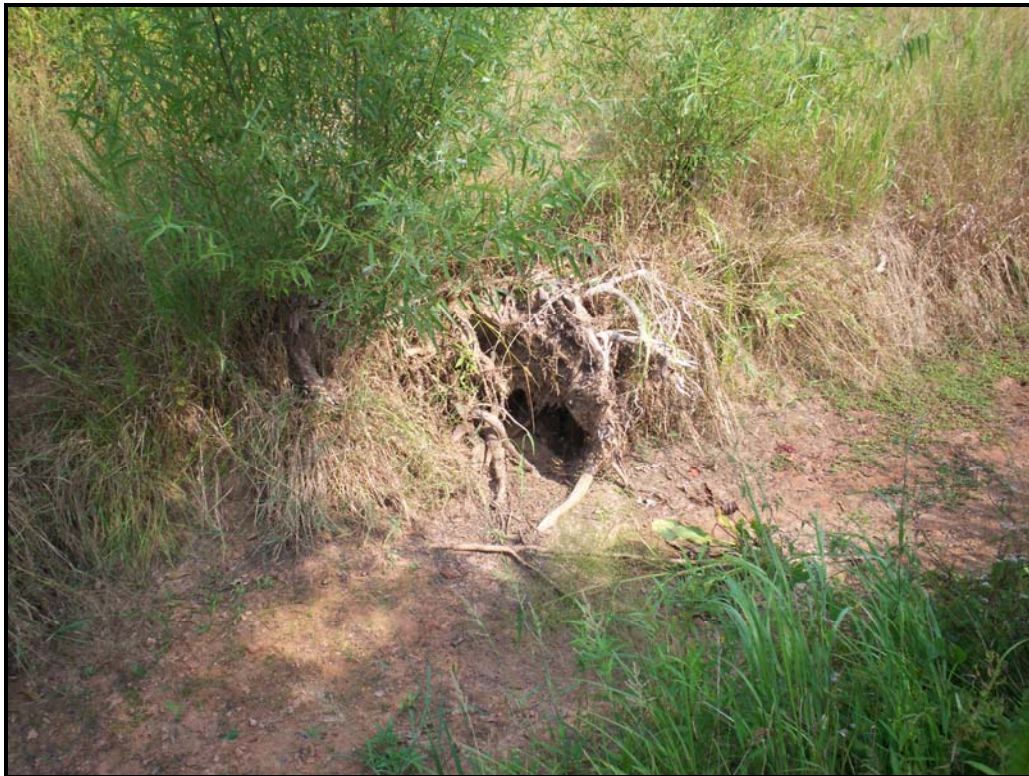
**Photo 6. Rootwad on left bank at station 8+00-looking downstream.**
