**Stonebridge Mitigation Project
Moore County, North Carolina**

Year 3 Monitoring Report

October 2008

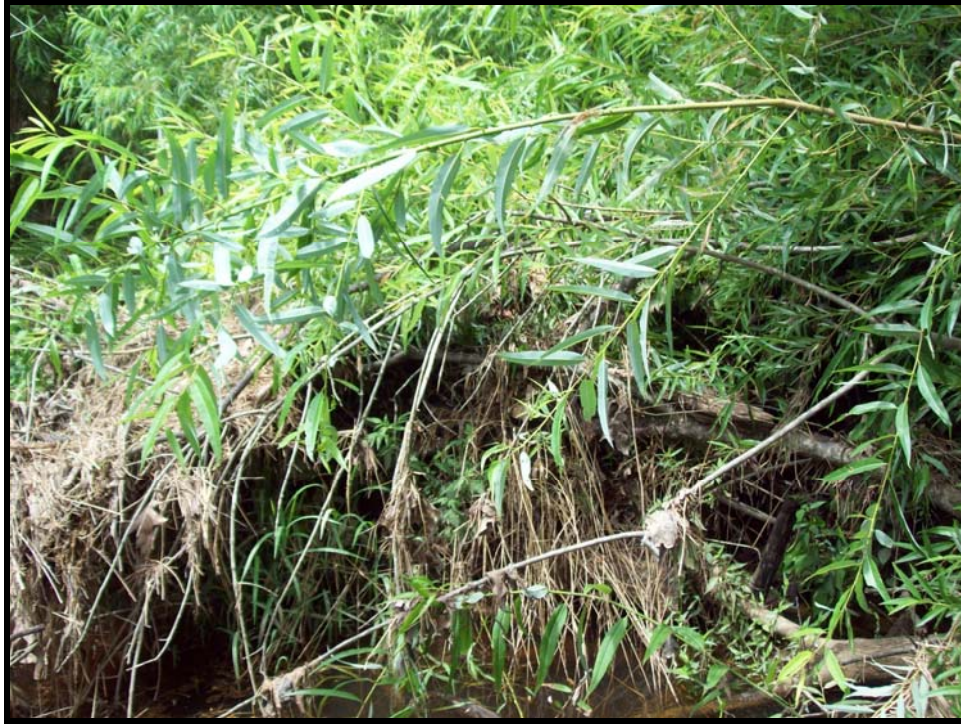
SPA 1. Debris jam at Station 32+50.

The stream morphology is stable. Very little fluvial erosion was observed. Sedimentation that has occurred in the stream channel is minor and does not need to be addressed at this time. Removal of the debris jams at stations 32+50 and 46+50 are recommended to help reduce channel blockage, which could cause bank erosion. The fence near station 48+50 should be repaired to prevent further bank damage from cattle entering the channel. The vegetation is generally surviving well.

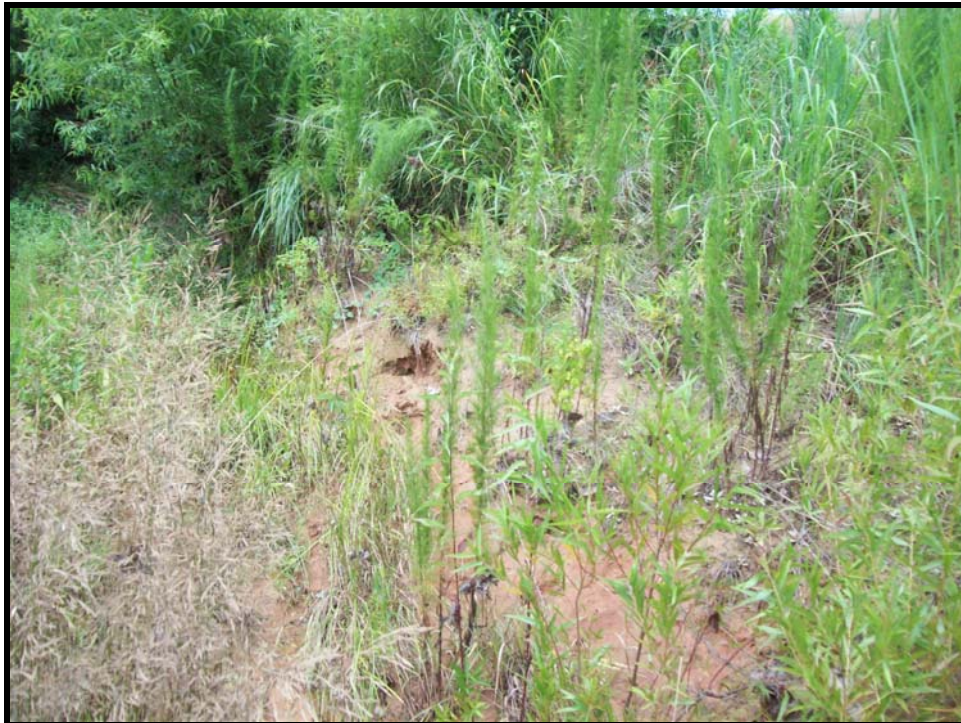
SPA 2. Minor erosion on left bank at Station 34+00.

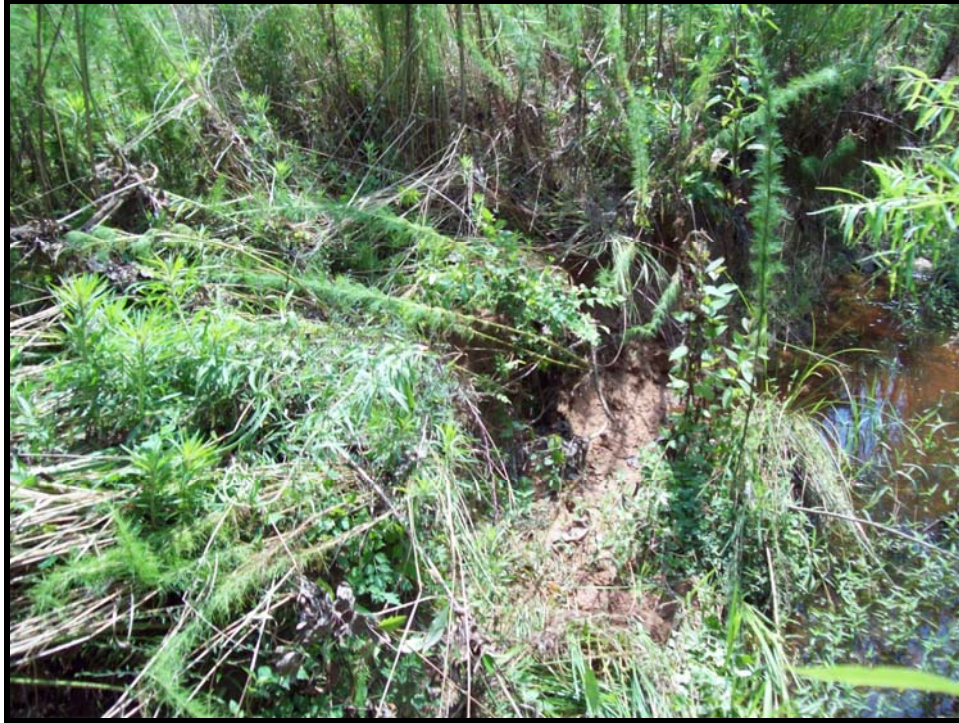
SPA 3. Minor erosion on right bank at Station 40+25.

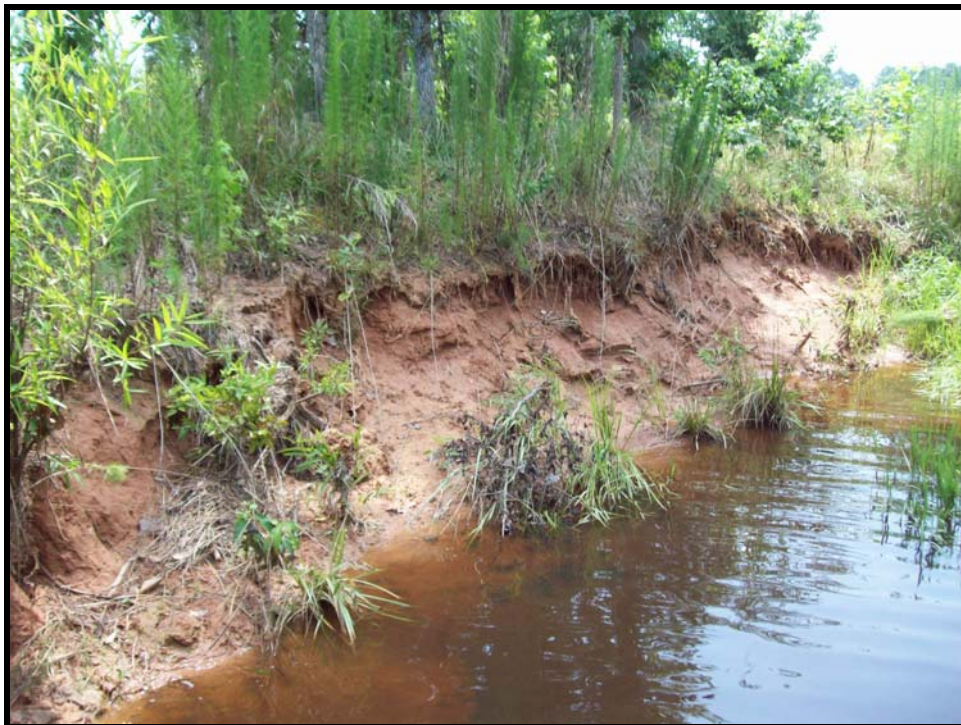
SPA 6. Erosion on right bank at Station 47+50.

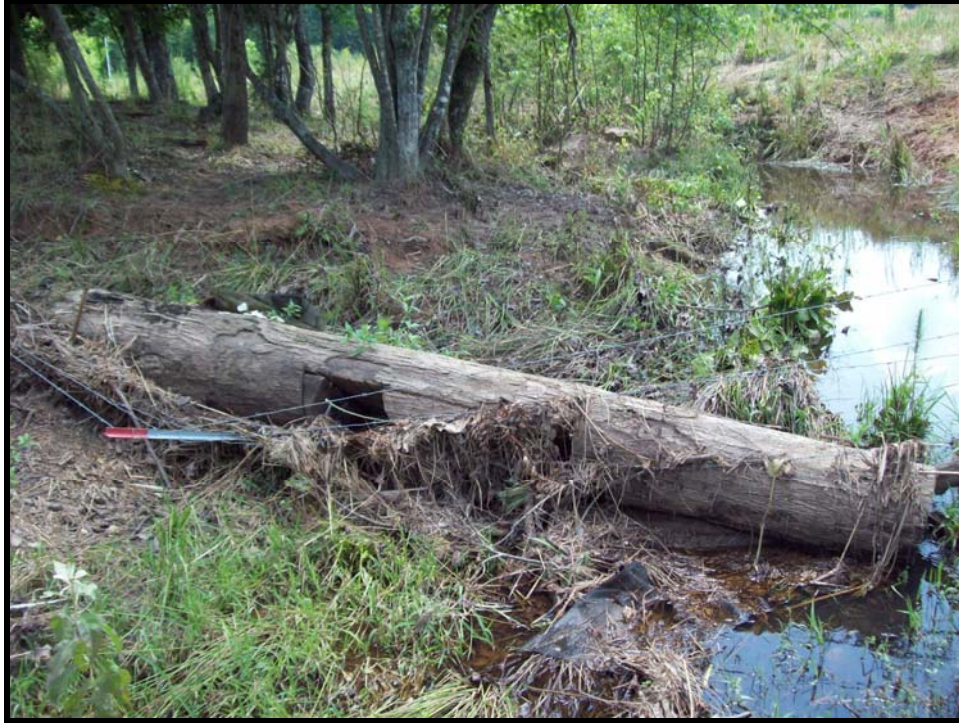
| SPA | Reach | Station | Description | Recommended Action |
|---|---|---|---|--|
| 7 | UT1 | 48+50 | Fence knocked over by displaced log toe structure | Repair fence |

SPA 7. Fence knocked over by displaced log toe structure at Station 48+50.

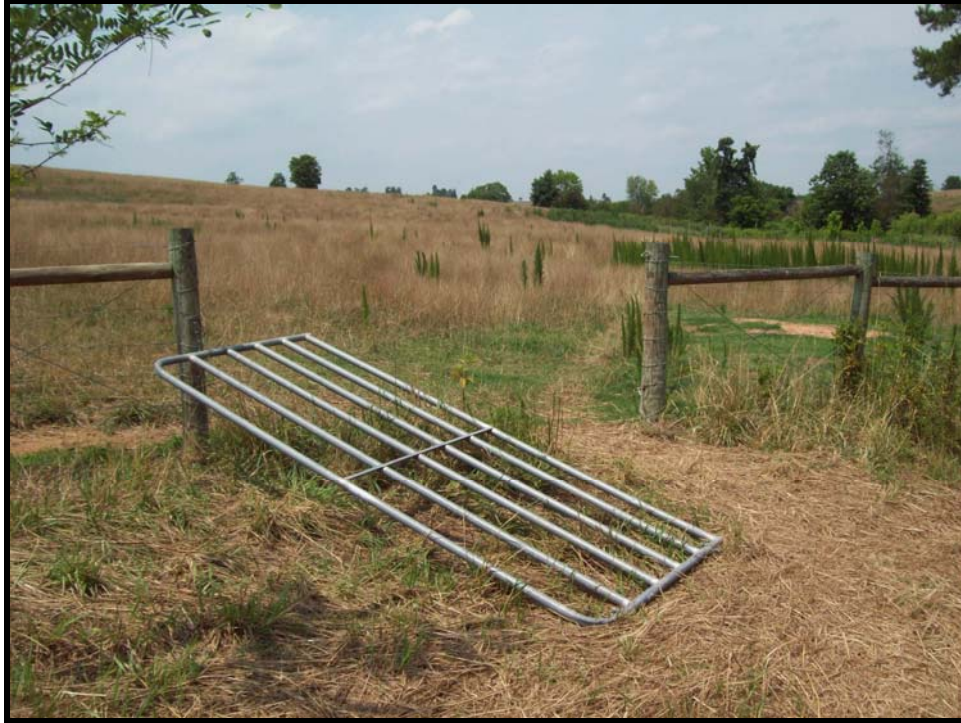
| SPA | Reach | Station | Description | Recommended Action |
|---|---|---|---|--|
| 10 | UT1 | 49+00 | Cattle gate off hinges allowing cattle to access the easement | Repair gate; remove cattle from easement |

SPA 10. Cattle gate off hinges at Station 49+00.

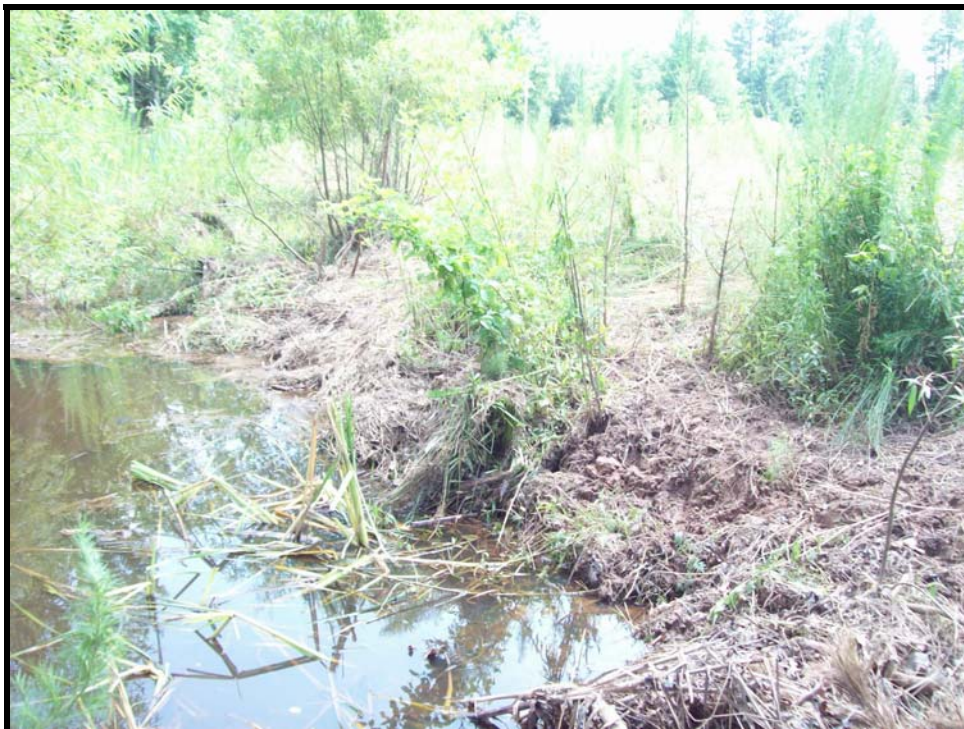
SPA 11. Erosion on left bank due to cattle at Station 49+50.

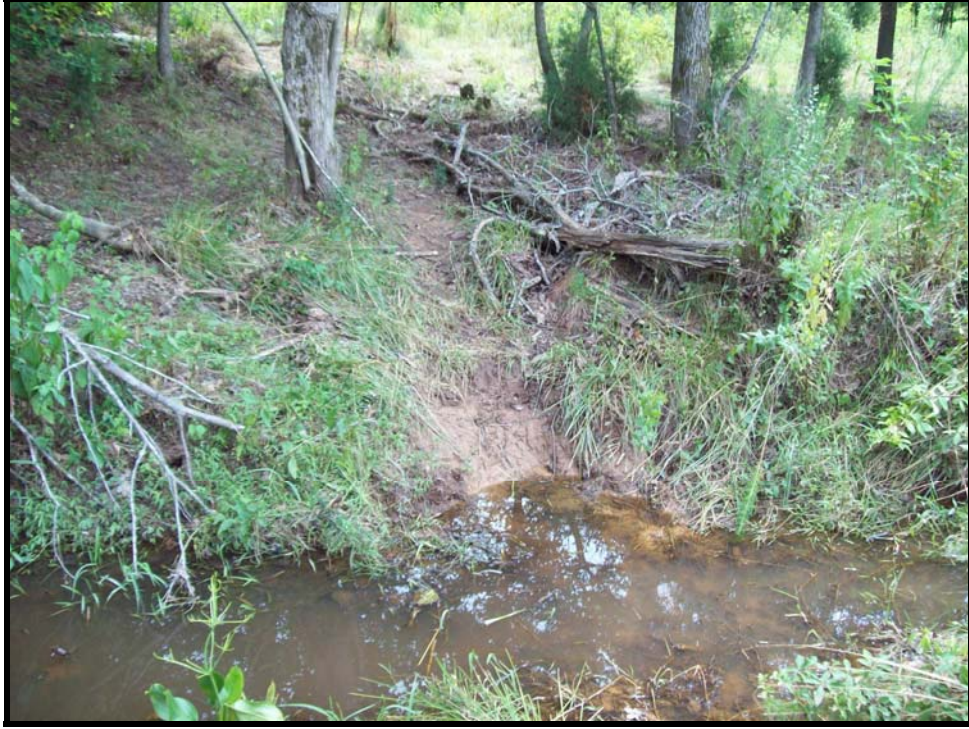
SPA 12. Erosion on right bank due to cattle hoof shear at Station 53+00.
