**Stonebridge Mitigation Project
Moore County, North Carolina**

FINAL Year 5 Monitoring Report

September 2010

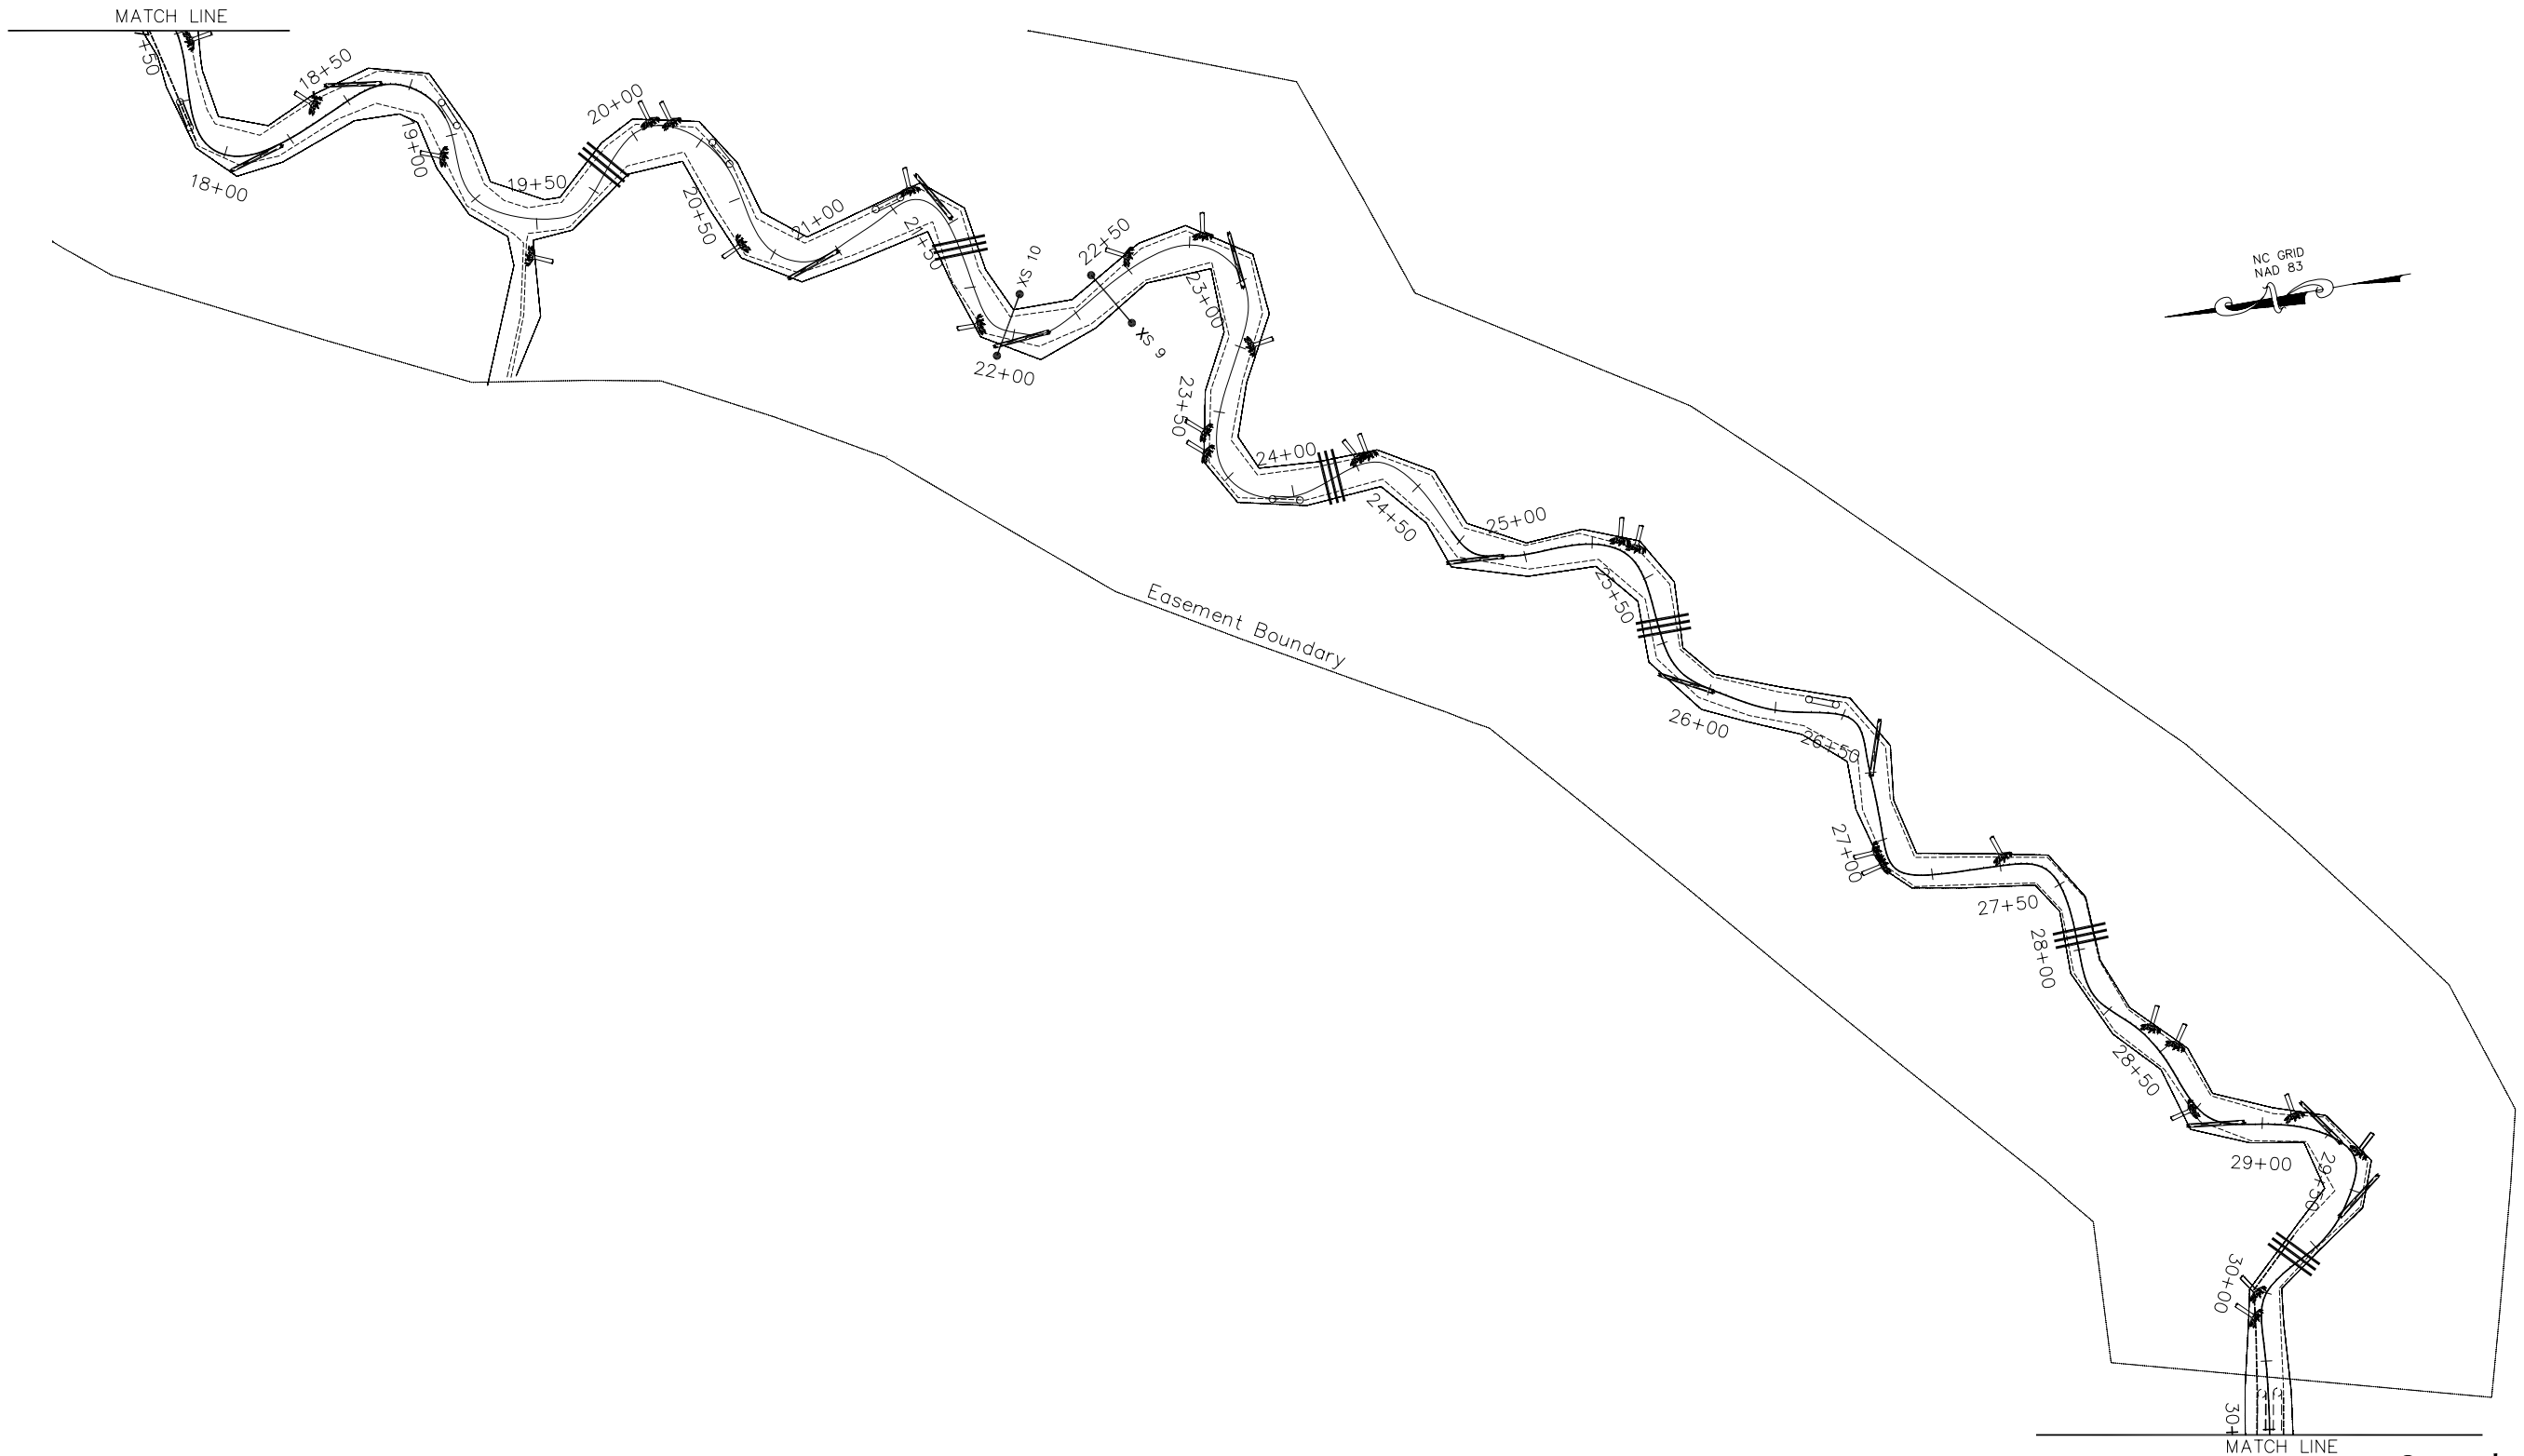
Figure 4A

A number of minor issues were observed, but no remedial action is recommended (**Table 8**). Most previous issues have stabilized or are becoming stable. Minor erosion present along some of the banks is due to the cattle intrusion described earlier, and in the buffer area, trampled herbaceous vegetation is localized. No impacts to stream stability were observed and the cattle have been removed. Water is flowing around a log grade control structure and a log vane, causing minor erosion (SOA4, SOA5, and SOA6). A minor headcut has stabilized due to vegetation.

Feature	STA	Description	Photo Number
Bank Erosion and Buffer Vegetation Trampled	UT1 48+50, 33+50 to 30+90 UT 2 throughout	Minor damage due to cattle incursion and bank remains stable. No action recommended.	SOA 1
Right Bank Erosion	UT1 47+50 to 47+80	Minor erosion on right bank. Area has nearly stabilized since previous monitoring survey observation in 2009.	SOA 2
Right Bank Erosion	UT1 40+15 to 40+60	Minor erosion on right bank.	SOA 3
Log Grade Control Right Bank	UT2 2+50	Bank undercut along right bank at log grade control. Channel is stable and no headcut was observed. No action recommended.	SOA 4
Log Vane	UT1 16+00	Log vane undercut with minor headcut upstream. Channel upstream and downstream stable. No action recommended.	SOA 5
Log Vane	UT1 11+00	Log vane undercut. Channel upstream and downstream are stable and unaffected. No action recommended.	SOA 6
Headcut	UT1 2+15	Minor headcut. Vegetation has stabilized the channel.	SOA 7
