East Prong of the Roaring River 2004 Annual Monitoring Report

2004 The East Prong of the Roaring River Monitoring Abstract

This is the 4th year of the 5-year monitoring plan for the East Prong of the Roaring River

Date of Completion	October 2000
Monitoring Dates	2001, 2002, 2003, October 2004

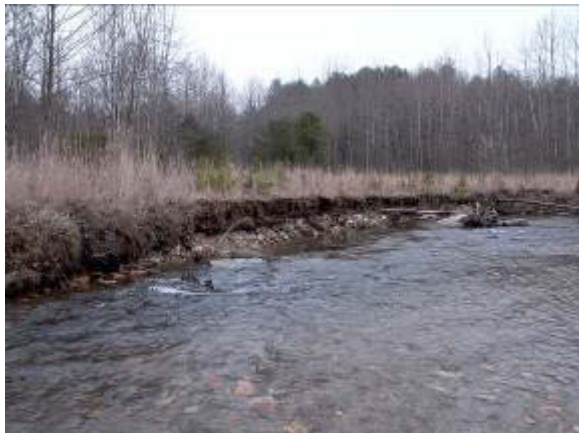
**Issue Photo 1. Bank Erosion STA ~28+75
Reach 2**

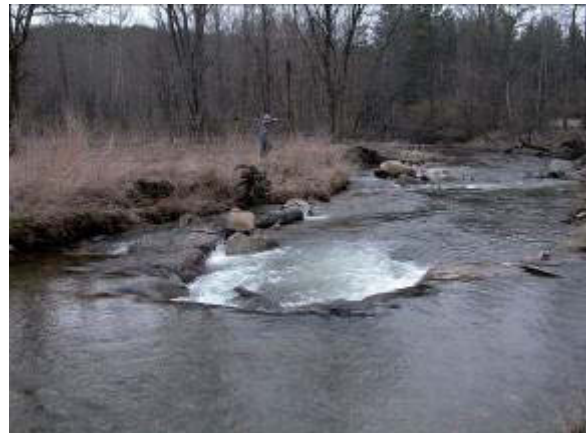
**Issue Photo 2. Erosion Cross Vane STA ~12+90
Reach 4**

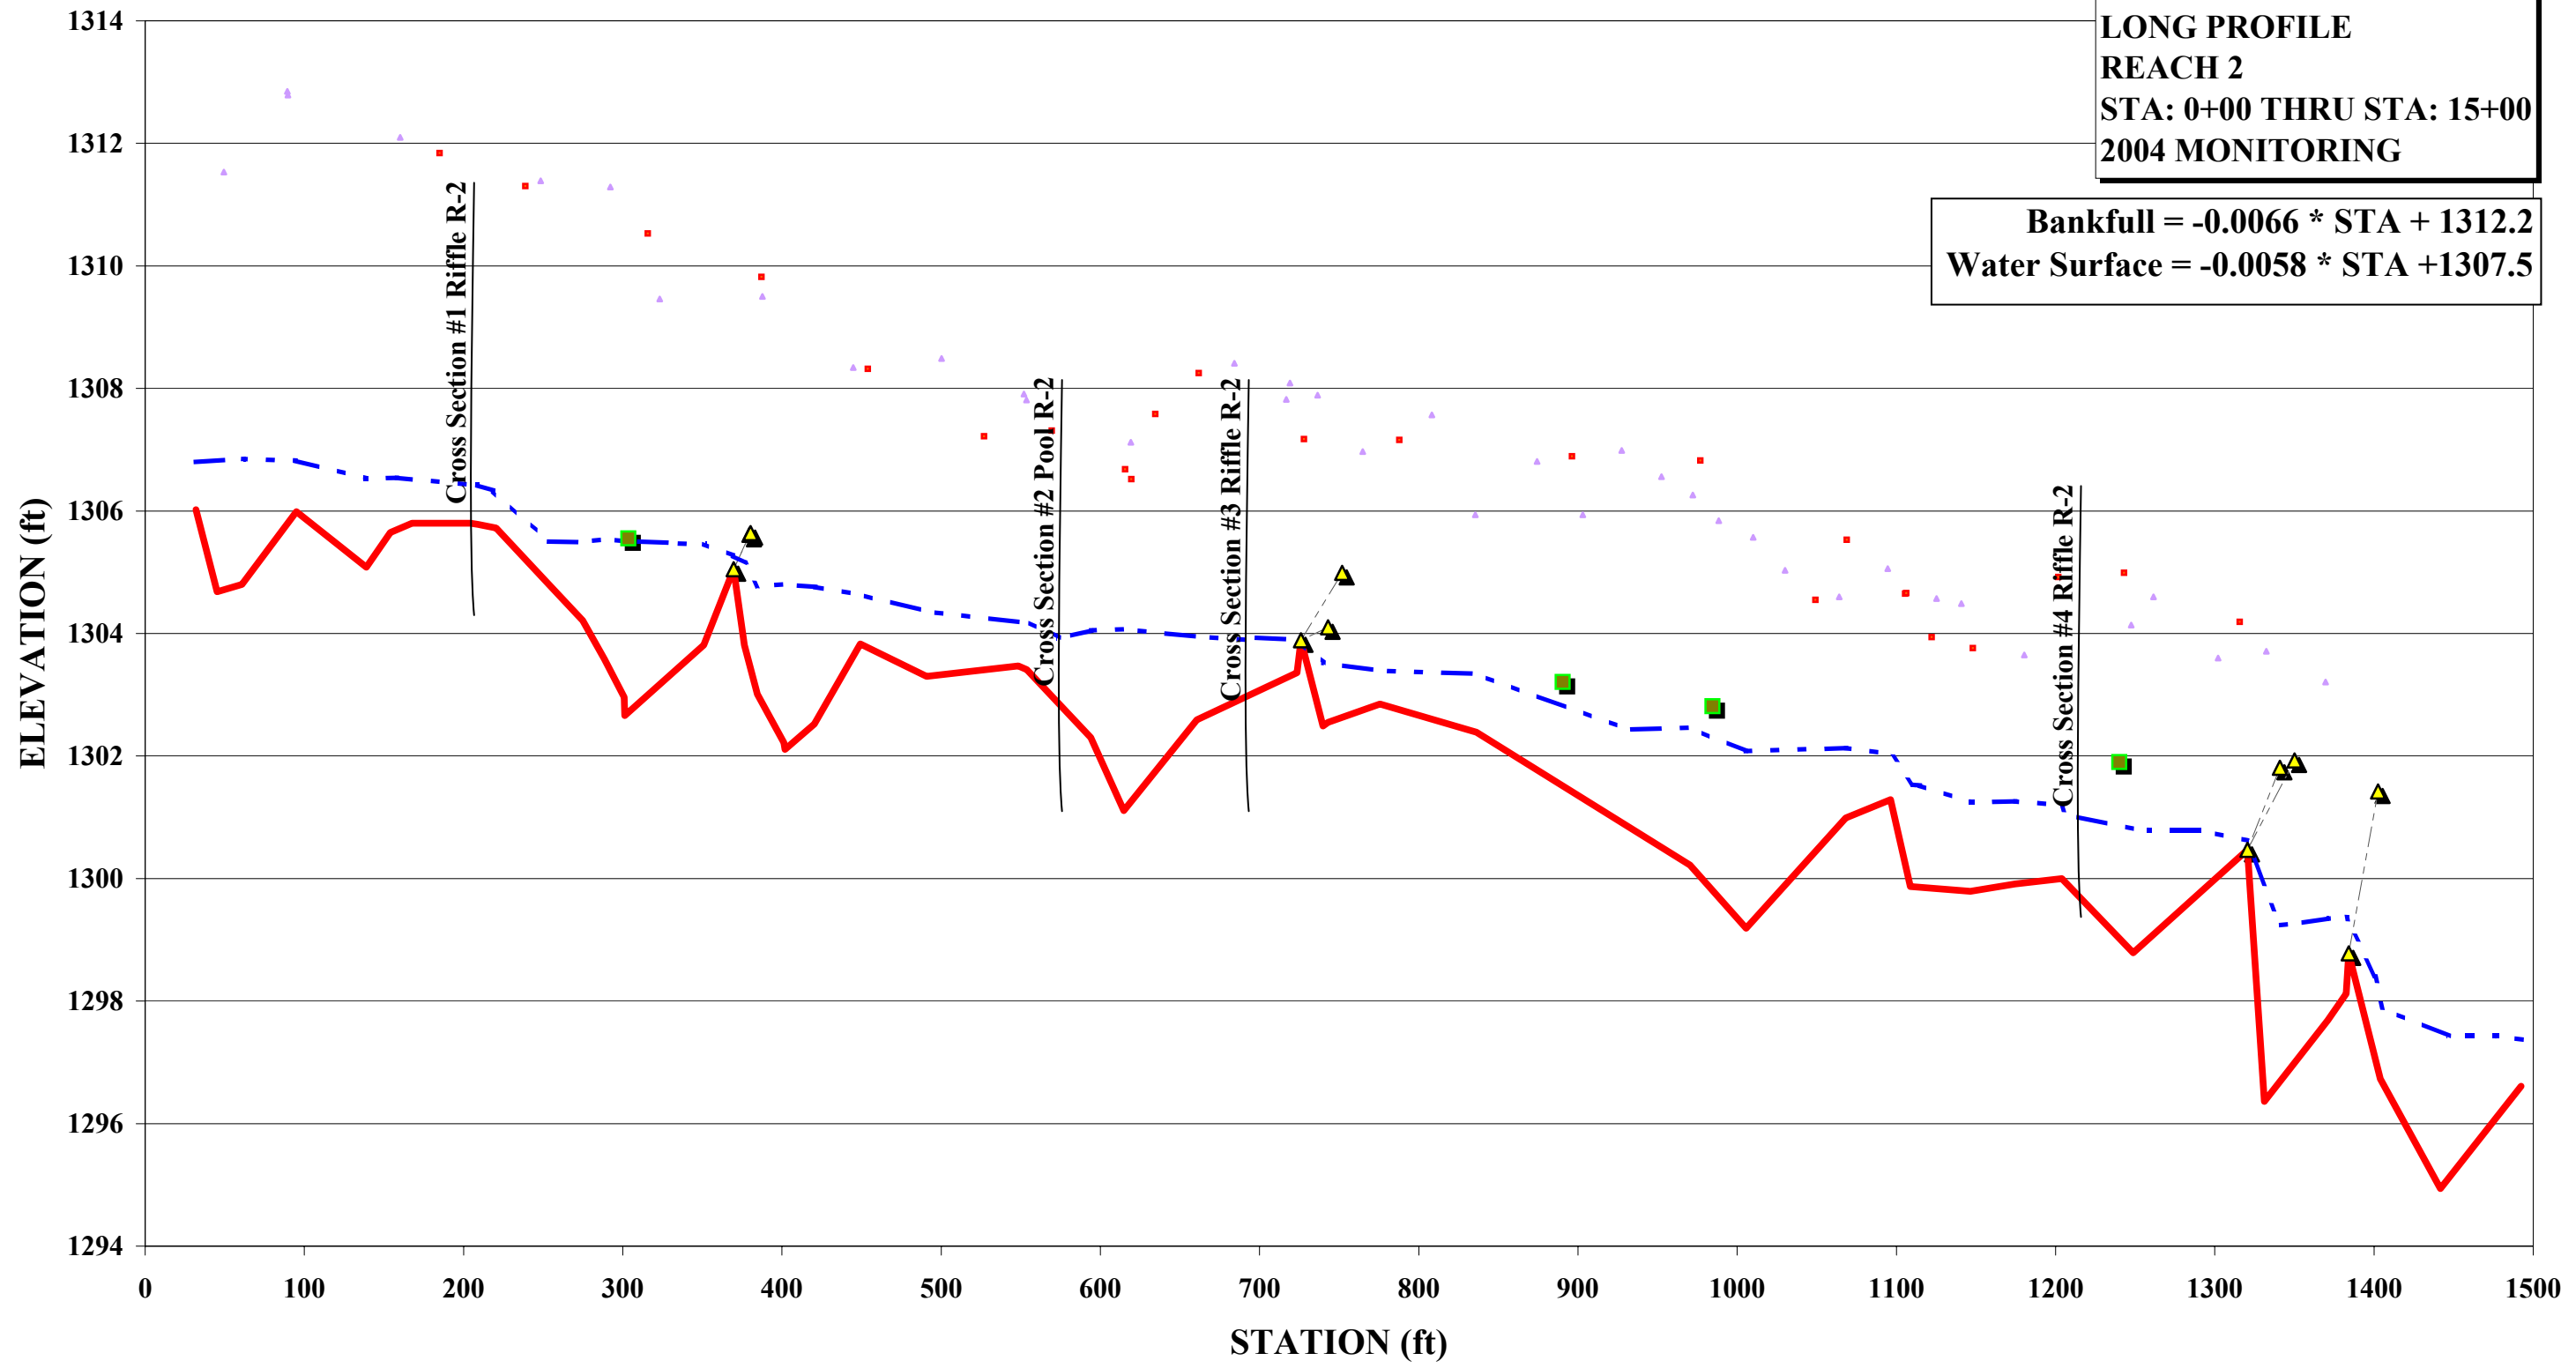
**STONE MOUNTAIN
LONG PROFILE
REACH 2
STA: 0+00 THRU STA: 15+00
2004 MONITORING**

- Rock Cross Vanes
 - There are two rock cross vanes that have piping around the vane arm located on Reach-2 at stations 13+00 and 14+50. If these two structures fail there will be a massive head-cut through the system.

- At station 13+00 there is bank erosion on the left bank and water is piping past the rock cross vane. At this point the structure is still holding grade a lower elevation but ultimate will occur if this vane is not repaired or redesigned.

- At station 14+50 there is bank erosion on the left bank and water is piping past the rock cross vane. At this point the structure is still holding grade at a lower elevation but ultimate failure will occur if this vane is not repaired or redesigned.

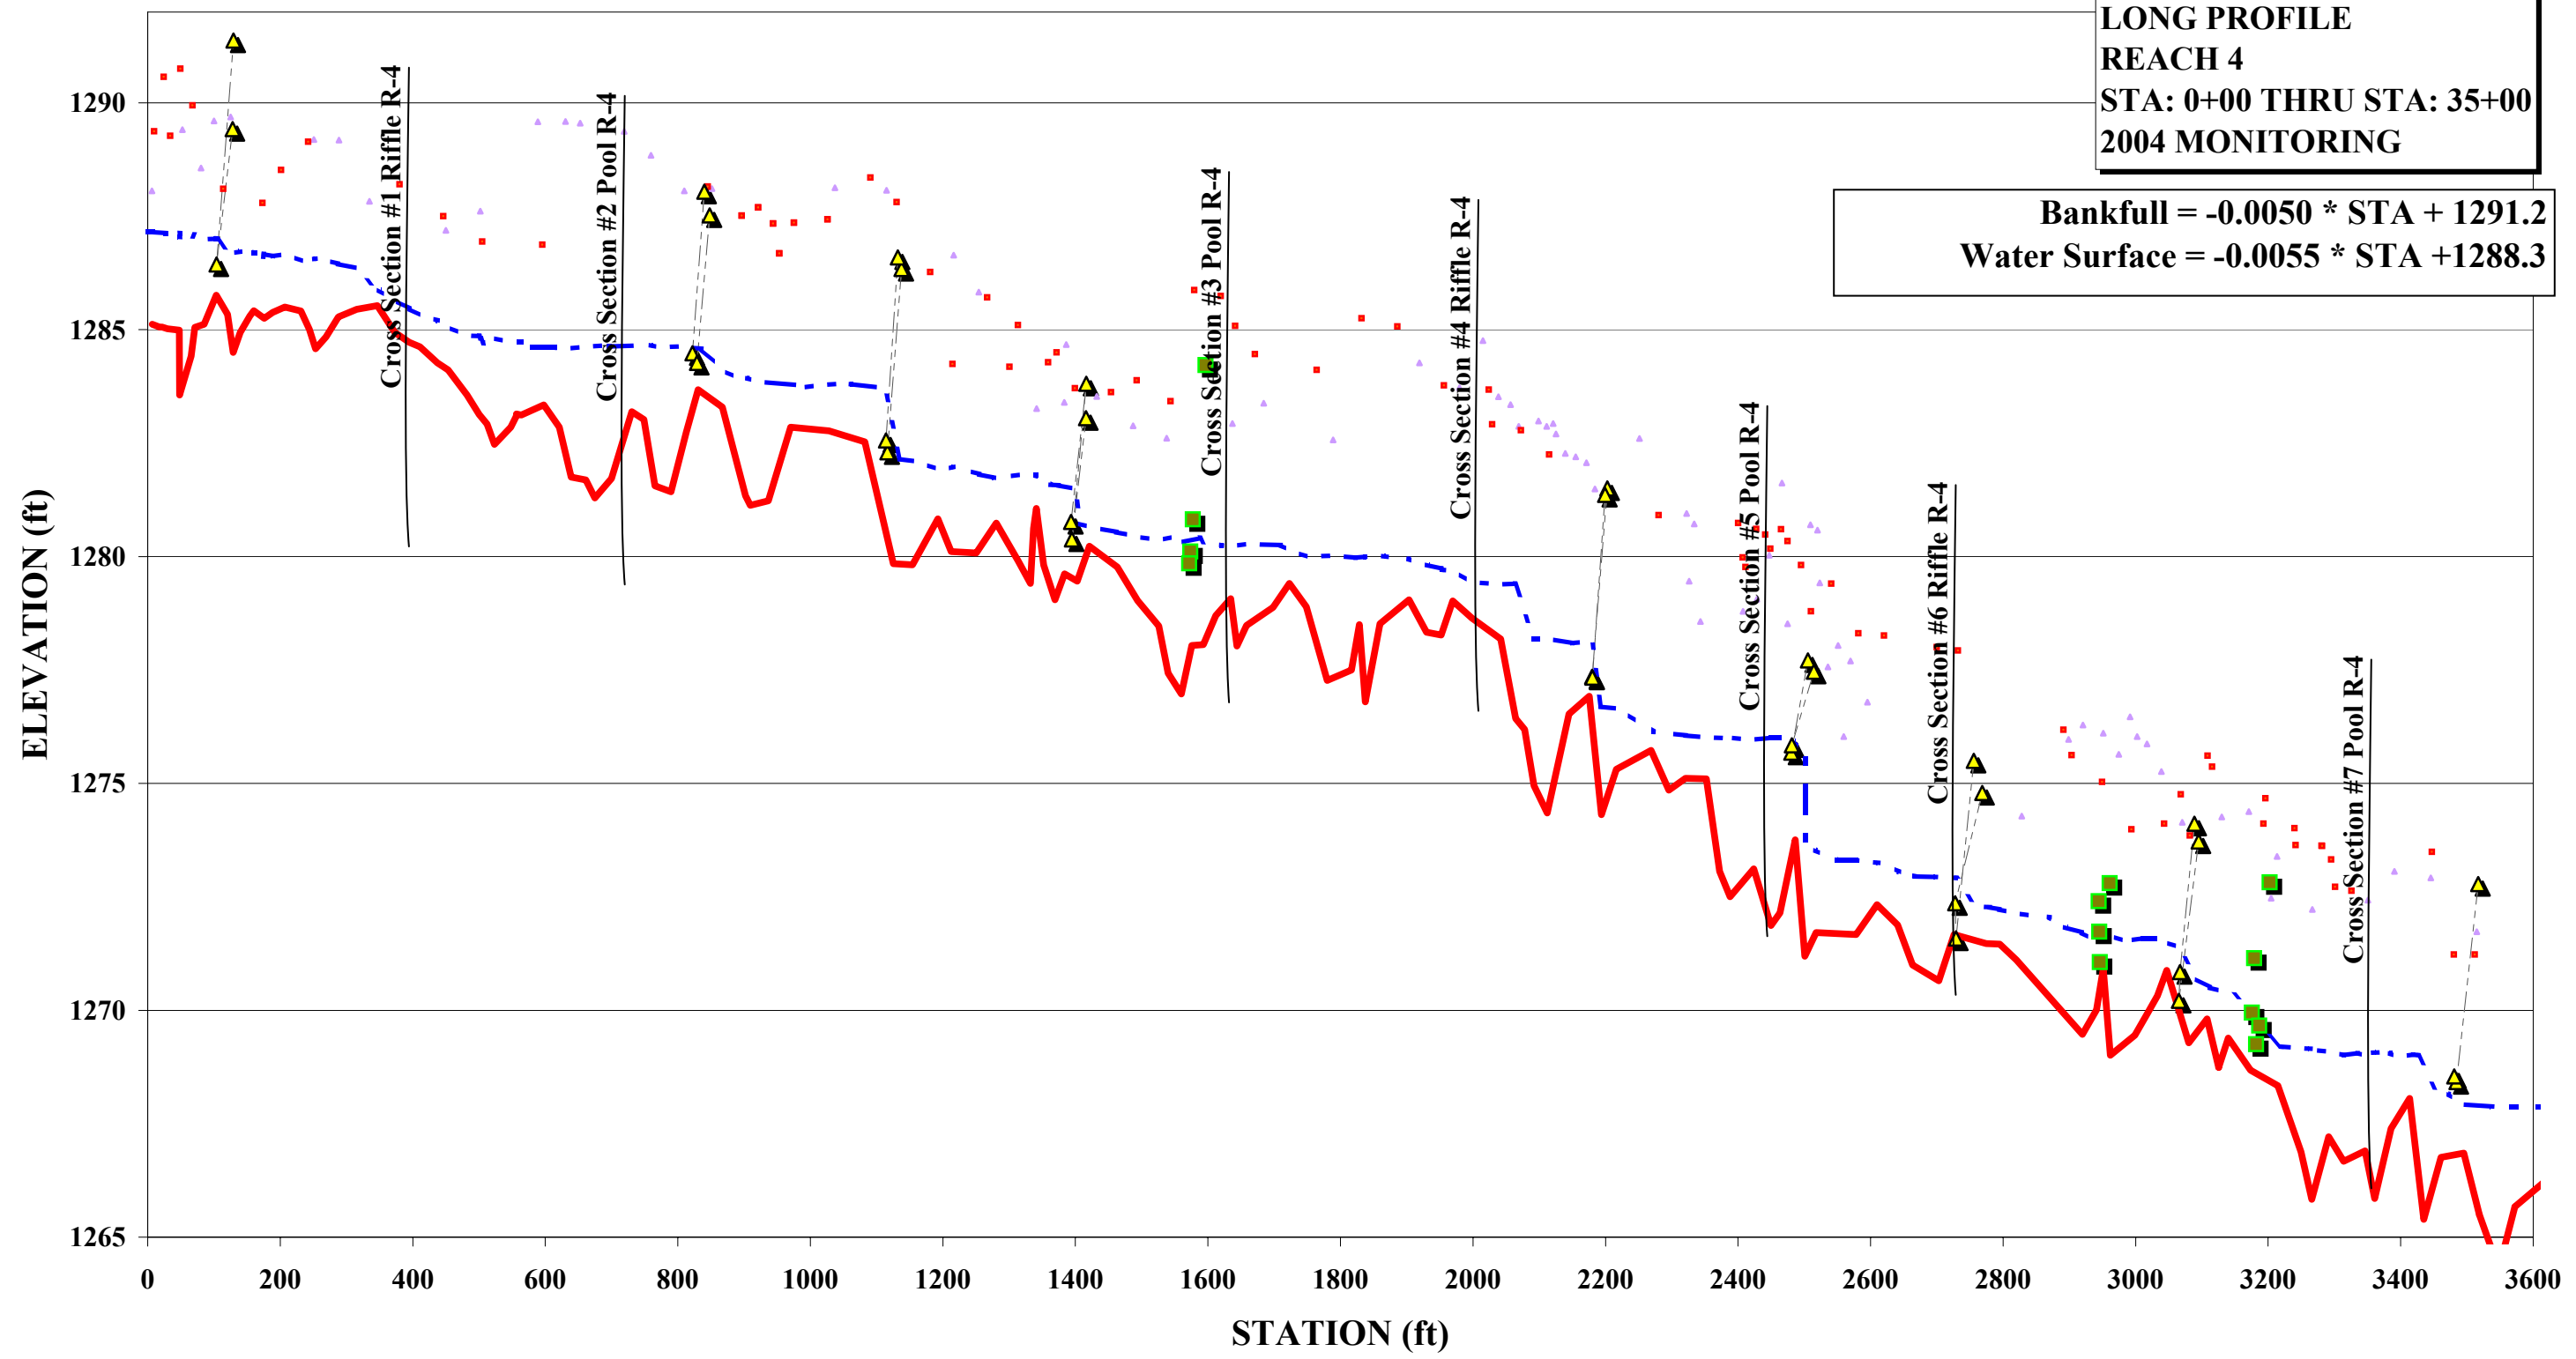
**STONE MOUNTAIN
LONG PROFILE
REACH 4
STA: 0+00 THRU STA: 35+00
2004 MONITORING**

- There is one rock cross vanes that have piping around the vane arm located on Reach-4 at stations 25+20. If these two structures fails there will be a localized head-cut.

- At station 25+20 there is massive bank erosion on the right bank and water is piping past the rock cross vane. At this point the structure is not holding grade ultimate failure will occur if repairs or redesign are not pursued
