**East Prong of the Roaring River at Stone
Mountain State Park
Stream Restoration
Annual Monitoring Report
Monitoring Year: 2008
Measurement Year: 8
As-built Date: 2000
NCEEP Project Number: 364**

Draft Submitted: October, 2008
Final Submitted: May 2009

**EAST PRONG OF THE ROARING RIVER at STONE MOUNTAIN STREAM
RESTORATION
2008 MONITORING REPORT**

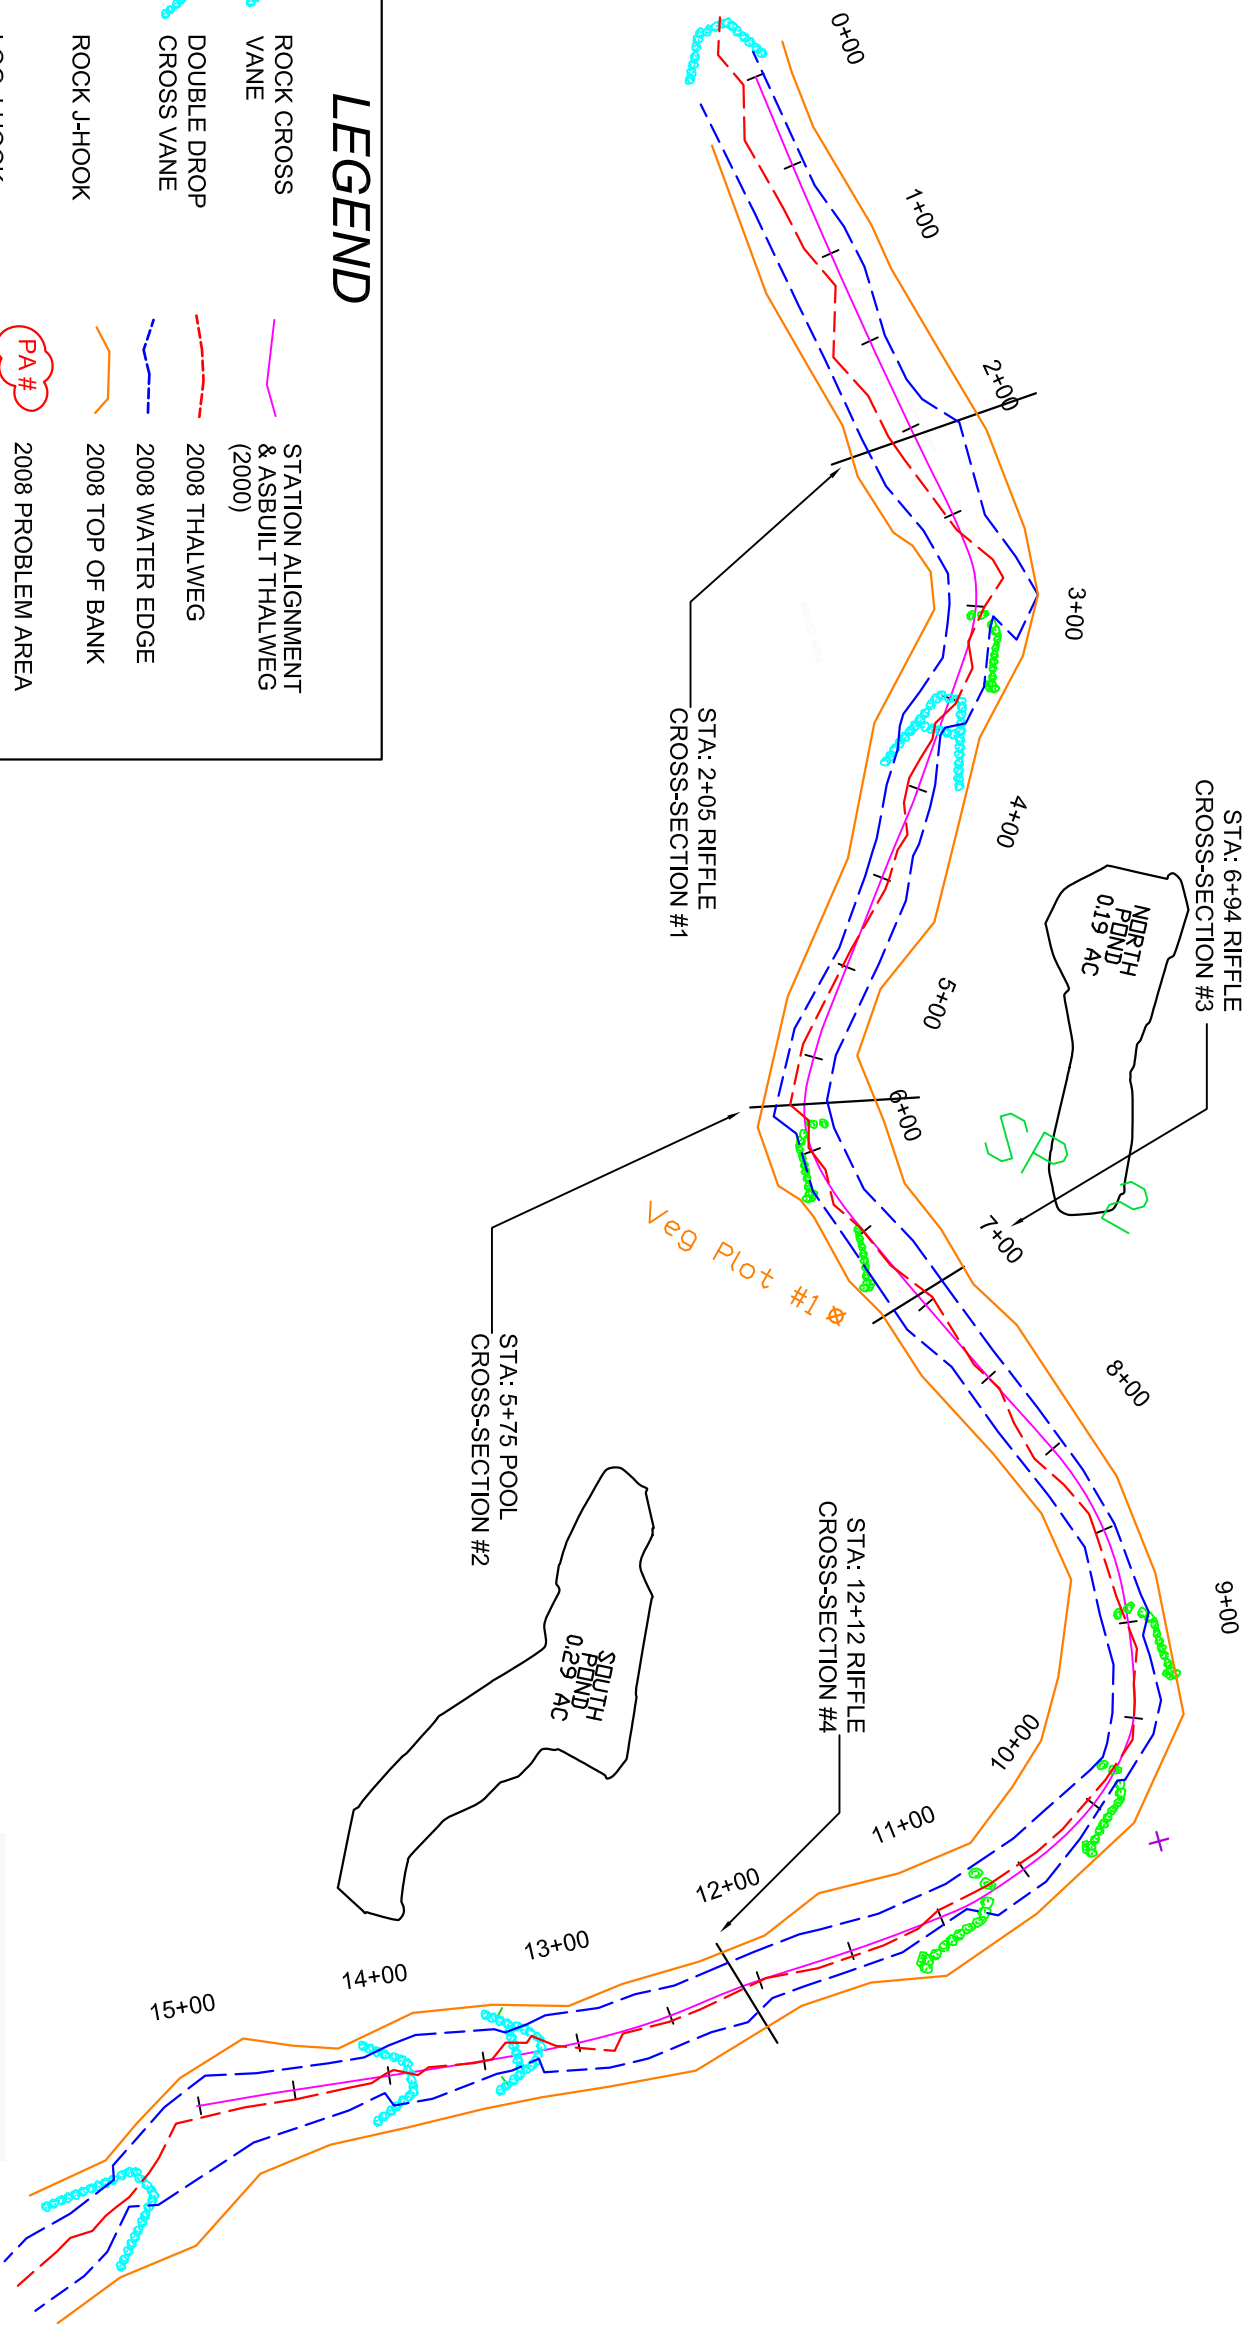
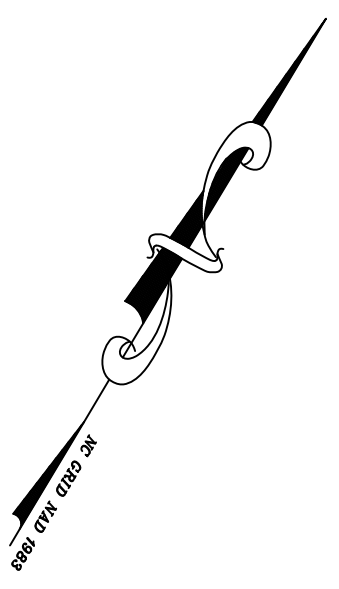
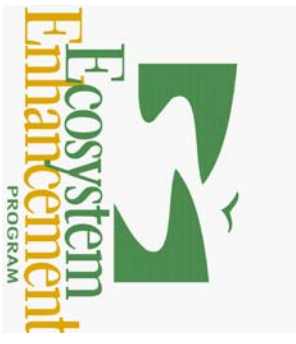
2008 CURRENT CONDITION
 PLAN VIEW REACH-2

No problem areas were identified in Reach 2 during the 2008 monitoring period. Two problem areas were identified in Reach 4. Problem area 18 (PA 18) has been observed in previous monitoring reports and problem area 37 (PA 37) represents a new area of concern. This problem area consists of a beaver dam located at station 19+00, which is backing up water and obstructing flow. The beaver dam has also caused erosion on the left bank in the vicinity of the dam.

Problem Number	Feature Issue	Station numbers	Suspected Cause
PA 18	Bank Slump on left bank	3+25 to 3+75 R4	Lack of deep rooting vegetation and steep bank slope
PA 37	Beaver dam backing up water and left bank erosion	19+00 to 19+30 R4	Beaver activity

No problem areas were identified in Reach 2 during the 2008 monitoring period. Two problem areas were identified in Reach 4. Problem area 18 (PA 18) has been observed in previous monitoring reports and problem area 37 (PA 37) represents a new area of concern. This problem area consists of a beaver dam located at station 19+00, which is backing up water and obstructing flow. The beaver dam has also caused erosion on the left bank in the vicinity of the dam. It is recommended that the beaver dam be removed so the stream can flow as intended.

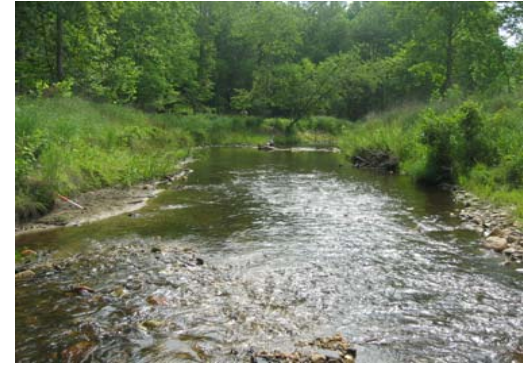
Photo of Cross-Section 4 - Reach 4 - Looking Downstream @ STA 20+00

Year 8 - 2008	Year 7 - 2007	Year 6 - 2006	Year 5 - 2005	Year 4 - 2004	Year 3 - 2003	Year 2 - 2002	Year 1 - 2001	AS-BUILT 2000
Area	140.9	143.9	141.2	147.3	141.4	139.5	140.7	139.5	
Width	44	44.2	45.5	44.7	41.3	45.9	45.0	45.0	
Mean Depth	3.2	3.3	3.1	3.3	3.4	3.1	3.1	3.1	
Max Depth	4.6	4.7	4.9	4.9	5.0	4.5	4.0	3.9	
W/D	13.7	13.6	14.6	13.6	12.0	14.8	15.0	14.5

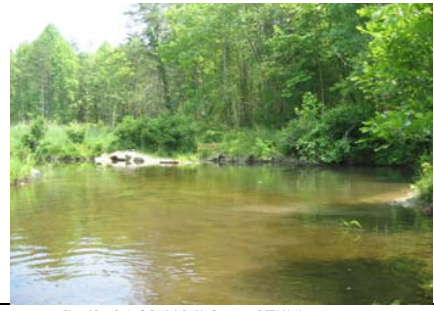
Photo of Cross-Section 5 - Reach 4 - Looking Downstream @ STA 24+10

Year 8 - 2008	Year 7 - 2007	Year 6 - 2006	Year 5 - 2005	Year 4 - 2004	Year 3 - 2003	Year 2 - 2002	Year 1 - 2001	AS-BUILT 2000
Area	184.9	200.4	202.1	184.6	180.7	175.1	183.9	183.6	
Width	56.6	59.8	54.5	64.0	54.2	56.0	60.0		
Mean Depth	3.3	3.4	3.7	2.9	3.3	3.1	3.4		
Max Depth	4.8	5.3	6.6	5.8	5.8	5.8	4.8		
WD	17.3	17.8	14.7	22.2	16.3	17.9	16.0

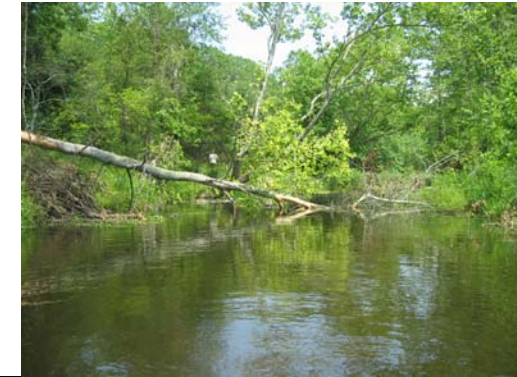
Photo of Cross-Section 6 - Reach 4 - Looking Downstream @ STA 26+70

Year 8 - 2008	Year 7 - 2007	Year 6 - 2006	Year 5 - 2005	Year 4 - 2004	Year 2 - 2002	Year 1 - 2001	AS-BUILT 2000
Area	209.7	224.5	212.1	210.3	223.1	193.4	210.1	
Width	43.2	42.6	44.7	44.7	45.2	36.7	46.3	
Mean Depth	4.9	5.3	4.7	4.7	4.9	5.3	4.5	
Max Depth	7.2	8.5	7.3	7.4	7.3	7.4	6.0	
W/D	8.9	8.1	9.4	9.5	9.2	7.0	10.2
