(MY1) FINAL MONITORING REPORT - *Stream Mitigation*

STRAWBERRY HILL MITIGATION PROJECT

Johnston County, North Carolina

NCDMS Project #100094

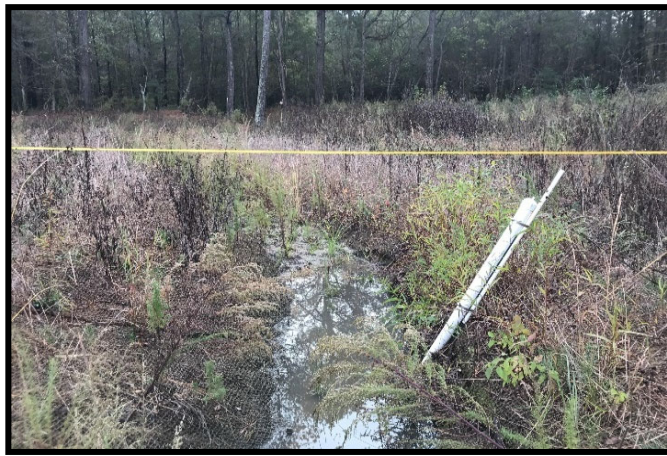
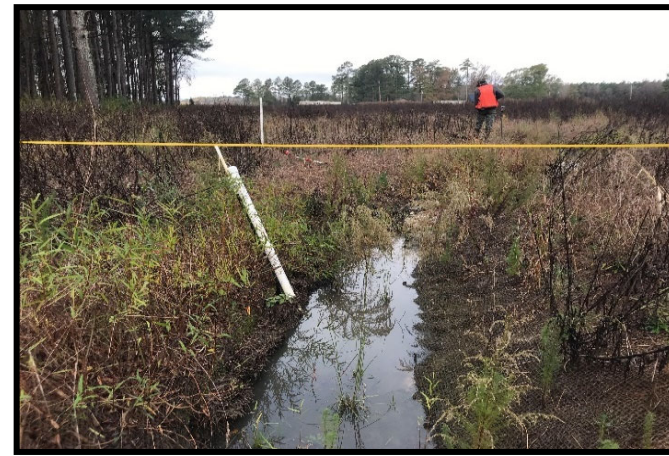
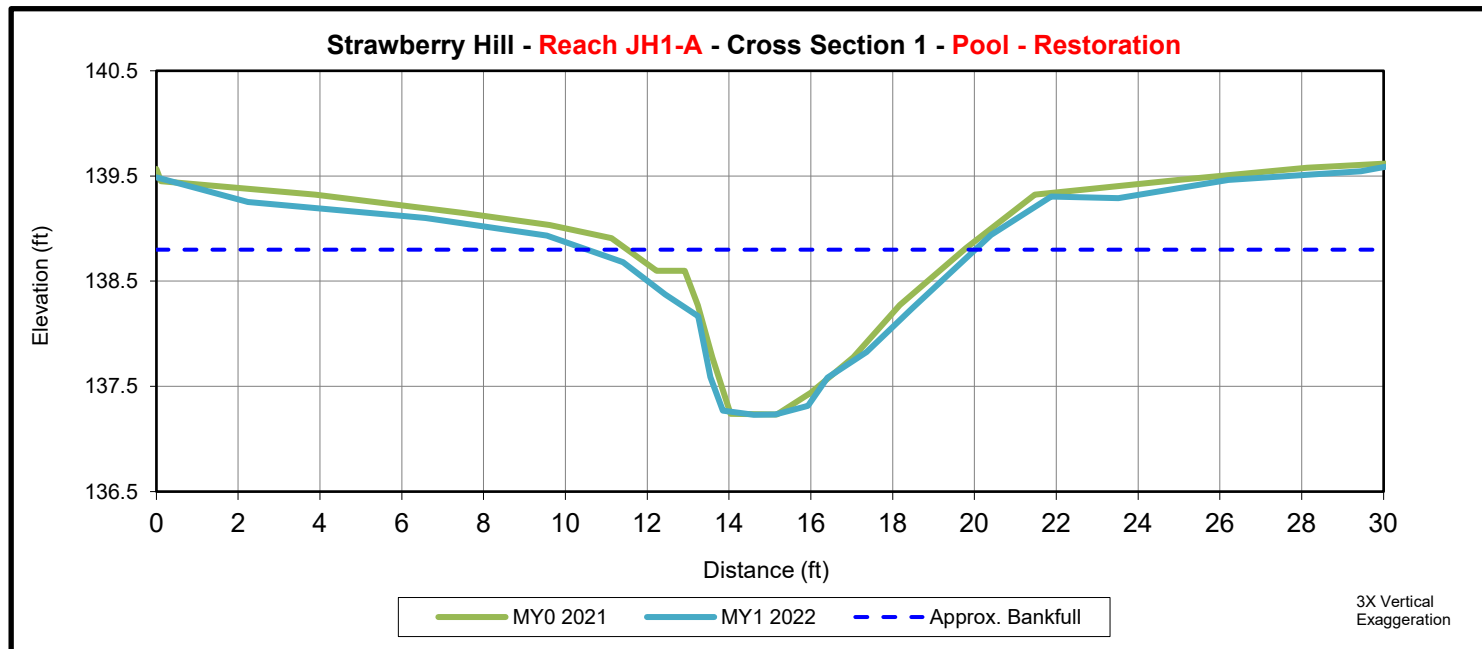
Cross Section 1 (Pool - JH1-A)						
	MY0	MY1	MY2	MY3	MY5	MY7	MY+
Bankfull Elevation (ft) - Based on AB-Bankfull ¹ Area	---	---					
Bank Height Ratio Based on AB Bankfull ¹ Area	---	---					
Thalweg Elevation	137.24	137.23					
LTOB ² Elevation	138.91	138.93					
LTOB ² Max Depth (ft)	1.7	1.70					
LTOB ² Cross Sectional Area (ft ²)	7.60	9.00

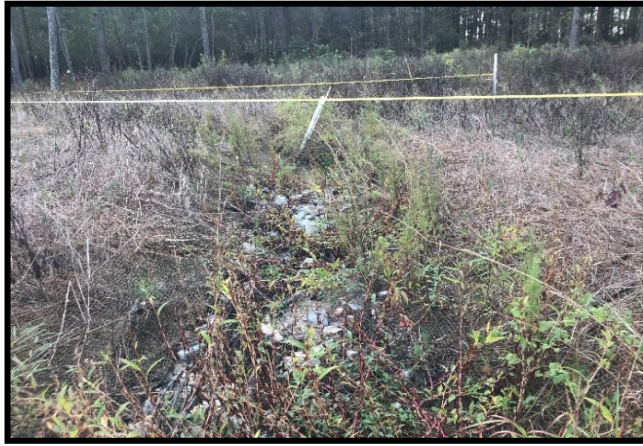
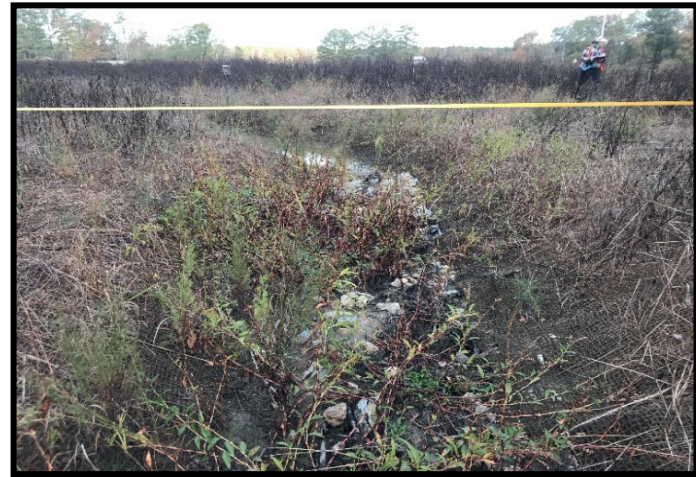
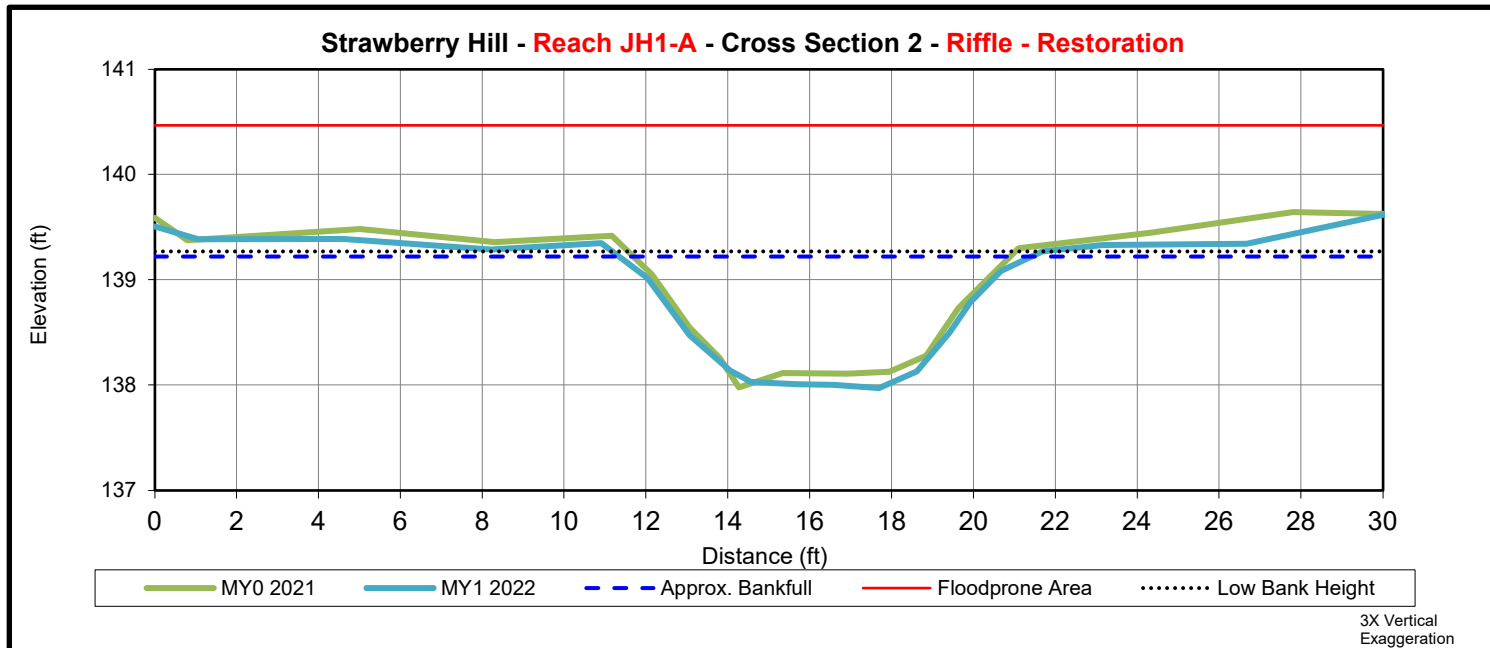
Cross Section 2 (Riffle - JH1-A)						
	MY0	MY1	MY2	MY3	MY5	MY7	MY+
Bankfull Elevation (ft) - Based on AB-Bankfull ¹ Area	139.30	139.22					
Bank Height Ratio - Based on AB Bankfull ¹ Area	1.00	1.04					
Thalweg Elevation	137.98	137.97					
LTOB ² Elevation	139.30	139.27					
LTOB ² Max Depth (ft)	1.3	1.30					
LTOB ² Cross Sectional Area (ft ²)	8.20	8.70

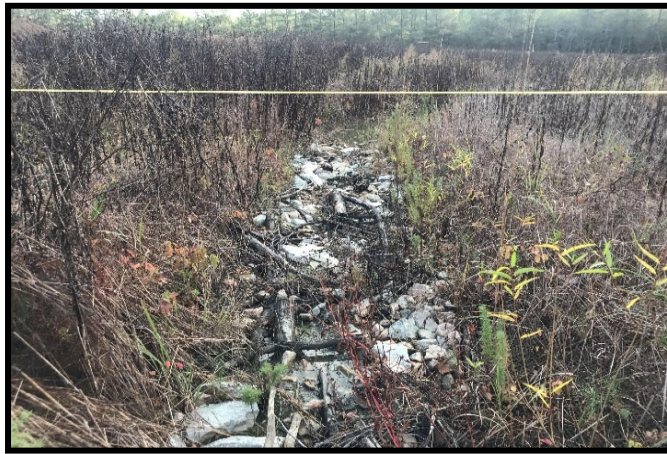
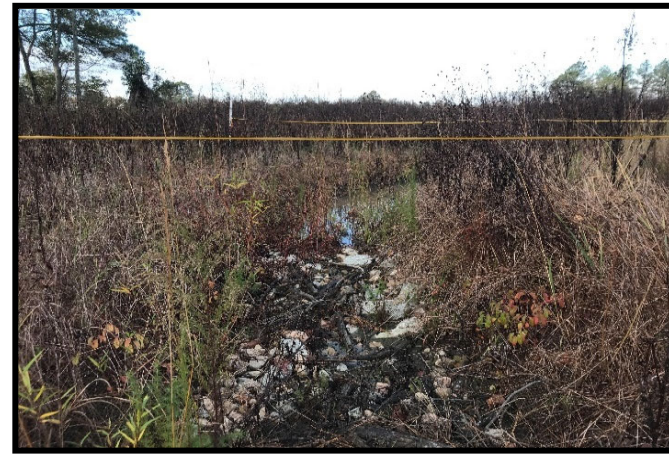
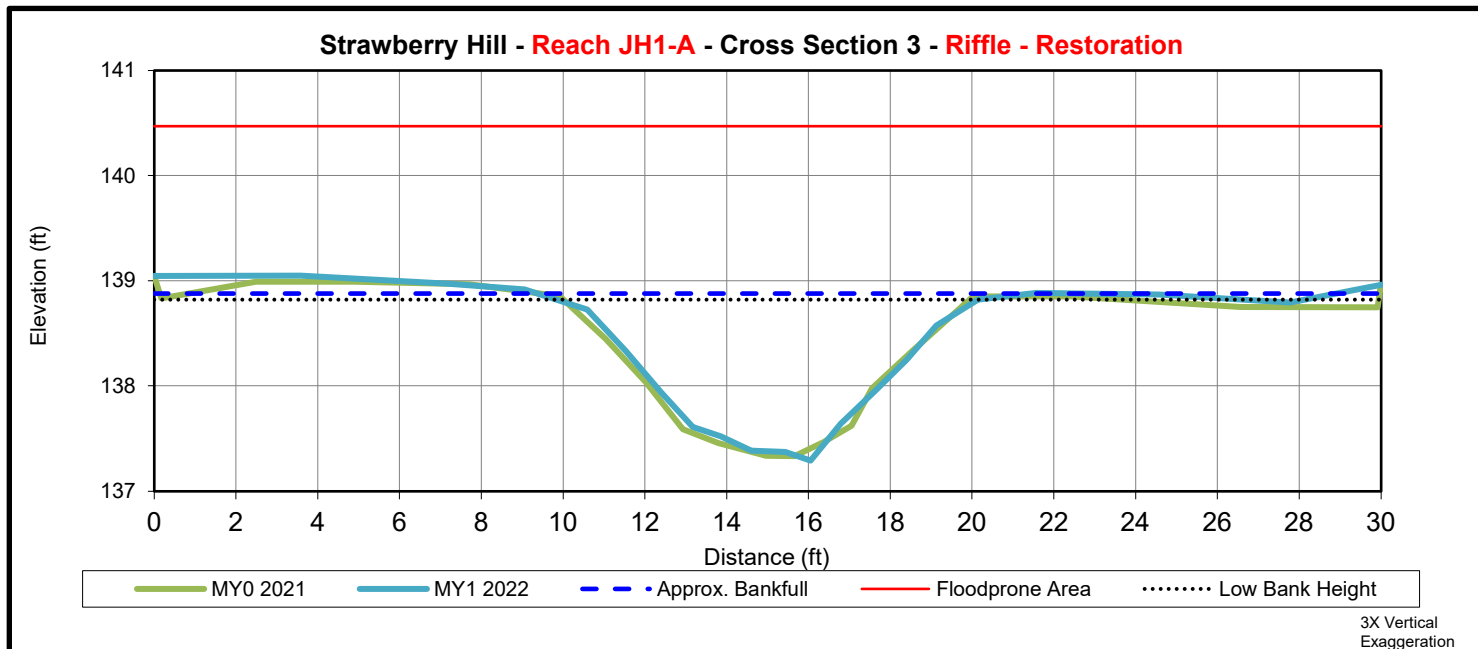
Cross Section 3 (Riffle - JH1-A)						
	MY0	MY1	MY2	MY3	MY5	MY7	MY+
Bankfull Elevation (ft) - Based on AB-Bankfull ¹ Area	138.85	138.88					
Bank Height Ratio - Based on AB Bankfull ¹ Area	1.00	0.96					
Thalweg Elevation	137.34	137.29					
LTOB ² Elevation	138.85	138.82					
LTOB ² Max Depth (ft)	1.5	1.53					
LTOB ² Cross Sectional Area (ft ²)	9.20	8.60

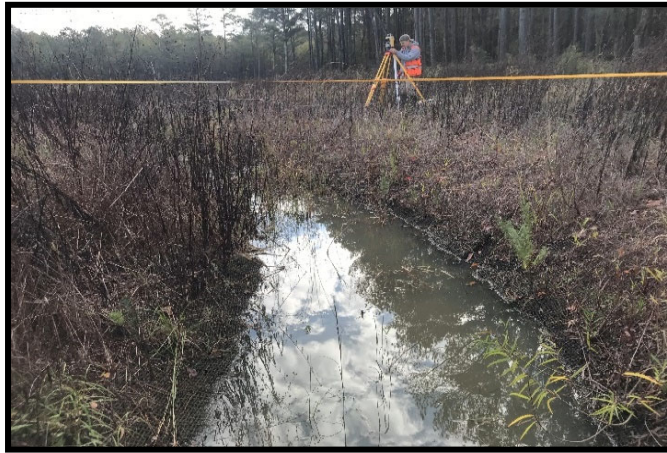
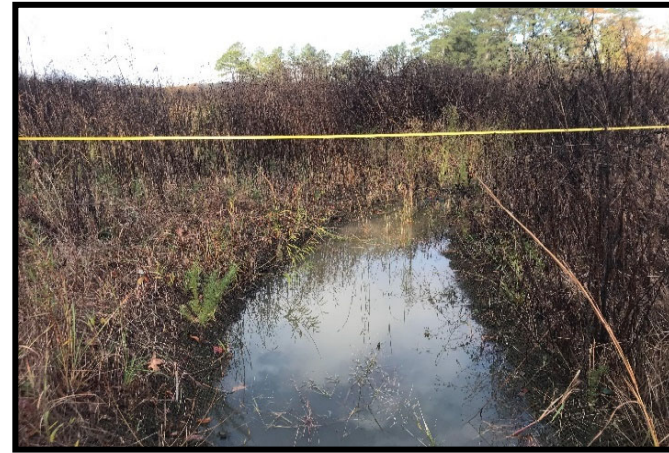
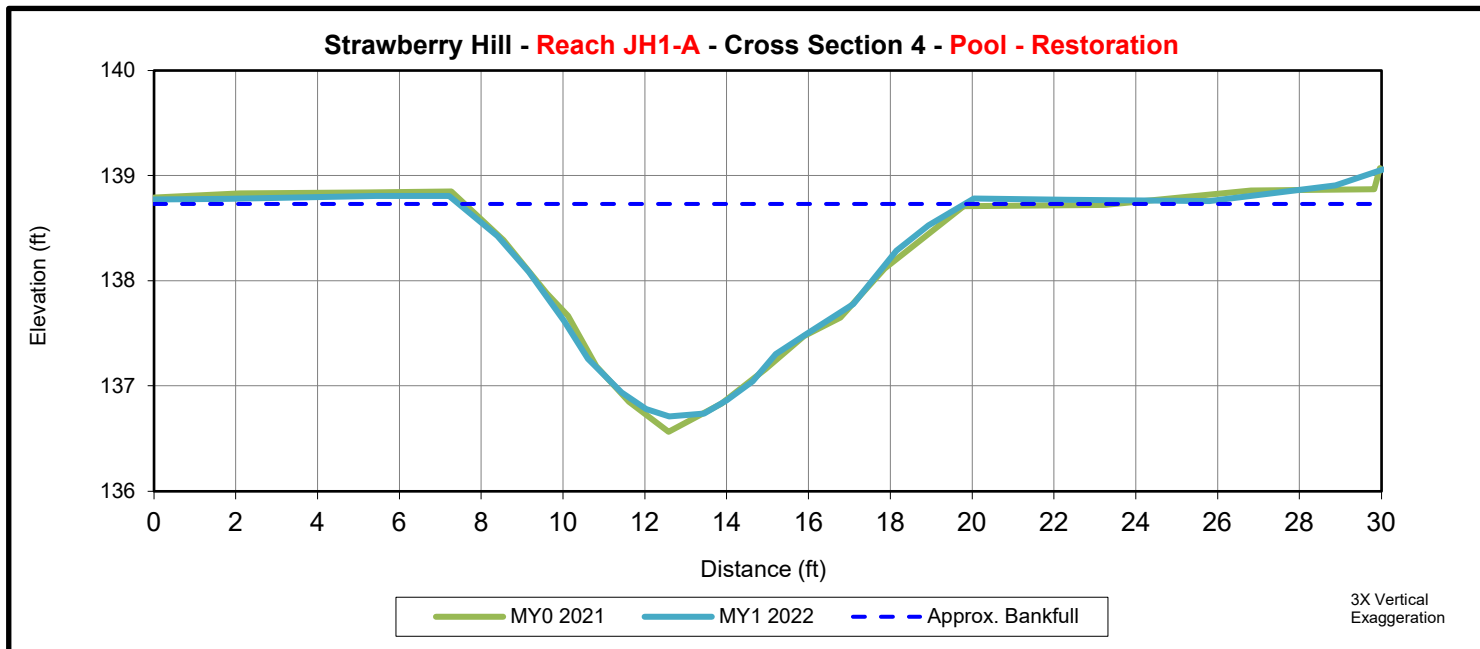
Cross Section 4 (Pool - JH1-A)						
	MY0	MY1	MY2	MY3	MY5	MY7	MY+
Bankfull Elevation (ft) - Based on AB-Bankfull ¹ Area	---	---					
Bank Height Ratio - Based on AB Bankfull ¹ Area	---	---					
Thalweg Elevation	136.57	136.71					
LTOB ² Elevation	138.71	138.78					
LTOB ² Max Depth (ft)	2.1	2.07					
LTOB ² Cross Sectional Area (ft ²)	13.70	14.40

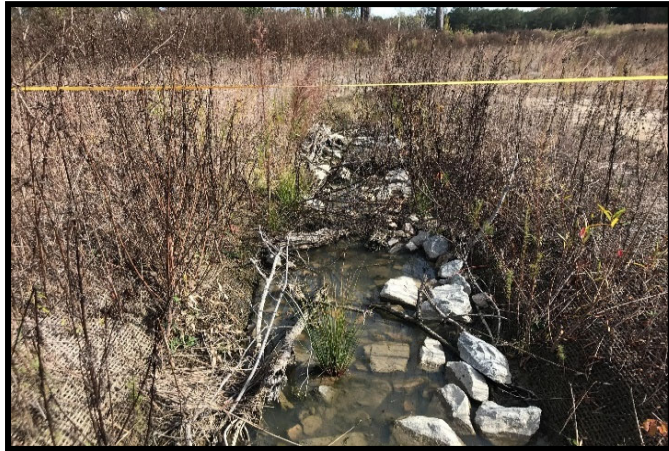
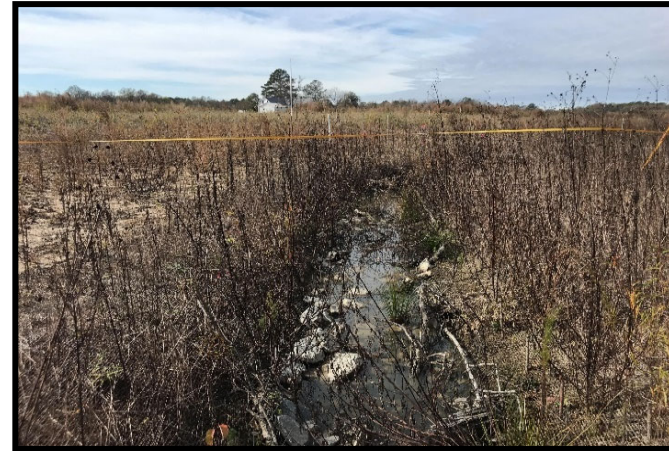
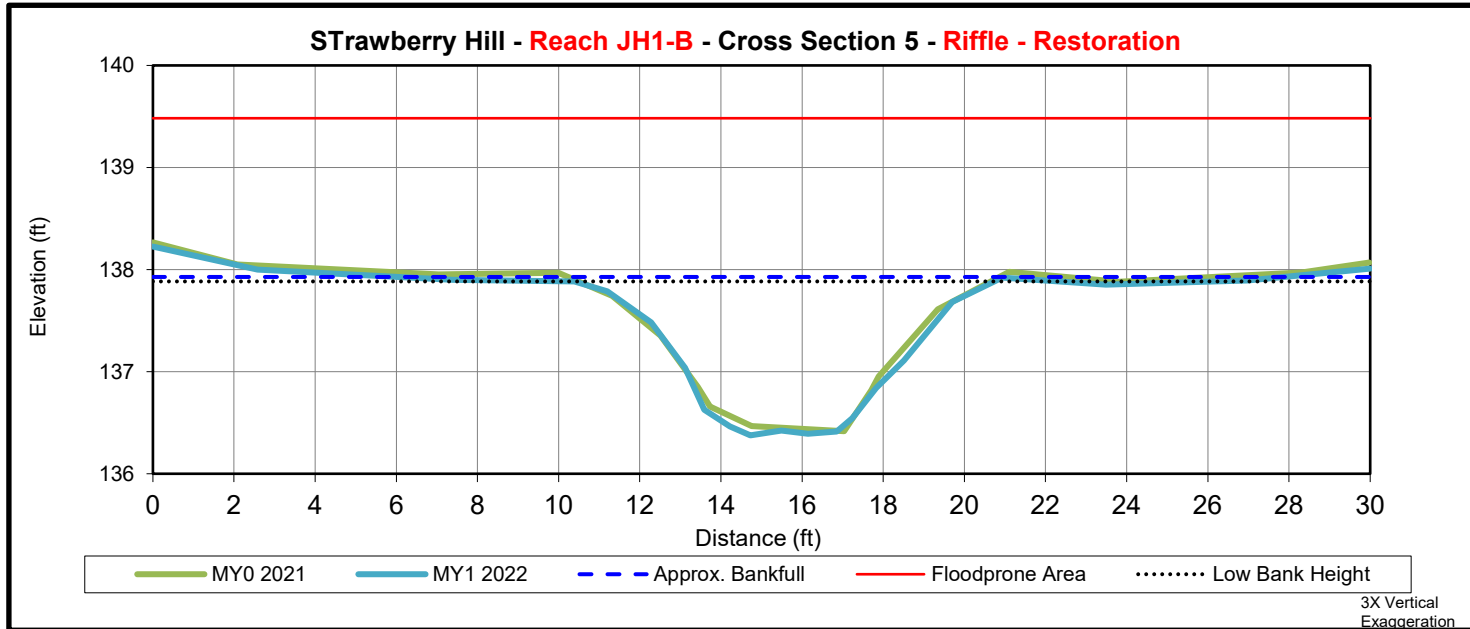
Cross Section 5 (Riffle - JH1-B)						
	MY0	MY1	MY2	MY3	MY5	MY7	MY+
Bankfull Elevation (ft) - Based on AB-Bankfull ¹ Area	137.97	137.93					
Bank Height Ratio - Based on AB Bankfull ¹ Area	1.00	0.97					
Thalweg Elevation	136.42	136.38					
LTOB ² Elevation	137.97	137.88					
LTOB ² Max Depth (ft)	1.6	1.51					
LTOB ² Cross Sectional Area (ft ²)	9.10	8.60

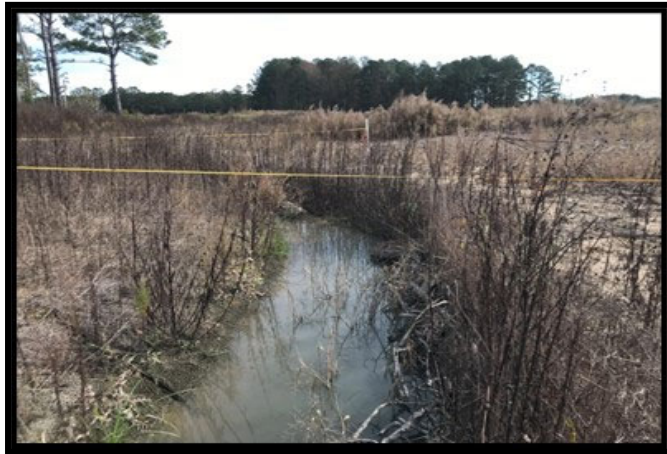
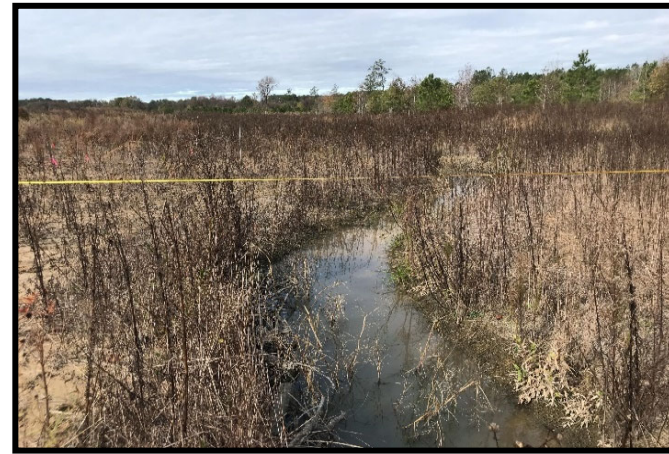
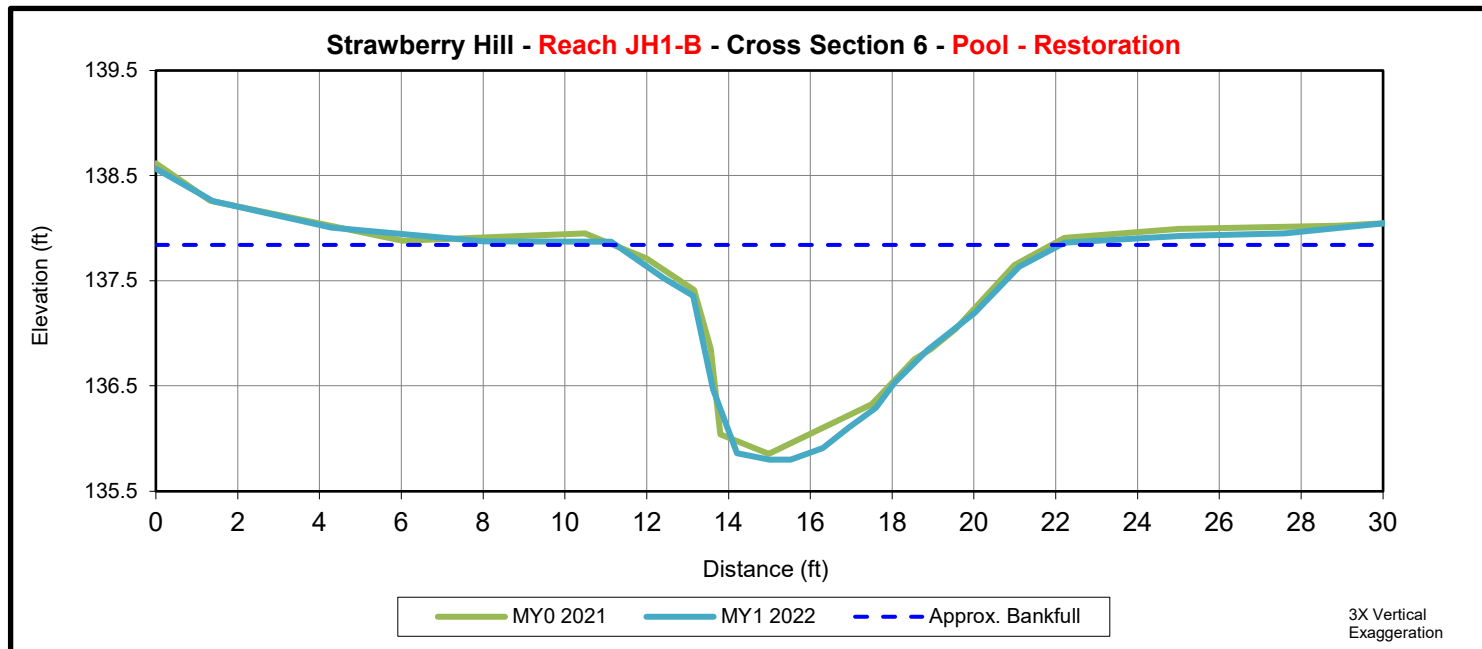
Cross Section 6 (Pool - JH1-B)						
	MY0	MY1	MY2	MY3	MY5	MY7	MY+
Bankfull Elevation (ft) - Based on AB-Bankfull ¹ Area	---	---					
Bank Height Ratio - Based on AB Bankfull ¹ Area	---	---					
Thalweg Elevation	135.85	135.80					
LTOB ² Elevation	137.91	137.86					
LTOB ² Max Depth (ft)	2.1	2.06					
LTOB ² Cross Sectional Area (ft ²)	11.50	11.70

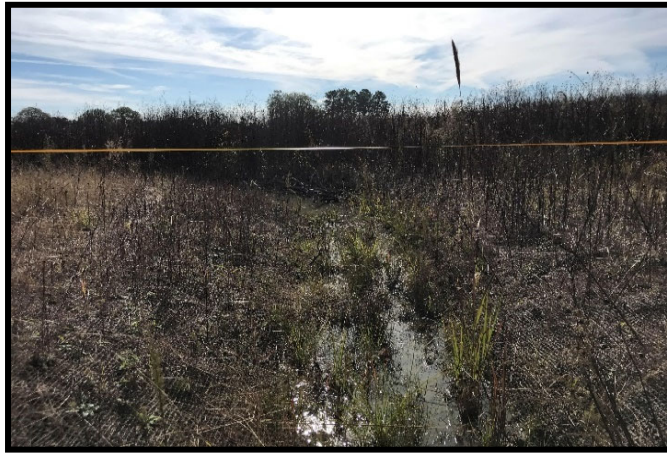
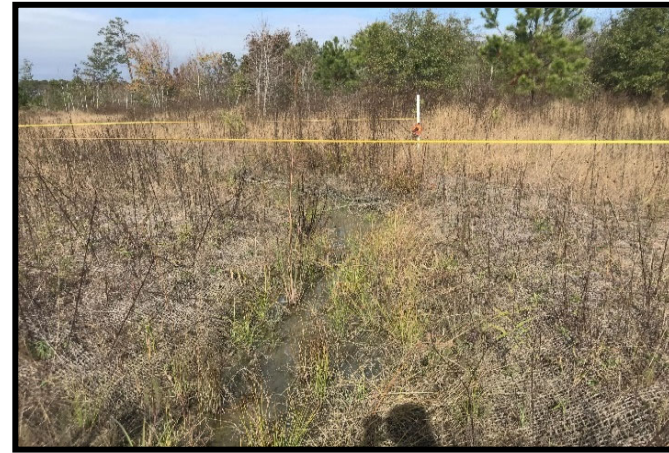
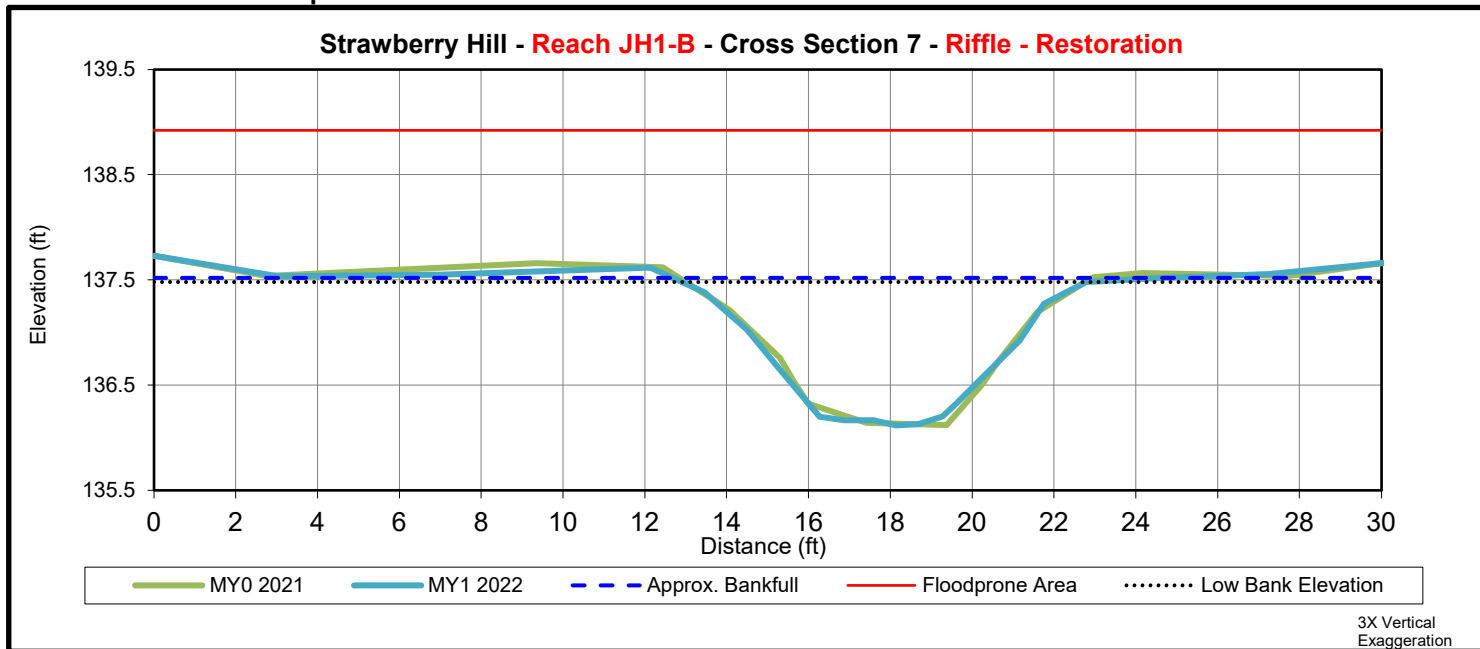
Cross Section 7 (Riffle - JH1-B)						
	MY0	MY1	MY2	MY3	MY5	MY7	MY+
Bankfull Elevation (ft) - Based on AB-Bankfull ¹ Area	137.52	137.52					
Bank Height Ratio - Based on AB Bankfull ¹ Area	1.00	0.97					
Thalweg Elevation	136.12	136.12					
LTOB ² Elevation	137.52	137.48					
LTOB ² Max Depth (ft)	1.4	1.36					
LTOB ² Cross Sectional Area (ft ²)	8.30	7.90

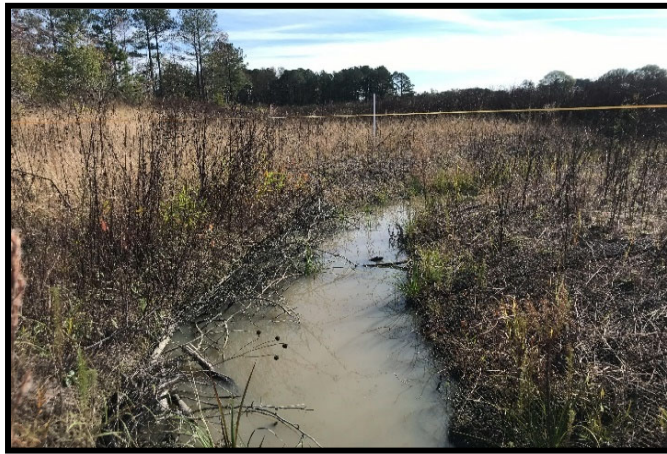
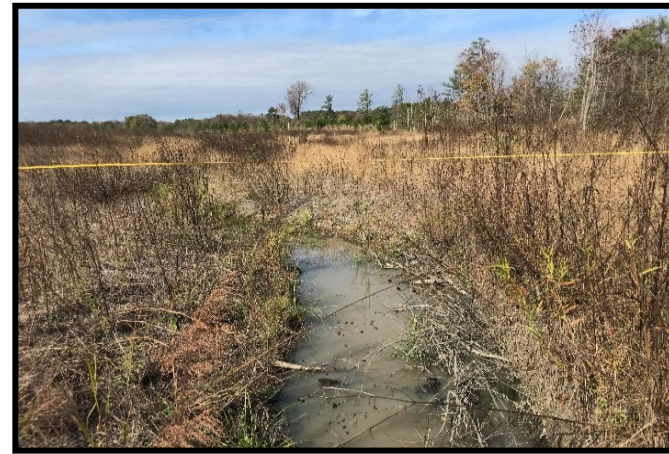
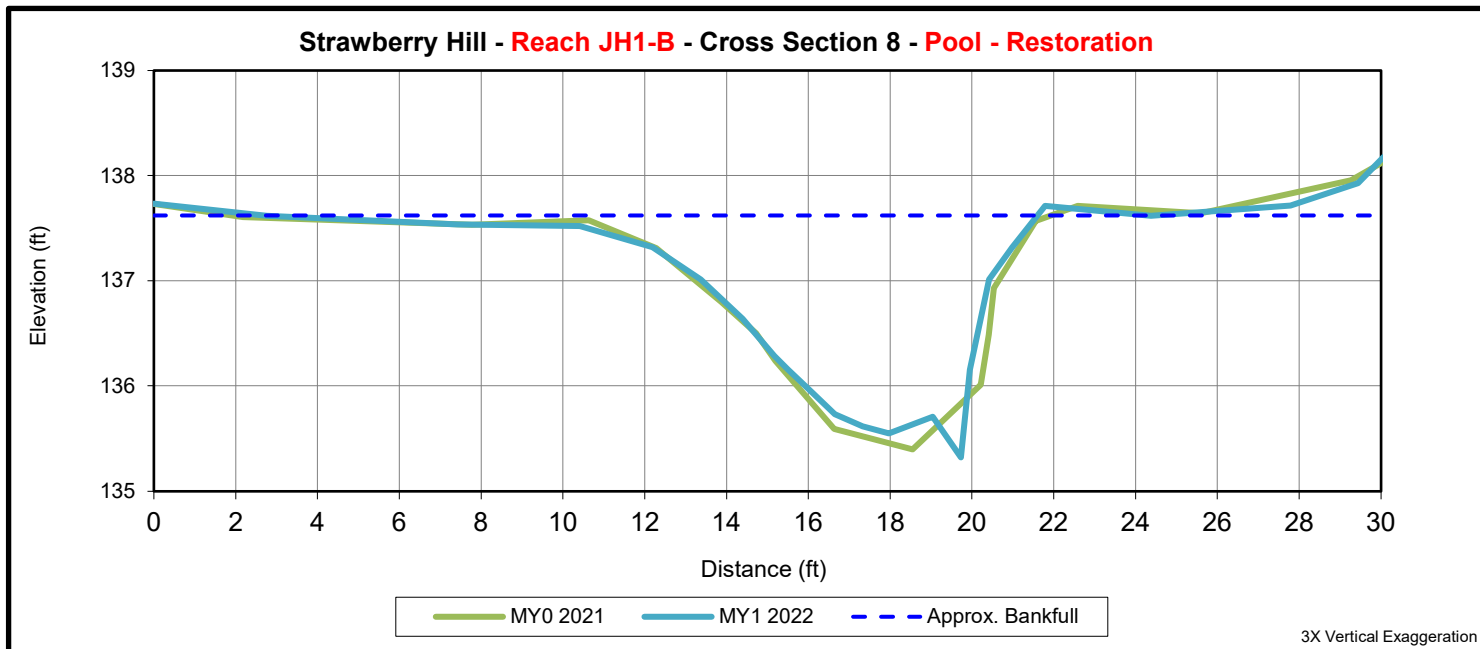
Cross Section 8 (Pool - JH1-B)						
	MY0	MY1	MY2	MY3	MY5	MY7	MY+
Bankfull Elevation (ft) - Based on AB-Bankfull ¹ Area	---	---					
Bank Height Ratio Based on AB Bankfull ¹ Area	---	---					
Thalweg Elevation	135.40	135.32					
LTOB ² Elevation	137.57	137.52					
LTOB ² Max Depth (ft)	2.2	2.20					
LTOB ² Cross Sectional Area (ft ²)	12.50	11.40

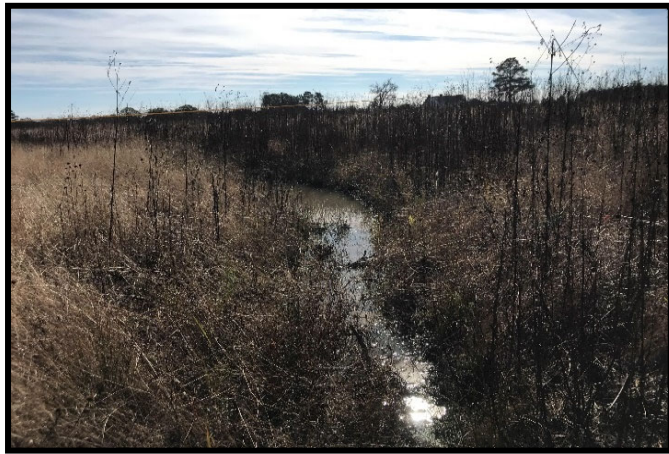
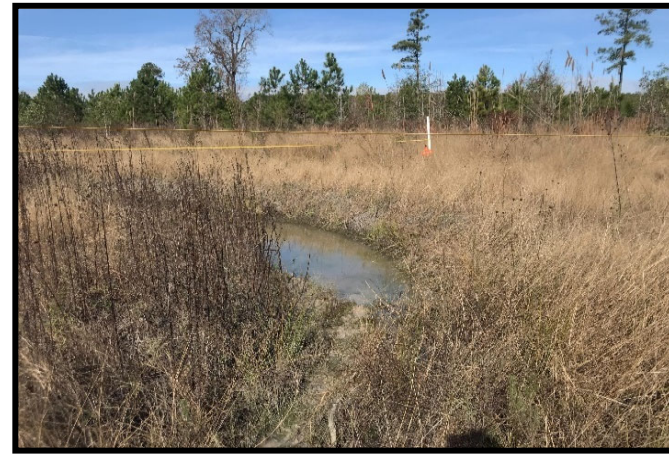
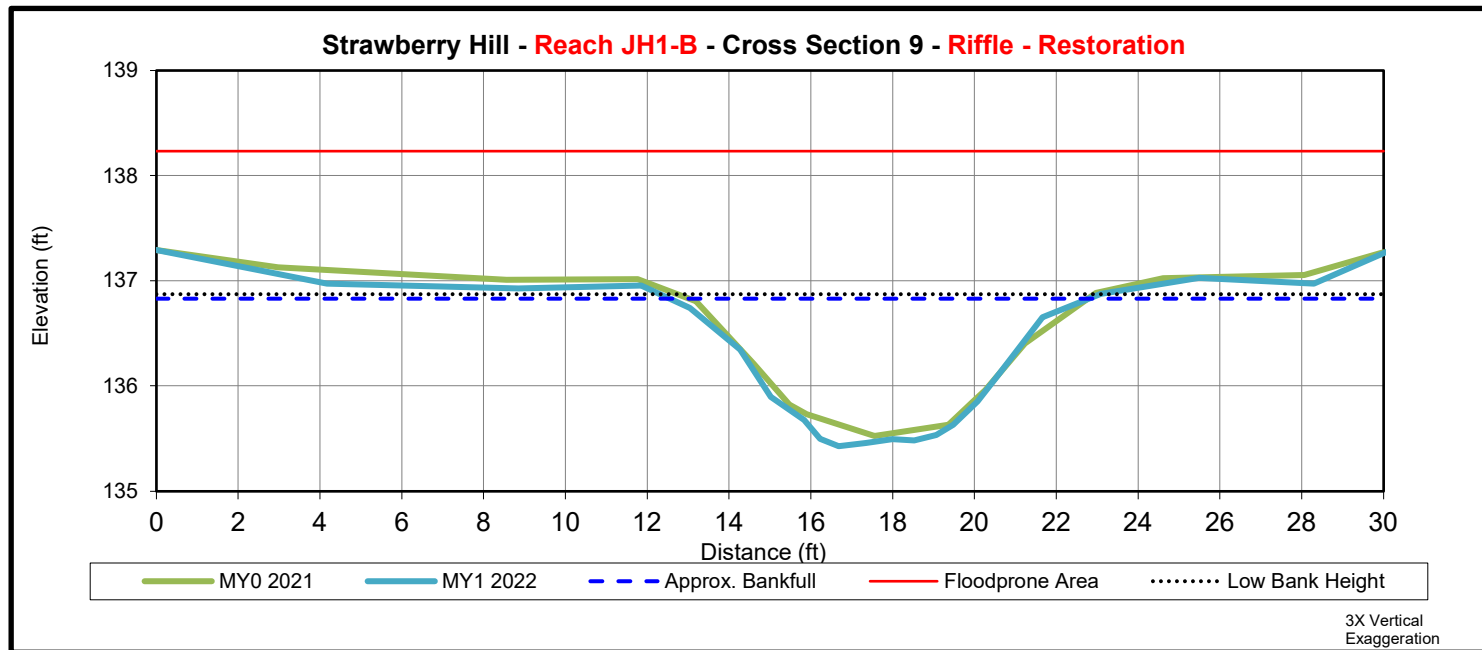
Cross Section 9 (Riffle - JH1-B)						
	MY0	MY1	MY2	MY3	MY5	MY7	MY+
Bankfull Elevation (ft) - Based on AB-Bankfull ¹ Area	136.88	136.83					
Bank Height Ratio - Based on AB Bankfull ¹ Area	1.00	1.03					
Thalweg Elevation	135.53	135.43					
LTOB ² Elevation	136.88	136.87					
LTOB ² Max Depth (ft)	1.4	1.44					
LTOB ² Cross Sectional Area (ft ²)	8.30	8.70

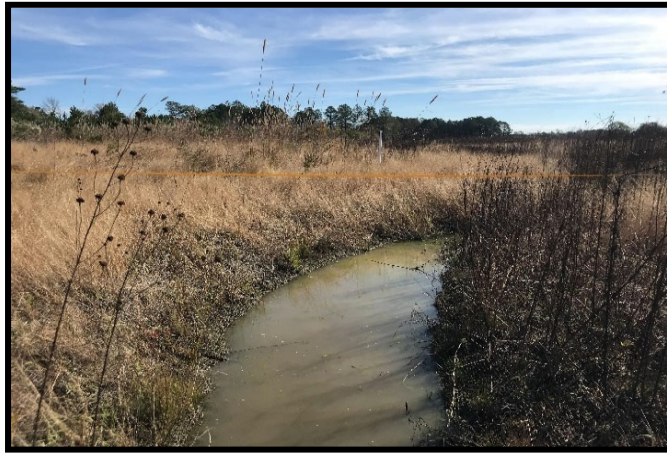
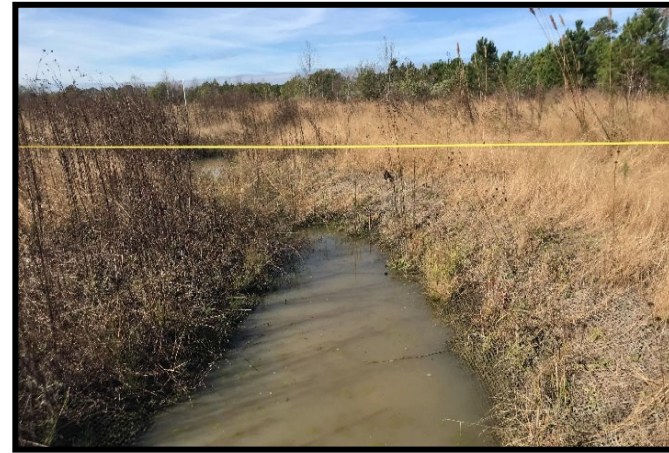
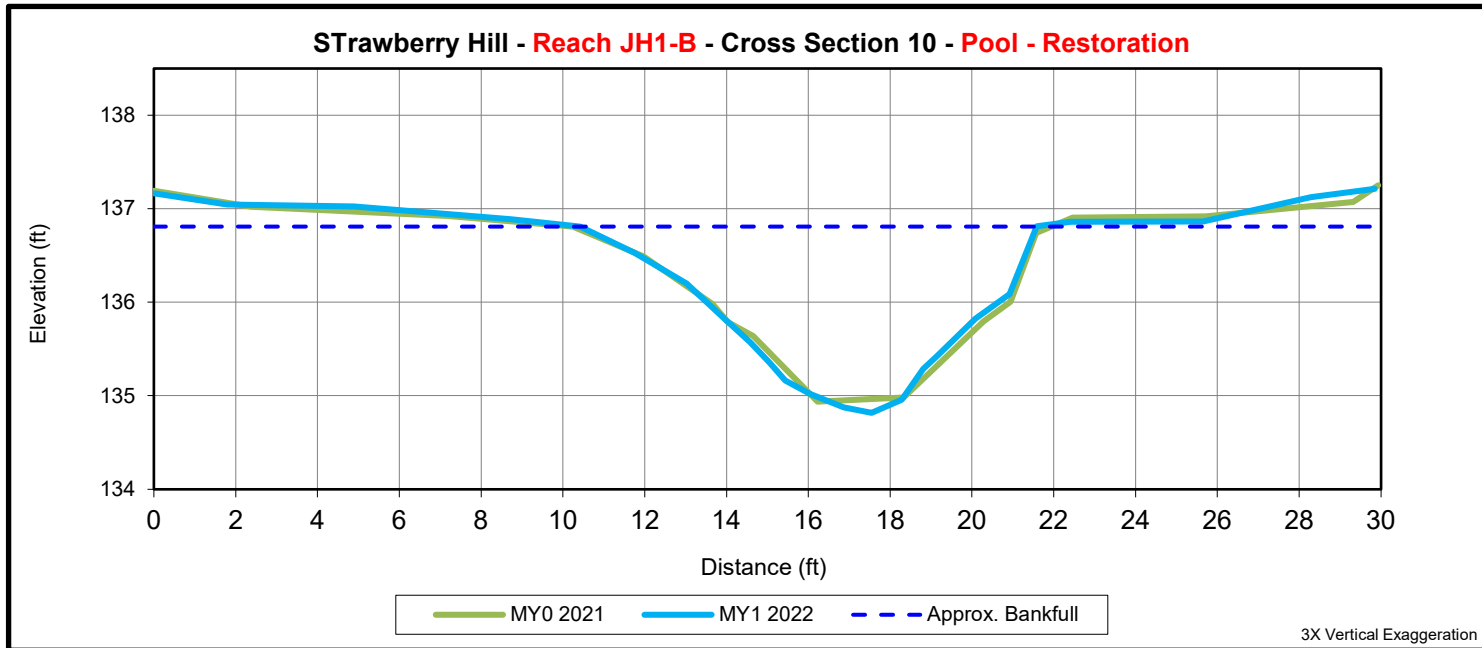
Cross Section 10 (Pool - JH1-B)						
	MY0	MY1	MY2	MY3	MY5	MY7	MY+
Bankfull Elevation (ft) - Based on AB-Bankfull ¹ Area	---	---					
Bank Height Ratio - Based on AB Bankfull ¹ Area	---	---					
Thalweg Elevation	134.94	134.82					
LTOB ² Elevation	136.81	136.81					
LTOB ² Max Depth (ft)	1.9	1.99					
LTOB ² Cross Sectional Area (ft ²)	12.20	12.20

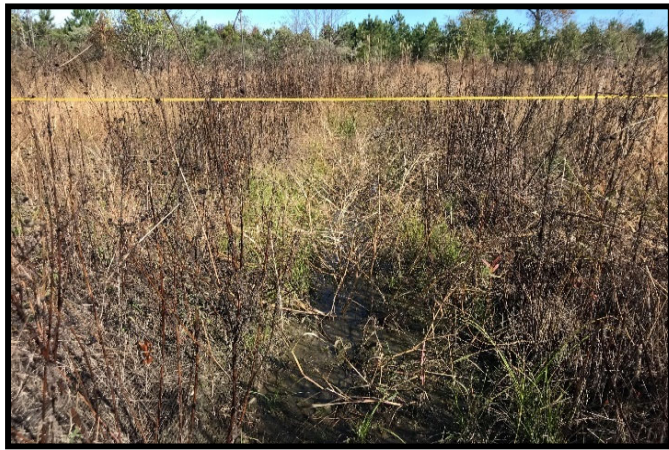
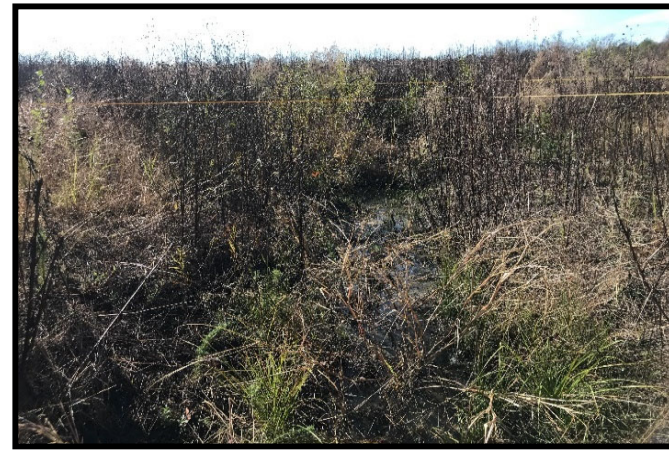
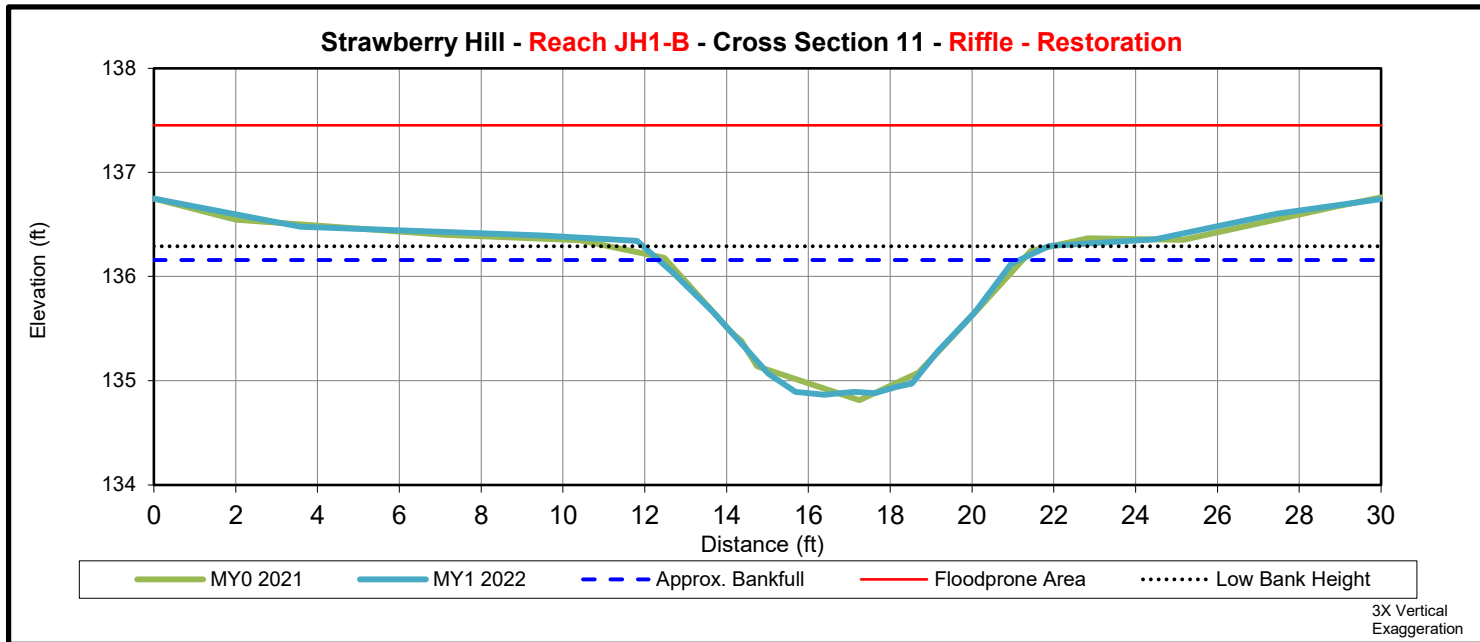
Cross Section 11 (Riffle - JH1-B)						
	MY0	MY1	MY2	MY3	MY5	MY7	MY+
Bankfull Elevation (ft) - Based on AB-Bankfull ¹ Area	136.18	136.16					
Bank Height Ratio Based on AB Bankfull ¹ Area	1.00	1.10					
Thalweg Elevation	134.81	134.87					
LTOB ² Elevation	136.18	136.29					
LTOB ² Max Depth (ft)	1.4	1.43					
LTOB ² Cross Sectional Area (ft ²)	7.30	8.50

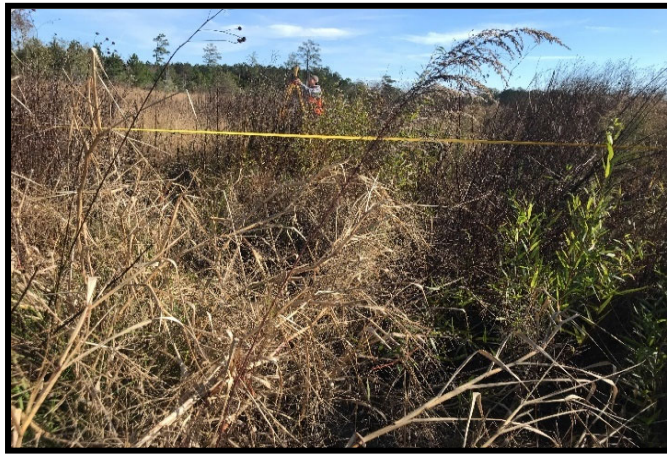
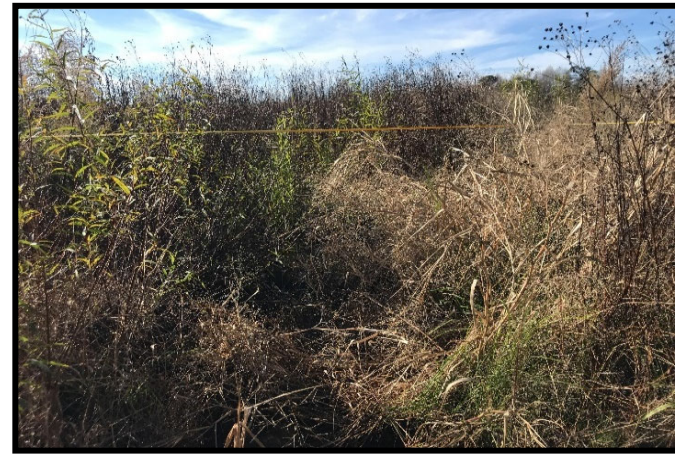
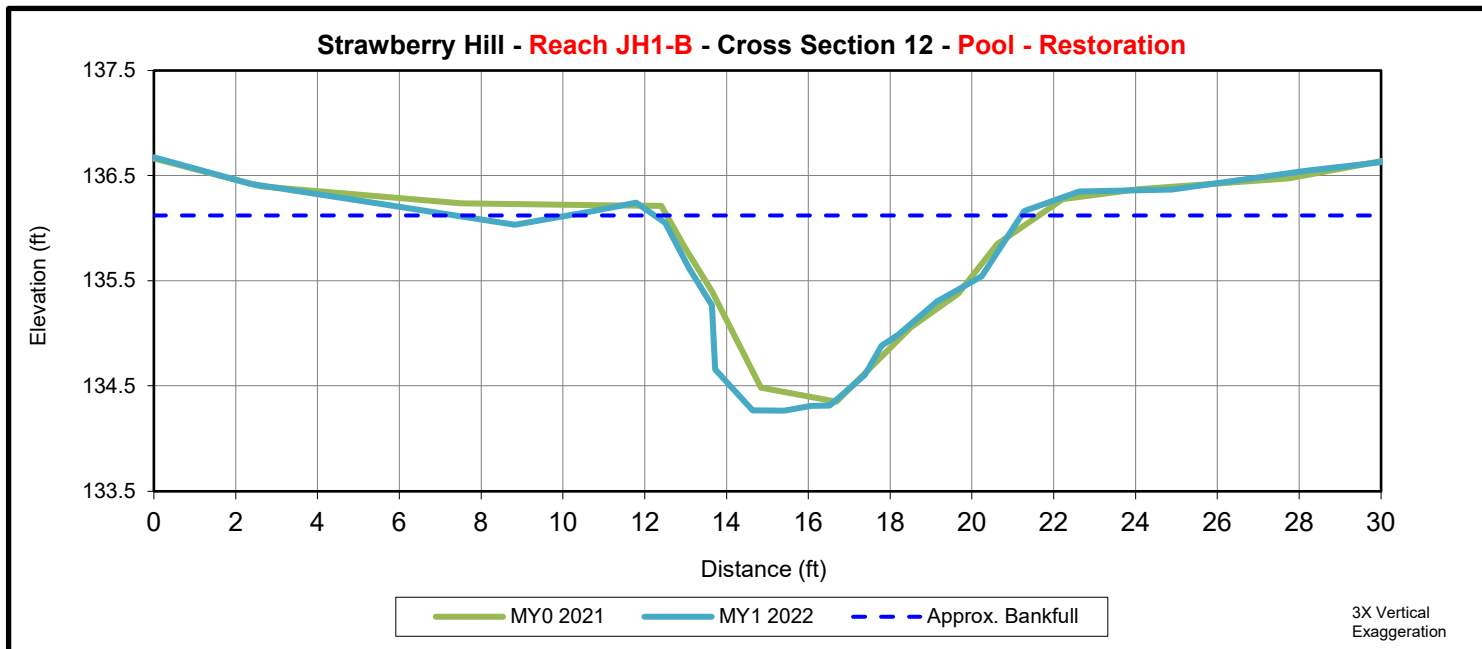
Cross Section 12 (Pool - JH1-B)						
	MY0	MY1	MY2	MY3	MY5	MY7	MY+
Bankfull Elevation (ft) - Based on AB-Bankfull ¹ Area	---	---					
Bank Height Ratio Based on AB Bankfull ¹ Area	---	---					
Thalweg Elevation	134.35	134.27					
LTOB ² Elevation	136.22	136.24					
LTOB ² Max Depth (ft)	1.9	1.98					
LTOB ² Cross Sectional Area (ft ²)	10.10	11.20

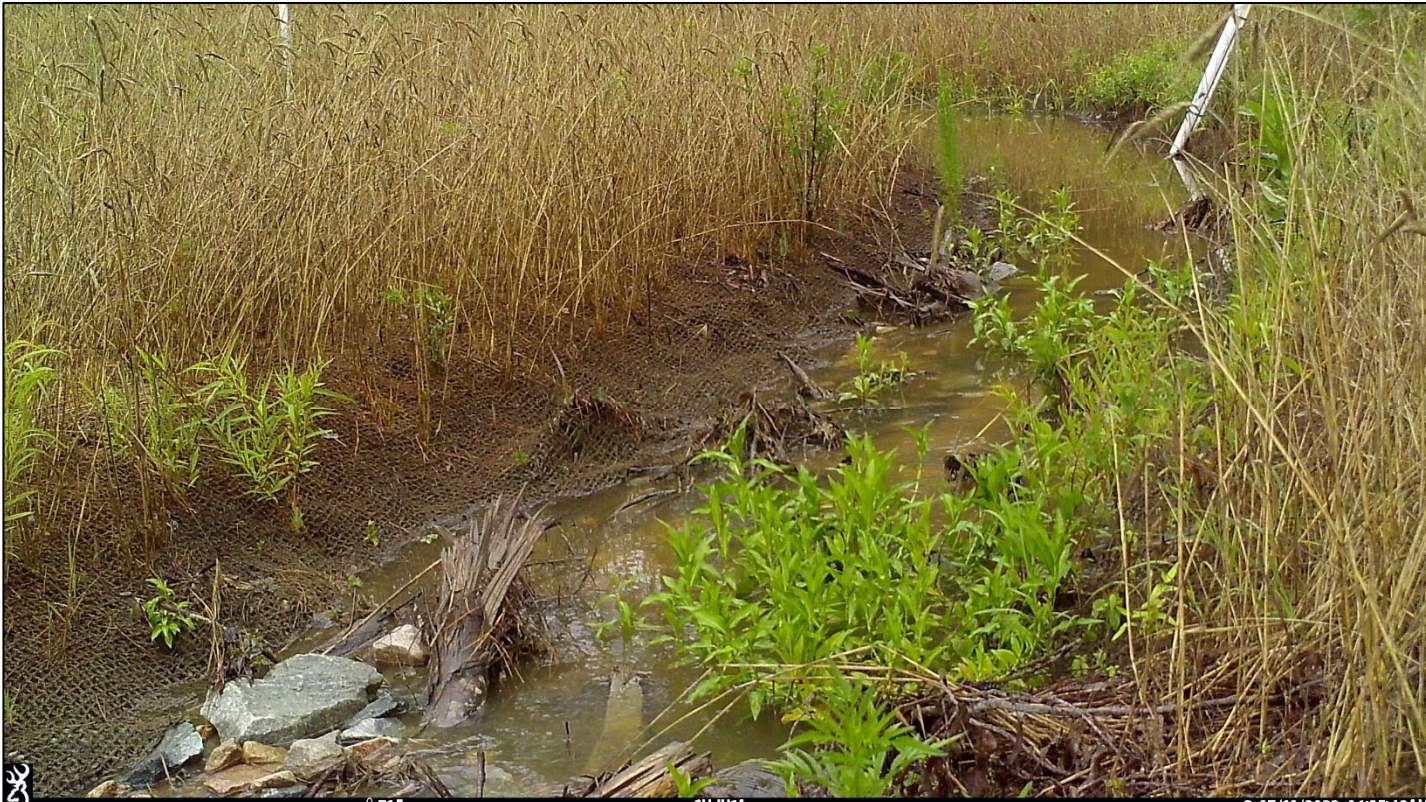
71F SH JH1A 07/10/2022 06:35:48AM

Strawberry Hill Flow Cam Photos (MY1) – Longest Event (4 days; 7/8/22-7/12/22)
