MY2 MONITORING REPORT - Stream Mitigation

STRAWBERRY HILL MITIGATION PROJECT

Johnston County, North Carolina

NCDMS Project #100094

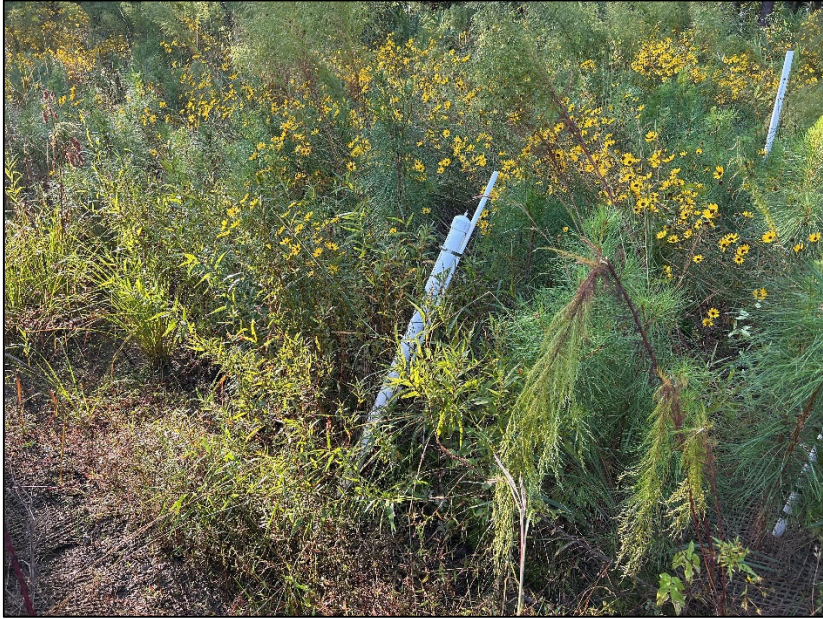
One flow gauge and one stage recorder are documenting conditions on reaches JH1-A and JH1-B, respectively. The stage recorder is in place to document bankfull events. The flow gauge is in place to document presence and persistence of stream flow in the intermittent channel. In addition, a camera rig (flow camera) was installed in conjunction with the flow gauge on JH1-A in the attempt to capture daily images of stream flow through the riffle.

Flow Gauge JH1-A (Looking Upstream) (10/3/2023)
