# Stricker Branch Stream Restoration Project Contract # D06054-G

County: Cabarrus  
Cataloging Unit: Yadkin 03040105; Targeted Watershed 020040  
Monitoring Firm POC: Mid-Atlantic Mitigation, LLC  
Rich Mogensen (704) 782-4133  
Prepared For: Ecosystem Enhancement Program

## Year 1 (2008) Monitoring Report

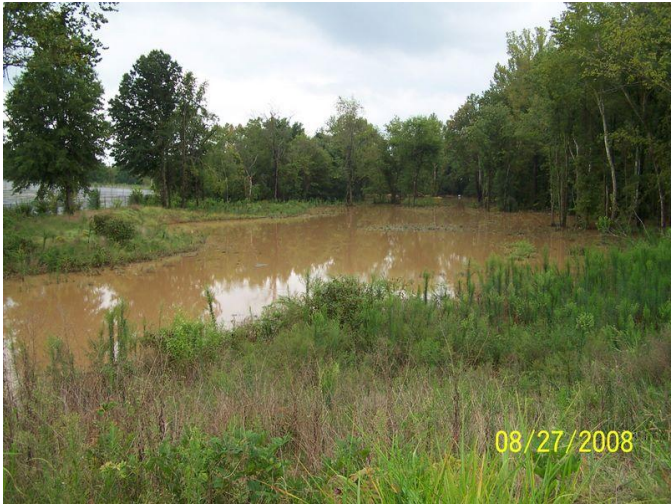
Lower section, below Sign Drive

Aftermath of hurricane remnant rain event August 25<sup>th</sup> through 28<sup>th</sup> totaling approximately 23 inches over 4 days.
