Stricker Branch Stream Restoration Project Contract # D06054-G

County: Cabarrus
Cataloging Unit: Yadkin 03040105; Targeted Watershed 020040
Monitoring Firm POC: Mid-Atlantic Mitigation, LLC
Rich Mogensen (704) 782-4133
Prepared For: Ecosystem Enhancement Program

Year 2 (2009) Monitoring Report

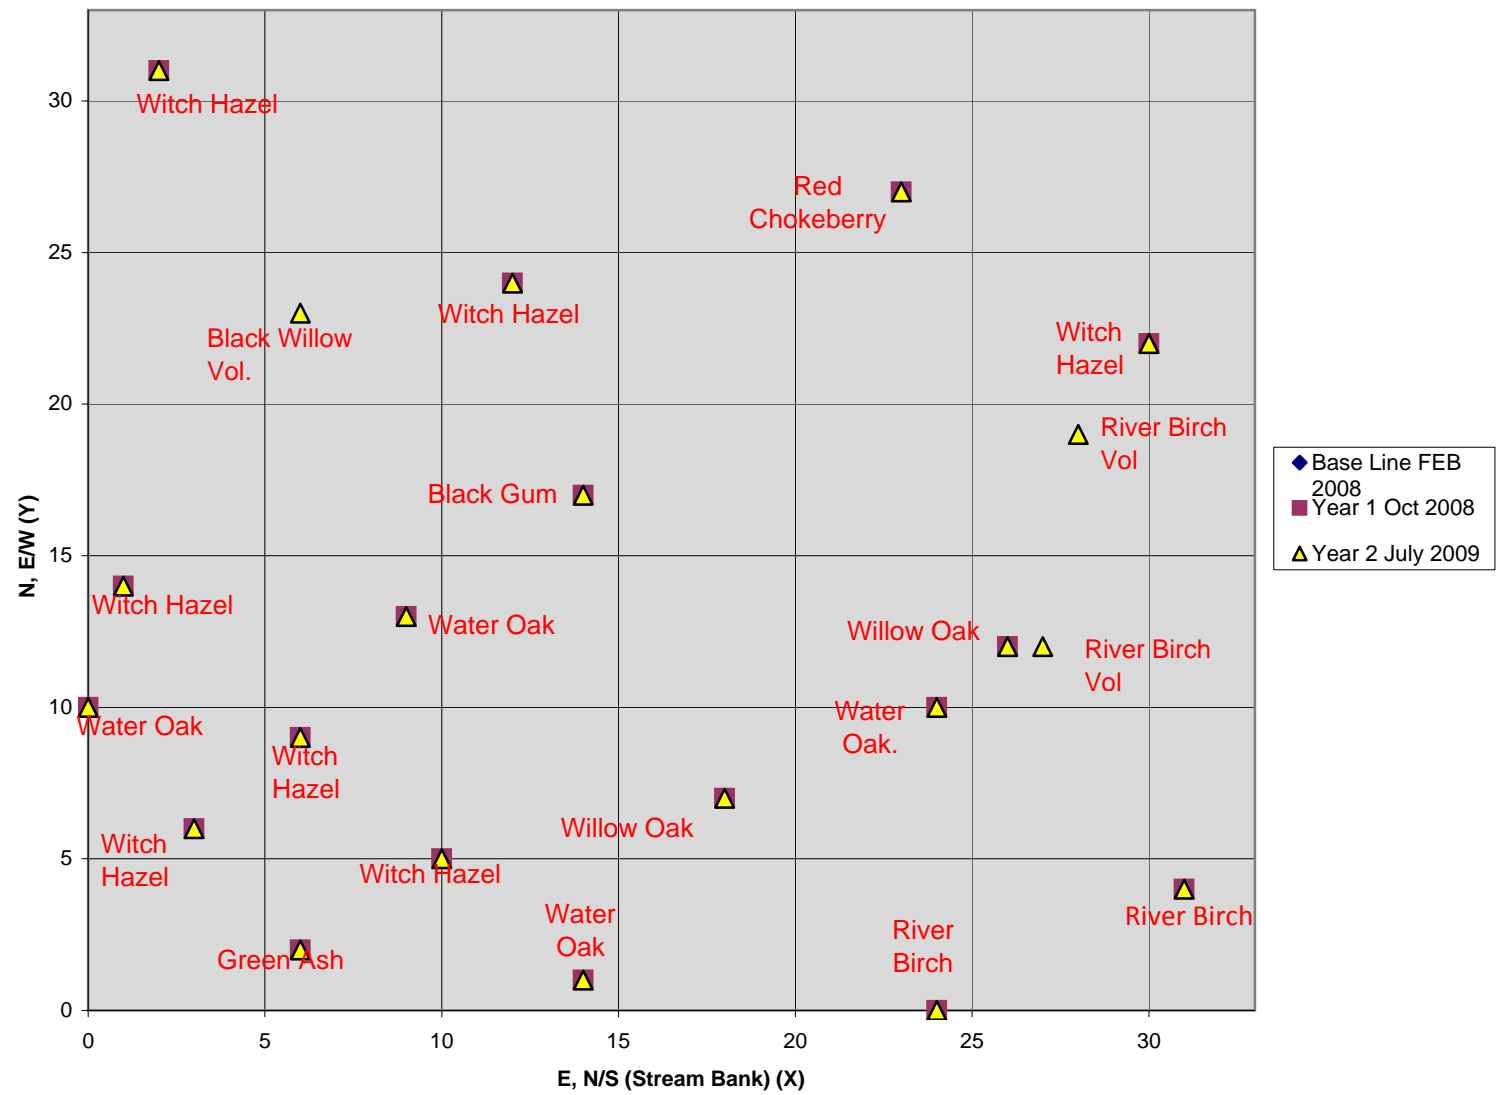
VP 3

The north east quadrant of this plot has been subject to several wash outs and continues to be inundated with sand and debris, which are hostile to vegetation. Propose moving this plot slightly south west

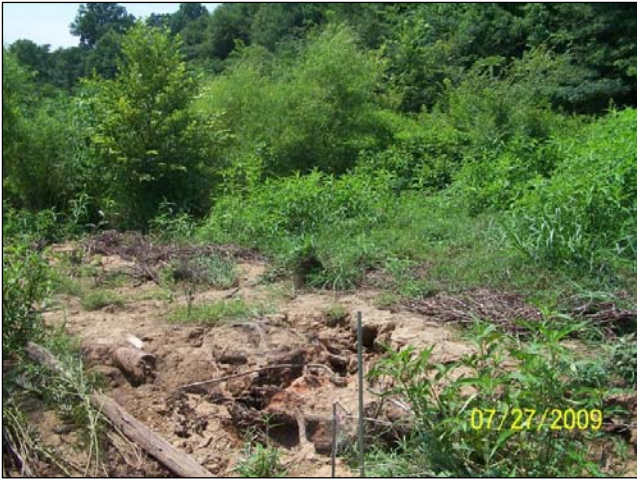
Photo Point 3 – Veg. Plot 6

Plot 6 was difficult to count last year due to dense herbaceous growth, the hope was that more individuals would be found surviving in Year 2. Only two individuals not found last year were found in this years count. In addition, the plot was subject to scouring during an over bank event. This plot is in bad shape with 0% cover in the scour area and high mortality of planted stems. The scour damage will be repaired and the plot will be replanted with gallon size trees this winter. The current stems per acre calculation for plot 6 is 280, with no volunteers present and less than 50% cover. Areas were cover is not disturbed are dominated by *polygonum pennsylvanicum* though not to the same degree as Year 1.

Damage repair and replanting will be done in Plot 6 this fall/winter. A 90 degree angle has developed in the stream at approximately station 204+50. Large concrete debris was left in place at the time of construction and may be the cause of this sharp bend. This debris will be removed prior to the next growing season and stabilized with live stakes. The area between station 201 and station 204 will be carefully observed this winter to determine if remedial work is necessary or if the area is progressing towards a stable and vegetated state.

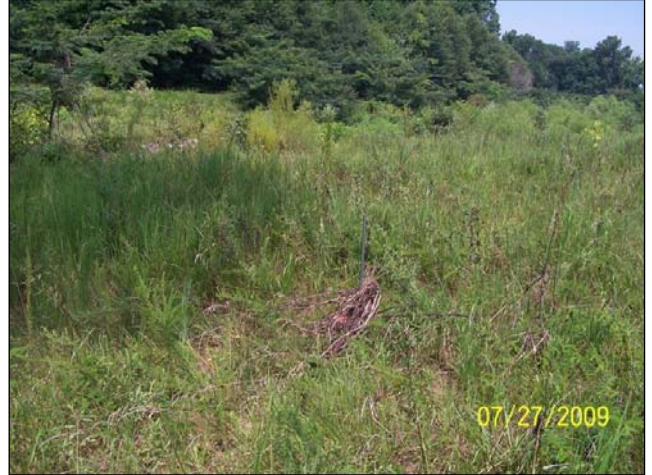
Photo Point 9 – Veg. Plot 5

Plot 5 lost three planted individuals in addition to four individuals declared dead last year. Seven individuals lost last year among dense herbaceous growth were easily identified this year. One river birch volunteer has grown out of the stump of a dead transplanted alder. This plot now contains 480 stems per acre without counting volunteers. Plot 5 is no longer dominated by *polygonum* as in year one, but still contains greater than 75% cover with mixed grasses dominating.

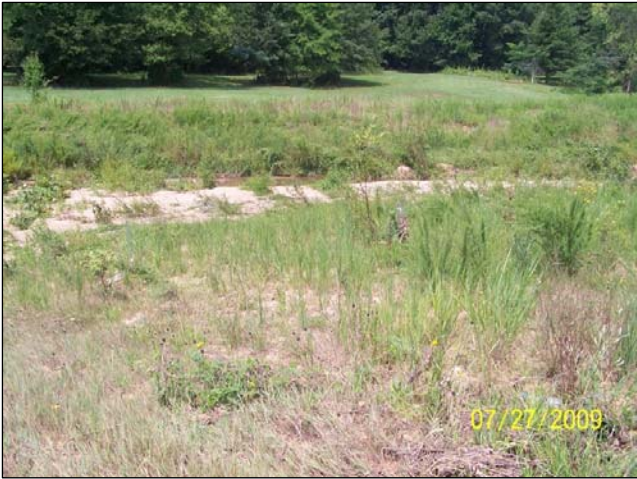
Photo Point 16 – Veg. Plot 4

Plot 4 continues to sustain damage from sand deposition from bankfull events. The sand deposition has killed most of the livestakes in the north east quadrant of the plot. Because the problem in this area is deposition, not erosion, replacement livestakes are not necessary and given the hostile conditions in this plot any replanting would potentially be self defeating. Two cottonwood volunteers and two black willow volunteers are present in the plot and have been added to the grid. Currently, not counting volunteers, the plot has 320 stems per acre, which is low for year 2. Including the volunteers in this count brings the stems per acre to 480. Rather than suggesting a replant for this plot, it may be more effective to move the plot five feet south along the stream bank out of the range of the sand deposition area. Outside of the sand deposition area the plot demonstrates greater than 75% cover with a composition similar to Plot 3, above.

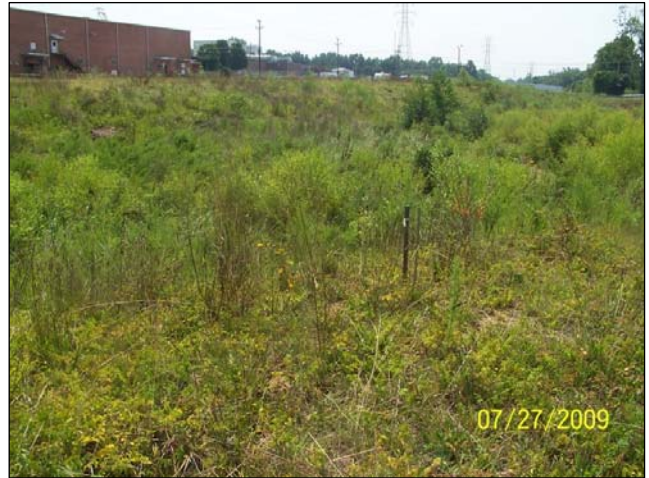
Photo Point 21 – Veg. Plot 3

Plot 3 lost one planted individual in addition to the four individuals lost last year. This is reasonable mortality for Year 2 along with 100% survival of live stakes. One new black willow volunteer was noted this year and added to the grid. Herbaceous cover is greater than 75% and dominated with upland dry meadow species like dog fennel. Plot 3 contains 400 stems per acre not including volunteers.

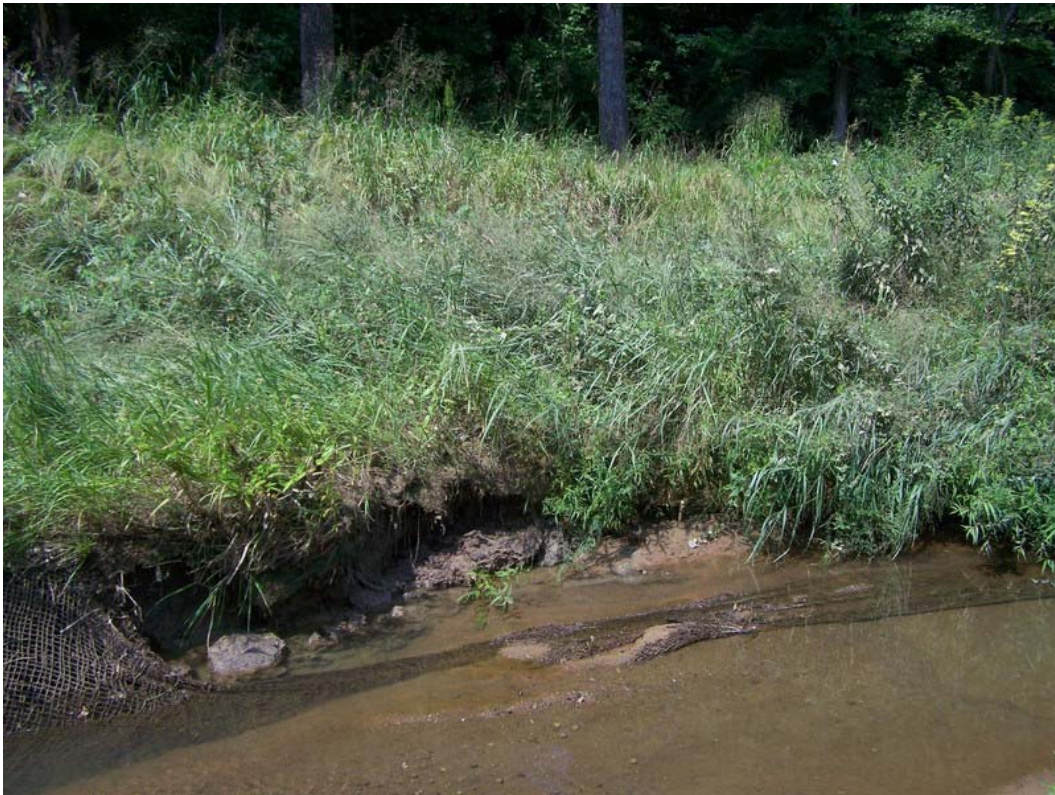
Problem Area at Station 229, right bank will be live staked this winter and watched.

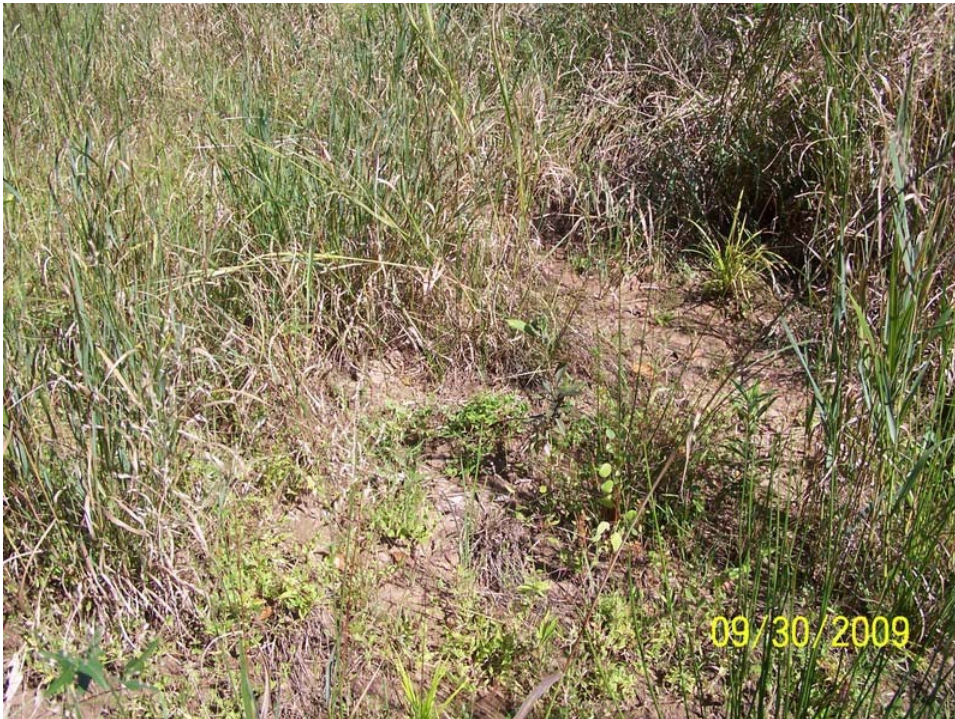
Scour and silt in XS 1, mostly re-vegetated

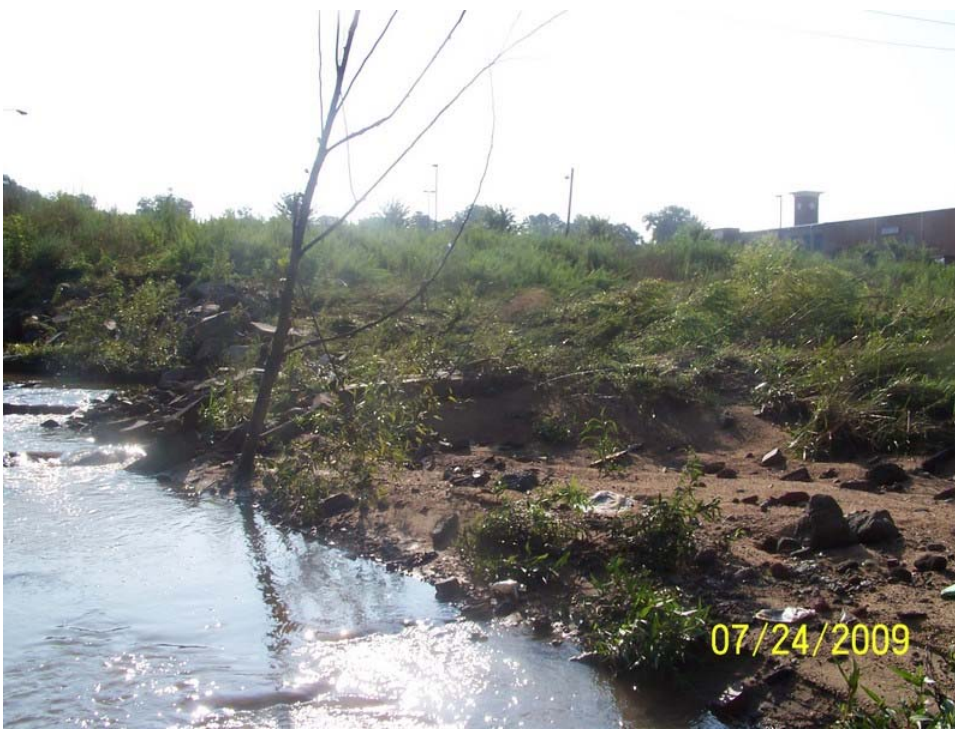
Area at start of easement below McGill Ave has repaired itself to a reasonable degree without intervention

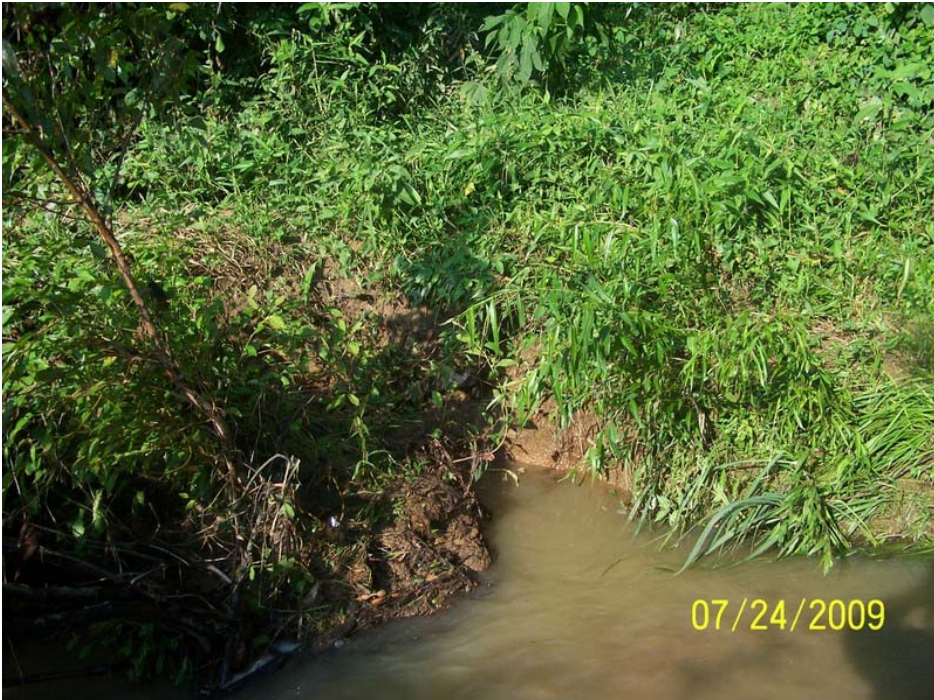
Other “rough” areas just below McGill Ave. will be live staked again and watched

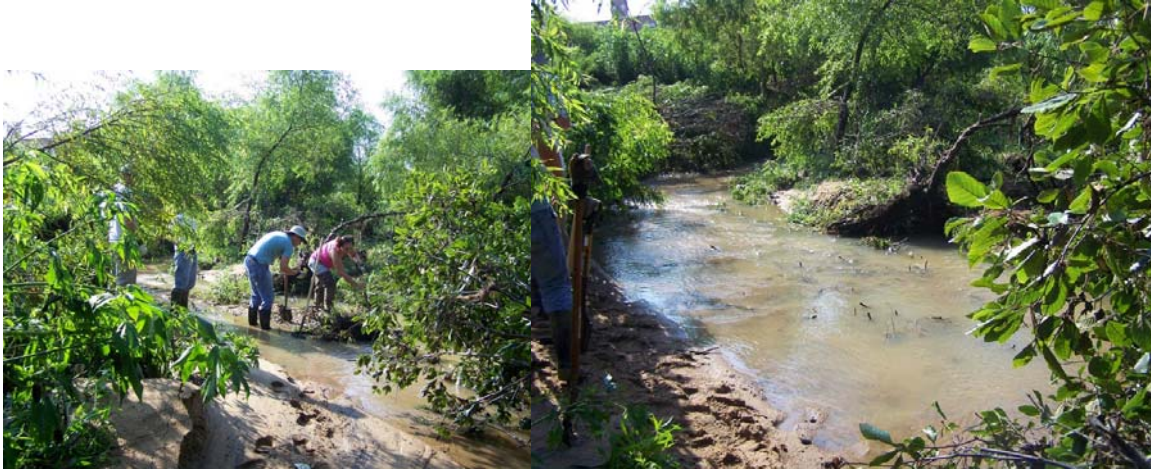
Overall, the stream channel has stabilized well and weathered multiple bankfull events. Sudden, severe, flash flood type events are typical of urbanized streams. Areas that sustained damage due to bankfull conditions were repaired by hand along several rills in the middle section. Other repairs, which are documented in the photo log include removal of two island bars formed around washed out alder transplants below McGill Road. These

islands were causing bank erosion on the right bank due to the shift in flow. The herbaceous vegetative cover has also developed a healthy and diverse community throughout most of the site. The planted trees and shrubs have also done well and are supplemented by an existing buffer community which will provide a seed source for volunteers well suited to the current site conditions.

Alder tree had dislodged from the bank and developed into a center bar island, which has now been removed.

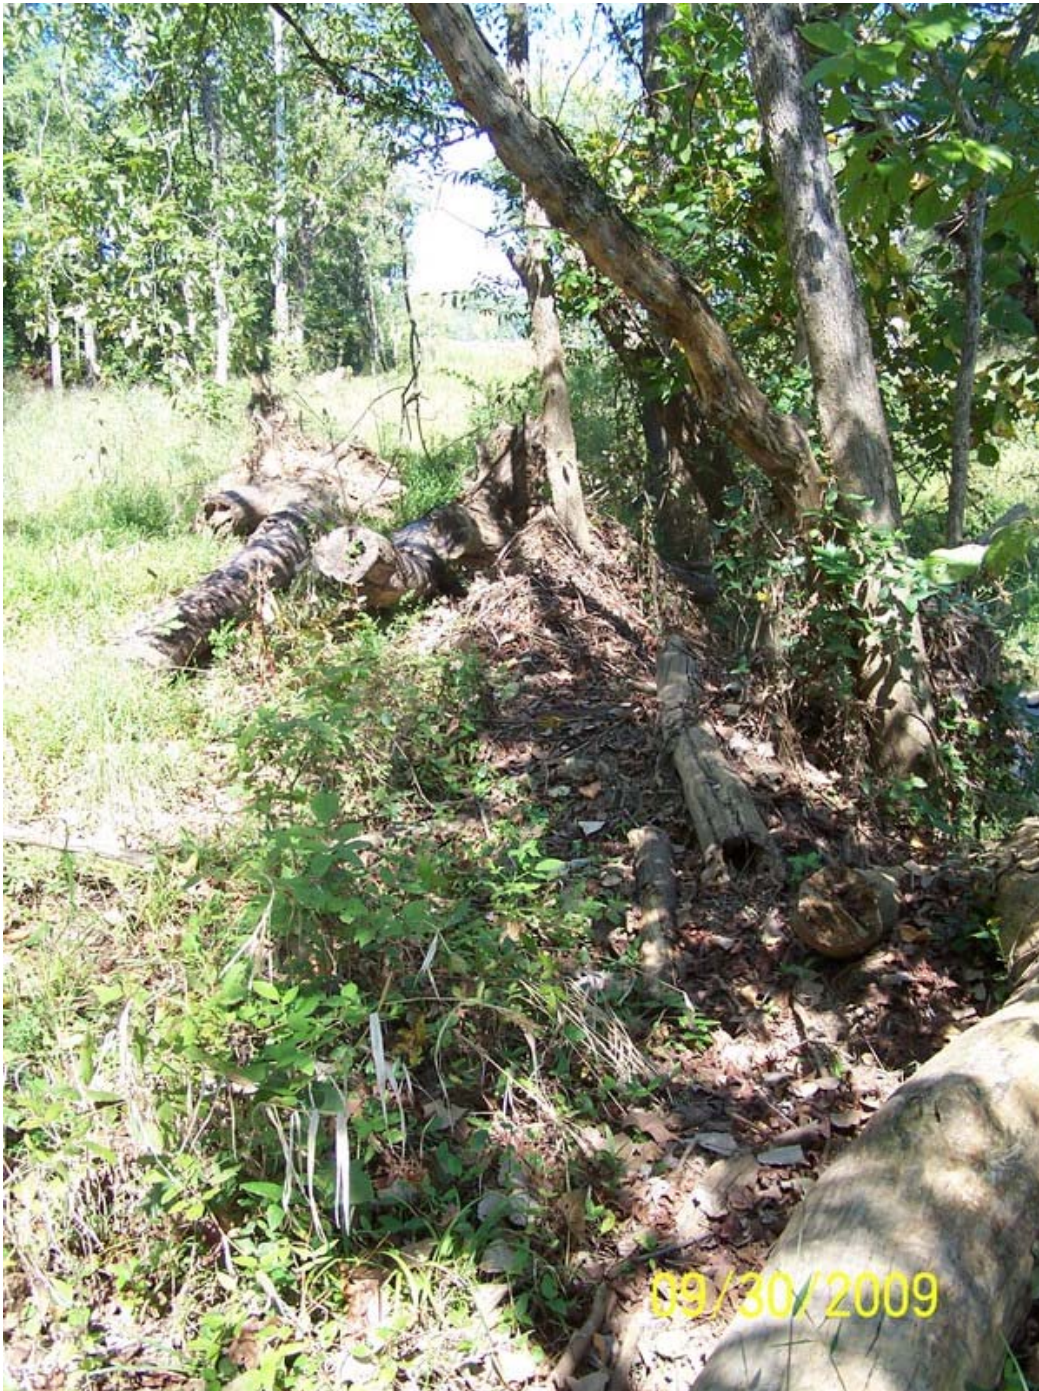
Rack Lines and Debris
