**SUCK CREEK STREAM RESTORATION
(Project No. .00012)**

MONITORING YEAR 2 (2005)

Submitted to:
North Carolina Department of Environment and Natural Resources
Ecosystem Enhancement Program
Raleigh, North Carolina

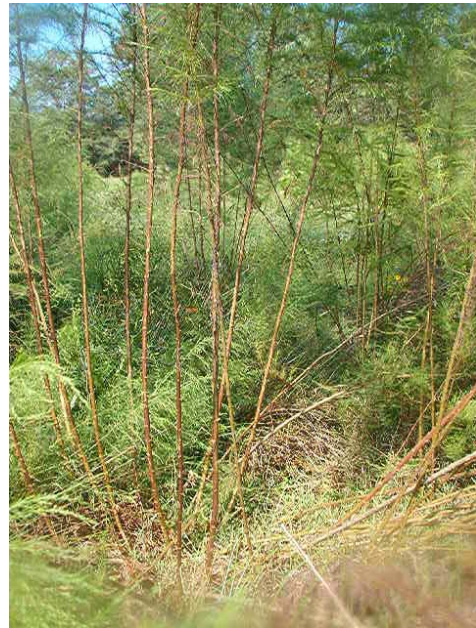
Feature/Issue	Station #/Range	Probable Cause	Photo #
Bare Bank	11+50	Backwater eddy scour	1
	19+10	Scour behind failed root wad	2
	22+80	Bank scour from upland sheet flow	3
Bare Flood Plain	22+80	Upland sheet flow	3
	Vegetation Plot 2	unknown	VP-2
	Vegetation Plot 3	unknown	VP-3
	Vegetation Plot 4	unknown	VP-4
