**SUCK CREEK STREAM RESTORATION
(Project No. 0117950008)**

MONITORING YEAR 3 of 5 (2006)

January 2007

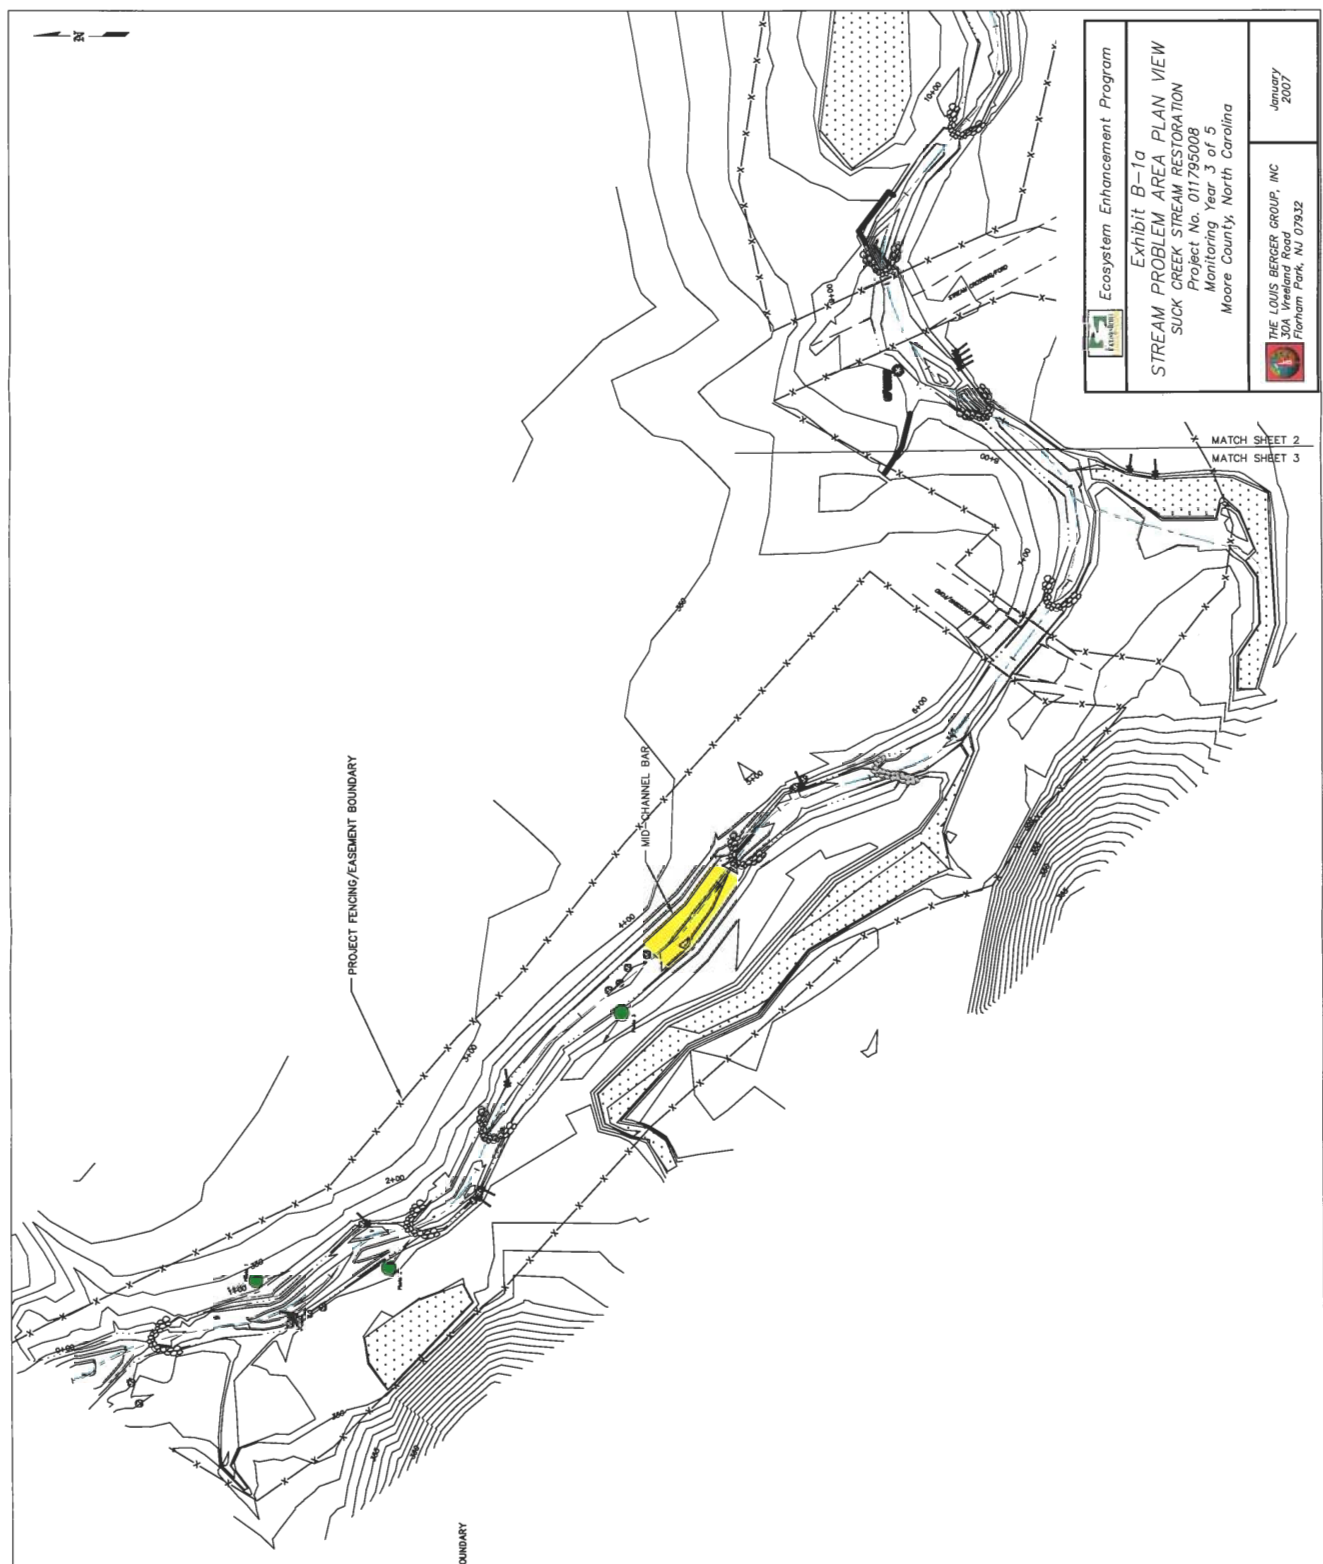
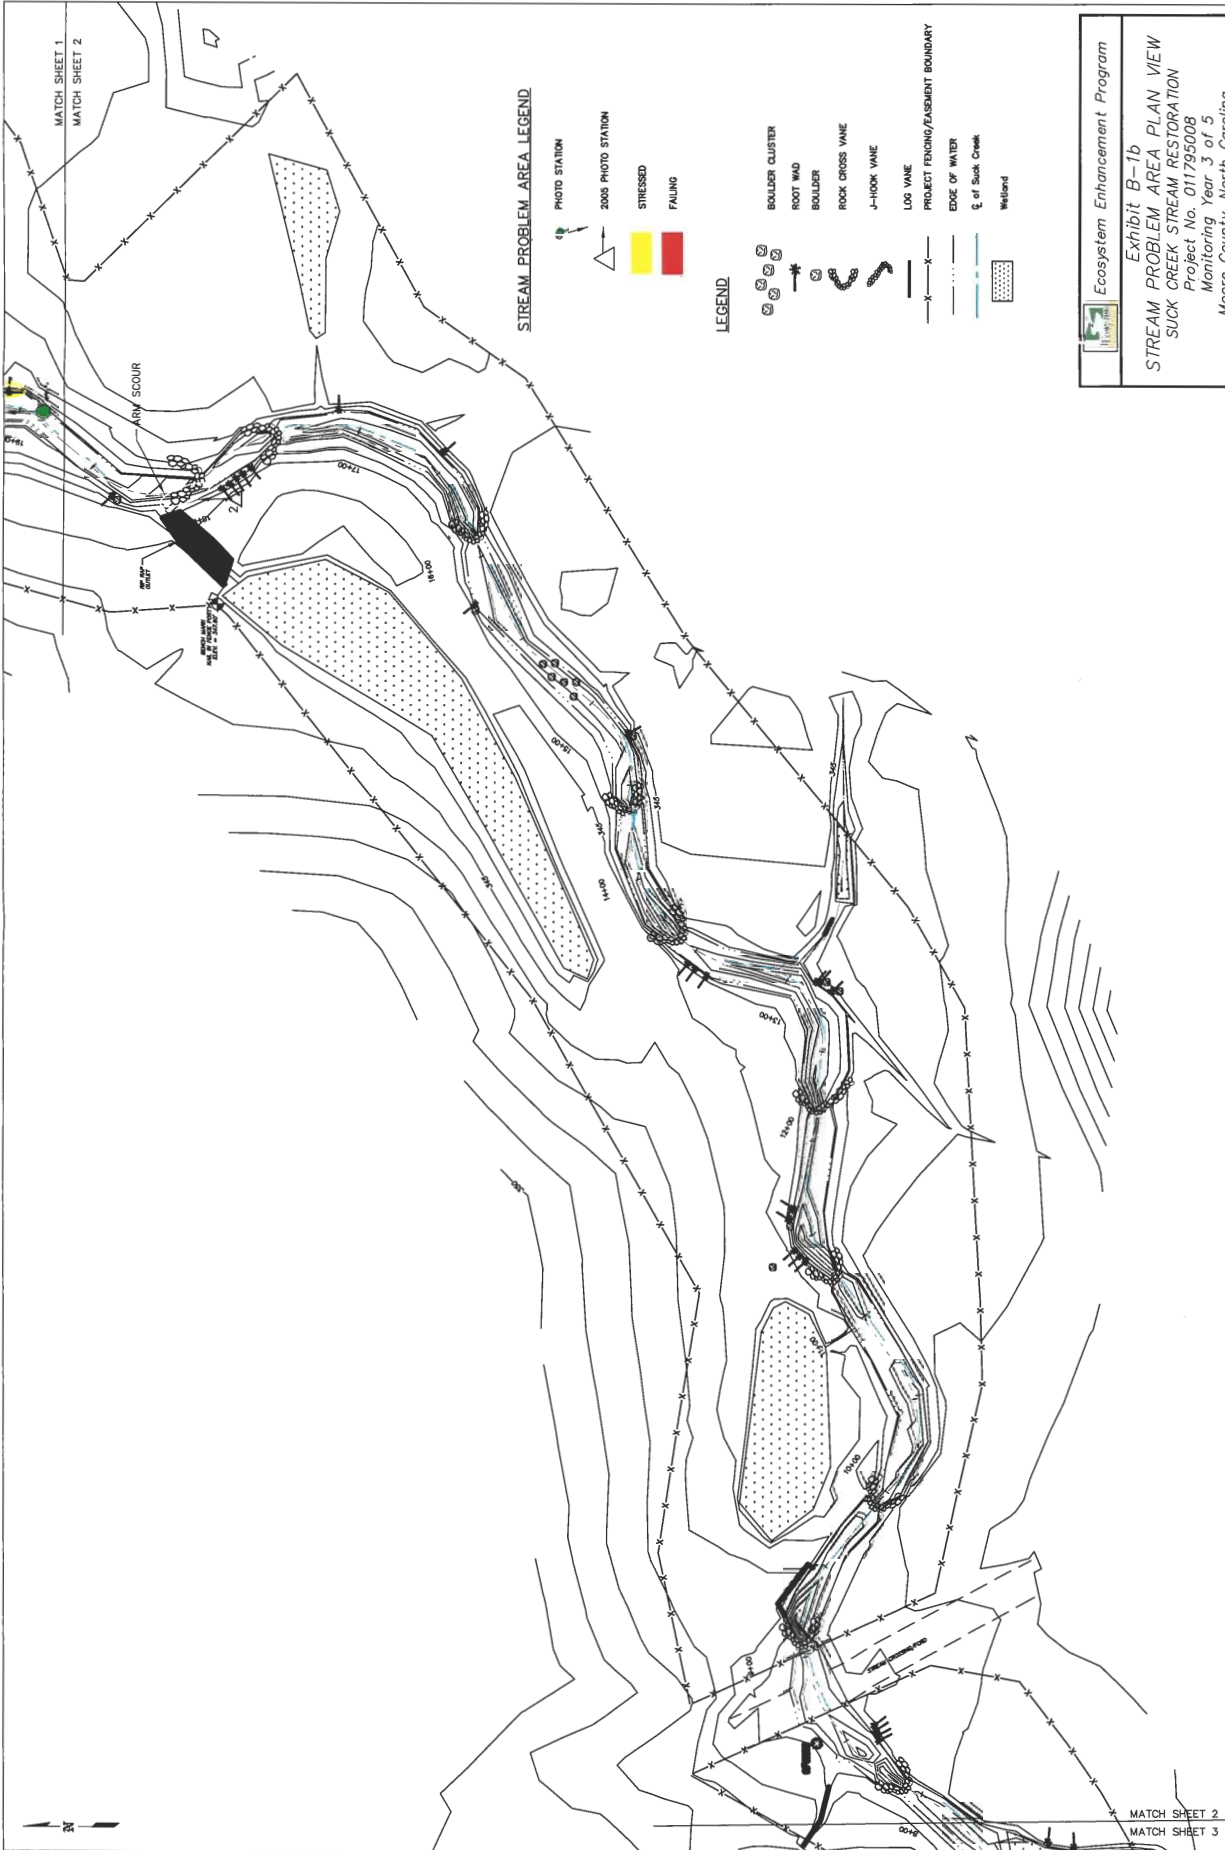
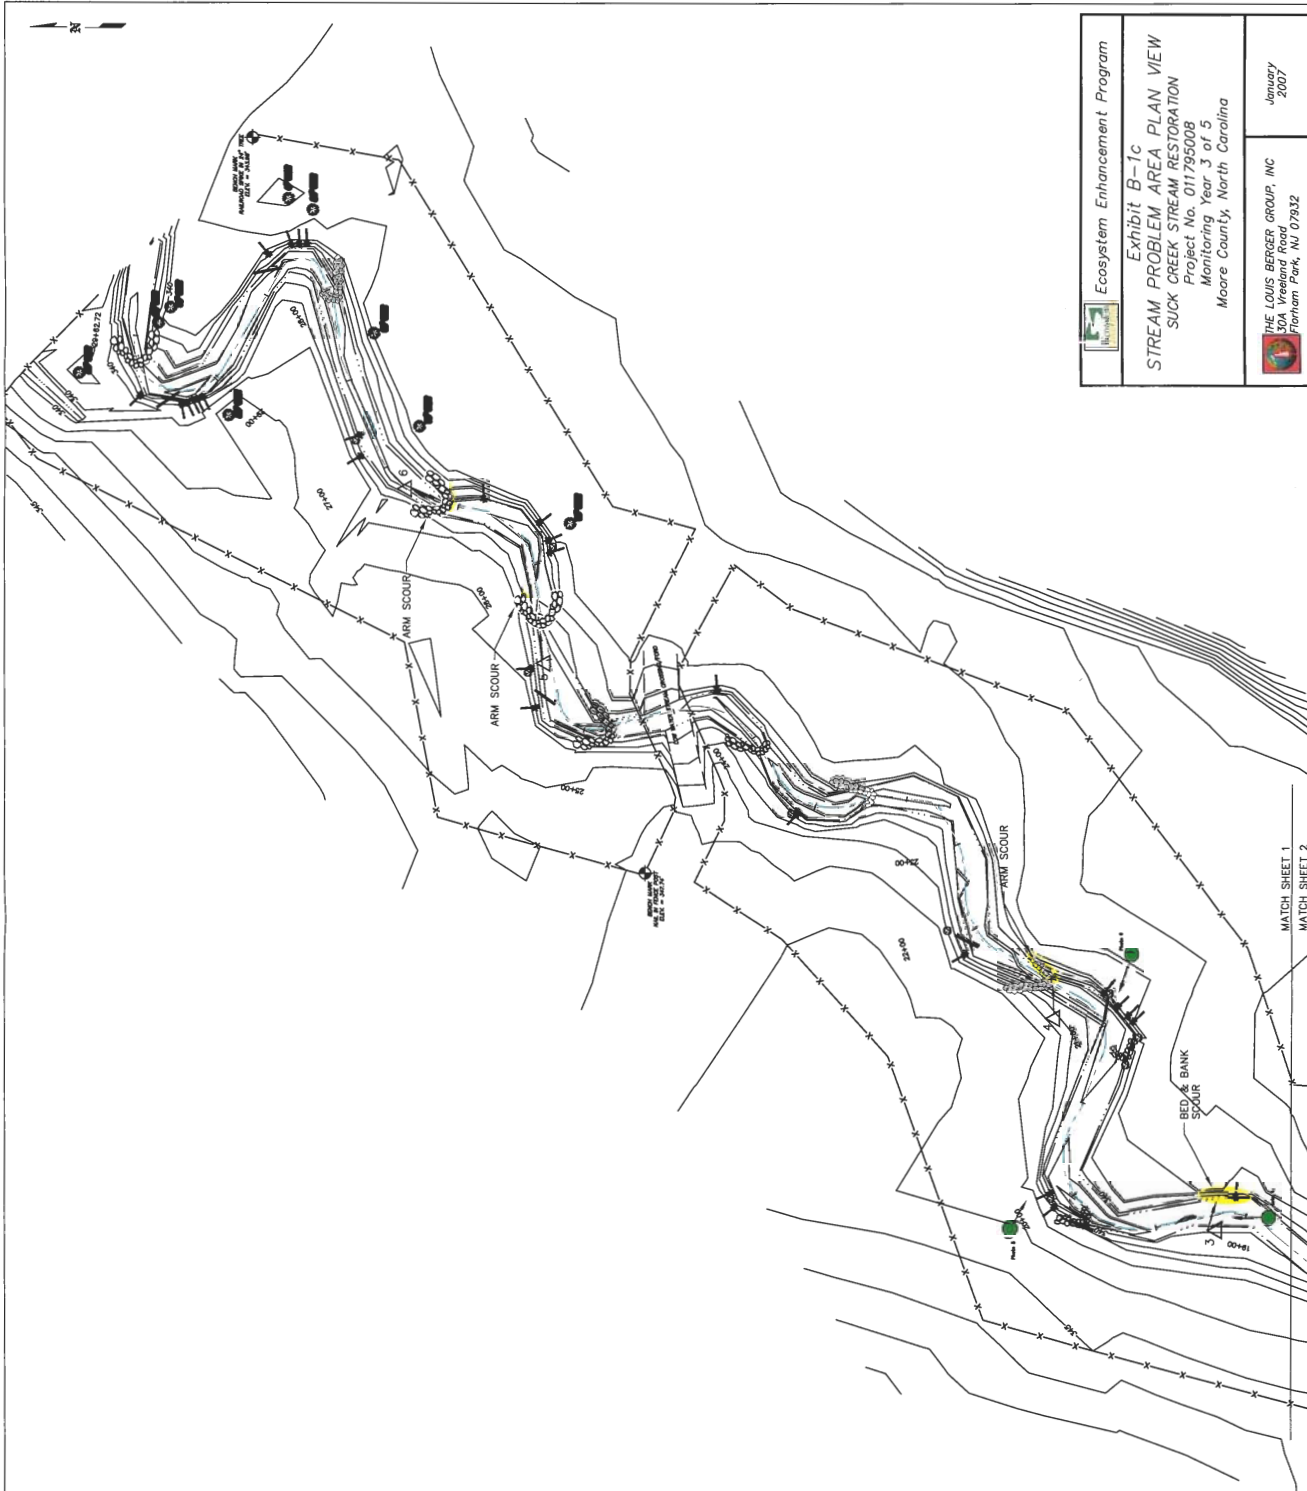
There were no new problem areas identified during Year 3 monitoring. All Year 2 problem areas were unchanged, had not degraded further, or herbaceous vegetation had established on the problem area. The root wad failure at Station 19+10 has stabilized and vegetated and is not considered a problem area. This area will be looked at in future monitoring to track its stability. A summary of the problem structures observed during Year 3 monitoring with notes about each structures status is provided in Appendix B.

The mid-channel bar downstream of the boulder field (Stations 4+00 to 4+60) has become vegetated with rice cutgrass (*Leersia oryzoides*). This feature likely occurs because of unfocused velocity, down stream of the boulder field, and too slight a water surface slope. Low water levels due to the late summer drought may have also created shallow water conditions conducive for the germination and establishment of rice-cut grass. No maintenance actions are recommended at this time.

The root wad failure at Station 19+10 that caused bank erosion last year has stabilized. The banks and fabric matting have formed a vegetated slumping bank.

Feature Issue	Station Numbers	Suspected Cause	Photo Number / ID
Mid channel bar	4+00 to 4+60	Slope too slight to move sediment. More sediment has deposited and vegetation has established.	Station 4+00
Cross Vane, arm scour	18+00	Large voids between rocks in vane. No change from prior year.	Station 18+00
Root wad failure	19+10	Improper installation. Vegetation has established.	Station 19+10
Cross Vane, arm scour	21+60	Large voids between rocks in vane. No change from prior year.	Station 21+60
Cross Vane, arm scour	25+70	Large voids between rocks in vane. No change from prior year.	Station 25+70
Cross Vane, arm scour	26+60	Large voids between rocks in vane. No change from prior year.

Maintenance is recommended on the cross vanes at Stations 21+60 and 26+60 since scour between and around individual rocks in the arm is extensive and the arm of the structure is not creating a bar behind the structure of any kind. Sediment has deposited atop the vane arms and has become vegetated. Piping between vane rocks still continues.
