SUCK CREEK STREAM RESTORATION
(Project No. 368)
FINAL

MONITORING YEAR 4 of 5 (2007)

Submitted
October 2007

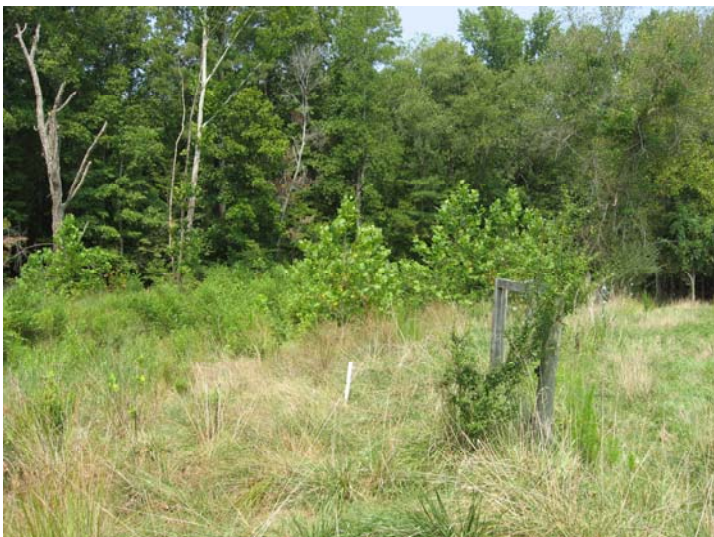
CVS Vegetation Plot 7

In analyzing Monitoring Year 3 CVS reports versus Monitoring Year 4 reports one notable change is in the Vigor category, more entries for the lower vigor scores 2, 1, 0 and Missing were reported for 2007 than for 2006. The likely reason is the severe drought that Moore County is experiencing. Drought as a cause for damage increased somewhat from MY3 to MY4; however, the increase from insect damage was more robust. Two new entries to the damage category at Suck Creek are Livestock and Beaver. Livestock graze the neighboring fields, and evidence was found indicating they pushed through fencing at the stream crossing. This affected Plot 6 and Plot 7 the most; little or no livestock damage was observed in other plots.

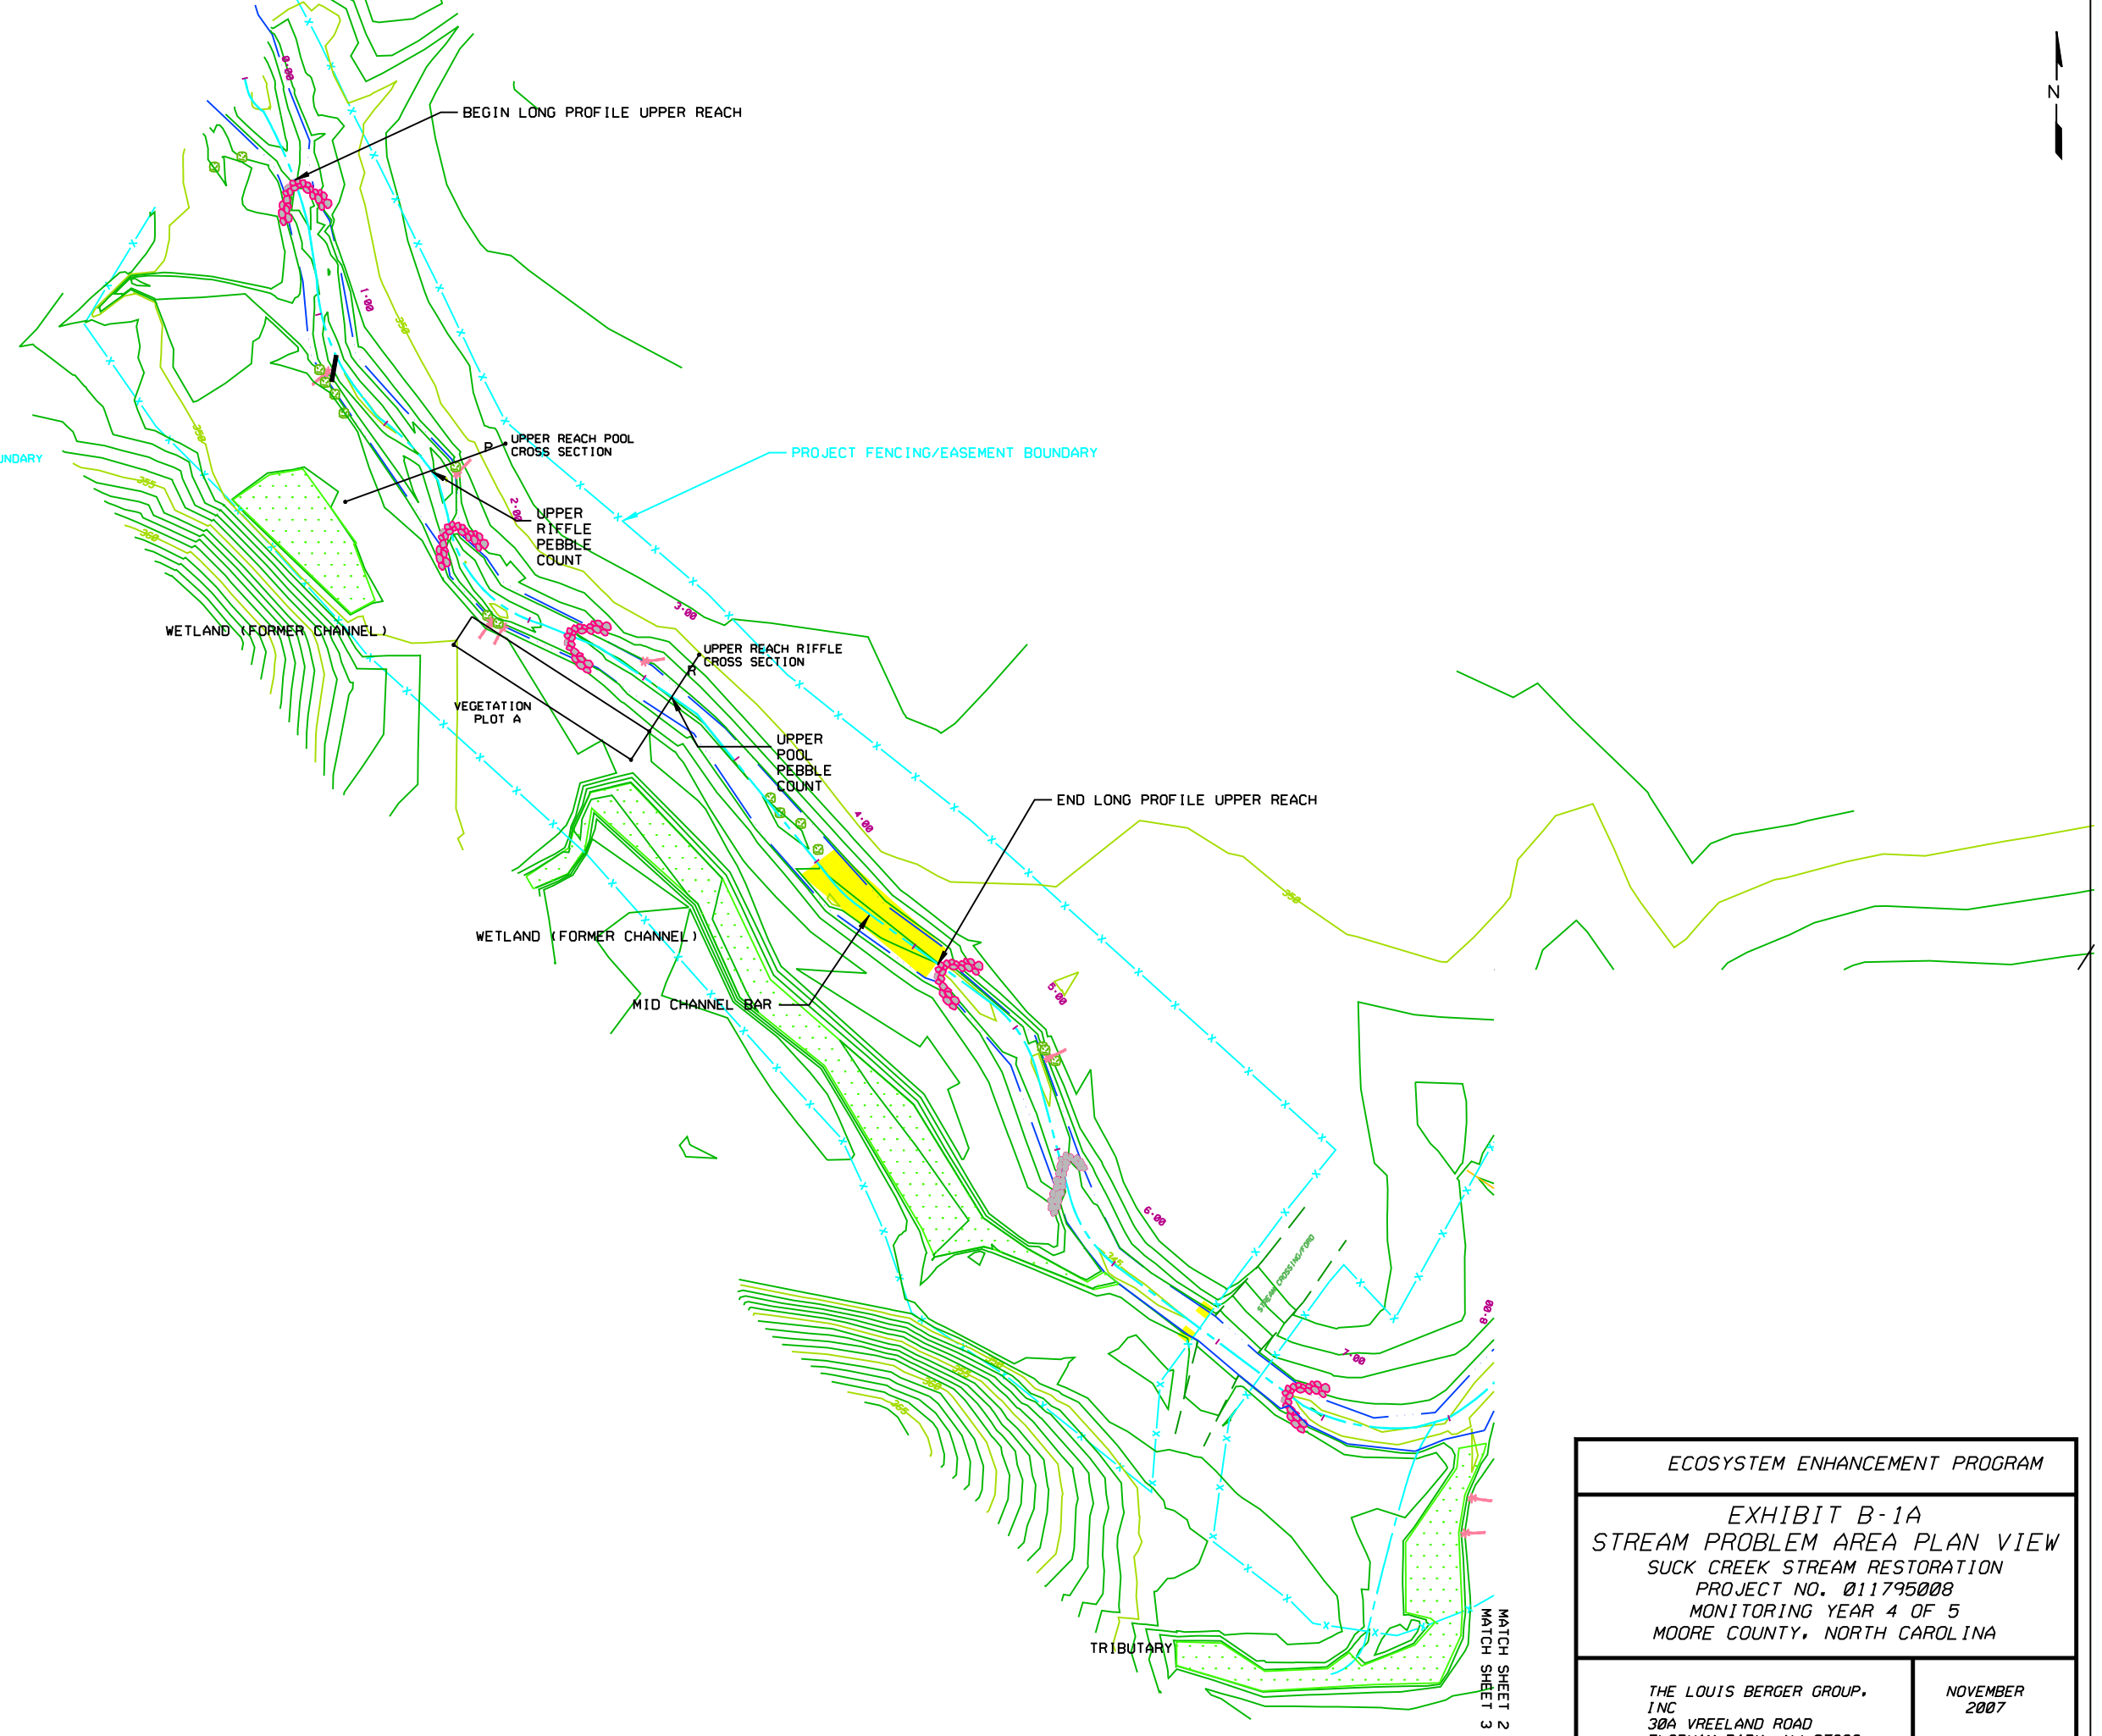
ECOSYSTEM ENHANCEMENT PROGRAM	
EXHIBIT B-1A STREAM PROBLEM AREA PLAN VIEW SUCK CREEK STREAM RESTORATION PROJECT NO. 011795008 MONITORING YEAR 4 OF 5 MOORE COUNTY, NORTH CAROLINA	
THE LOUIS BERGER GROUP, INC 30A VREELAND ROAD FLORHAM PARK, NJ 07932	NOVEMBER 2007

Feature Issue	Station Numbers	Suspected Cause	Photo Number /ID
Mid channel bar	4+00 to 4+60	Slope too slight to move sediment. More sediment has deposited and vegetation has established.	Station 4+00
Damaged bank	6+40	Cows trampled when entering stream.	Station 6+40
Flow backup	8+75 – 11+30	Beaver dam/debris dam at cross vane structure at 11+30	Station 8+75, 9+00-11+30
Cross Vane blockage	11+30	Beaver dam/debris dam	Station 11+30
Cross Vane, LB arm scour	18+00	Cross Vane failure, flow undermined left bank and now water flows around the vane instead of through it.	Station 18+00
Mid channel bar	19+00	Sediment has deposited and vegetation has established.	Station 19+10
Cross Vane, arm scour	21+60	Large voids between rocks in vane. No change from prior year.	Station 21+60
Log vane failure	25+50	Log vane has separated from bank, altering channel flow.	Station 25+50
Cross Vane	25+70	Large voids between rocks in vane. No change from prior year.	Station 25+70

Four maintenance actions are recommended at this time. Where cattle have entered the stream and caused bank destabilization, replacement and strengthening of fencing at the first cattle crossing on the upper reach is recommended. The removal of a beaver dam/debris dam at station 11+30 is recommended to disrupt ponding upstream and restore appropriate flow and water surface levels. Maintenance should be considered on the cross vanes at Stations 18+00, 21+60, 25+70 and 26+60 since scour between and around individual rocks in the arm is extensive and the arm of the structure is not creating a bar behind the structure of any kind. Piping between vane rocks still continues. Additional maintenance at Station 25+50 to reposition the log vane structure is suggested.
