**Suck Creek Stream Restoration
Project No. 368
2008 Monitoring Report (Final): Year 5 of 5**

March 2009

Prepared for: NCDENR-EEP
1652 Mail Service Center
Raleigh, NC 27699-1652

Prepared by: Jordan, Jones, & Goulding
9101 Southern Pine Blvd., Suite 160
Charlotte, NC 28273

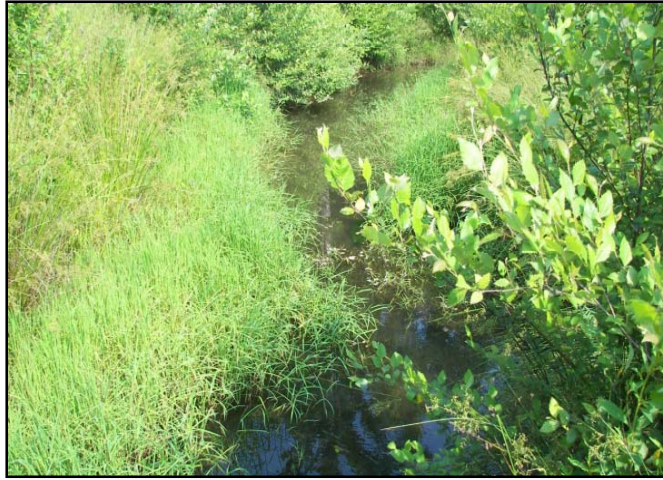
Cross-Section 1: View Upstream (6/2008)

Cross-sections 1 and 2 are located within the Upper Reach. No significant changes in channel dimension were observed that indicate vertical or lateral instability is occurring.
