Suther (Dutch Buffalo Creek) Stream and Wetland Restoration Project

**EEP Project No. 370
2010 Final Monitoring Report: Year 1 of 5**

**Construction Completed: November 2009
Submission Date: June 2011**

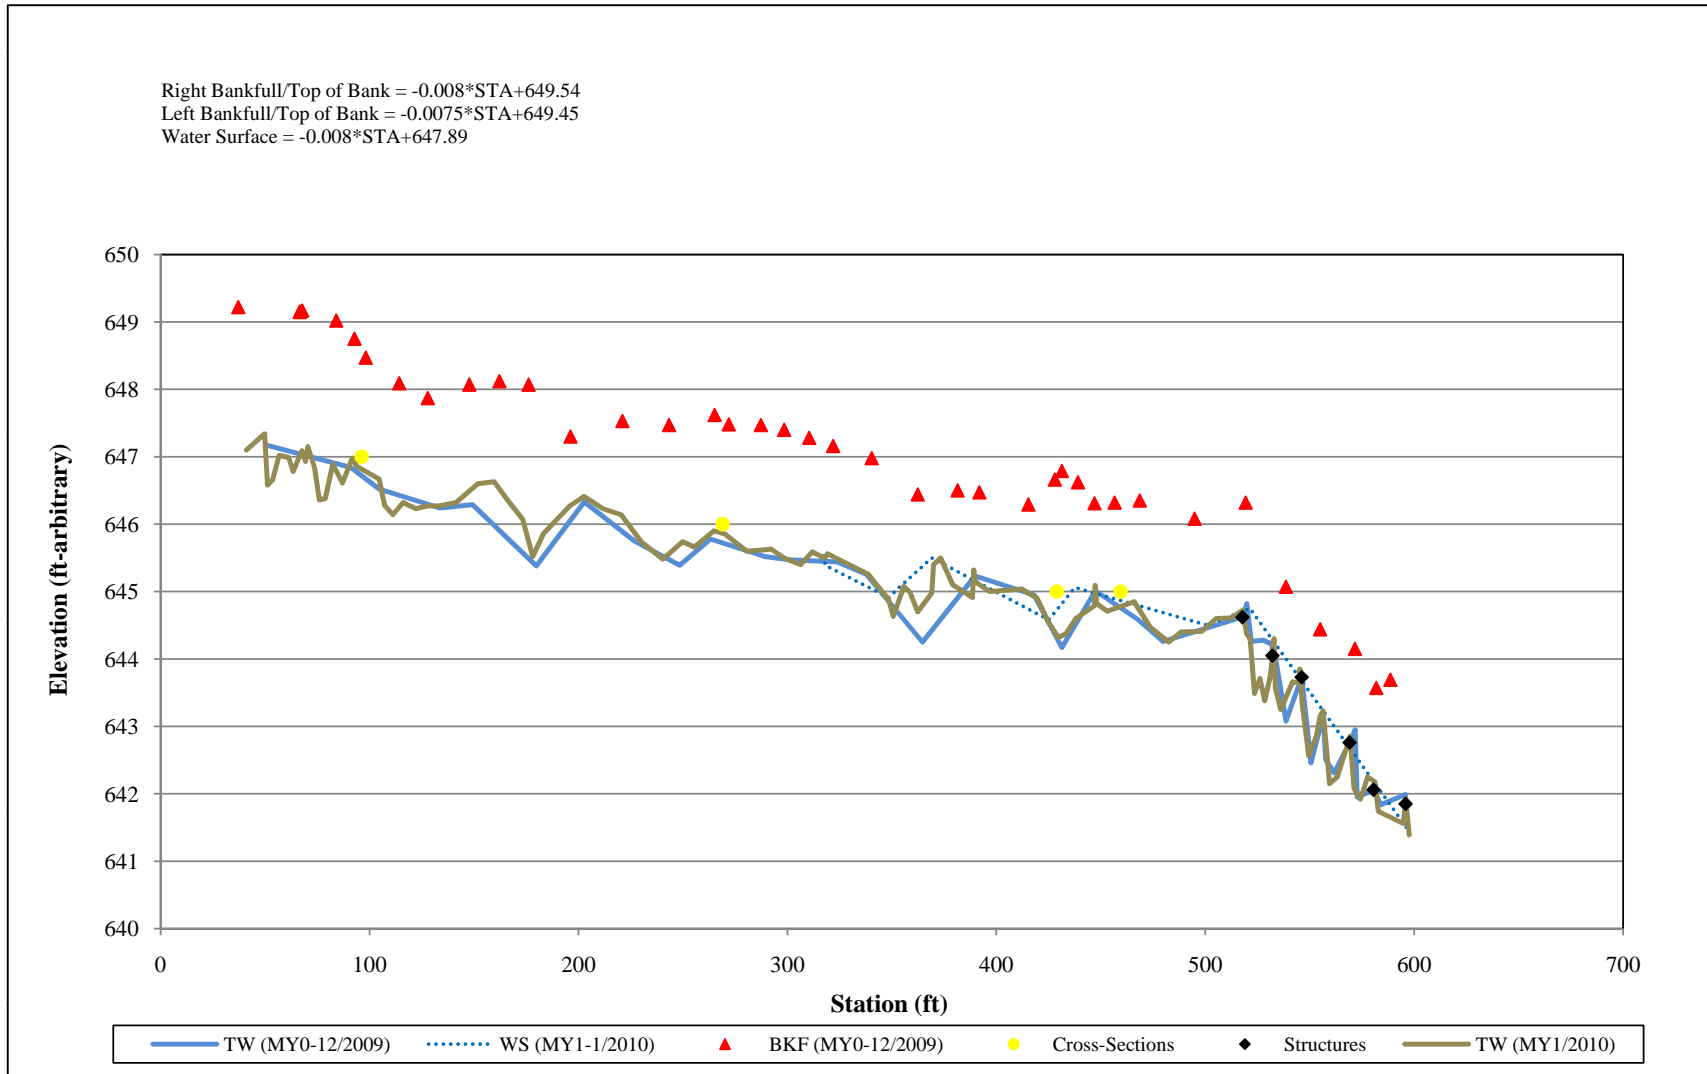
Figure 4. Longitudinal Profile with Annual Overlays

As noted, a majority of the channel was dry at the time of the survey, which limited the collection of select data used for annual comparisons. Additionally, portions of the data collected for the longitudinal profile during the baseline survey effort were inadvertently omitted from the MY0 monitoring report. Information provided in this MY1 report includes the omitted longitudinal profile data. Please refer to Appendix D, Figure 4 for a comparison of the revised baseline longitudinal profile and the current monitoring year data.
