**SUTHER STREAM & WETLAND RESTORATION SITE -- EEP #370
Cabarrus County NC -- PeeDee River HUC# 03040105-020060**

MY-3 (2014) ANNUAL MONITORING REPORT (Final)

**North Carolina Department of Environment & Natural Resources
Ecosystem Enhancement Program (DENR-EEP) -- Contract # 5764**

Data Collected: Aug-Sep 2014 Final Report Submitted: Mar 2015

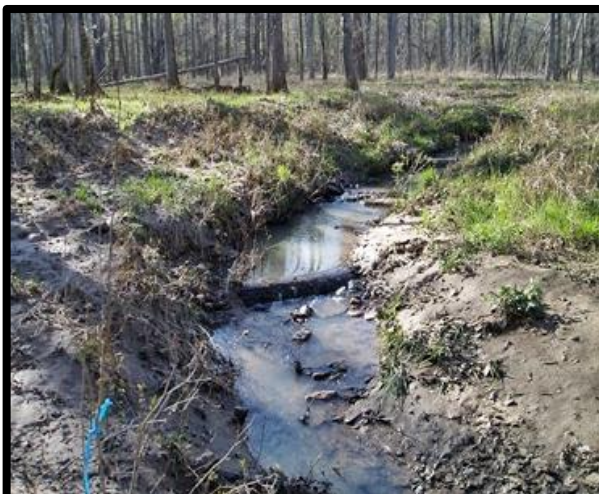
Restored Tributary station 05+80, Photo Point #31, facing NW (upstream). Sparse bank vegetation. 10Apr2014.

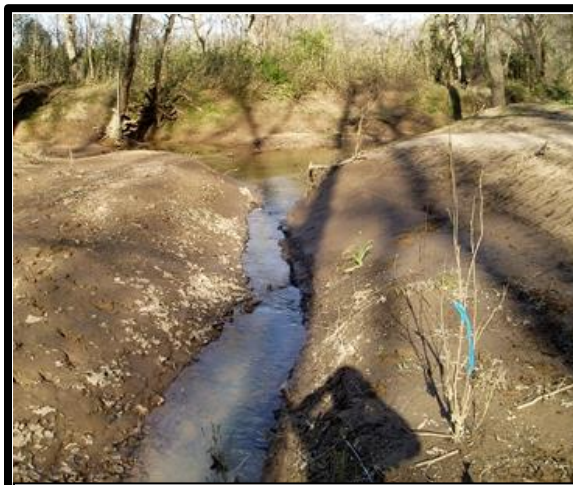
Restored Tributary station 05+80, Photo Point #31, facing E (downstream). Sparse bank vegetation. 10Apr2014.
