**SUTHER STREAM & WETLAND RESTORATION SITE -- DMS #370  
Cabarrus County NC -- PeeDee River HUC# 03040105-020060**

**MY-4 (2015) ANNUAL MONITORING REPORT (Draft)**

**North Carolina Department of Environmental Quality  
Division of Mitigation Services (DENR-DMS) -- Contract # 5764**

**Data Collected: Sep-Oct 2015**

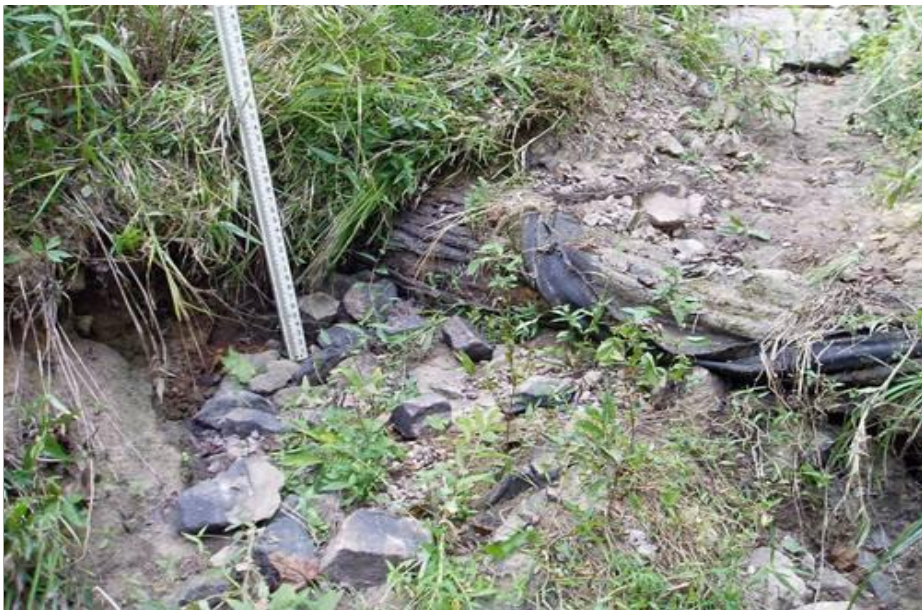
**Bank erosion at step-pool: Tributary station 5+30, Sep 2015**

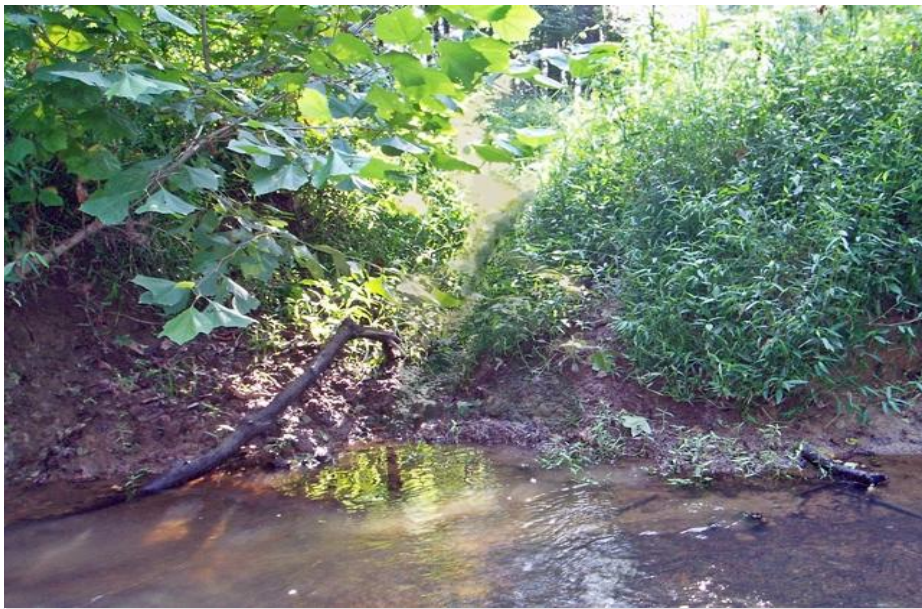
**DBC / Tributary confluence: pre-erosion, Aug 2014**

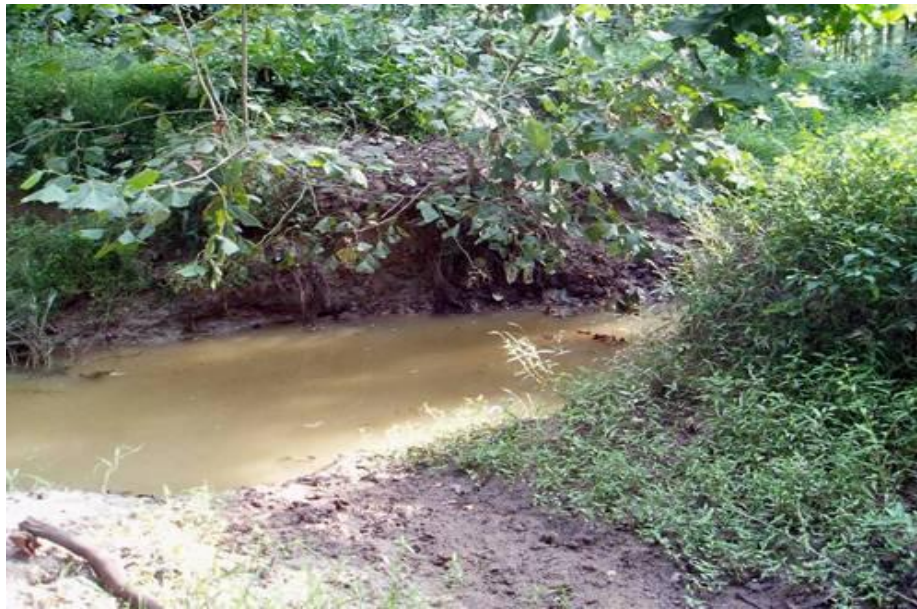
**DBC / Tributary confluence: erosion & bed scour, Sep 2015**

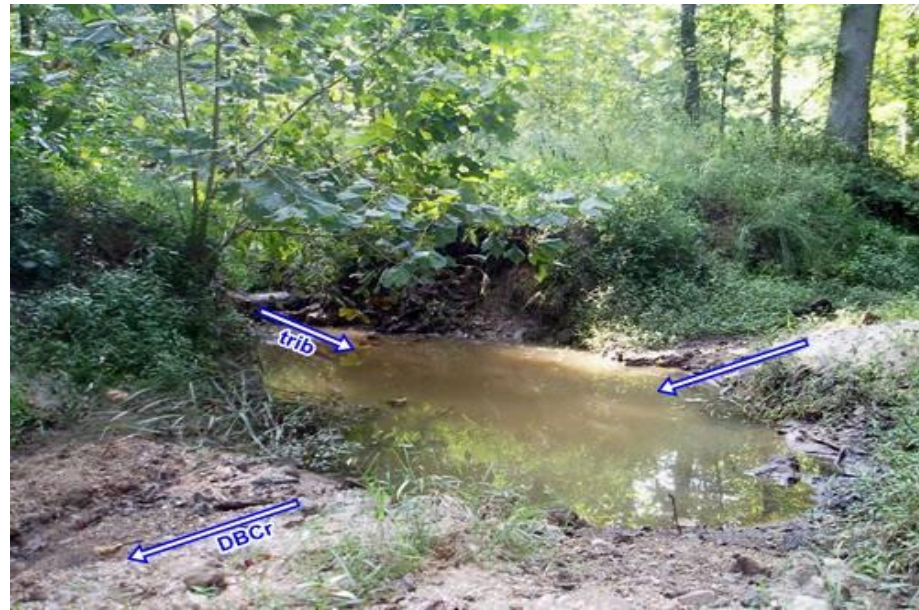
**Bed scour in DBC at Trib confluence, face upst, Sep 2015**

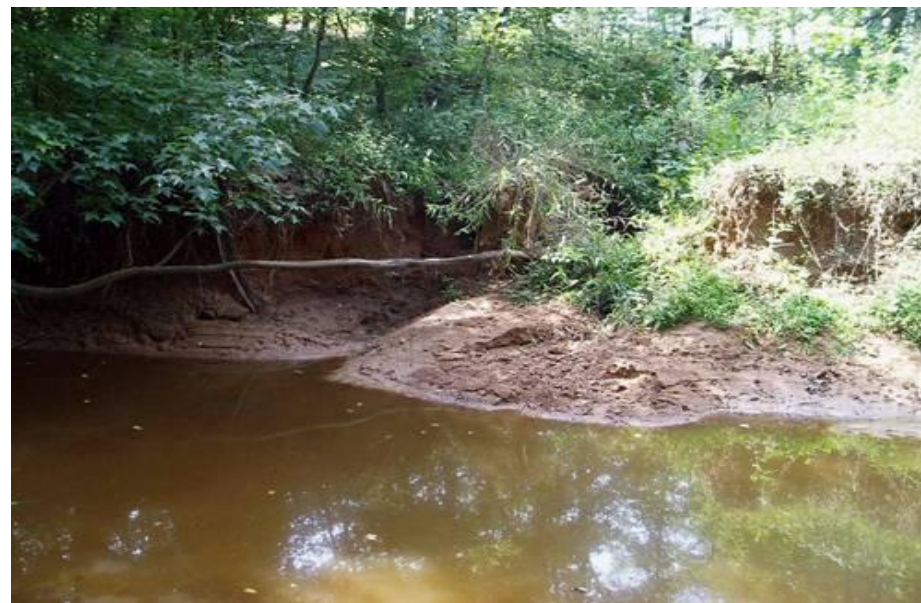
**DBC RBK sta 17+40 erosion, face across channel, Sep 2015**

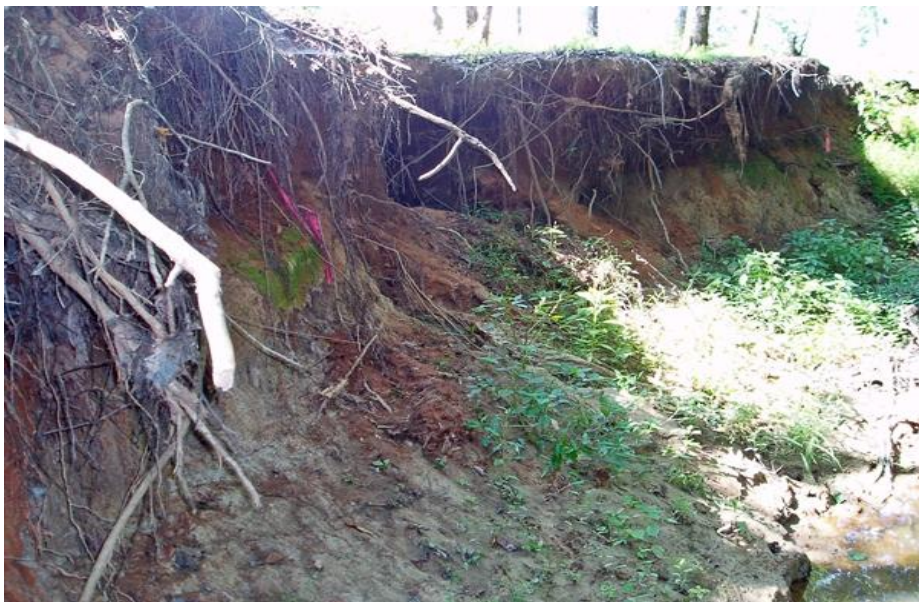
**DBC RBK sta 28+30 erosion pins 6-7, face upst, Sep 2015**

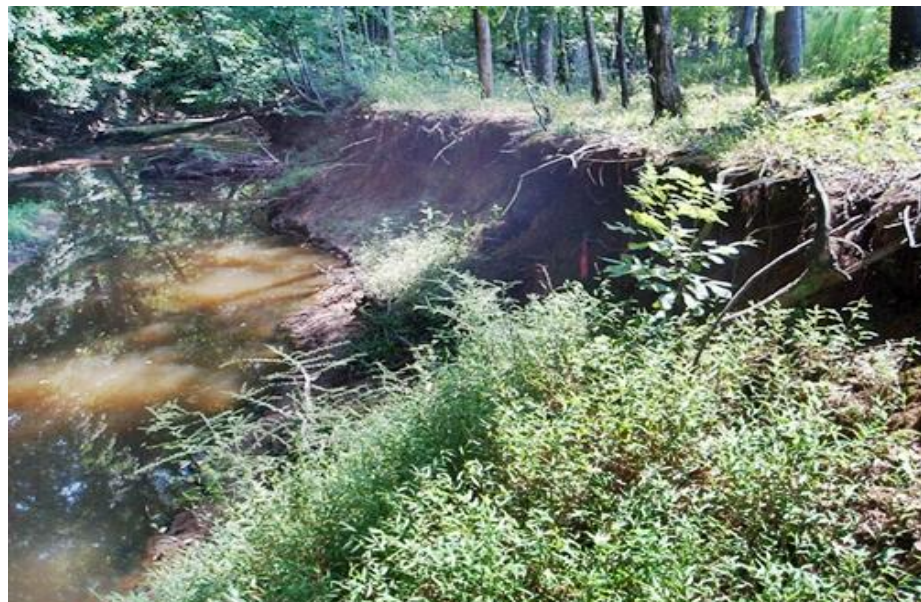
**DBC RBK sta 28+30 erosion pins 6-7, face dnst, Sep 2015**

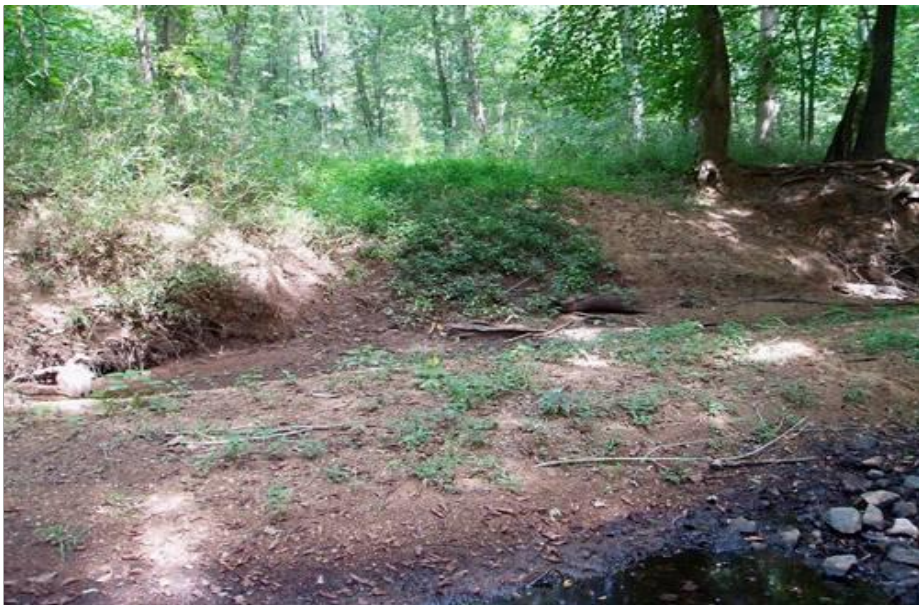
**DBC sta 32+50, construc crossing & mid-channel bar, Sep 2015**

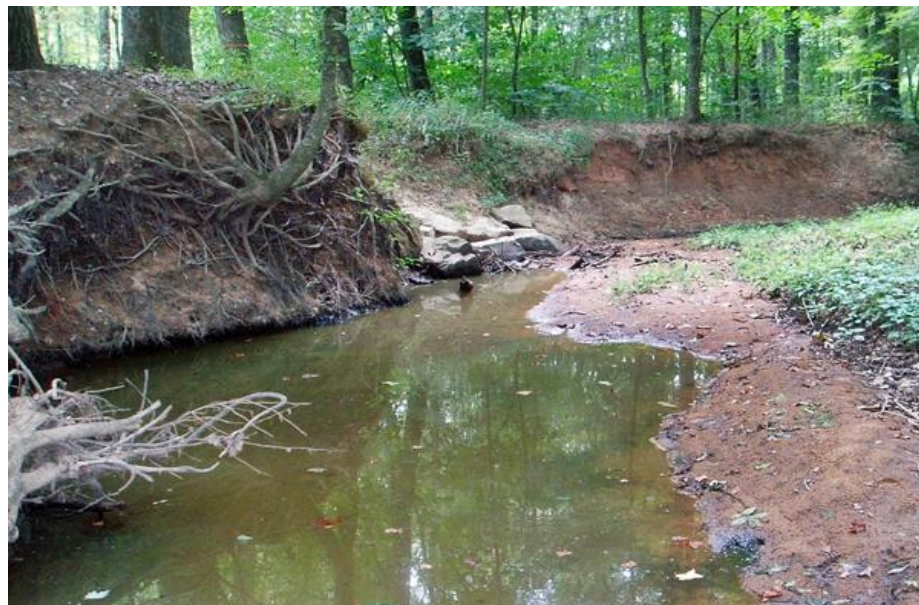
**DBC sta 35+80, face upst, RBK erosion, Sep 2015**

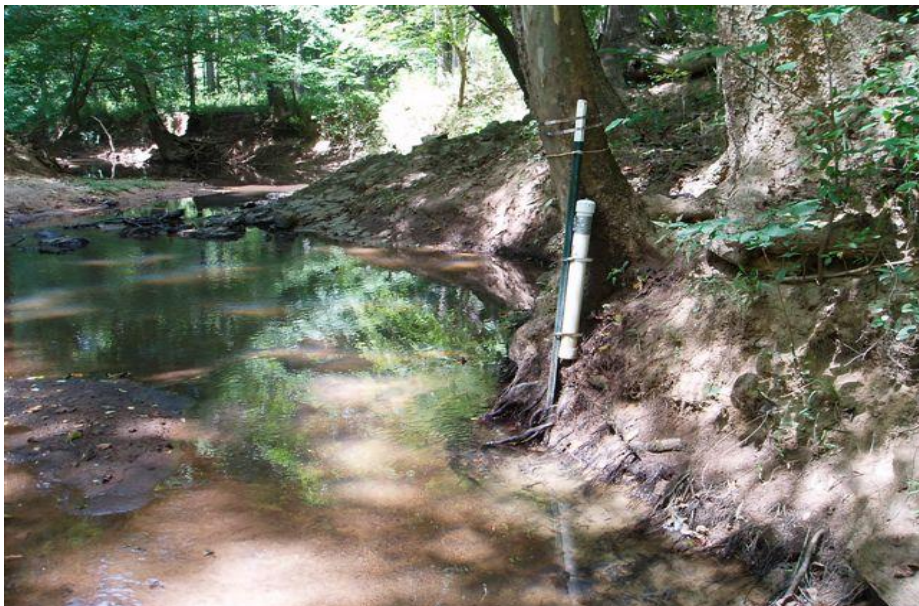
**Hobo gauge at DBC sta 37+60, 4/2014 to 8/2015 (photo Sep 2014)**

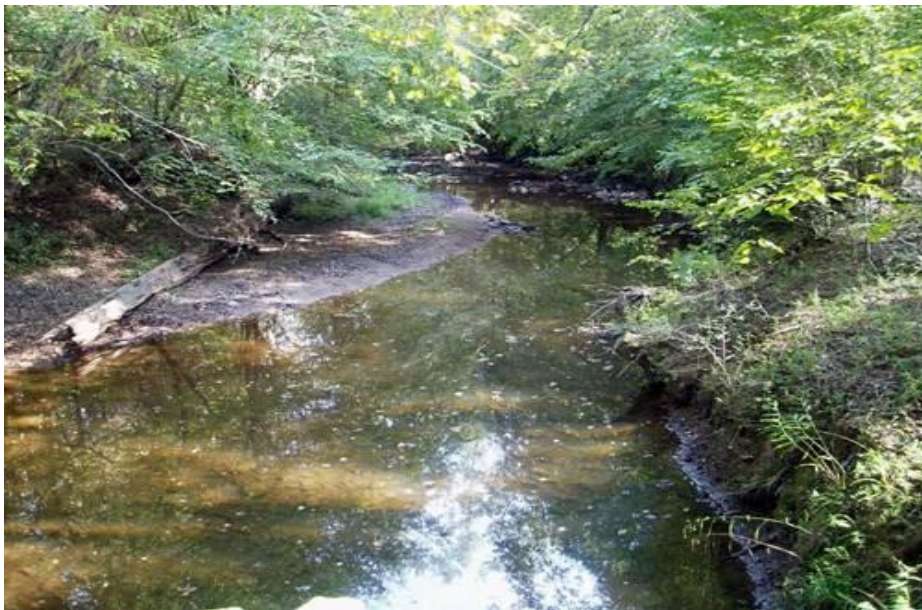
**DBC station 94+00 facing upstream, Sep 2015**

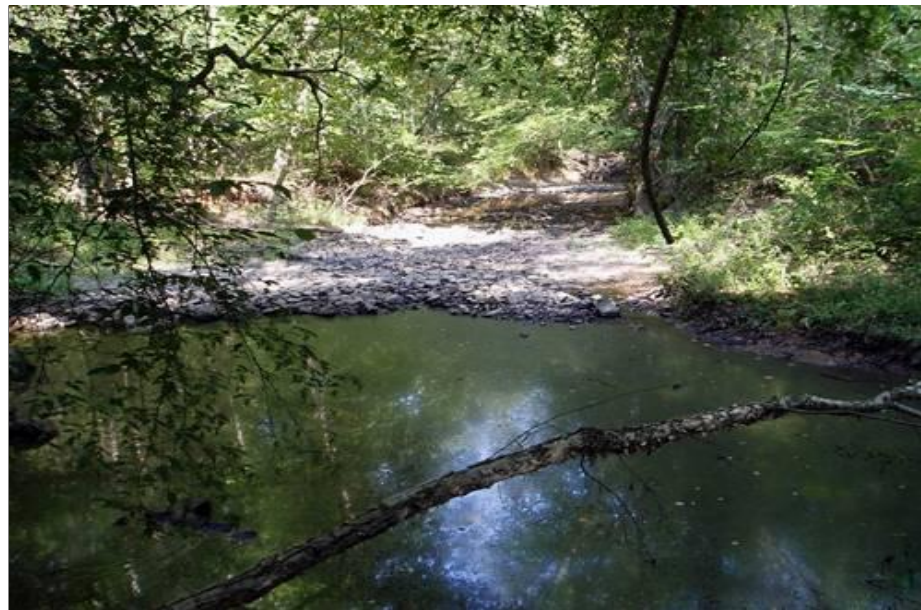
**DBC station 94+00 facing dnst, crushed-rock crossing**

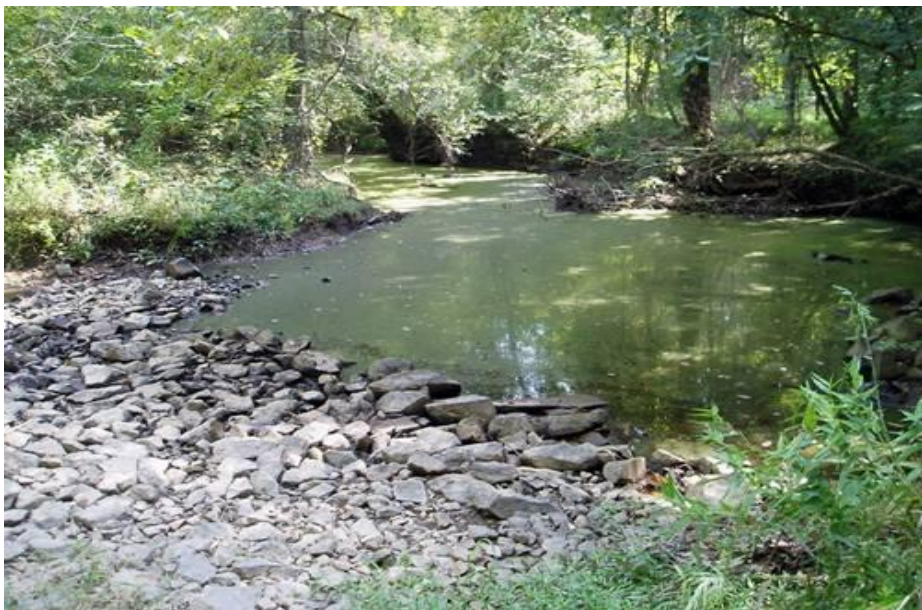
**DBC station 94+30 facing upst from rock crossing**

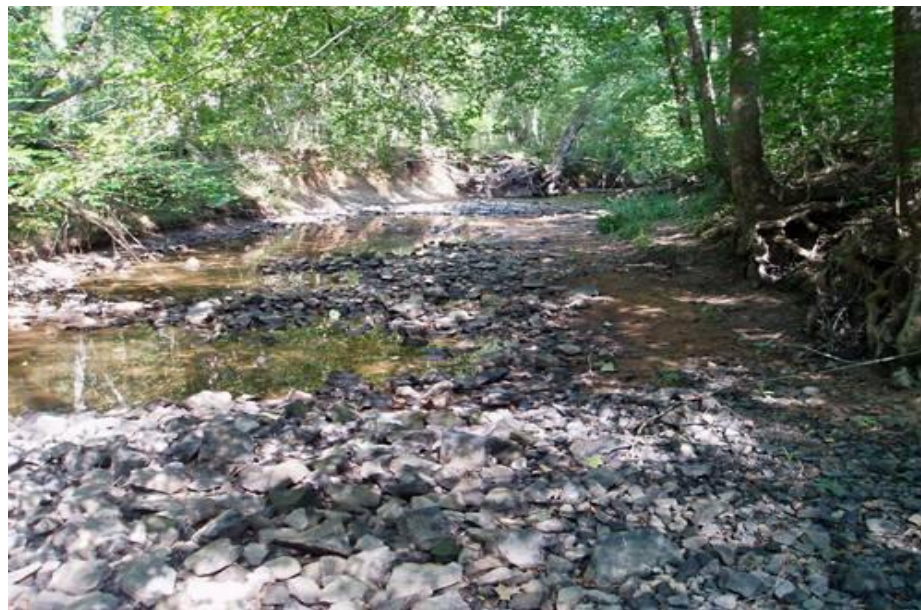
**DBC station 94+30 facing dnst from rock crossing**
