**SUTHER STREAM & WETLAND RESTORATION SITE -- DMS #370
Cabarrus County NC -- PeeDee River HUC# 03040105-020060**

MY-5 (2016) ANNUAL MONITORING REPORT

**North Carolina Department of Environmental Quality
Division of Mitigation Services (DENR-DMS) -- Contract # 5764**

Data Collected: Sept 2016

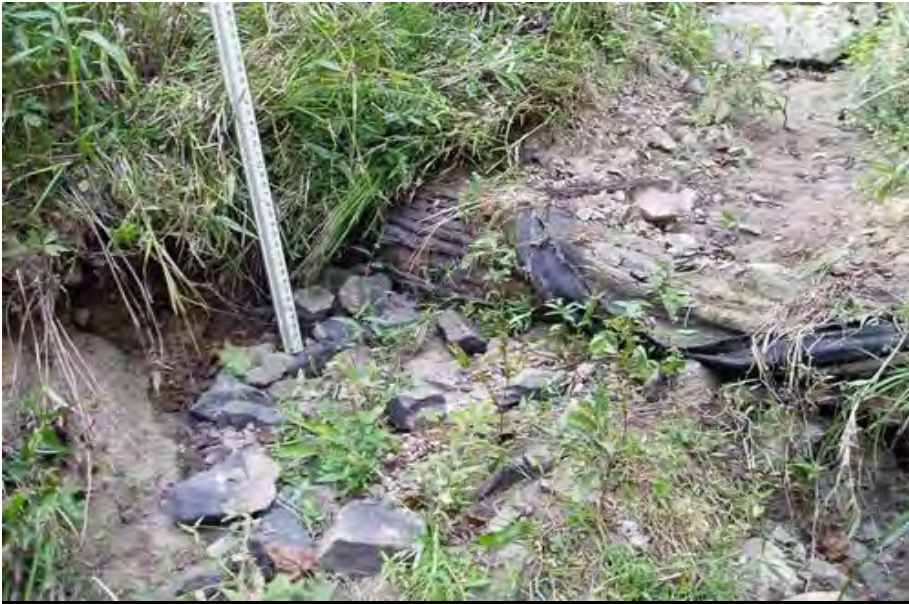
Bank erosion at step-pool: Tributary station 5+30, Sept 2015

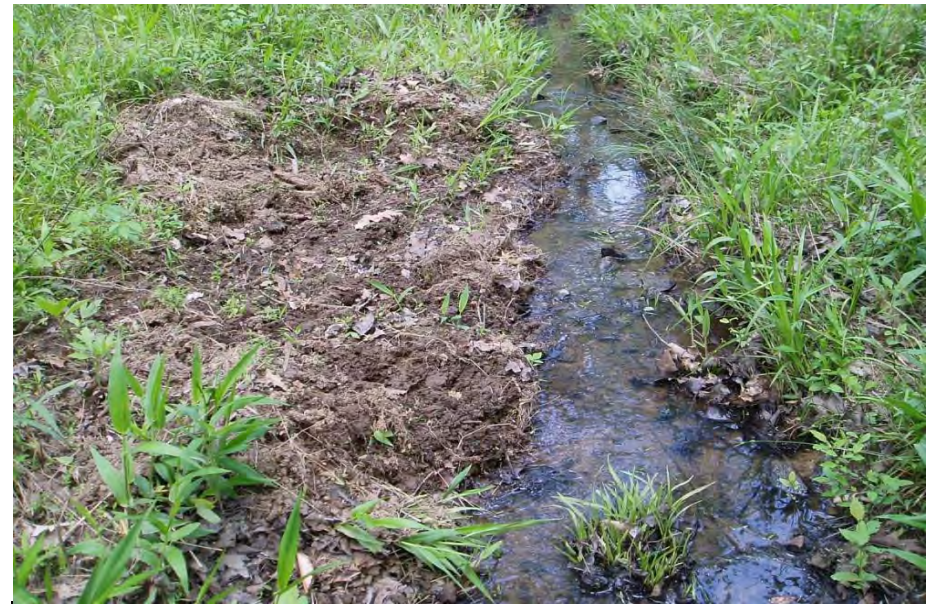
Hog-rooting along streambank: Tributary station 3+40, May 2015

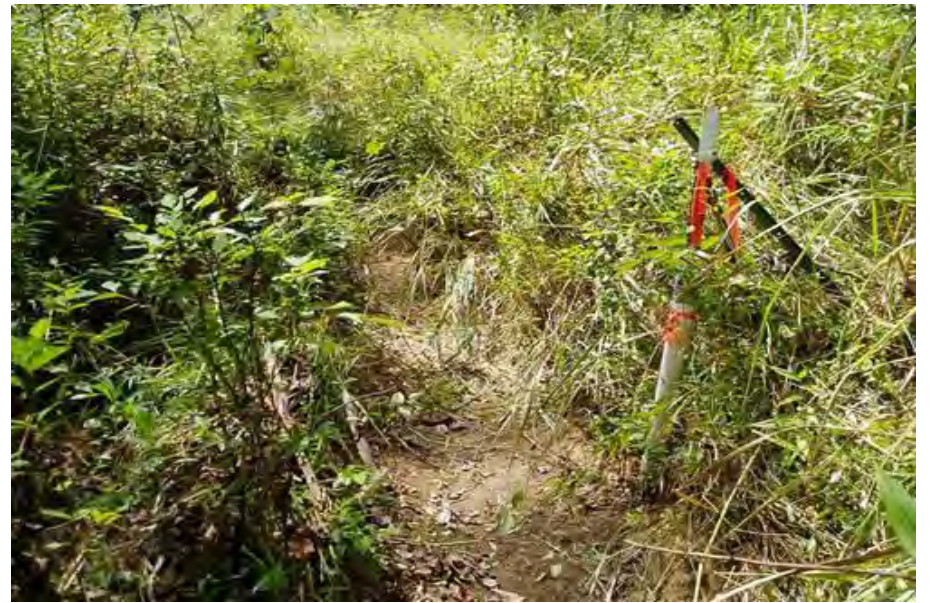
Hobo gauge moved to Trib sta 4+82 on 07 Aug 2015

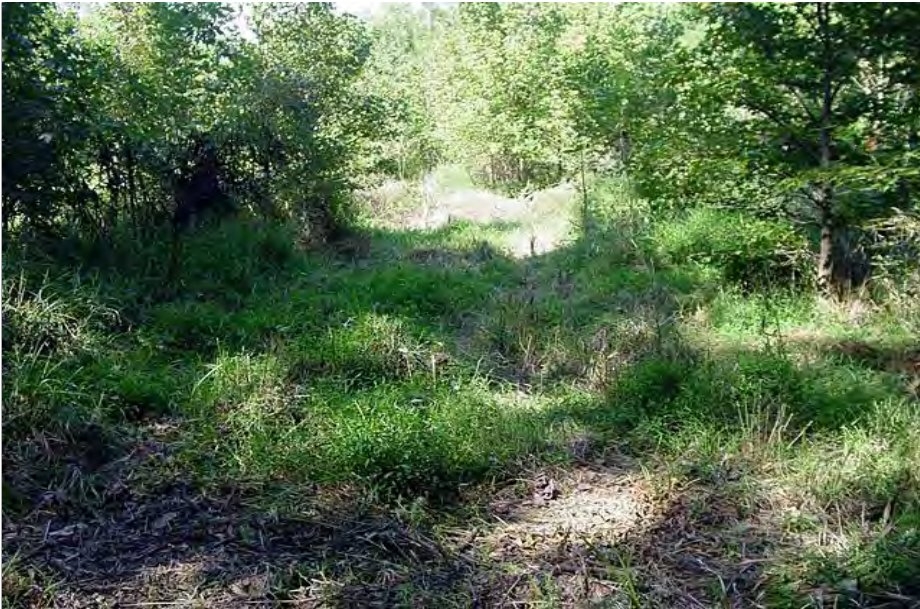
Mowed area: SW of Groundwater Gauge 2 (Facing NW), Sept 2016

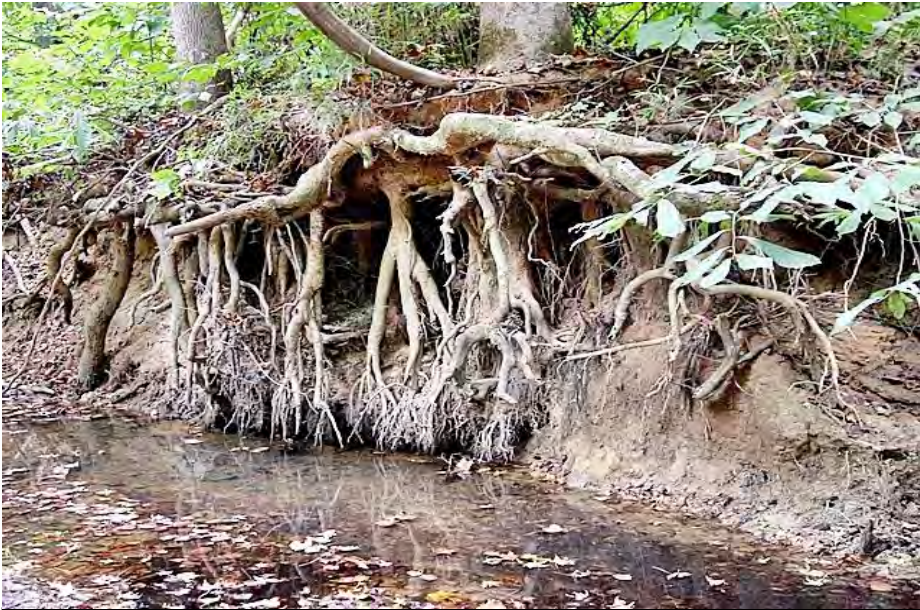
Bank Erosion: East of Bank Pins, Sept 2016

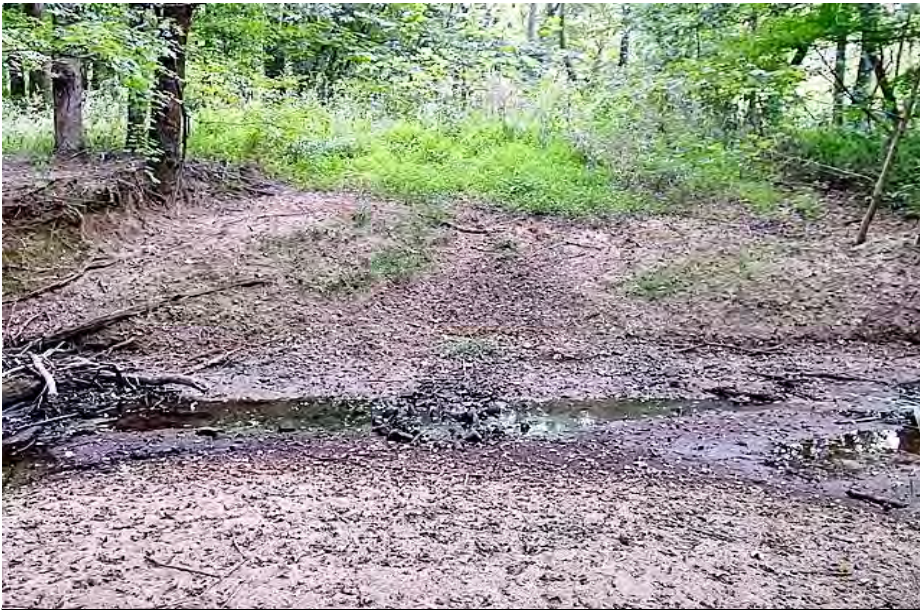
DBC construction crossing, Station 32+50, Sept 2016

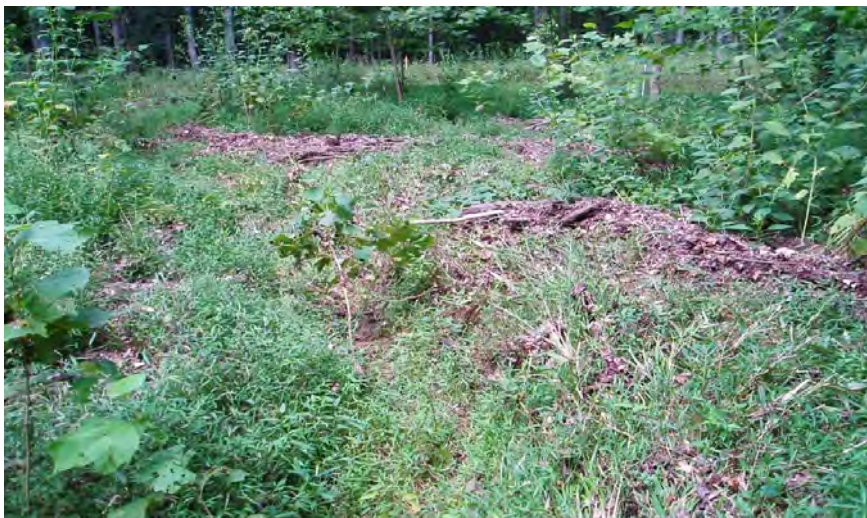
Wrack deposits on floodplain near Tributary station 01+50, 13 Sep 2016
