**SUTHER STREAM & WETLAND RESTORATION SITE -- DMS #370  
Cabarrus County NC -- Yadkin-PeeDee River HUC# 03040105-020060**

**MY-6 (2017) ANNUAL MONITORING REPORT**

**North Carolina Department of Environmental Quality  
Division of Mitigation Services (DENR-DMS) -- Contract # 5764  
USACE Action ID # SAW-2008-0218                      NCDWR Project # 20080134**

**Final Report: January 2018**

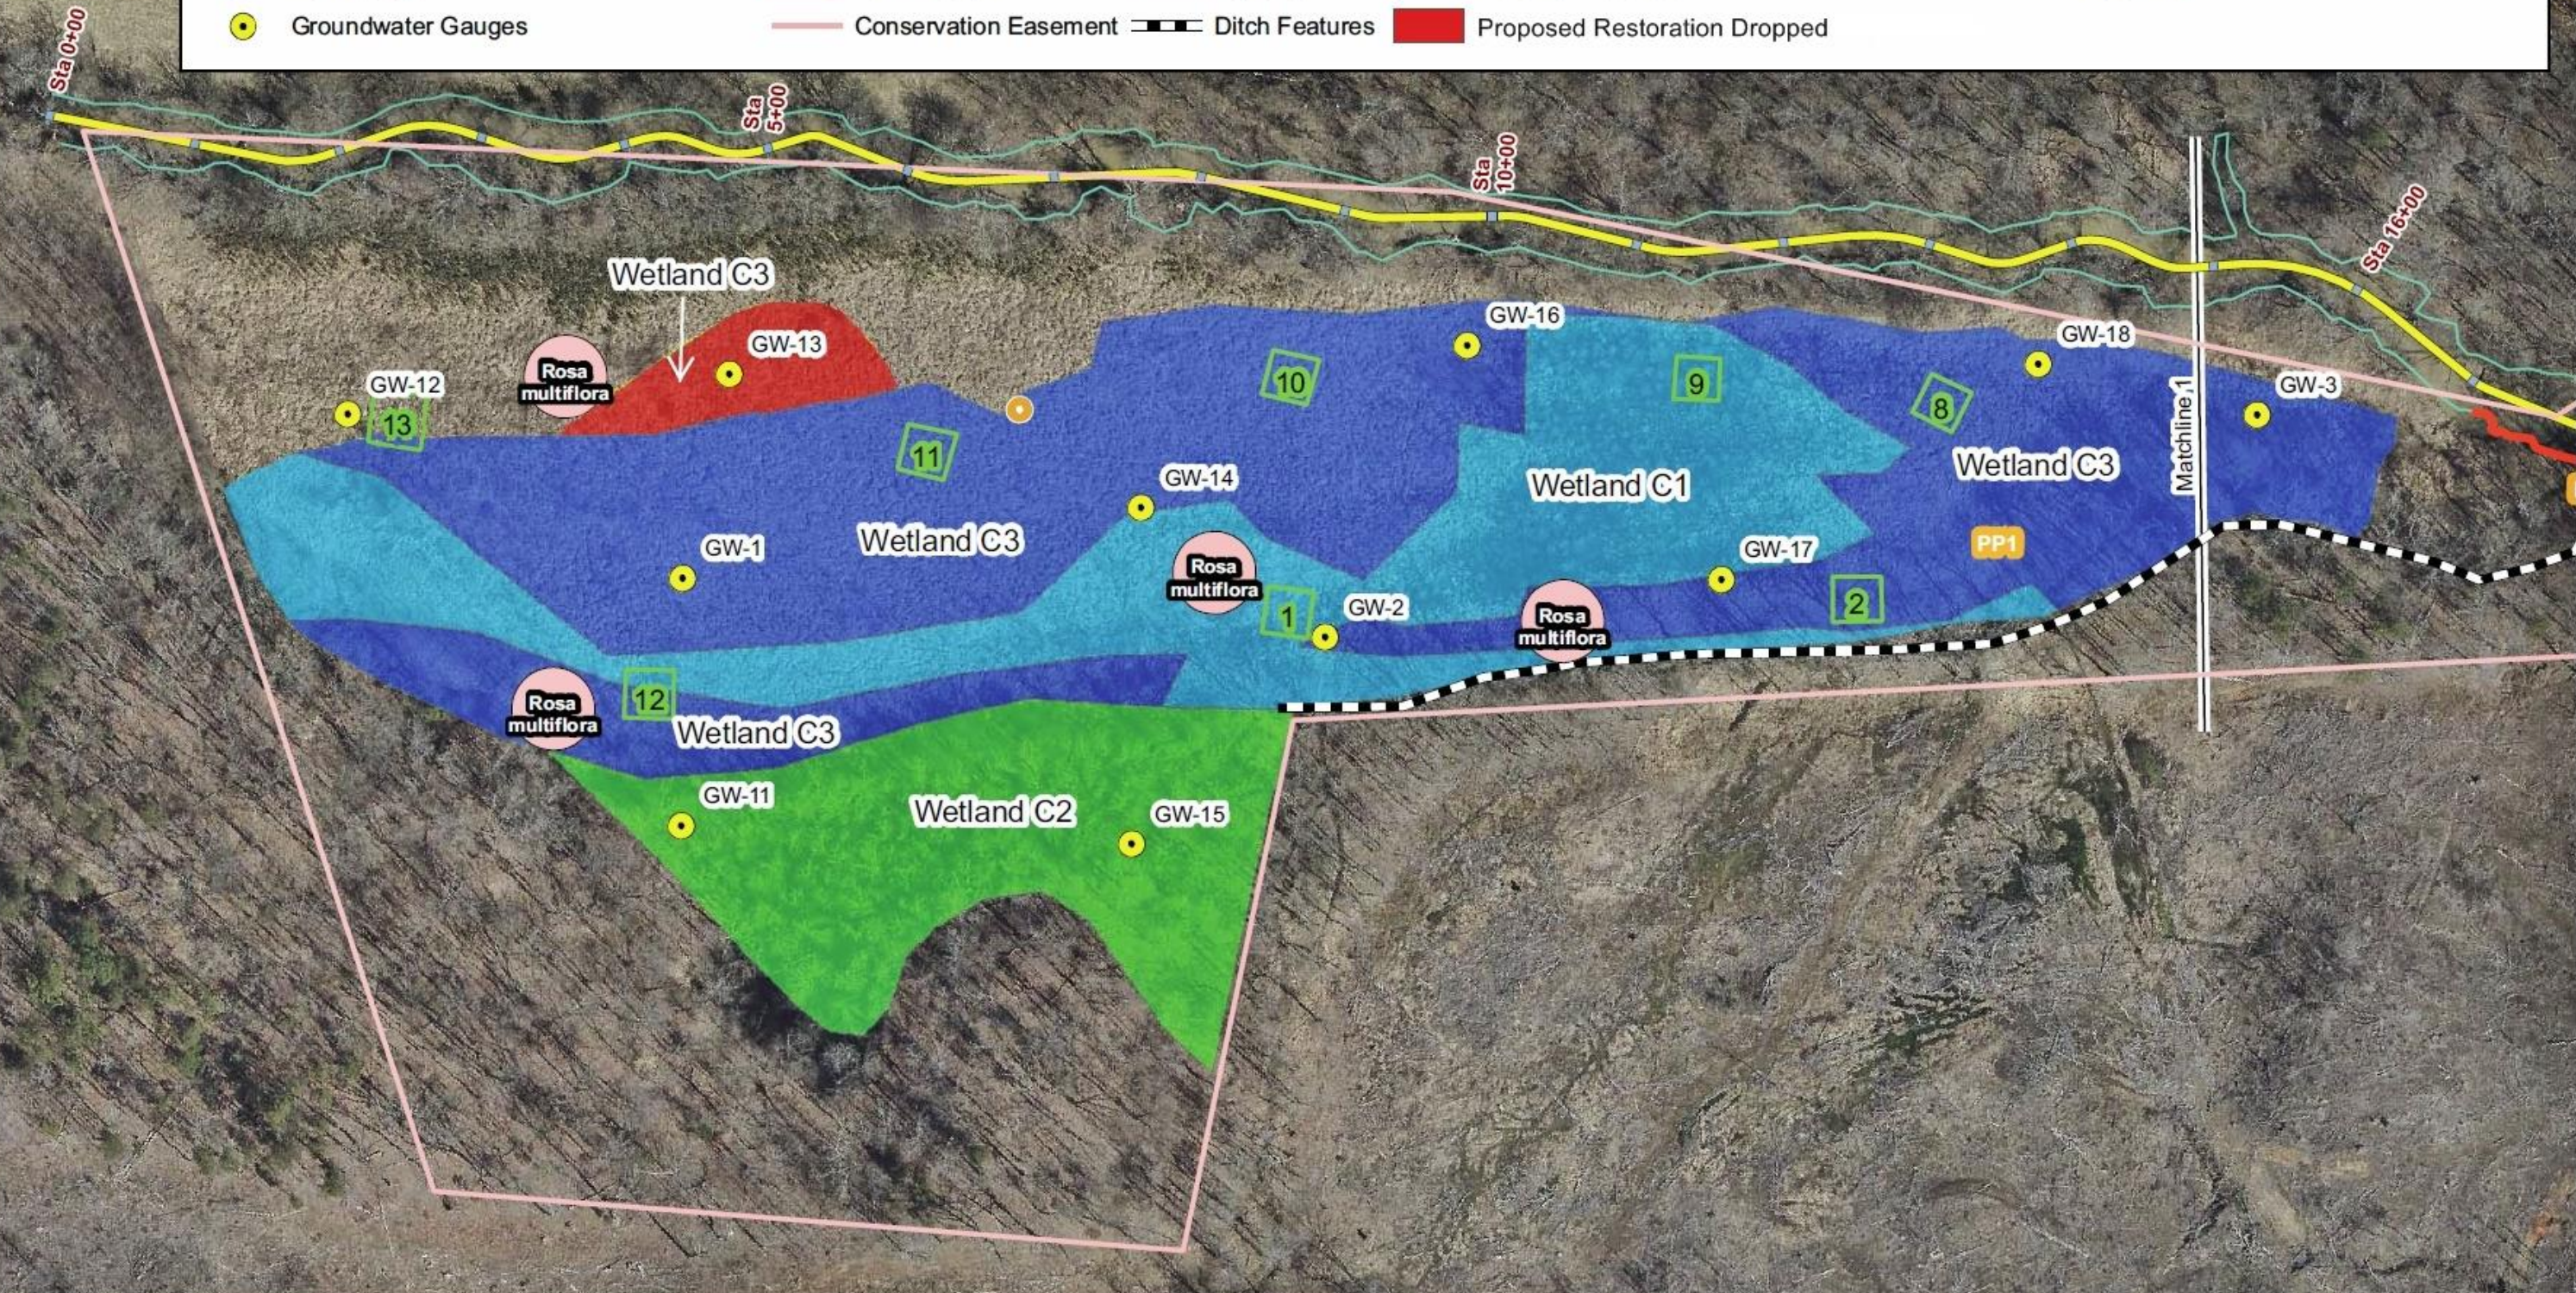
FIGURE 2.2  
 NOV 2017  
 MY6 of 6

The proposed wetland enhancement area B3 (previously mapped as AB2) did not meet hydrologic success criteria from 2010 to 2013. The two GW gauges in B3 (Old-4 and Old-5) were moved northeast in 2014 into area B1/B4, and area B3 is now deleted from credit assets (Figure 2.2). The proposed

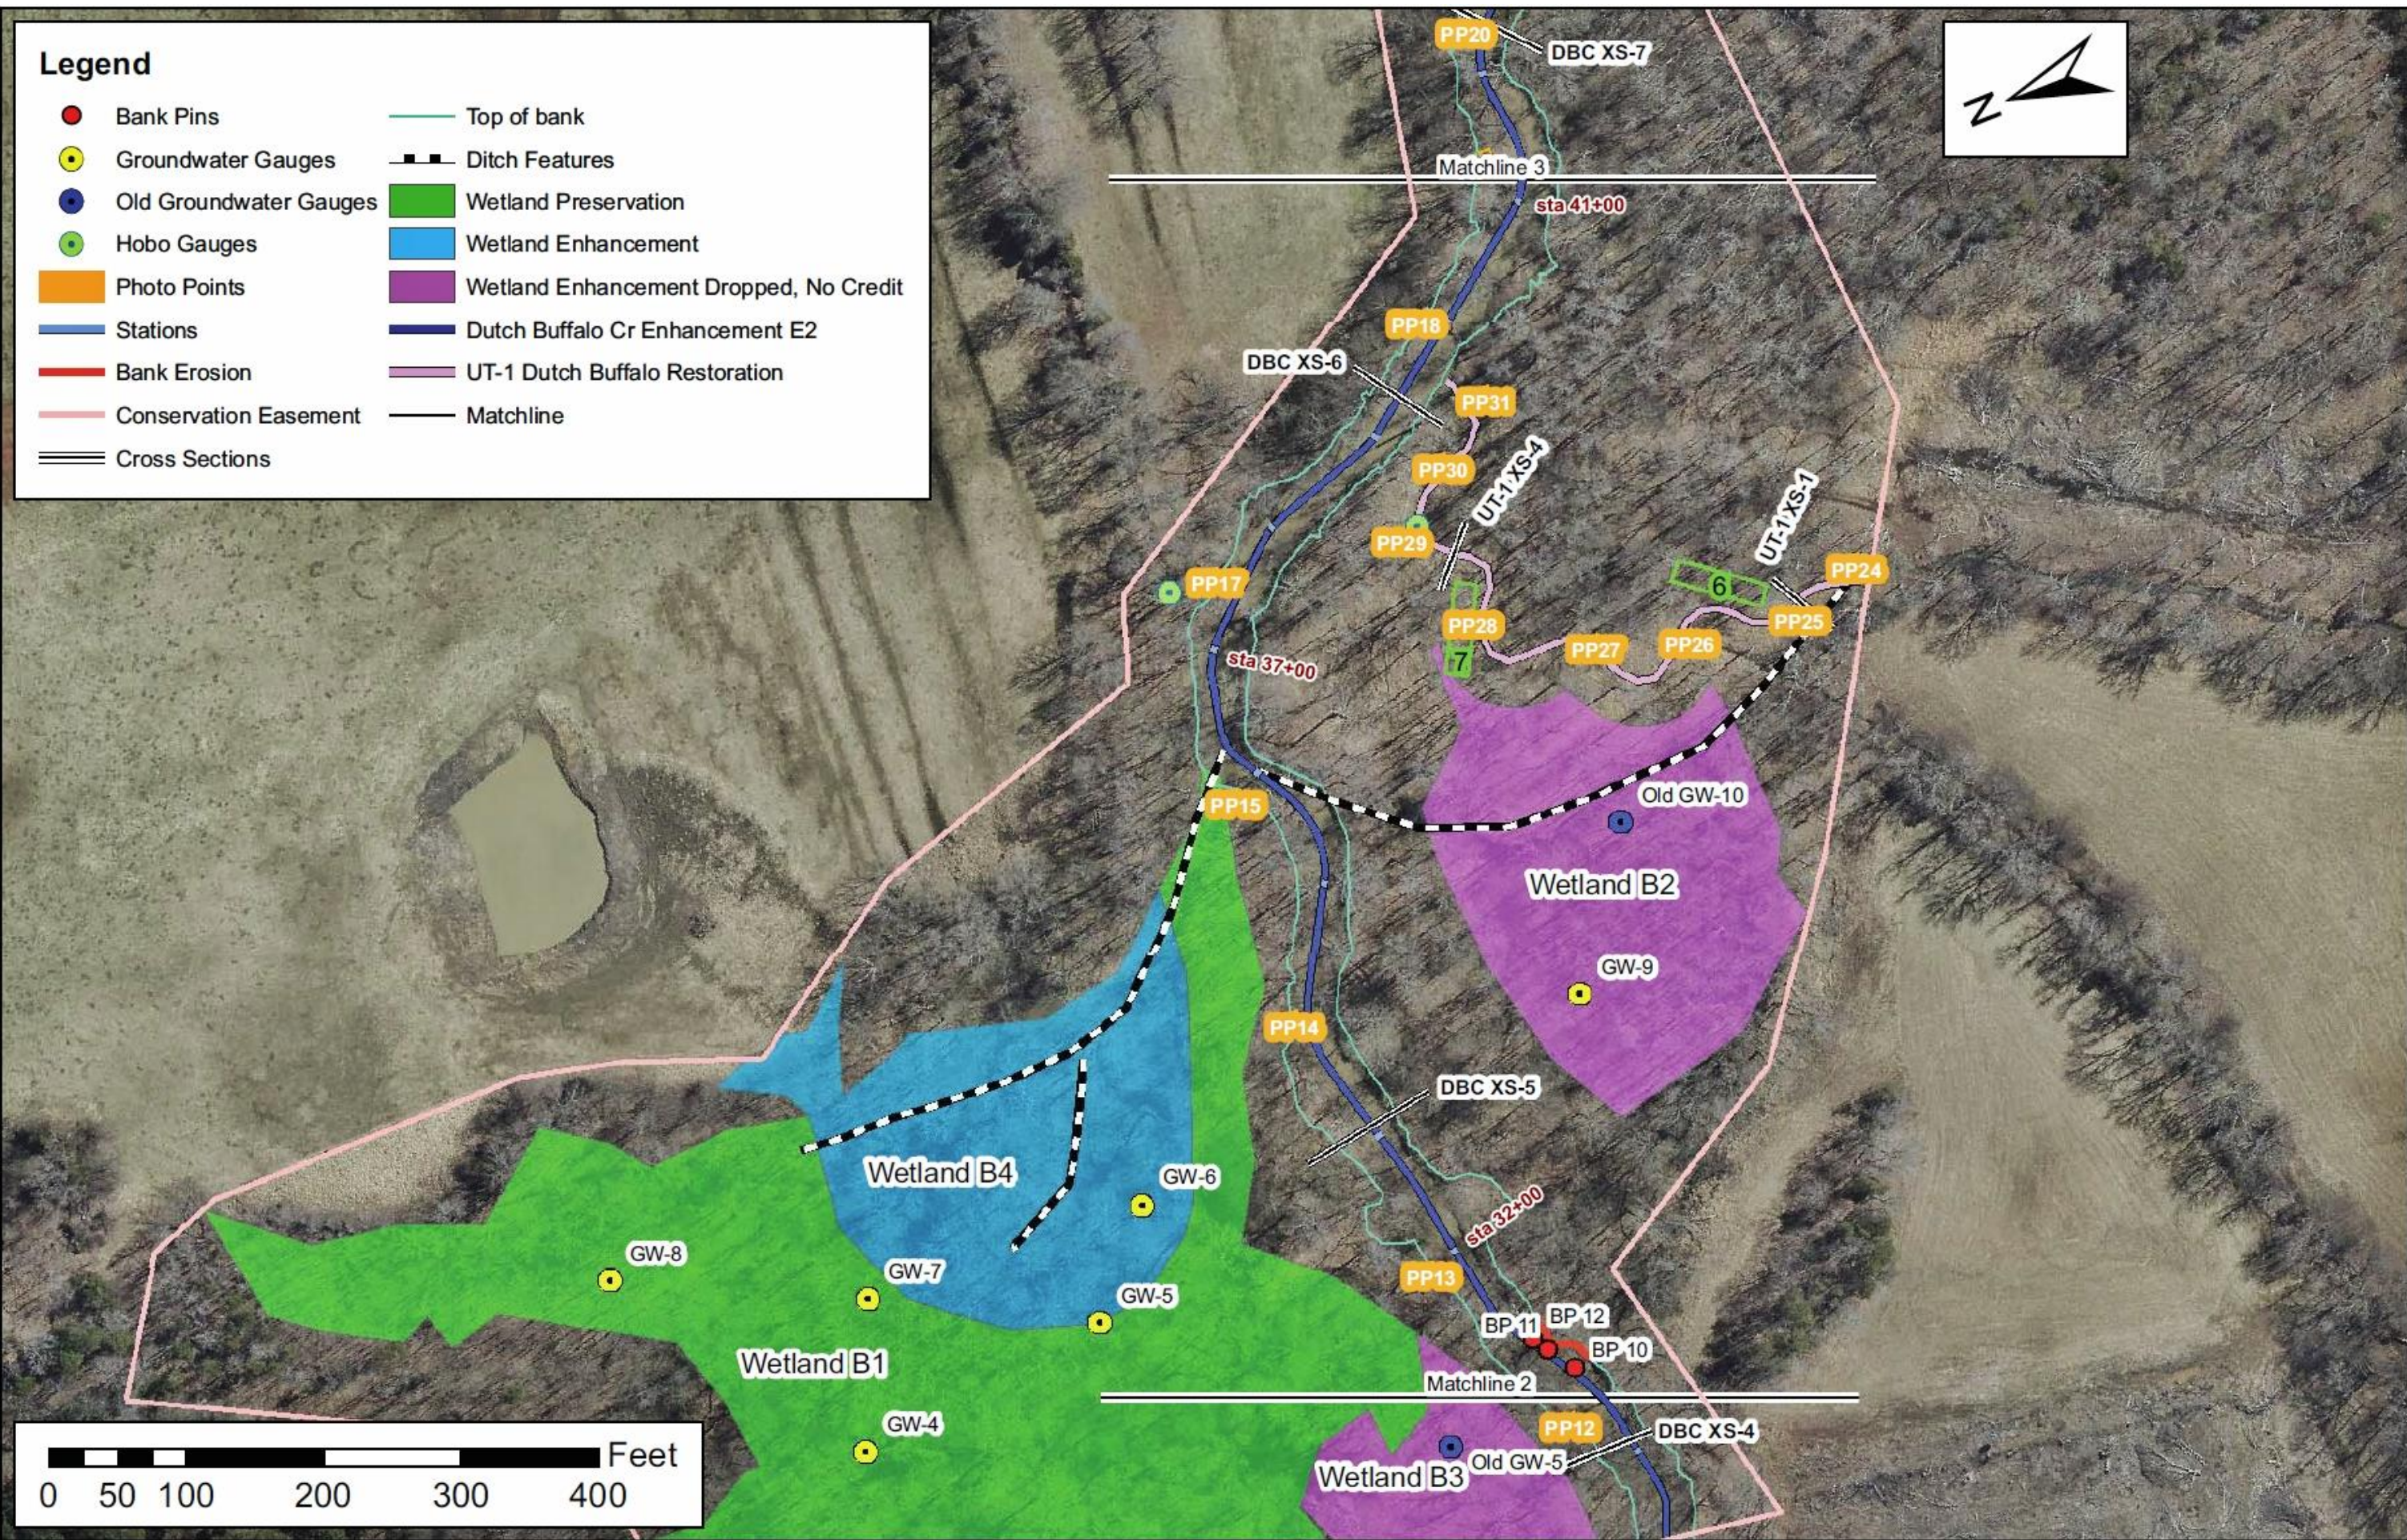
**FIGURE 2.3**  
 NOV 2017  
 MY6 of 6

wetland enhancement area B2 (previously mapped as AB3) also did not meet hydrologic success criteria from 2010 to 2017, based on GW gauges 9 and 10, and is also deleted from the credit assets (Figure 2.3). All of the five GW gauges in wetland area B1/B4 (preservation and enhancement areas) met hydrologic success criteria this year. Four gauges met criteria every year, and the fifth gauge (#8) met criteria in 4 of 6 years.

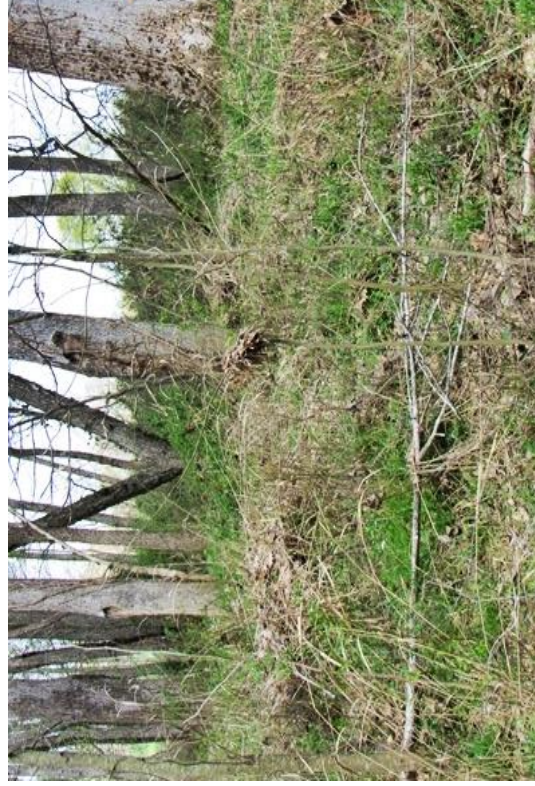
Photo: Wrack material on floodplain, UT-1 near station 3+00, May 2017

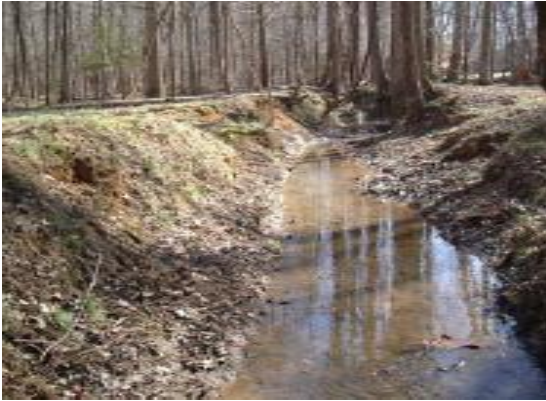
Prior to restoration this tributary was deeply incised and appeared to have been modified or straightened. The majority of the substrate in the tributary was fine sand. The stream banks had high angles, with little to no vegetation and represented a Rosgen G-type sandy gully. Overall, the instability of the stream was contributing to stream bank loss, increased sedimentation, and poor aquatic habitat.

***Unnamed Tributary prior to restoration***

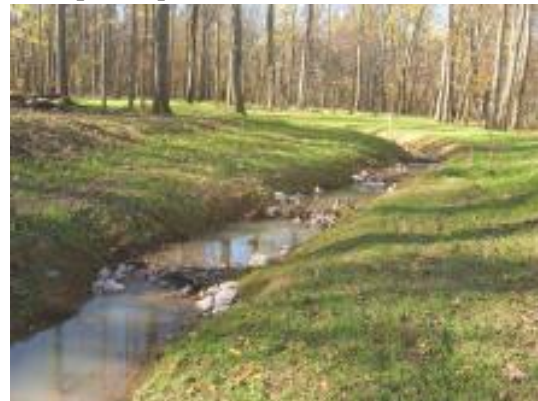
***Unnamed Tributary immediately after restoration***

The UT was restored using a Priority Level 1 and 2 approach as a C/E channel. Stream dimension, pattern and profile were re-established to maintain stability and establish riffle/pool sequences. The channel was relocated onto the floodplain and transitioned to meet up with the main channel of Dutch Buffalo Creek. Adjacent stream banks and riparian zones were replanted using native species appropriate to the area. Brush mattresses of native plant material were installed on the outside meander bends to provide bank protection and habitat. A cross-vane was installed at the beginning of the project above the channel plug to provide grade control, habitat, and bank protection while vegetation is established. A series of log vane step-pools were installed to transition the UT from its elevation to the elevation of the main channel.

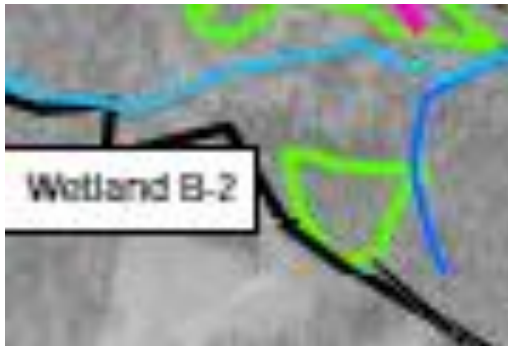
Wetland B-2 Cutout from Fig 5.1a of the 2007 site restoration plan

B-2: Due to gage performance to date it is unlikely that this polygon will be creditable at closeout. Its original conception as enhancement was based on the partial filling of the relic channel depicted in fig 3 along its border that would no longer drain seepage from the southwest of wetland B2.

B-2-1: Both the soil characteristics of this polygon and gage performance has led DMS to eliminate this as a creditable asset. See footnotes 7 and 12. Its original conception as enhancement was based the partial filling of the relic channel depicted in fig 3 along its border that would no longer drain seepage from the southwest of wetland B2.

***Both areas in Wetland B2 (B2 and B2-1) are being removed from crediting due to inadequate attainment of hydrology criteria.***

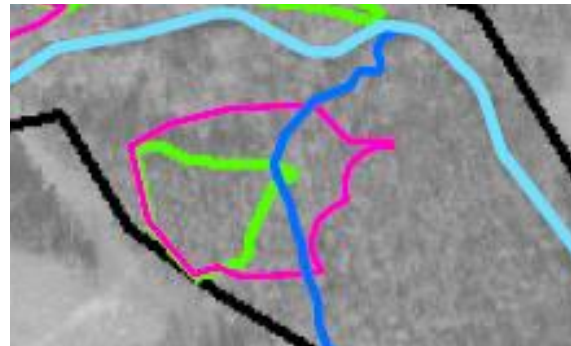
Wetland B-2/B-2-1 Cutout from Fig 1.2 of the 2010 MY0 Baseline Report

Both wells in this area failed to meet hydrology success criteria across four consecutive years of data collection between 2010 and 2013. This area, despite not being included in the original 2007 delineation, appeared as an understory-planted enhancement area in the planting plan of the 2007 restoration plan, and erroneously got carried over to the MY0/baseline report.

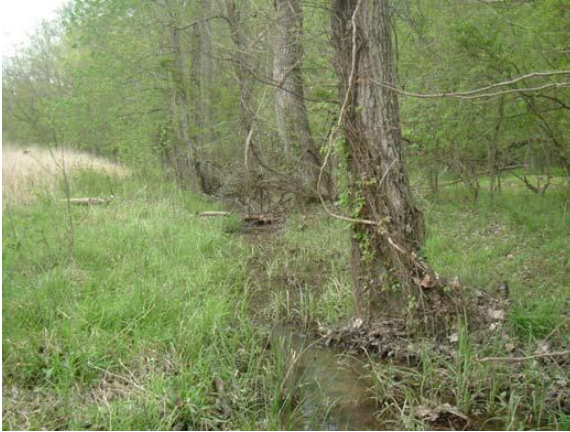
Wetland C ditch draining wetland

The ditches acted to drain surface water and shallow groundwater from the switch grass area by providing a drainage route at an elevation lower than potential groundwater levels. The first 100 feet of this channel (from convergence with Dutch Buffalo Creek moving upgradient) were partially filled and then restored with shallow log steps to retain more water in the wetland while allowing a gradual outlet. The remainder of these channelized ditches were plugged with a combination of clay plug material and native fill material to restore the ditches to current grade and try to restore groundwater to its pre-impacted levels. Although volunteer native vegetation has been strong in some sections, parts of Wetland C-1 required supplemental planting in winter 2015/2016 to establish a denser and more diverse natural community.

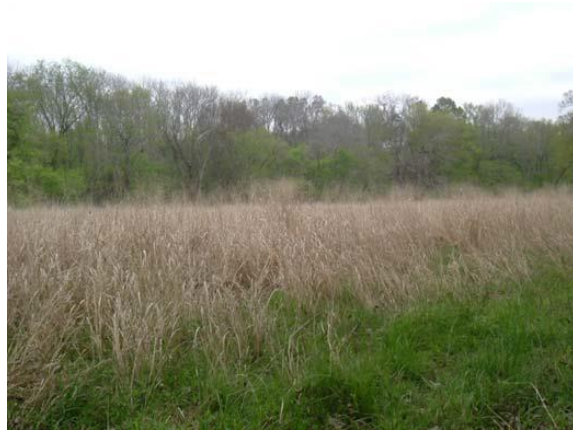
Wetland C area switchgrass field
