Tarlton Stream and Wetland Restoration Project

Contract #: D05013-1
County: Cumberland
Cataloging Unit: Cape Fear 03030004
Monitoring Firm POC: Mid-Atlantic Mitigation, LLC
Rich Mogensen (704) 782-4133
Kimley-Horn Associates, Inc.
Will Wilhelm (704) 333-5131
Prepared For: EEP Project Manager, Guy Pearce

Year 1(2006) Monitoring Report

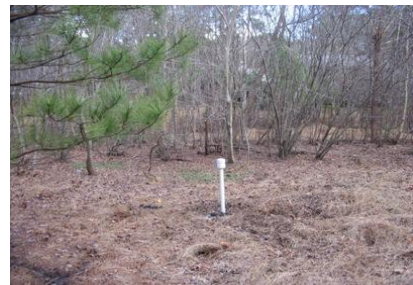
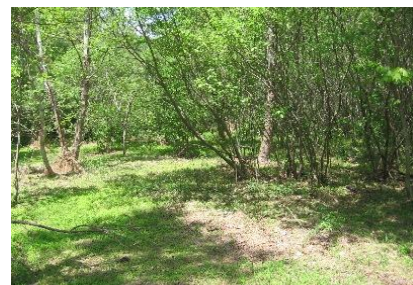
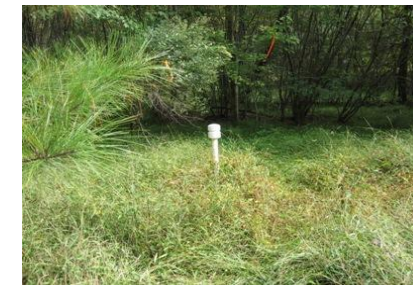
COMMENTS: 1/17/06 - soil is saturated with pockets of ponded water in depressions. 4/21/06 - area is dewatering slightly with new herbaceous growth. 10/19/06 - Herbaceous veg has done very well (see 4+ft tall *Polygonum sagittatum*). Stream downslope from gage has gone from multiple streams to single channel and may have some headcutting.

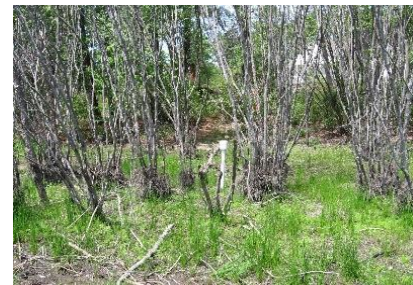
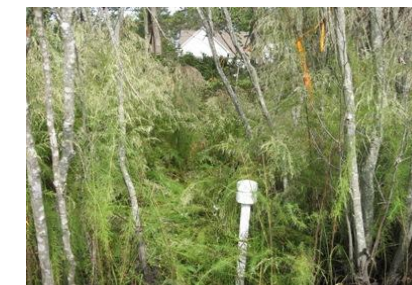
COMMENTS: 4/21/06 - area is dewatering slightly with new herbaceous growth. fennel is more dominant herbaceous veg. 10/19/06 - Fennel has taken over the location making locating the gage difficult. Many young alders are re-establishing.

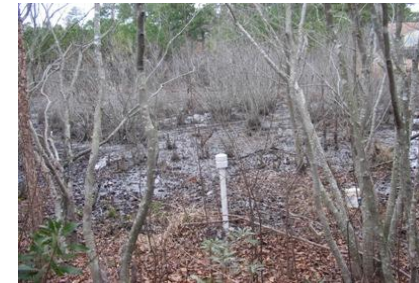
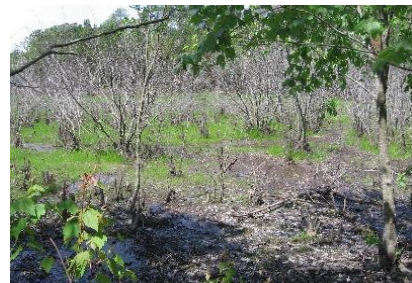
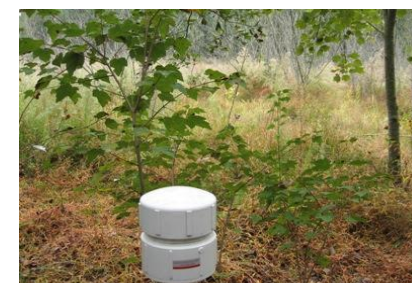
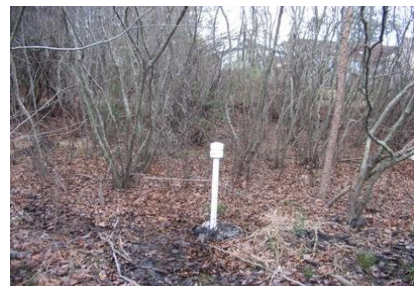
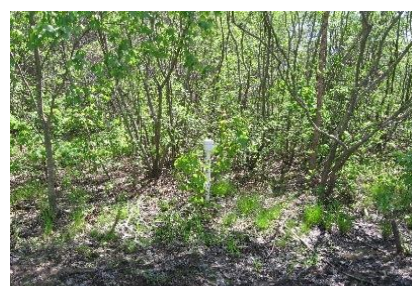
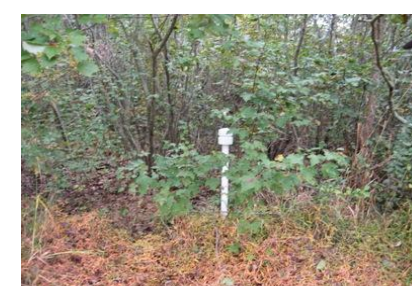
COMMENTS: 4/21/06 - area is dewatering slightly with new herbaceous growth. Alders are re-establishing 10/19/06 - Herbaceous vegetation is well established (*Polygonum sagittatum*).

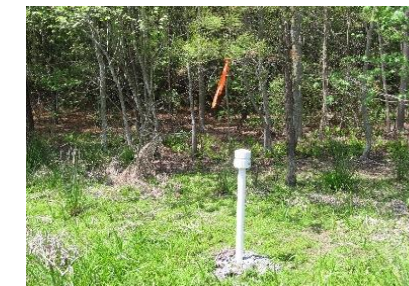
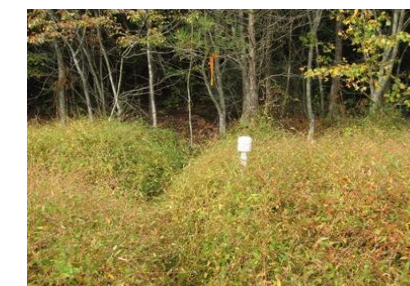
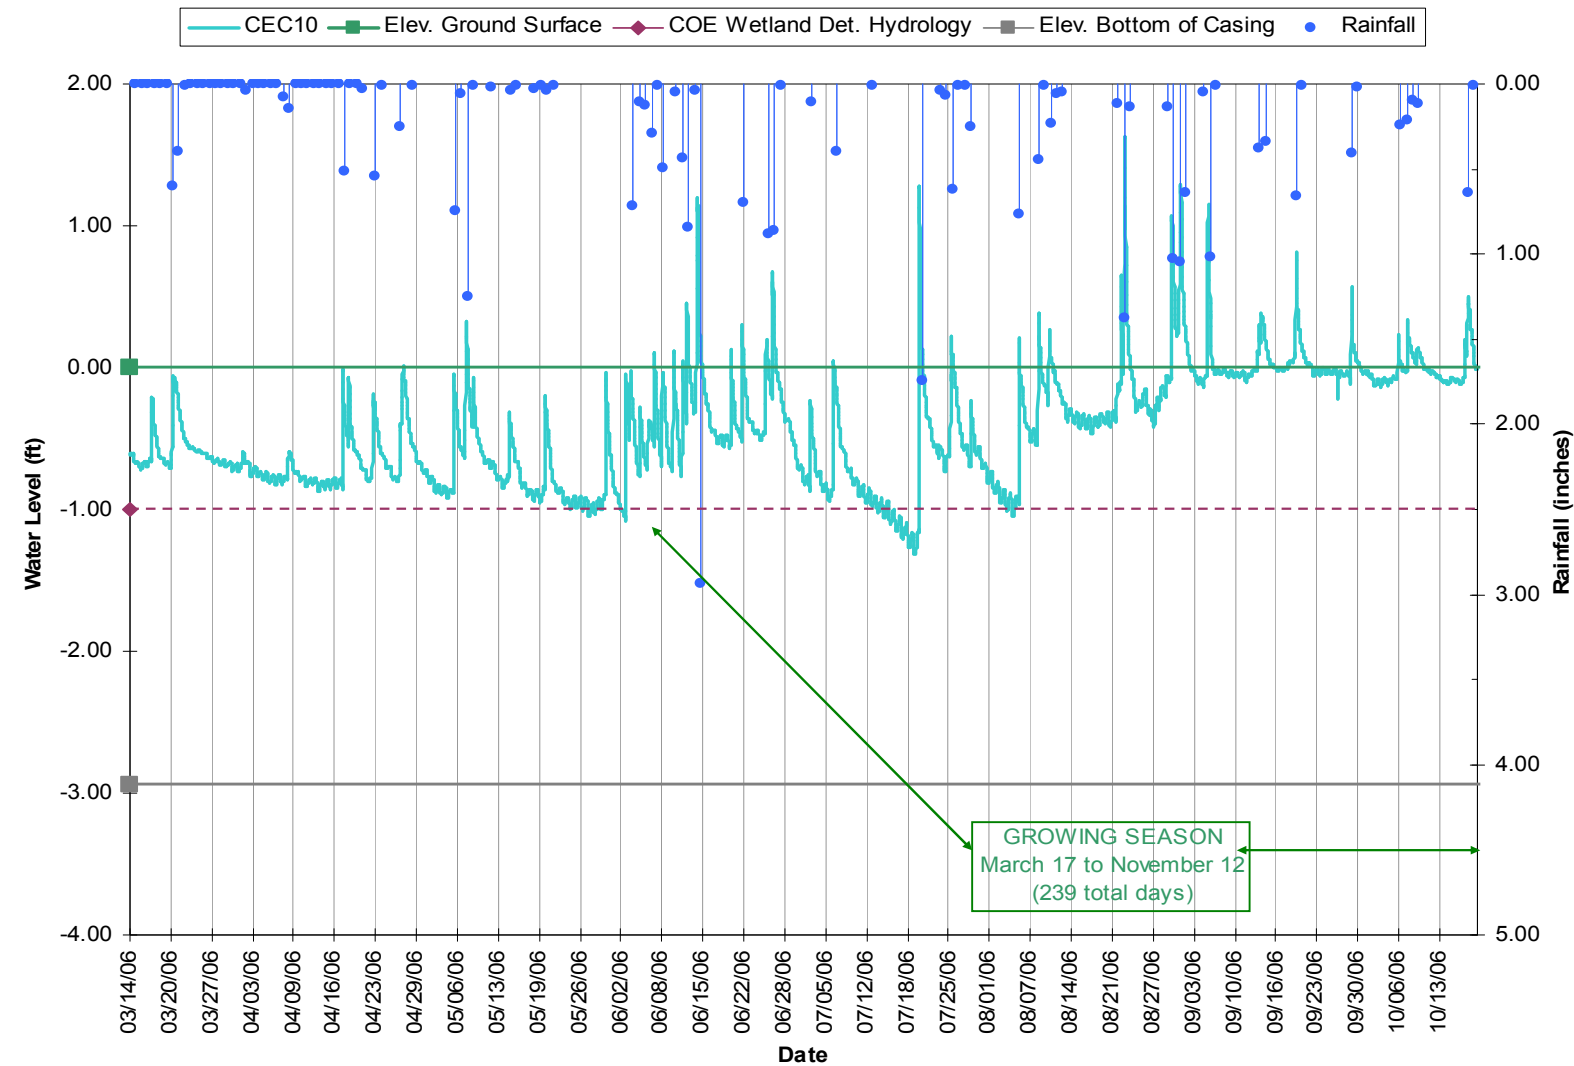
COMMENTS: 3/13/06 - gage relocated and installed within the project boundary. Remnants of beaver activity and smaller dams are evident. 10/19/06 - Herbaceous vegetation is well established (*Polygonum sagittatum*).

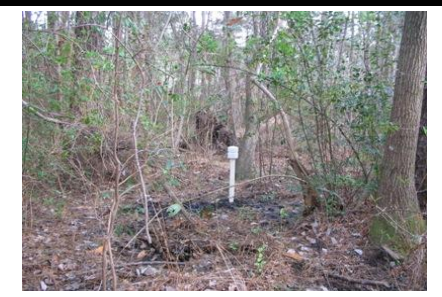
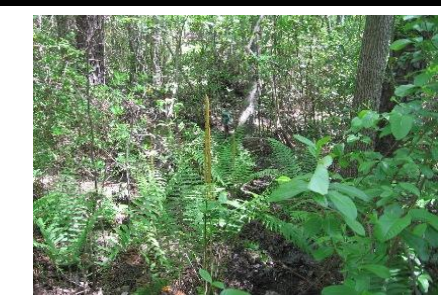
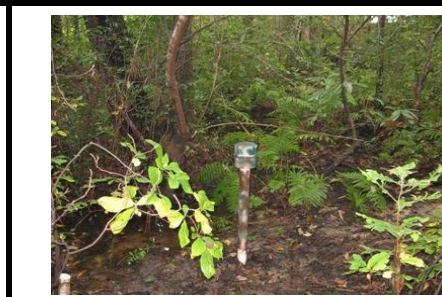
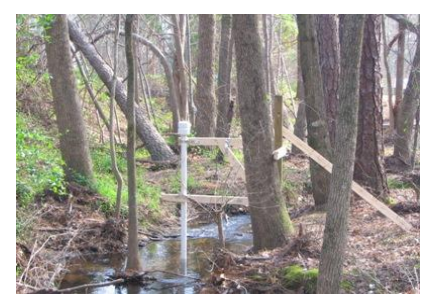
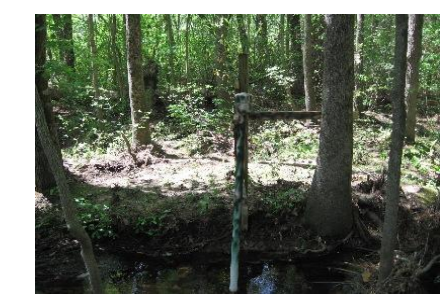
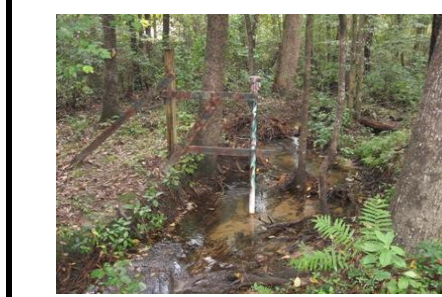
COMMENTS: 4/21/2006 - the gages were painted to not be visible from the road or adjacent homes. A cross section of the stream was sureyed and included the wetland gage. The wetland gage ground surface was assumed as elevation 0.00 pending additional survey of the site.
