Tarlton Stream and Wetland Restoration Project

Contract #: D05013-1
County: Cumberland
Cataloging Unit: Cape Fear 03030004
Monitoring Firm POC: Mid-Atlantic Mitigation, LLC
Rich Mogensen (704) 782-4133
Kimley-Horn Associates, Inc.
Will Wilhelm (704) 333-5131
Prepared For: EEP Project Manager, Guy Pearce

Year 2 (2007) Monitoring Report

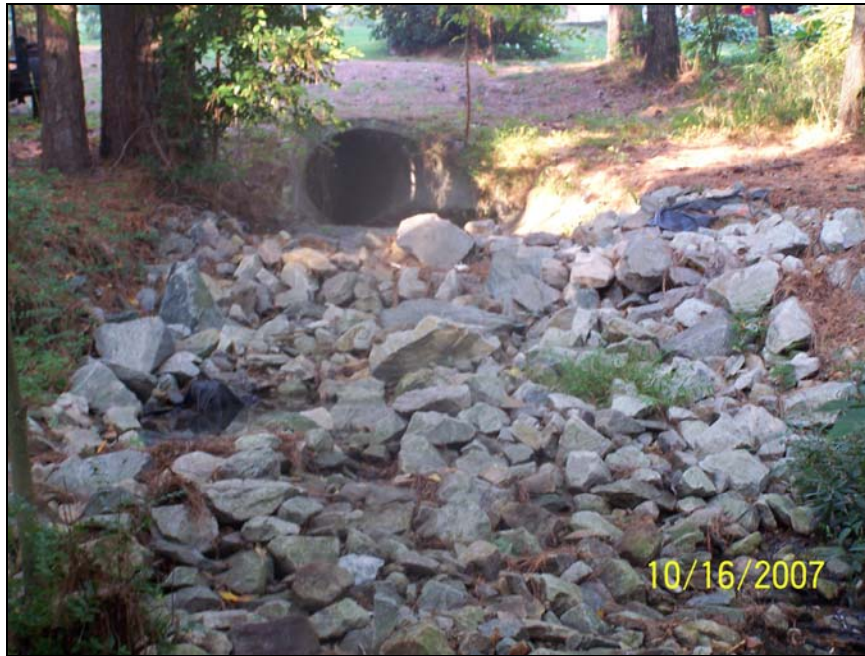
Storm water outfall 1, located in western prong in stream enhancement section (near well CE2).

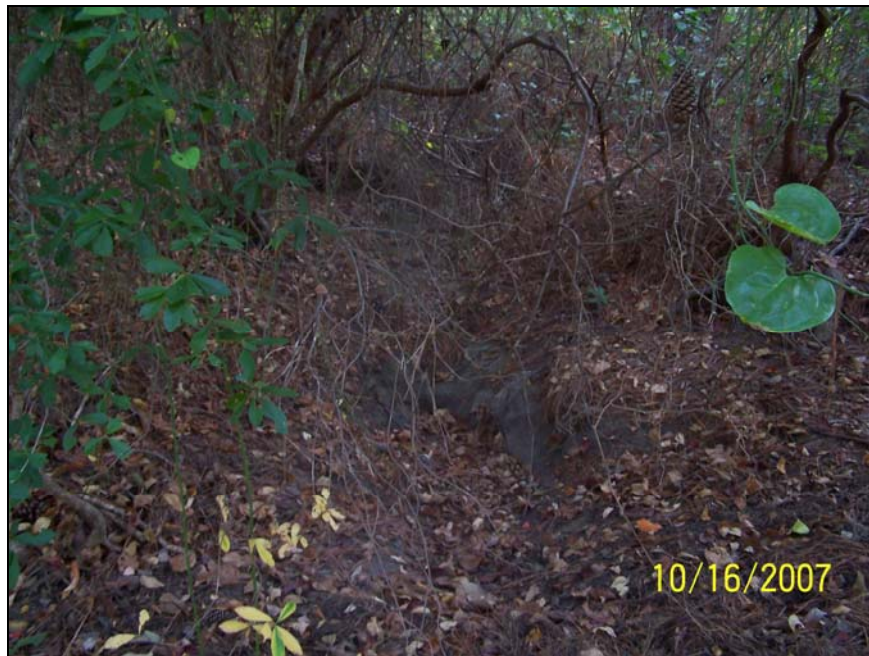
Storm water outfall 2, located in western prong in stream restoration section (near cross-section 10).

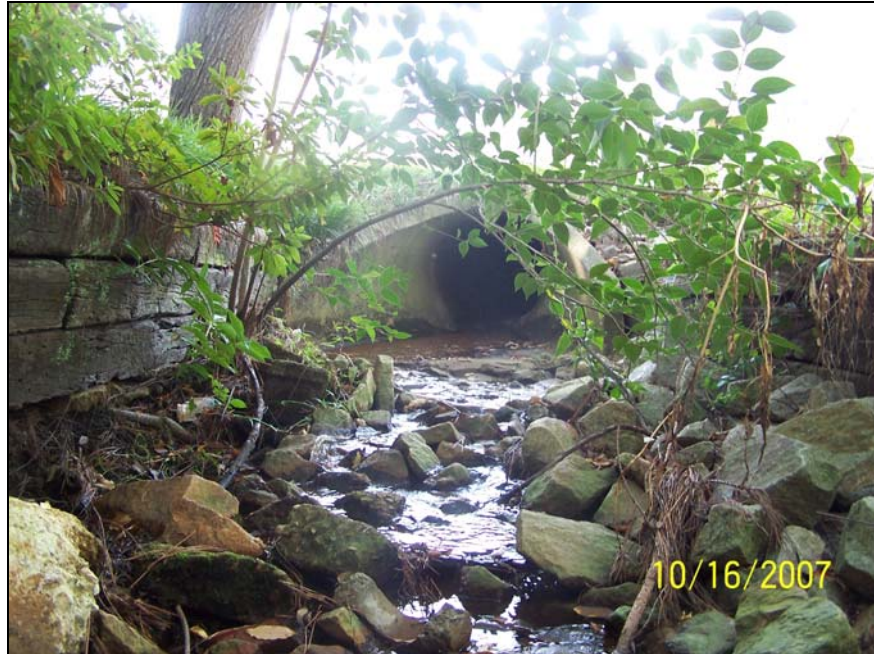
Storm water outfall 3, located in the western prong in stream restoration section (near well Tarlton4).

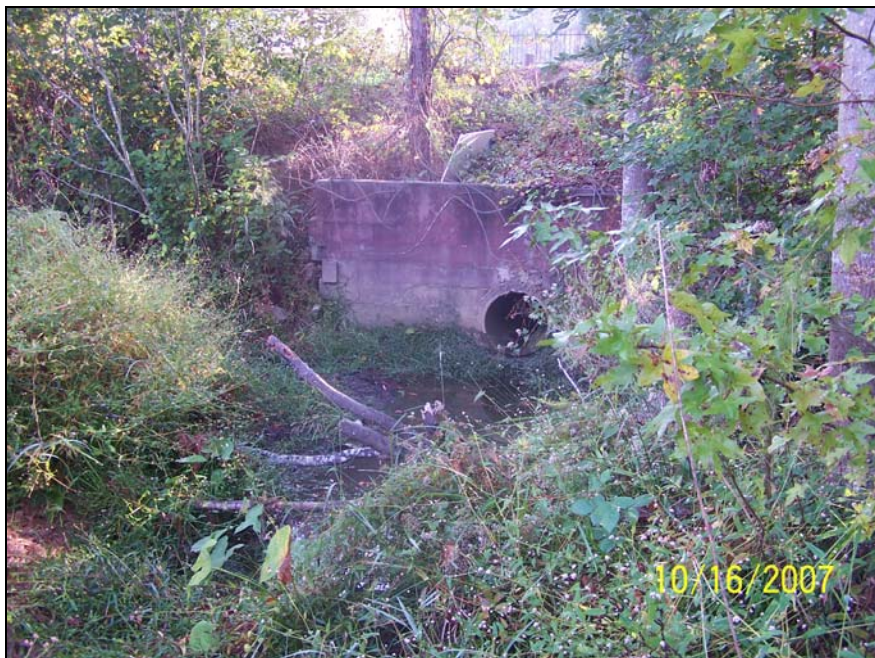
Storm water outfall 4, located in eastern prong in stream restoration section (near cross-section 1, also photo point 1).

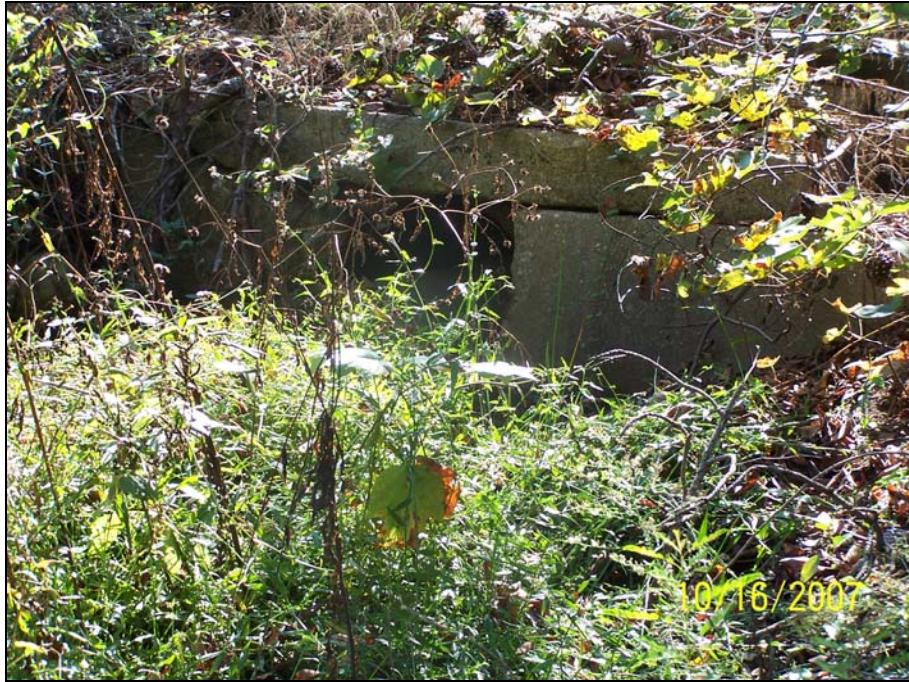
Storm water outfall 5, located in eastern prong in the stream restoration section.

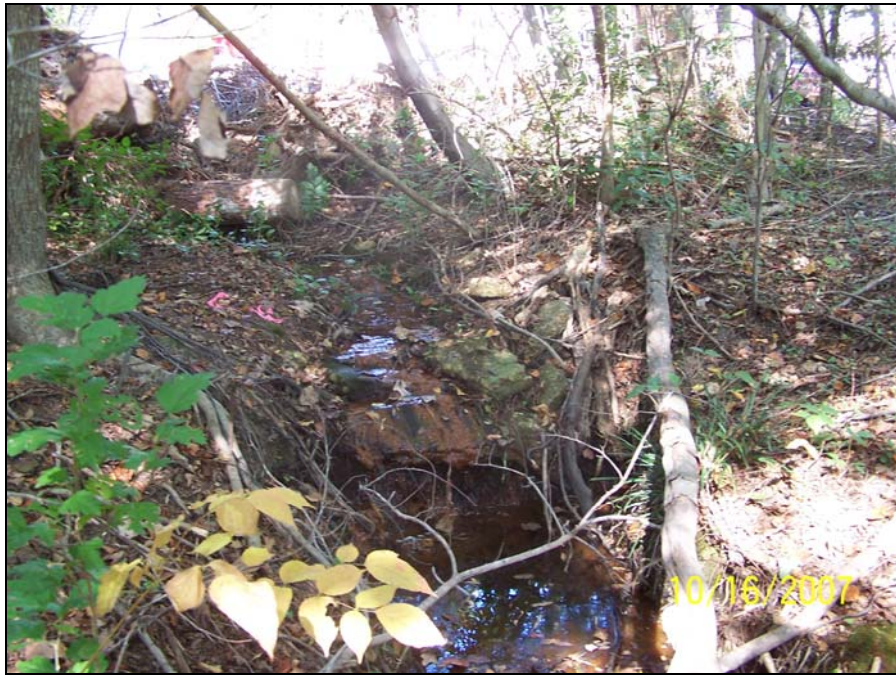
Storm water outfall 7, located in the eastern prong in the stream restoration section (near well CEC10).

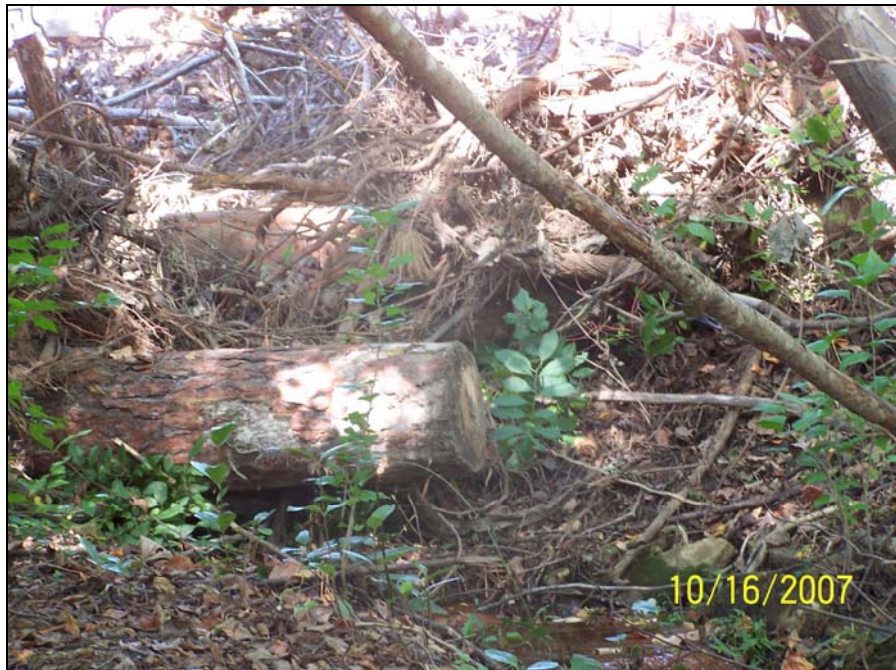
Storm water outfall 7 has debris blocking it from the landowner doing construction.
