Tarlton Stream and Wetland Restoration Project

Year 5 (2010) Monitoring Report

RE: Tarlton Wetland and Stream Restoration Project (D05013-1)

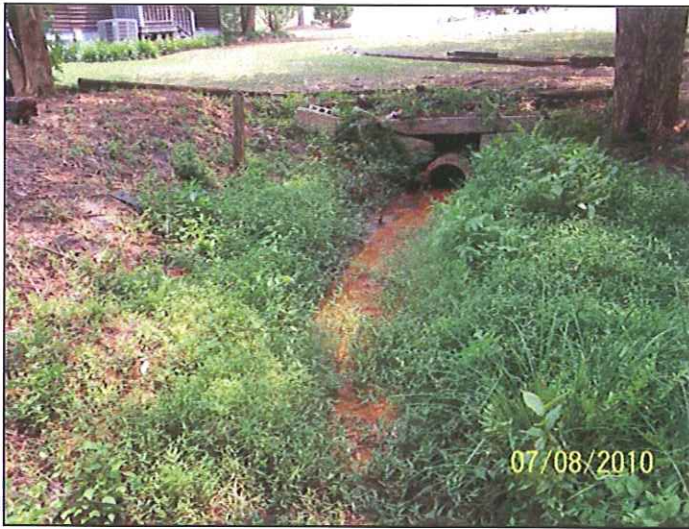
Outfall SE of well CEC10

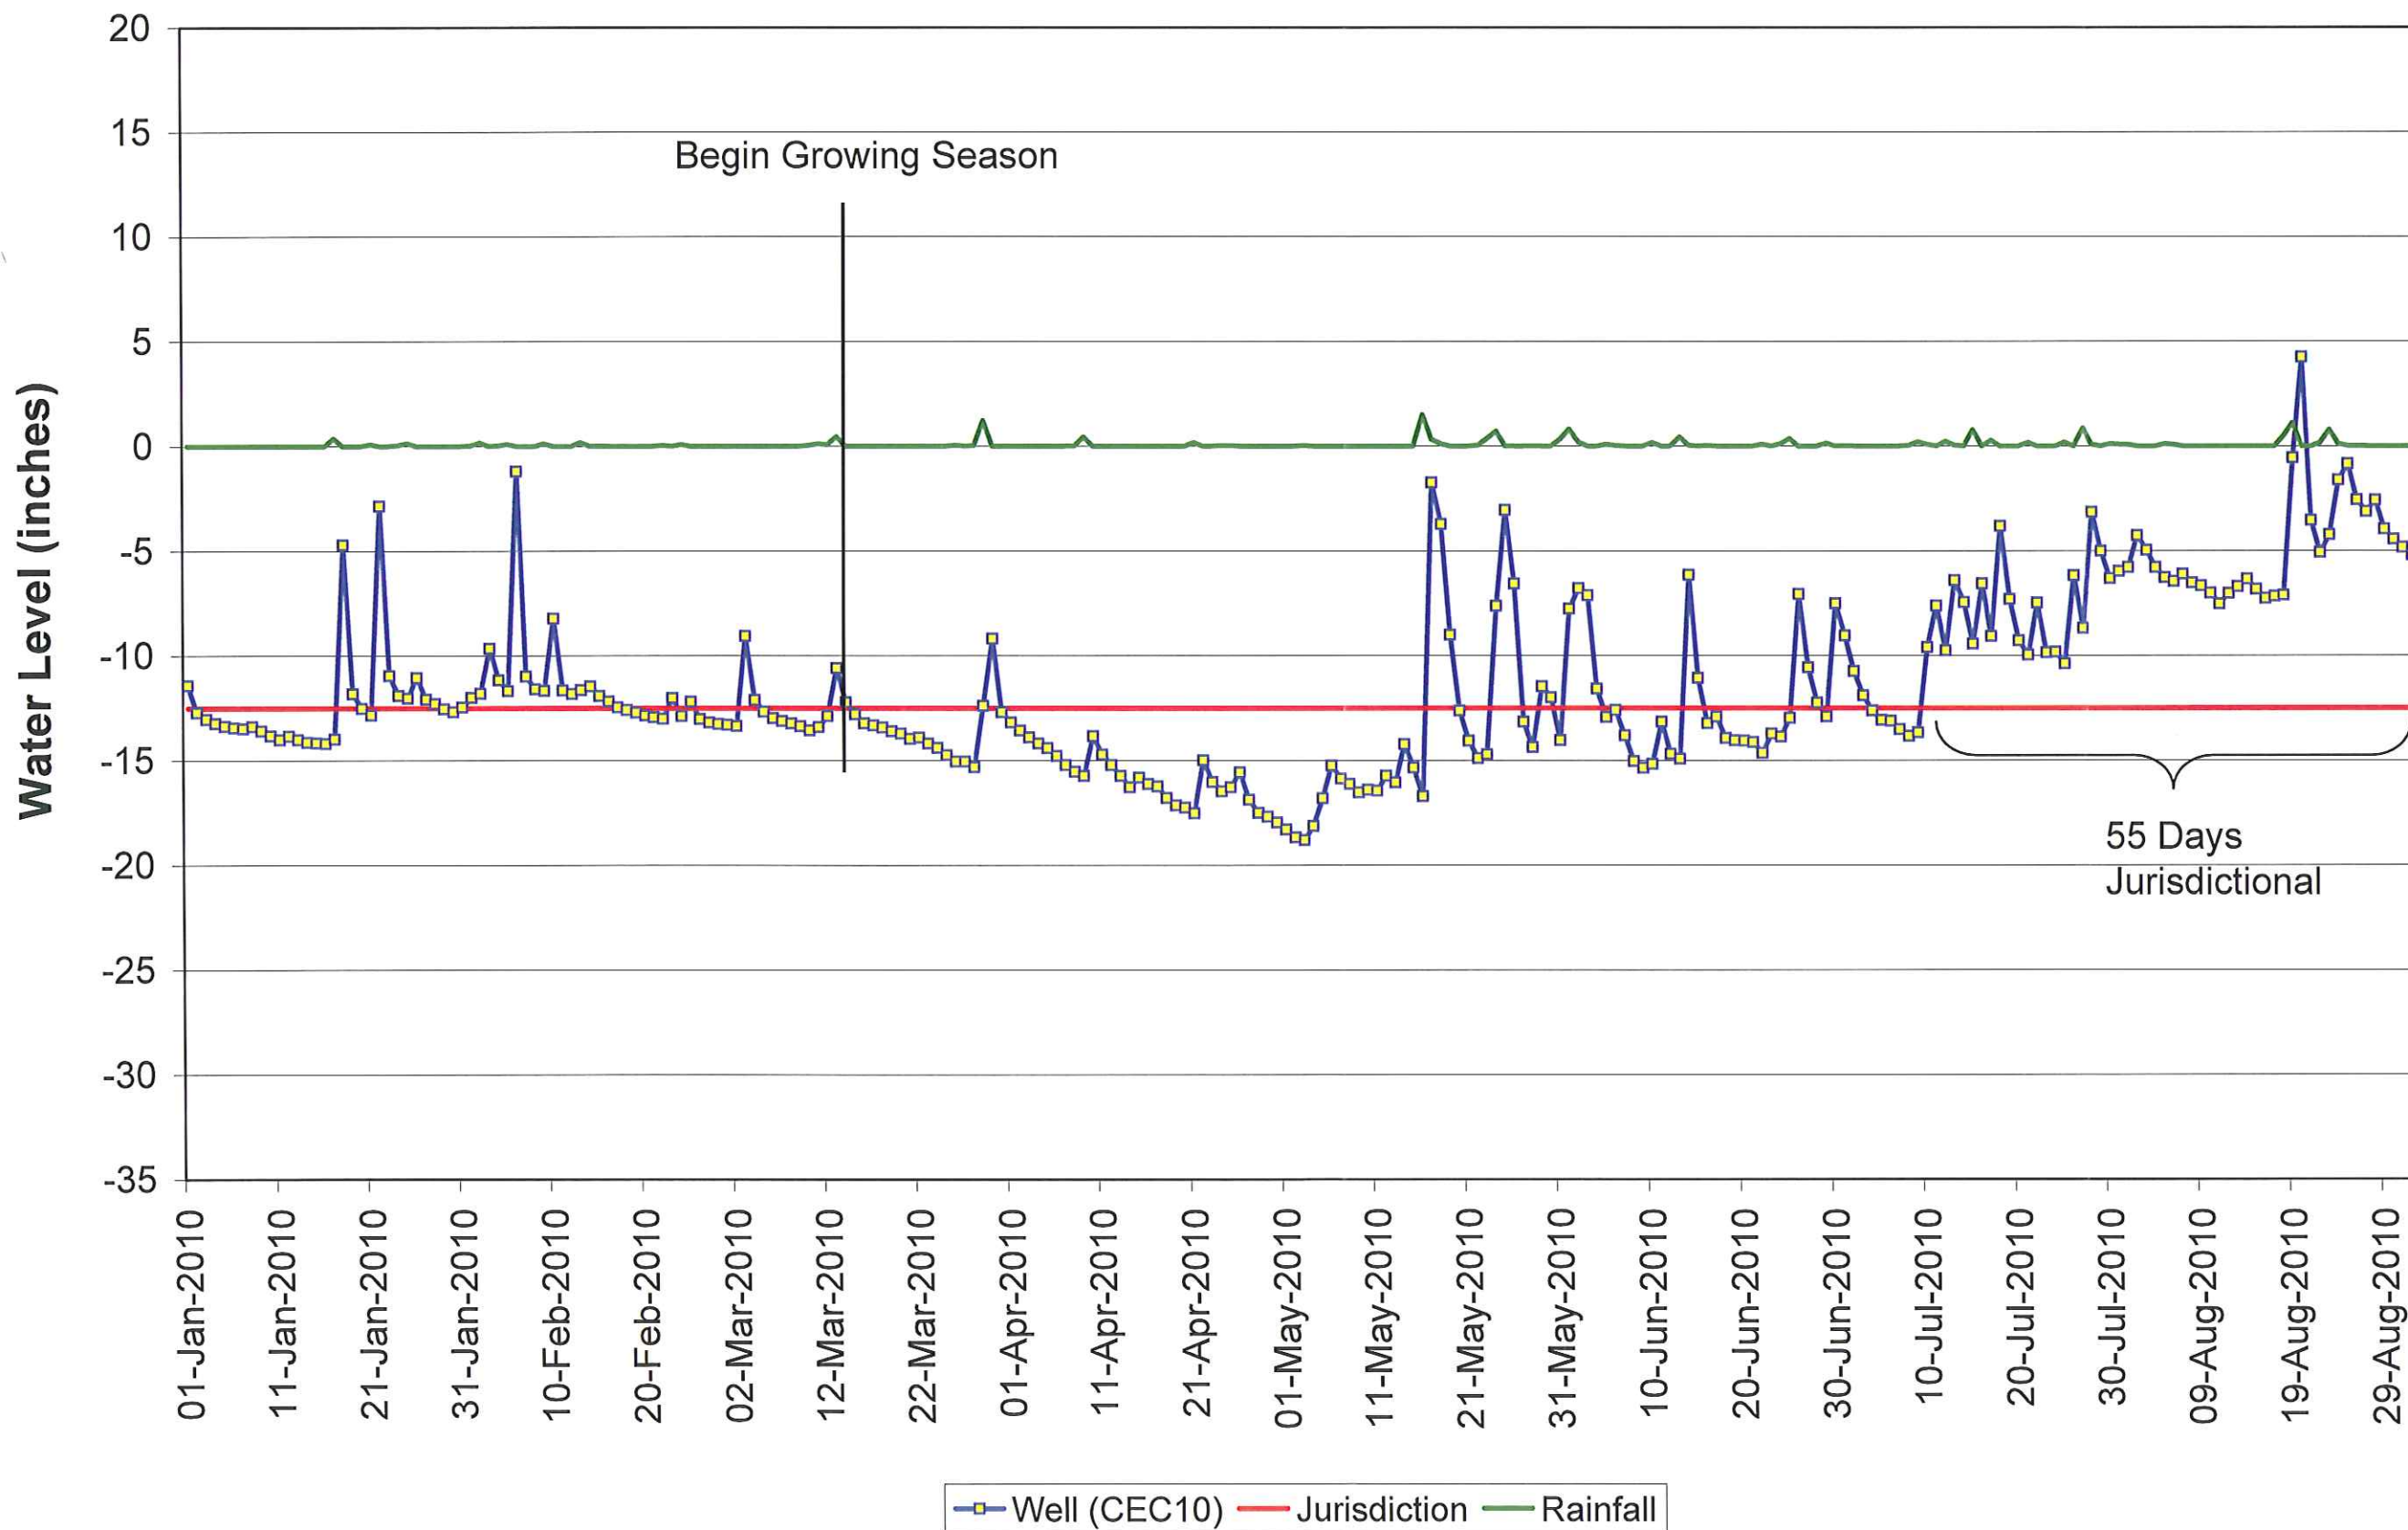
Water Level for Tarlton Well CEC10 with Rainfall Data

Overall, the site has shown consistent jurisdictional conditions every year. The region experienced moderate to extreme drought according to the Palmer Drought Severity Index from June of 2007 to August of 2008. During this time Gage CEC10 fell below the 10% threshold, but maintained the 5% threshold required for a drought year. Gage CC2 fell slightly below the 5% mark in 2007, but has performed well in all other years. These two gages are located in the driest areas of the site based on the last five years of observation and data.

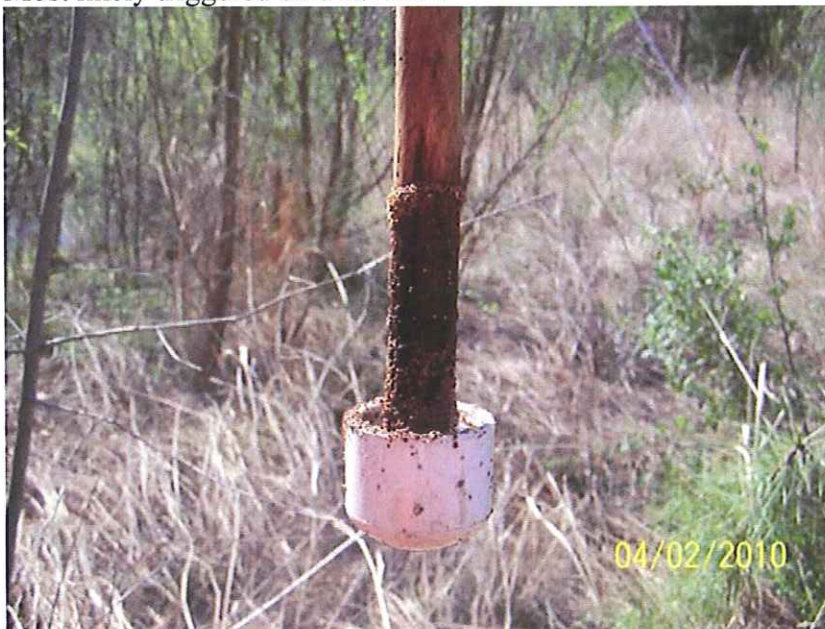
Most likely triggered on 3-29-2010

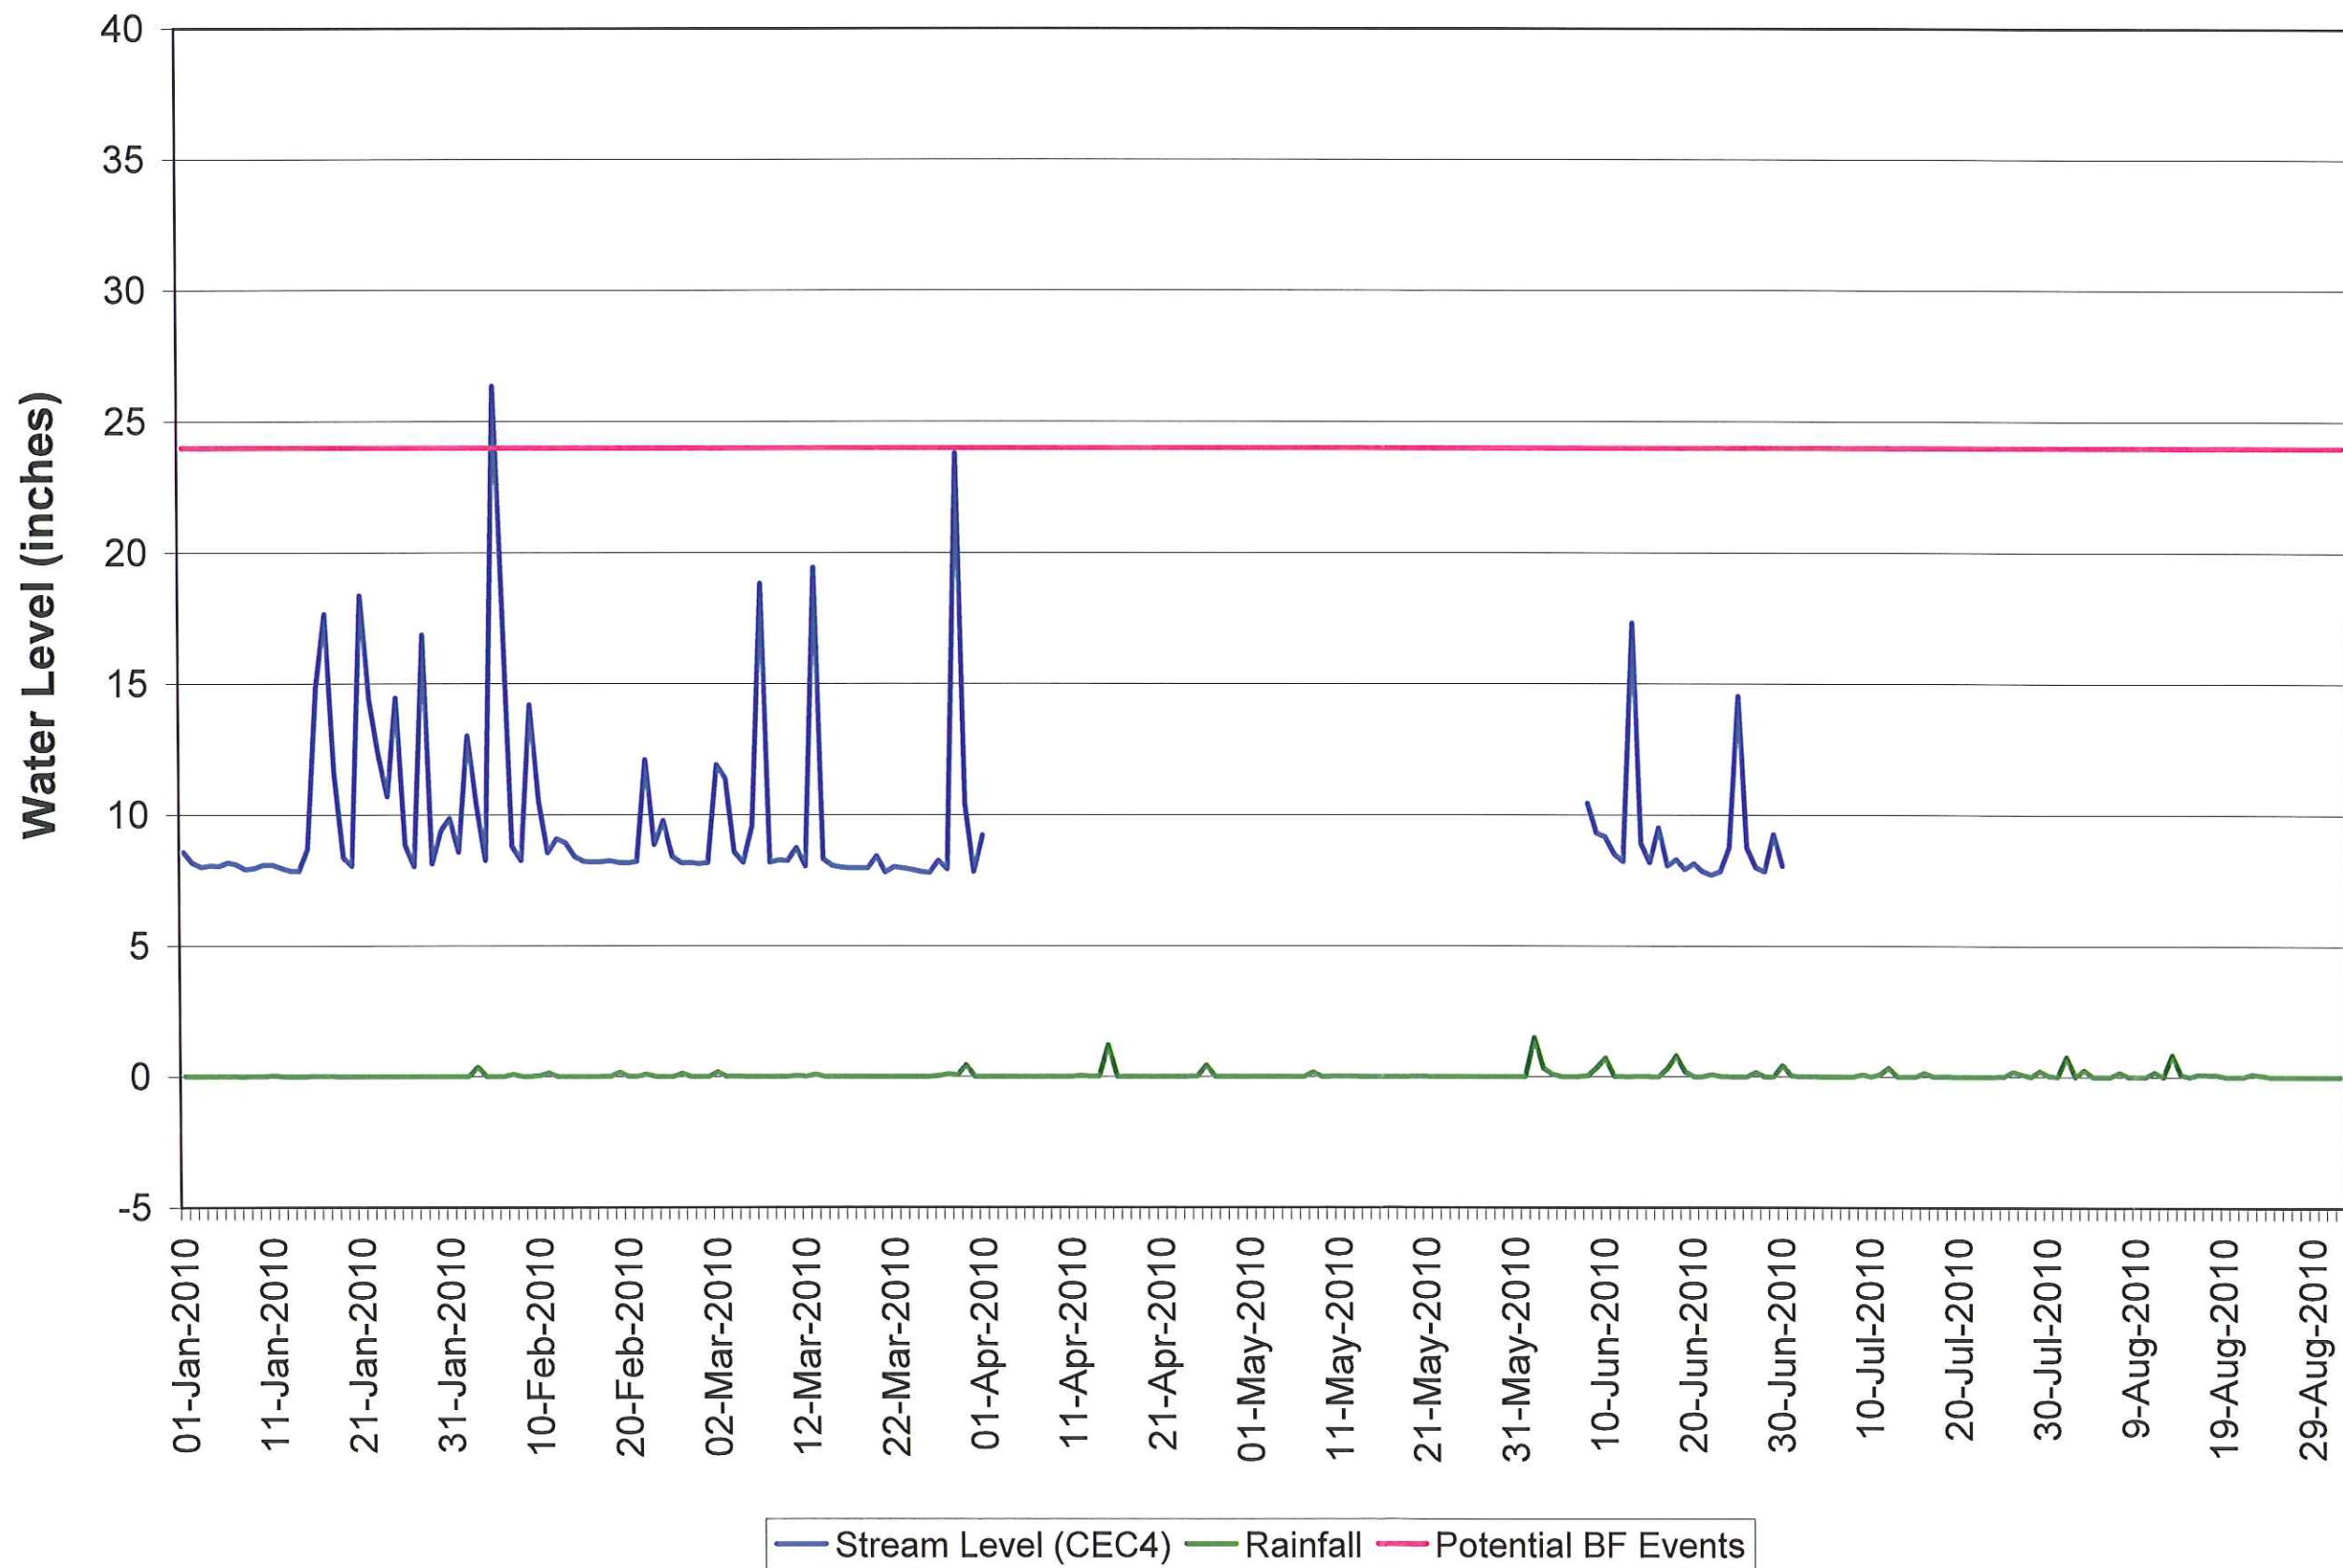
Stream Water Level vs. Rainfall

Rainfall amounts and stream gage peaks are shown in the table below. The stream gage rig was damaged and quit collecting relevant data around 8pm on July 5th, 2010. This was most likely due to an over bank event although it can not be traced to a significant rainfall event on the 5th of July. It is likely that rigging was simply undermined over time by constant ebb and flow and finally failed.
