FINAL
ANNUAL MONITORING REPORT
YEAR 1 (2012)
TATE FARM (RIPSHIN BRANCH)
STREAM/WETLAND RESTORATION SITE
ASHE COUNTY, NORTH CAROLINA
(EEP Project No. 372, Contract No. 004802)
Construction Completed December 2011

January 2013

Prepared by:
Axiom Environmental, Inc.
218 Snow Avenue
Raleigh, North Carolina 27603

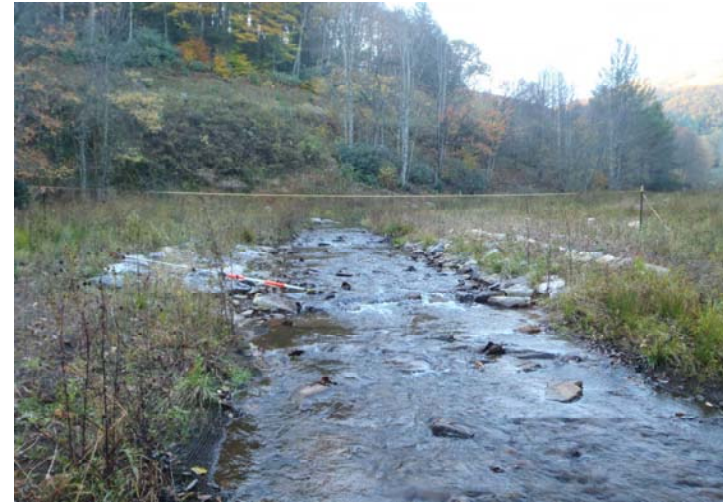
River Basin:	Upper New
Watershed:	Tate Farm
XS ID	XS - 1, Riffle
Drainage Area (sq mi):	1.6
Date:	10/16/2012
Field Crew:	Perkinson, Jernigan

SUMMARY DATA	
Bankfull Elevation:	58.9
Bankfull Cross-Sectional Area:	27.6
Bankfull Width:	23.4
Flood Prone Area Elevation:	60.8
Flood Prone Width:	>80
Max Depth at Bankfull:	1.9
Mean Depth at Bankfull:	1.2
W / D Ratio:	19.8
Entrenchment Ratio:	3.4
Bank Height Ratio:	1.0

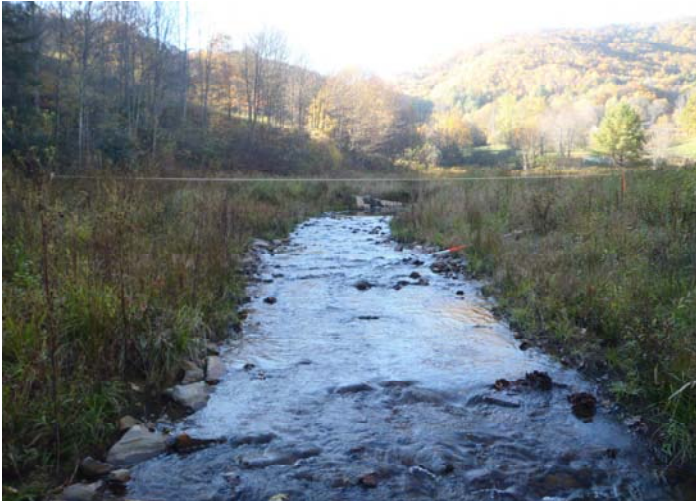
River Basin:	Upper New
Watershed:	Tate Farm
XS ID	XS - 3, Riffle
Drainage Area (sq mi):	1.6
Date:	10/16/2012
Field Crew:	Perkinson, Jernigan

SUMMARY DATA	
Bankfull Elevation:	66.0
Bankfull Cross-Sectional Area:	37.4
Bankfull Width:	28.1
Flood Prone Area Elevation:	68.1
Flood Prone Width:	>80
Max Depth at Bankfull:	2.1
Mean Depth at Bankfull:	1.3
W / D Ratio:	21.1
Entrenchment Ratio:	2.8
Bank Height Ratio:	1.0

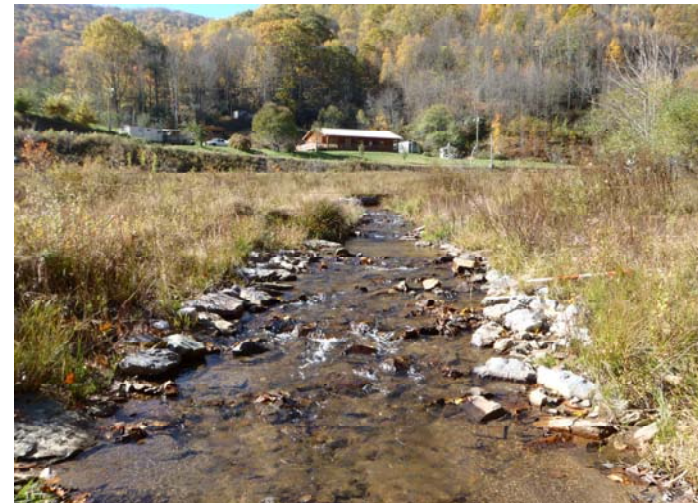
River Basin:	Upper New
Watershed:	Tate Farm
XS ID	XS - 4, Riffle
Drainage Area (sq mi):	1.6
Date:	10/16/2012
Field Crew:	Perkinson, Jernigan

SUMMARY DATA	
Bankfull Elevation:	77.7
Bankfull Cross-Sectional Area:	23.5
Bankfull Width:	21.4
Flood Prone Area Elevation:	79.7
Flood Prone Width:	>80
Max Depth at Bankfull:	2.0
Mean Depth at Bankfull:	1.1
W / D Ratio:	19.5
Entrenchment Ratio:	3.7
Bank Height Ratio:	1.0

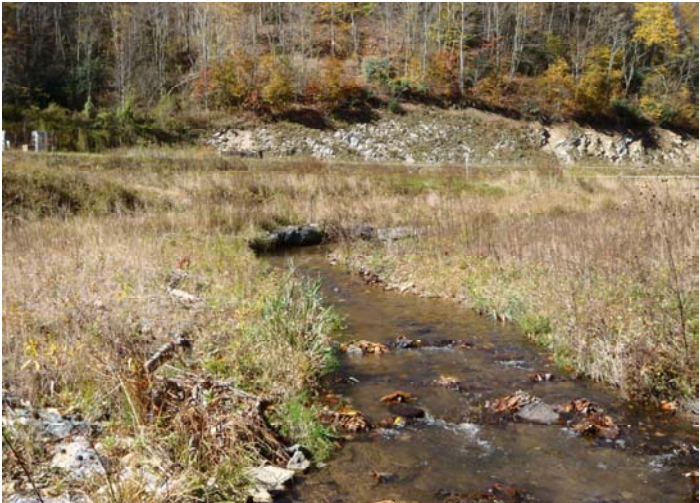
River Basin:	Upper New
Watershed:	Tate Farm
XS ID	XS - 5, Riffle
Drainage Area (sq mi):	1.6
Date:	10/16/2012
Field Crew:	Perkinson, Jernigan

SUMMARY DATA	
Bankfull Elevation:	82.9
Bankfull Cross-Sectional Area:	19.2
Bankfull Width:	21.7
Flood Prone Area Elevation:	84.8
Flood Prone Width:	>80
Max Depth at Bankfull:	1.9
Mean Depth at Bankfull:	0.9
W / D Ratio:	24.5
Entrenchment Ratio:	3.7
Bank Height Ratio:	1.0

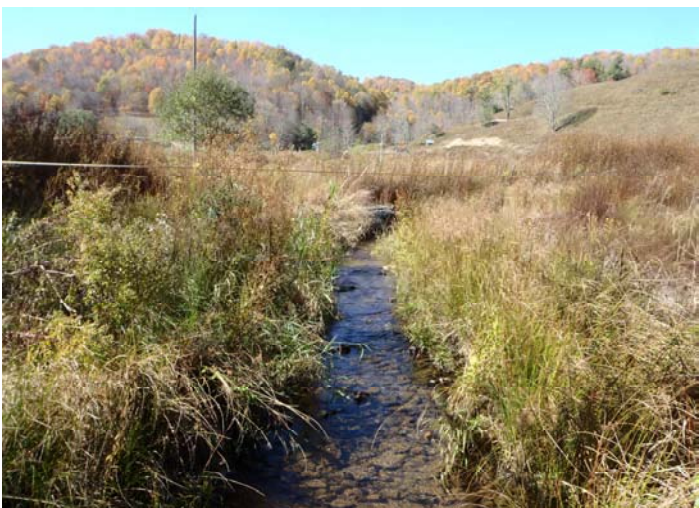
River Basin:	Upper New
Watershed:	Tate Farm
XS ID	XS - 6, Riffle
Drainage Area (sq mi):	0.6
Date:	10/16/2012
Field Crew:	Perkinson, Jernigan

SUMMARY DATA	
Bankfull Elevation:	80.0
Bankfull Cross-Sectional Area:	17.4
Bankfull Width:	17.4
Flood Prone Area Elevation:	81.7
Flood Prone Width:	>80
Max Depth at Bankfull:	1.7
Mean Depth at Bankfull:	1.0
W / D Ratio:	17.4
Entrenchment Ratio:	4.6
Bank Height Ratio:	1.0

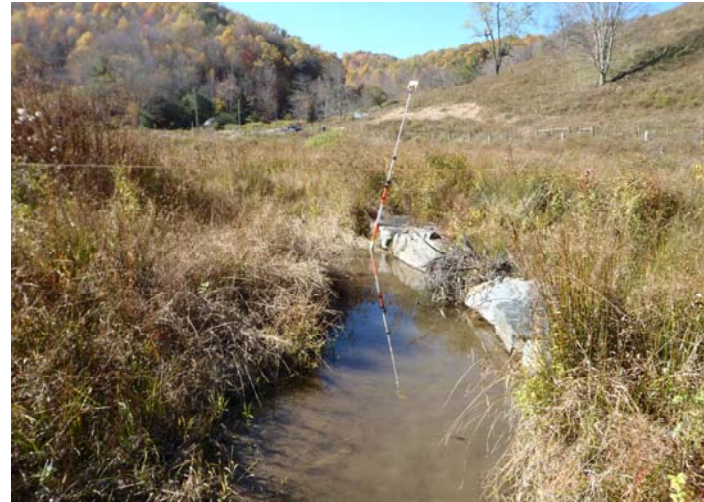
River Basin:	Upper New
Watershed:	Tate Farm
XS ID	XS - 7, Pool
Drainage Area (sq mi):	0.6
Date:	10/16/2012
Field Crew:	Perkinson, Jernigan

SUMMARY DATA	
Bankfull Elevation:	87.3
Bankfull Cross-Sectional Area:	14.5
Bankfull Width:	16.0
Flood Prone Area Elevation:	-
Flood Prone Width:	-
Max Depth at Bankfull:	2.4
Mean Depth at Bankfull:	0.9
W / D Ratio:	-
Entrenchment Ratio:	-
Bank Height Ratio:	-

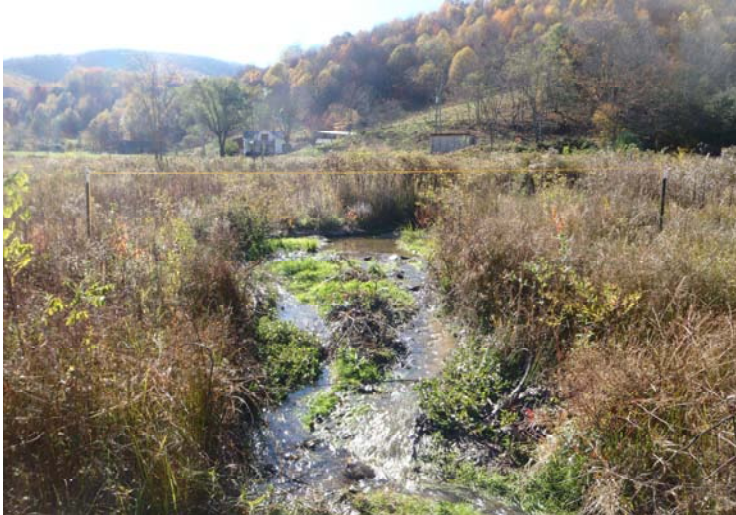
River Basin:	Upper New
Watershed:	Tate Farm
XS ID	XS - 8, Riffle
Drainage Area (sq mi):	0.6
Date:	10/16/2012
Field Crew:	Perkinson, Jernigan

SUMMARY DATA	
Bankfull Elevation:	94.5
Bankfull Cross-Sectional Area:	8.9
Bankfull Width:	17.4
Flood Prone Area Elevation:	95.7
Flood Prone Width:	>80
Max Depth at Bankfull:	1.2
Mean Depth at Bankfull:	0.5
W / D Ratio:	34.0
Entrenchment Ratio:	4.6
Bank Height Ratio:	1.0
