FINAL
ANNUAL MONITORING REPORT
YEAR 3 (2014)
TATE FARM (RIPSHIN BRANCH)
STREAM/WETLAND RESTORATION SITE
ASHE COUNTY, NORTH CAROLINA
(EEP Project No. 372, Contract No. 004802)
Construction Completed December 2011

Prepared by:
Axiom Environmental, Inc.
218 Snow Avenue
Raleigh, North Carolina 27603

November 2014

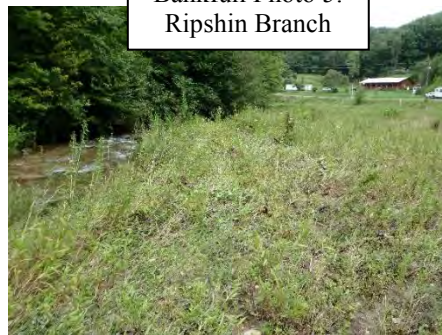
Bankfull Photo 5:
Ripshin Branch

Date of Data Collection	Date of Occurrence	Method	Photo (if available)
June 7, 2013	January 17, 2013	Approximately 3.9 inches of rain documented* at a nearby rain station over a four day period from January 14-17, 2013.	---
April 28, 2013	January 30, 2013	Wrack and sediment observe on top of banks after approximately 4.2 inches of rain was documented* at a nearby rain station on January 30, 2013.	1-3
June 12, 2013	May 7, 2013	Approximately 4.34 inches of rain documented over three days at the onsite rain gauge.	---
June 12, 2013	May 24, 2013	Wrack observed in the floodplain after approximately 5.92 inches of rain was documented over eight days at the onsite rain gauge.	4
August 13, 2013	July 4, 2013	Approximately 4.13 inches of rain documented over two days at the onsite rain gauge.	---
August 13, 2013	August 10, 2013	Wrack and laid back vegetation observed in the flood plain after approximately 3.52 inches of rain was documented at the onsite rain gauge.	5

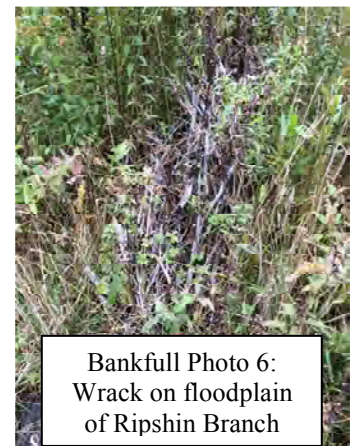
October 7, 2014	September 2-8, 2014	Wrack observed in floodplain after rainfall totaling 4.37 inches documented at the onsite rain gauge.	6

Bankfull Photo 6:
Wrack on floodplain
of Ripshin Branch
