FINAL
ANNUAL MONITORING REPORT
YEAR 4 (2015)
TATE FARM (RIPSHIN BRANCH)
STREAM/WETLAND RESTORATION SITE
ASHE COUNTY, NORTH CAROLINA
(DMS Project No. 372, Contract No. 004802)
Construction Completed December 2011

December 2015

Prepared by:
Axiom Environmental, Inc.
218 Snow Avenue
Raleigh, North Carolina 27603

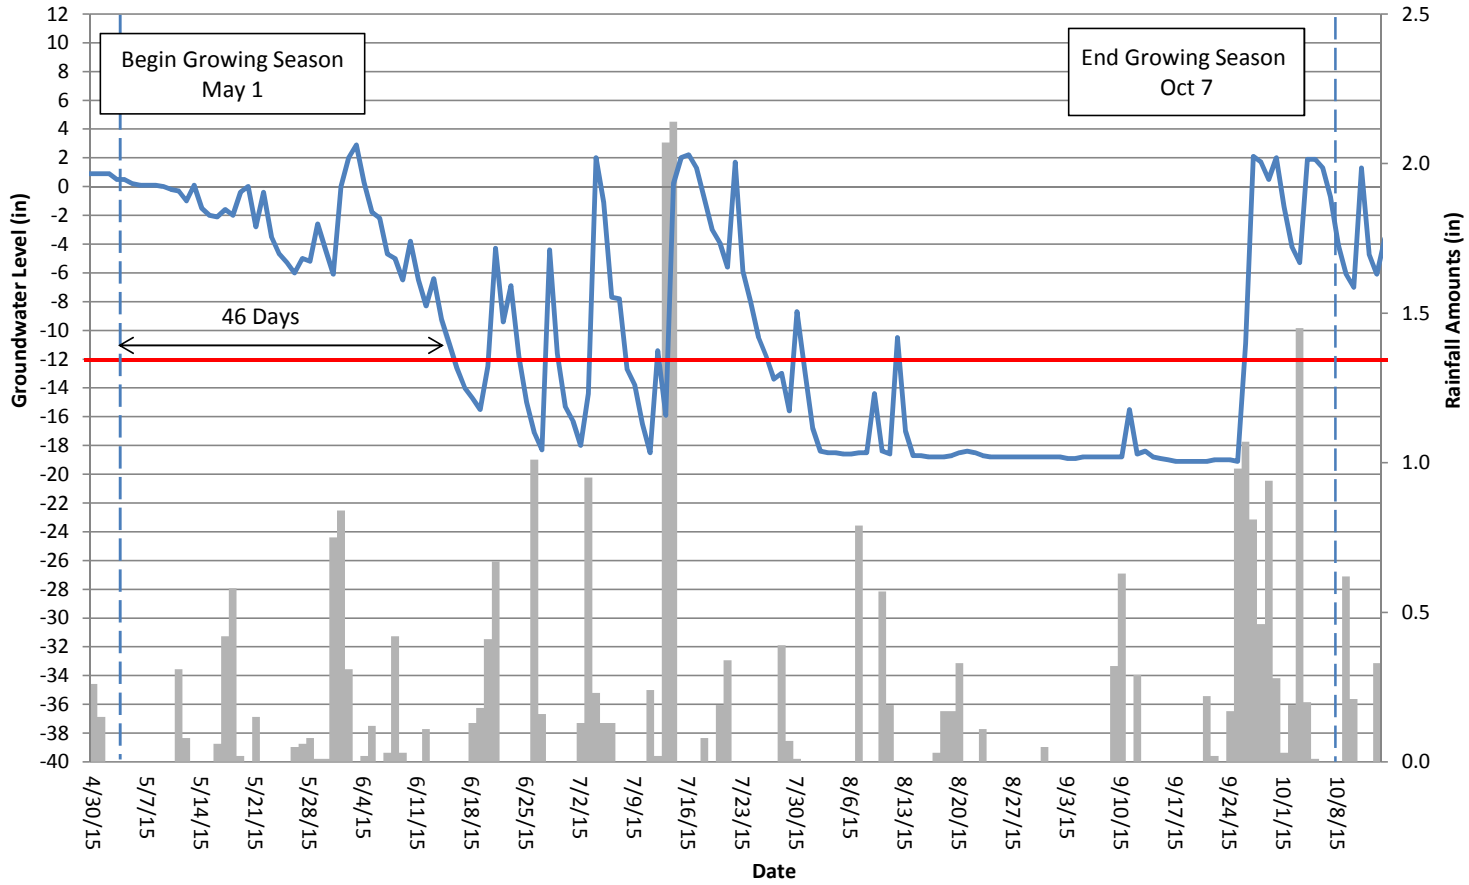
Tate Farm Groundwater Gauge 4 Year 4 (2015 Data)

**Gauge 4 malfunctioned at beginning of 2014 growing season resulting in loss of data. A battery failure at the beginning of the growing season resulted in a loss of data. The gauge was replaced and is currently functioning properly, but during a subsequent visit additional data was lost due to a failed Meazura PDA. Based on hydrology of the additional gauges, in addition to abundant precipitation, it is likely that Gauge 4 would have met success for year 3 (2014).
