FINAL
ANNUAL MONITORING REPORT
YEAR 5 (2016)
TATE FARM (RIPSHIN BRANCH)
STREAM/WETLAND RESTORATION SITE
ASHE COUNTY, NORTH CAROLINA
(DMS Project No. 372, Contract No. 004802)
Construction Completed December 2011

December 2016

Prepared by:
Axiom Environmental, Inc.
218 Snow Avenue
Raleigh, North Carolina 27603

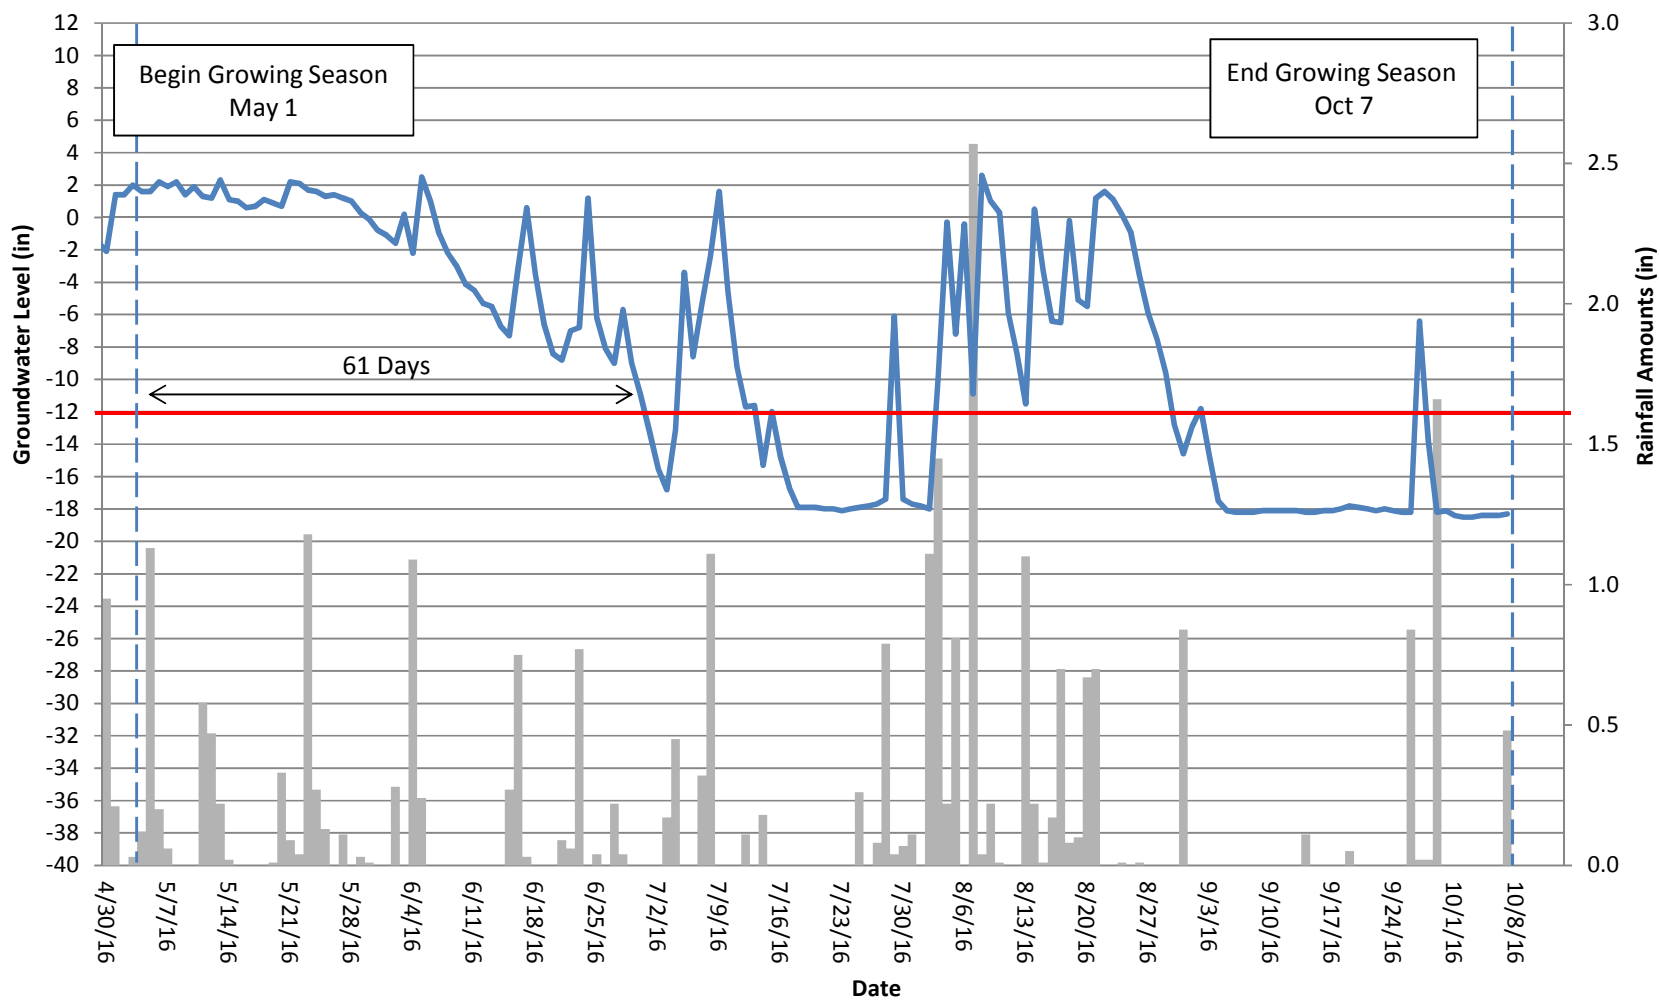
Tate Farm Groundwater Gauge 4 Year 5 (2016 Data)

**Gauge 4 malfunctioned at beginning of 2014 growing season resulting in loss of data. A battery failure at the beginning of the growing season resulted in a loss of data. The gauge was replaced and is currently functioning properly, but during a subsequent visit additional data was lost due to a failed Meazura PDA. Based on hydrology of the additional gauges, in addition to abundant precipitation, it is likely that Gauge 4 would have met success for year 3 (2014).
