**ANNUAL MONITORING REPORT
YEAR 6 (2017)
TATE FARM (RIPSHIN BRANCH)
STREAM/WETLAND RESTORATION SITE
ASHE COUNTY, NORTH CAROLINA
(DMS Project No. 372, Contract No. 004802)
Construction Completed December 2011**

May 2018

Prepared by:
Axiom Environmental, Inc.
218 Snow Avenue
Raleigh, North Carolina 27603

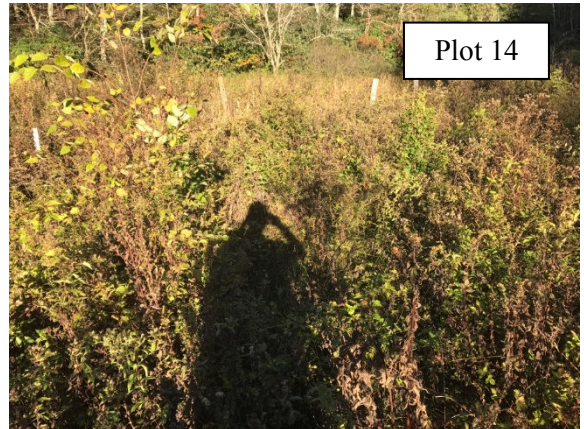
Plot 14

Overall, vegetation was below success criteria with an average of 252 planted stems/acre (excluding livestakes) across the Site. Six of the eighteen vegetation monitoring plots met, or exceeded success criteria. Plots 1-5 and 14 are located along the Ripshin Branch and unnamed tributary stream and wetland restoration areas. The vegetation within these areas is meeting success criteria with an average of 411 planted stems/acre. Additionally, four of the six plots in this area met or exceeded success criteria. Potential causes of the low stem counts at Plots 2 and 4 include excessive hydrology associated with wetland restoration and over competition by sedges and soft rush (*Carex* spp. and *Juncus effusus*, respectively). Plots 6-13 and 15-18 are located in the Enhancement (level II) areas throughout the remainder of the Site. Average total stem density throughout this area is 354 stems/acre. Additionally, only two of the twelve plots in these areas met or exceeded success criteria based on planted stem densities. Plots 15 and 18 have had zero planted stems since they were initially installed and measured during year 2 (2013). Plot placement according to the CVS methodology is random, and these plots were randomly placed in areas with no surviving planted stems. With just over two years between the planting of these reaches (May 2011) and initial CVS measurements (August 2013), it is difficult to pinpoint the cause of this planted stem mortality. Harsh, high elevation climate and nutrient-poor, rocky soils are likely factors attributing to the high rate of planted stem mortality in these areas.

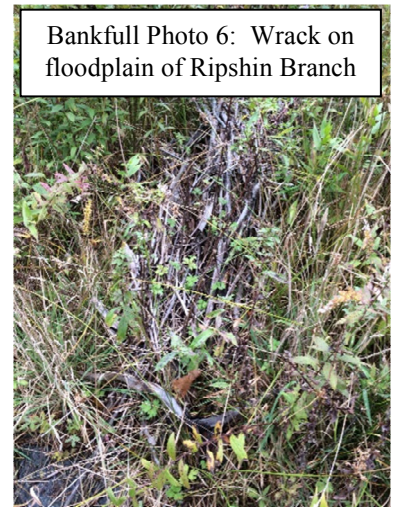
Bankfull Photo 6: Wrack on
floodplain of Ripshin Branch
