Thomas Creek Restoration Project Year 7 Monitoring/Closeout Report

Wake County, North Carolina

DMS Project ID Number – 96074, DEQ Contract No. 5549

Report Prepared and Submitted by Michael Baker Engineering, Inc.

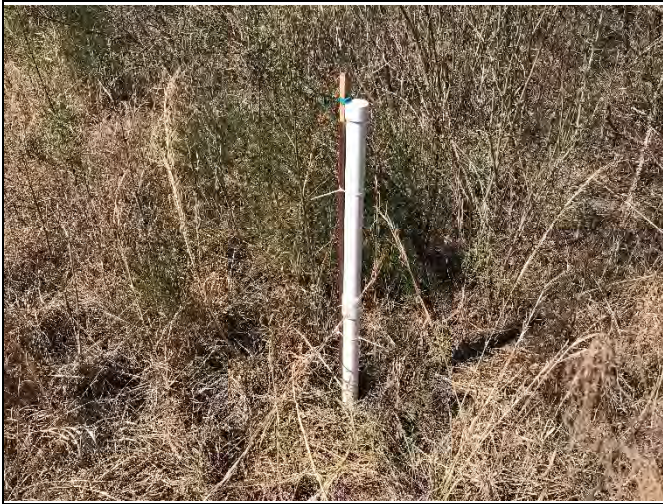
PP-31: Reach 2, Crest Gauge at Station 38+90

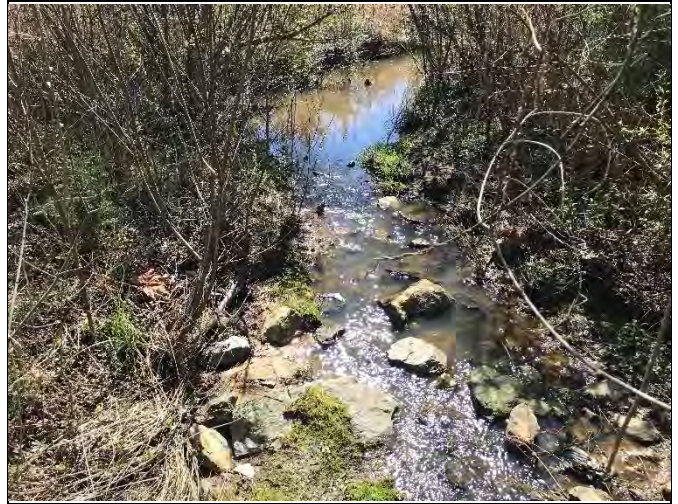
PP-32: Reach 2, view downstream at Station 39+40

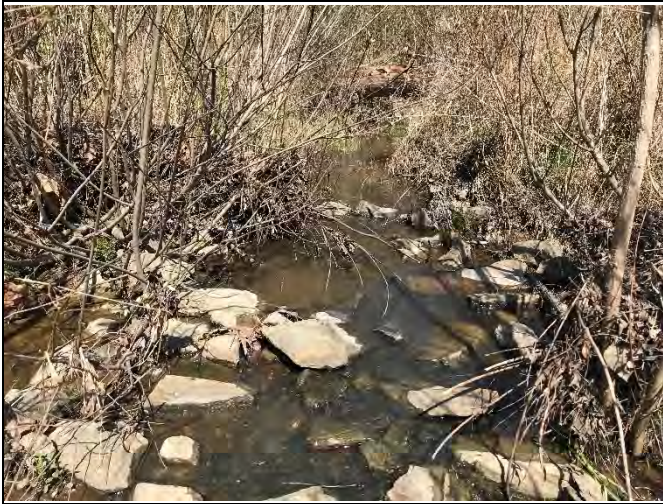
PP-33: Reach 2, view upstream at Station 41+50

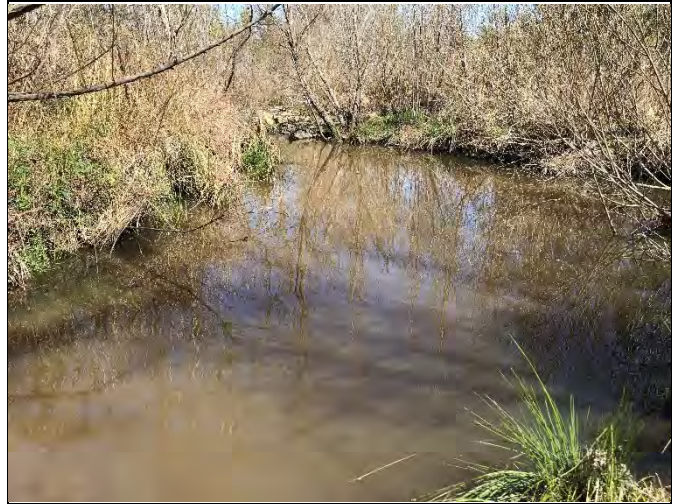
PP-34: Reach 1, view upstream at Station 42+75

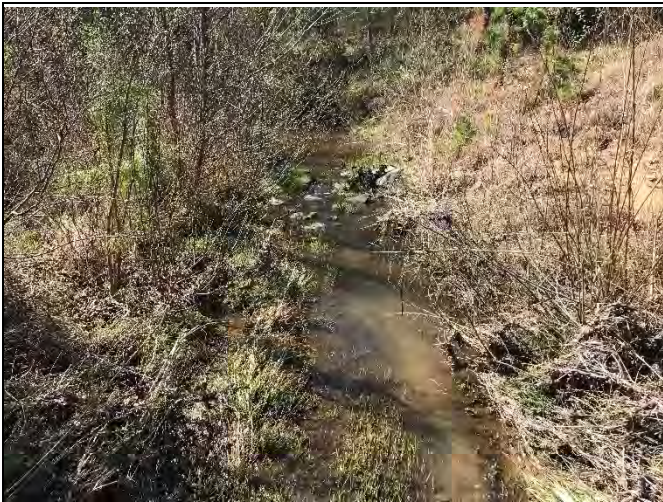
PP-35: Reach 1, view downstream at Station 43+25

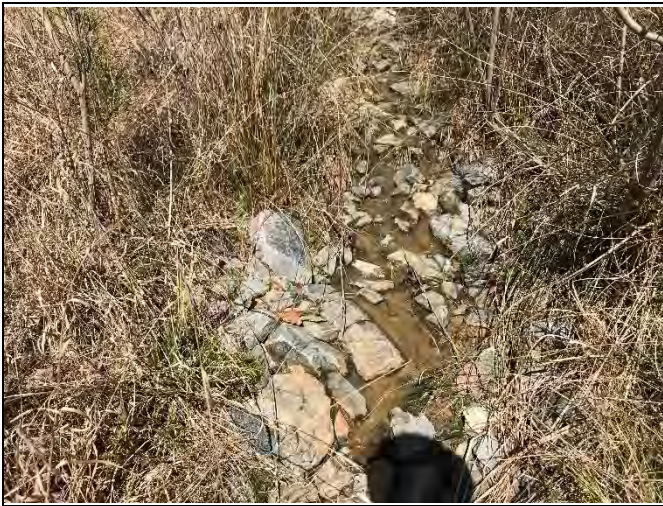
PP-37: Reach 6, view upstream at Station 10+75

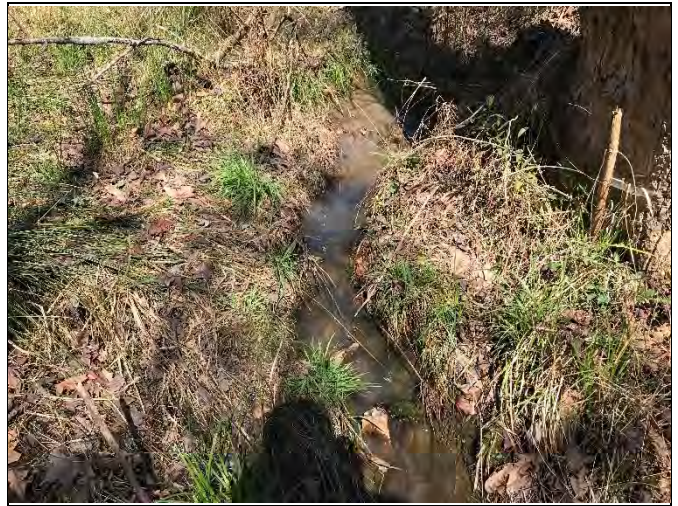
PP-38: Reach 6, view upstream at Station 11+50

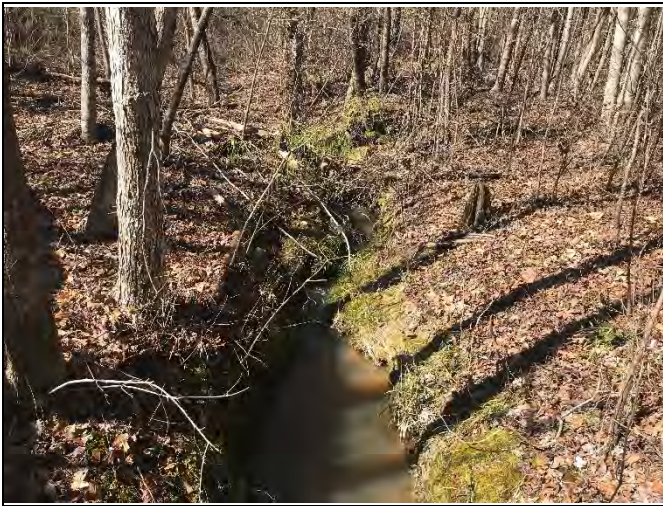
PP-39: Reach 6, view upstream at Station 15+25

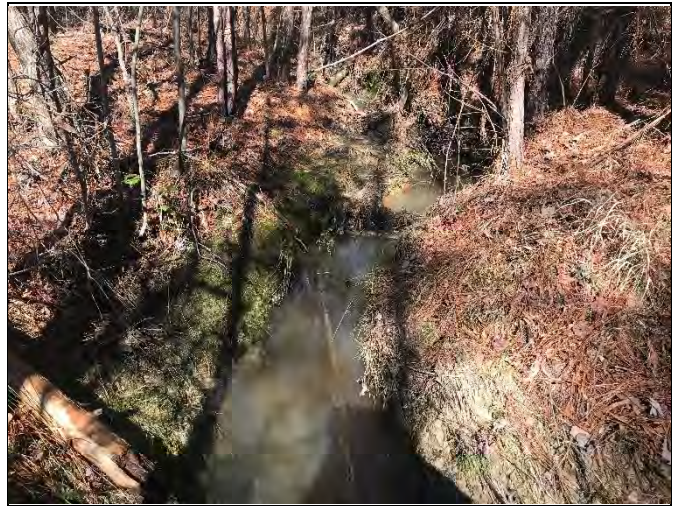
PP-40: Reach 6, view upstream at Station 18+90

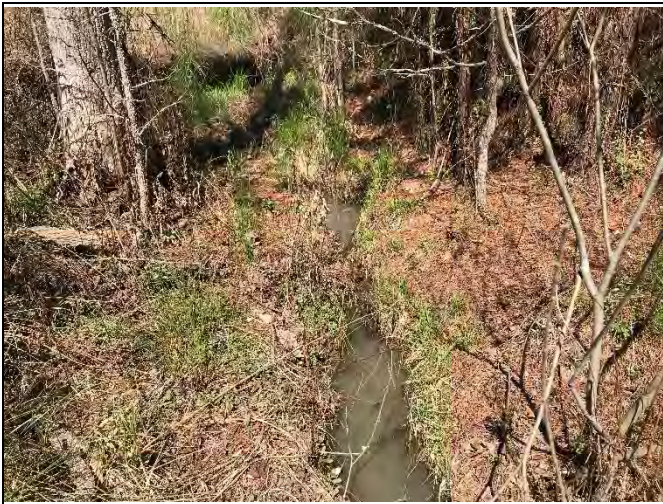
PP-41: Reach 6, view upstream at Station 25+50

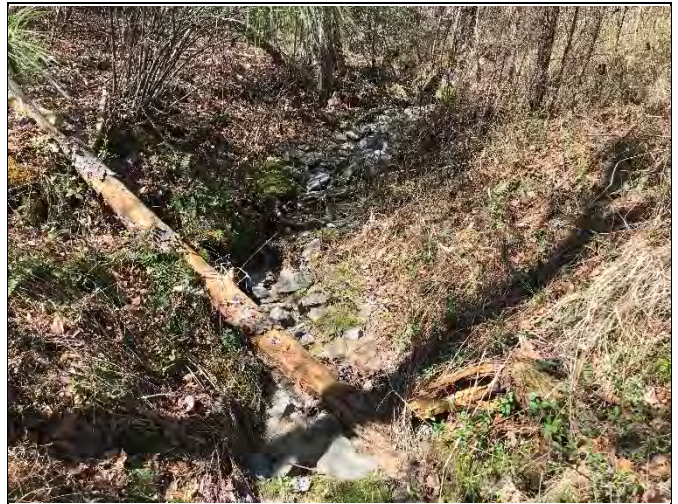
PP-42: Reach 7, view upstream at Station 10+40

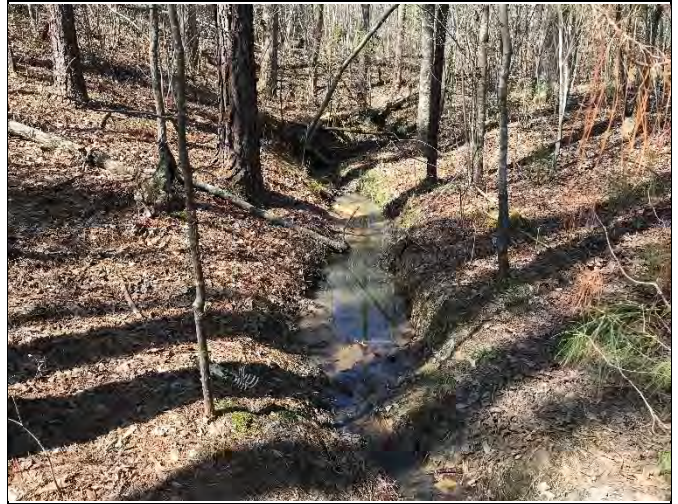
PP-44: Reach 7, view upstream at Station 15+00

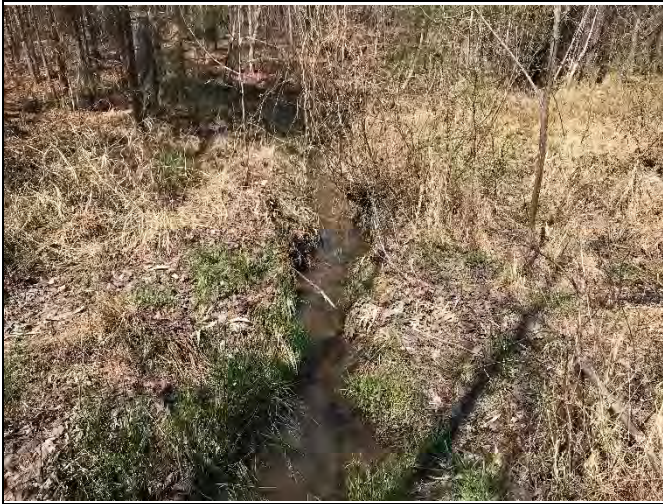
PP-45: Reach 5, view upstream at Station 30+25

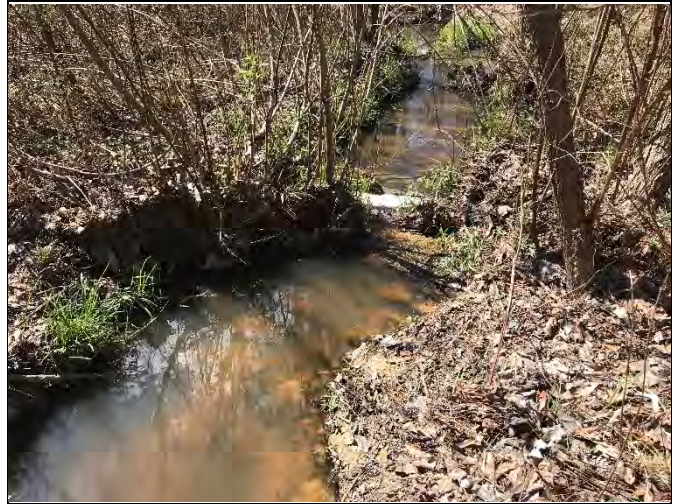
PP-46: Reach 5, view downstream at Station 30+75

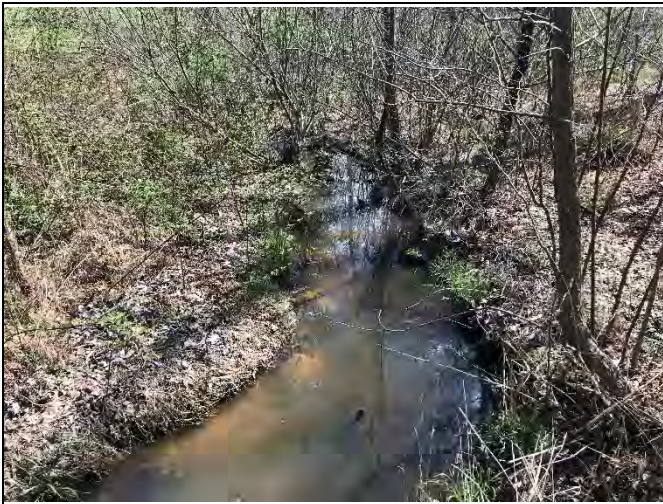
PP-47: Reach 5, view downstream at Station 31+40

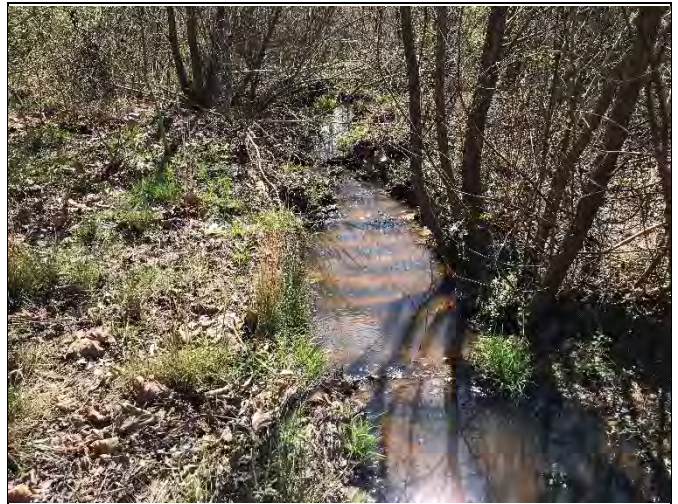
PP-48: Reach 5, view downstream at Station 32+50

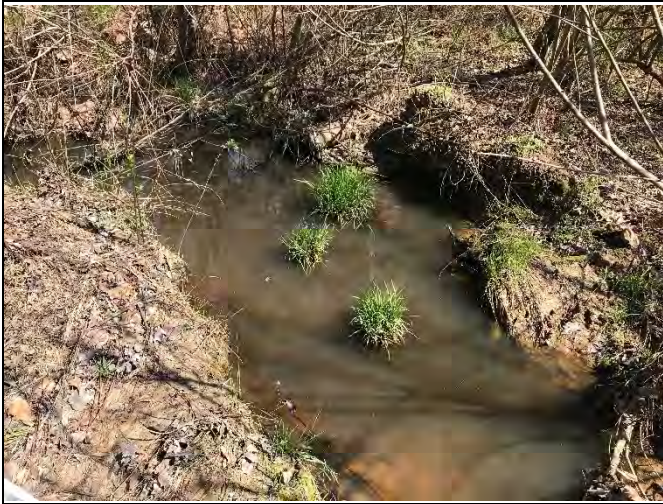
PP-49: Reach 5, view upstream at Station 33+10

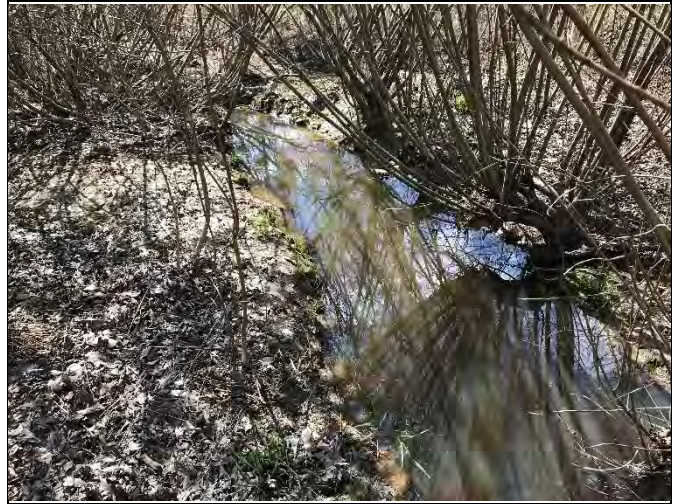
PP-50: Reach 5, view downstream at Station 33+75

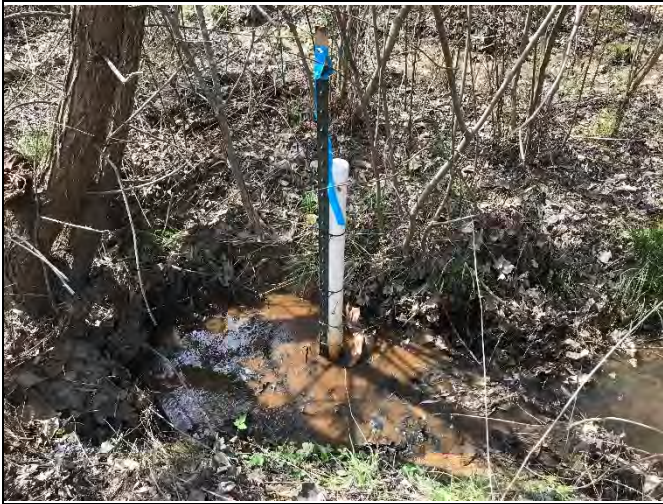
PP-51: Reach 5, Flow Gauge #2 at Station 33+90

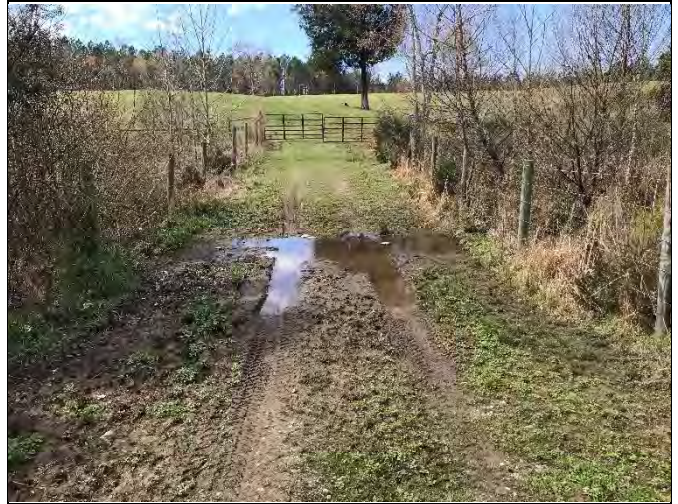
PP-52: Reach 5, view of crossing at Station 35+00 (note: no cattle in upper field so gate is OK to have open)

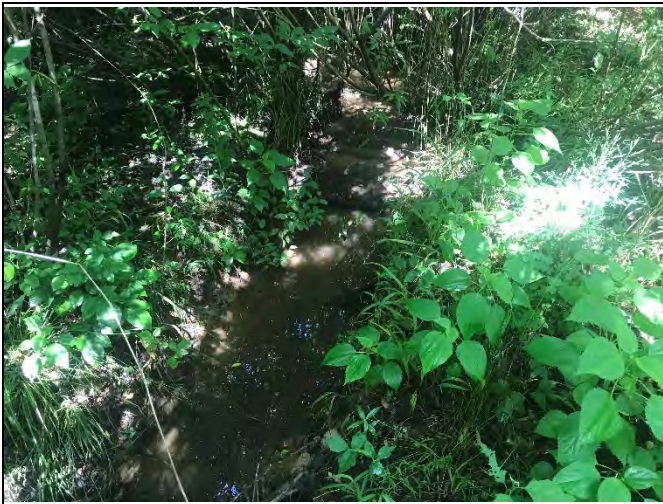
PP-53: Reach 5, view upstream at Station 36+40 (6/17/2022)

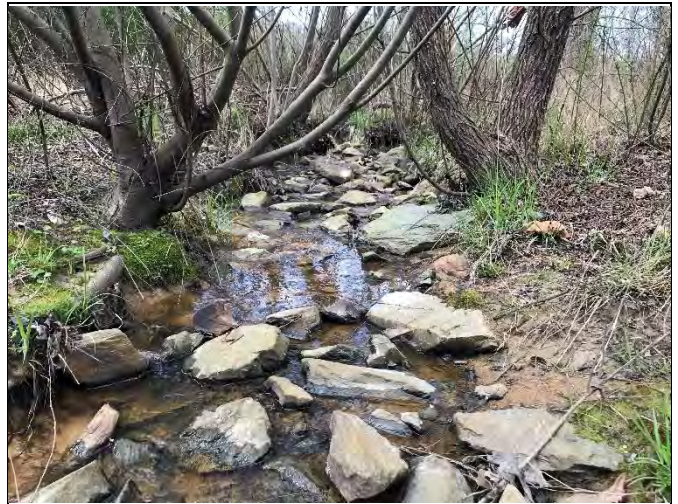
PP-54: Reach 5, view upstream at Station 36+75

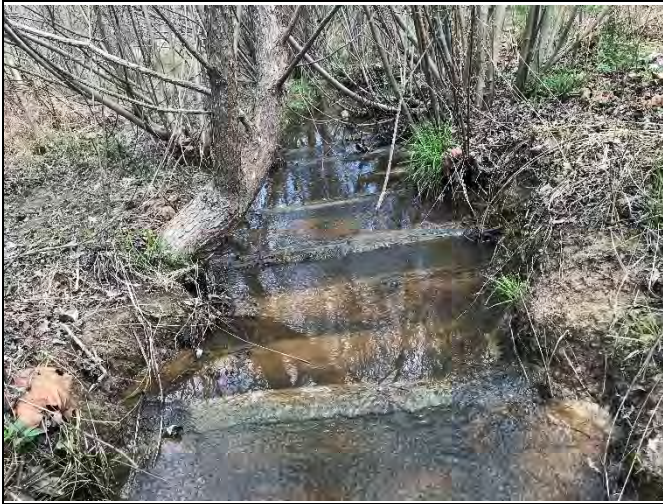
PP-55: Reach 5, view downstream at Station 37+30

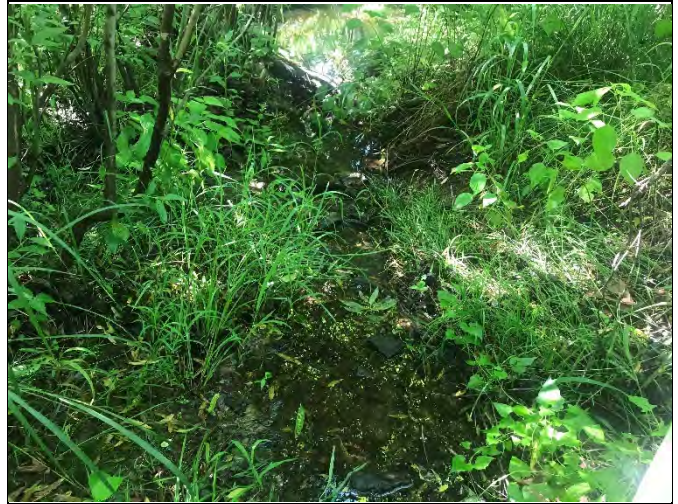
PP-56: Reach 5, view upstream at Station 38+50 (6/17/2022)

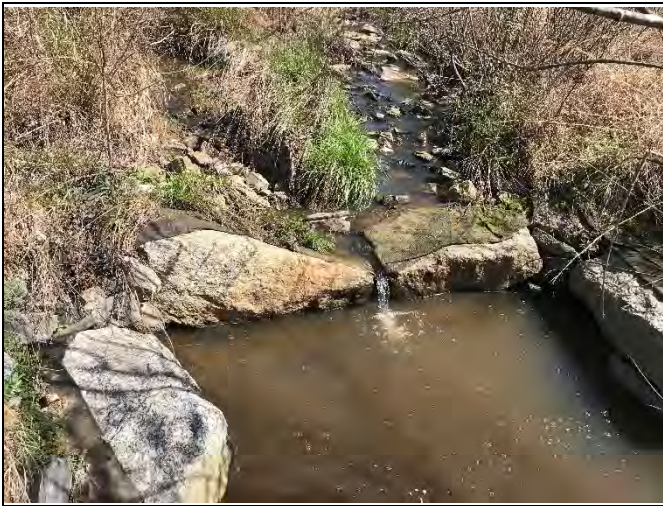
PP-57: Reach 5, view upstream at Station 39+90
(the confluence of R5 and R2)

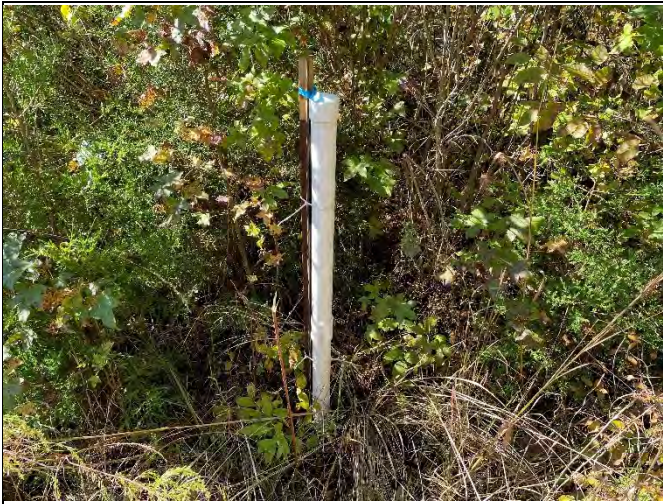
Crest Gauge on Reach R2 at Station 38+90
(photo from 10/19/22)

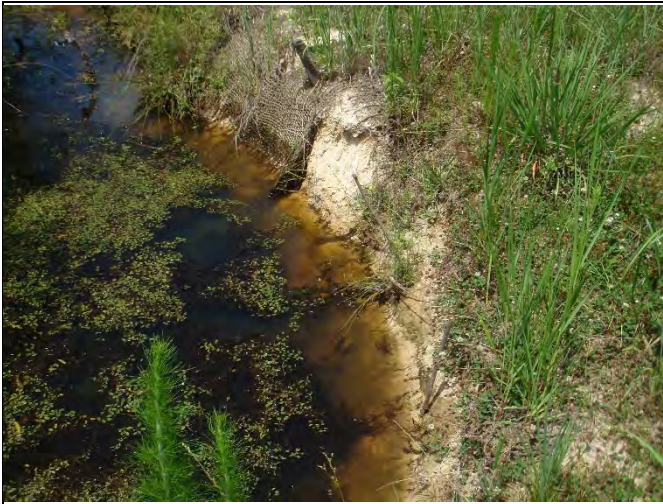
R2 bank scour MY3 (photo: 6/13/18)

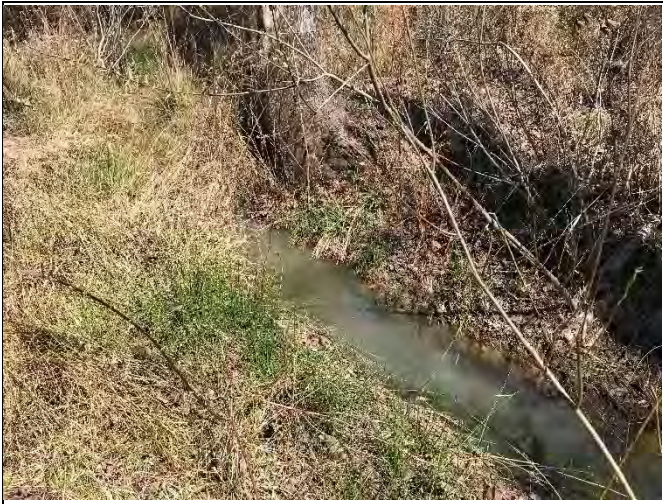
Flow on upper R6, upstream (photo: 3/25/2022)

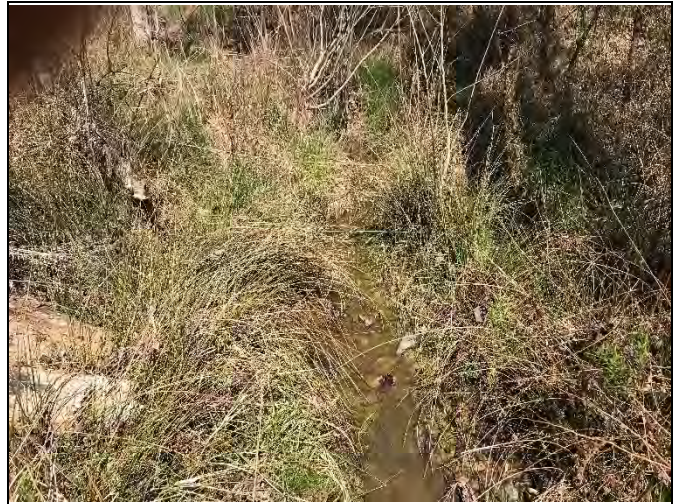
Flow on upper R6, upstream (photo: 3/25/2022)

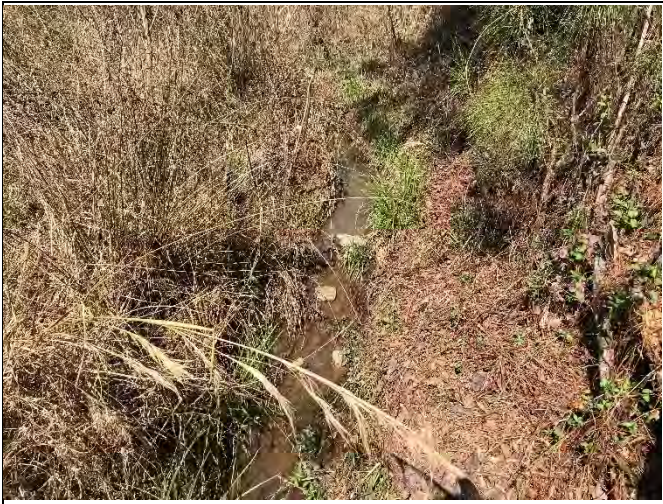
Flow on upper R6, upstream (photo: 3/25/2022)

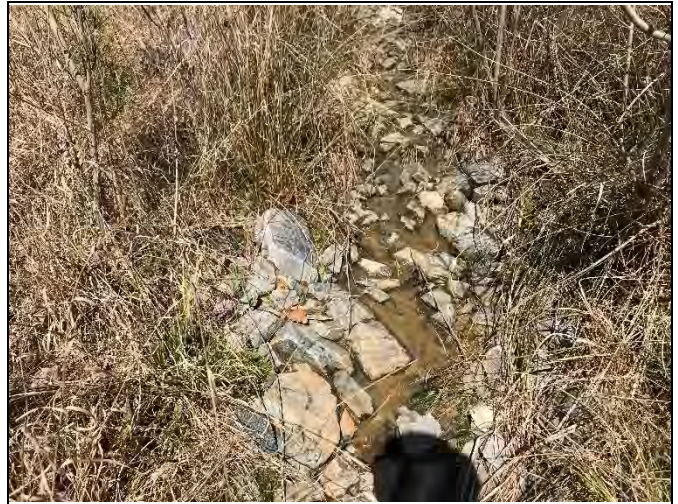
Flow on upper R6, upstream (photo: 3/25/2022)

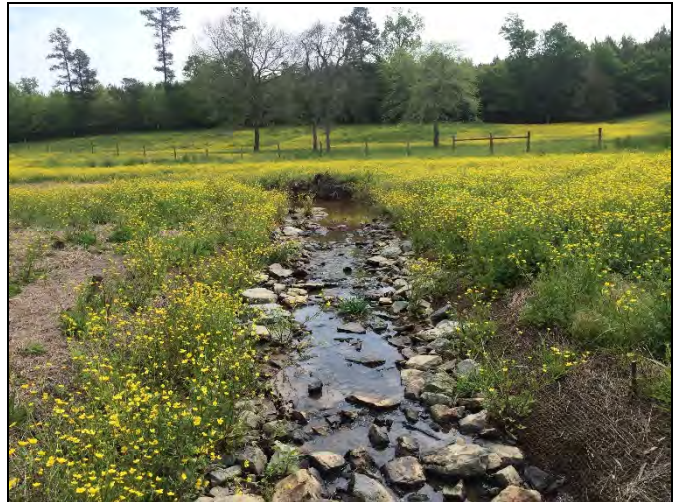
R2 station 37+50 As-built photo of riffle (photo: 4/28/16)
