Year 1 Monitoring Report for Stream Restoration of Thompsons Fork and Unnamed Tributary

McDowell County, NC
SCO # D06030-A

Submitted: December 2009

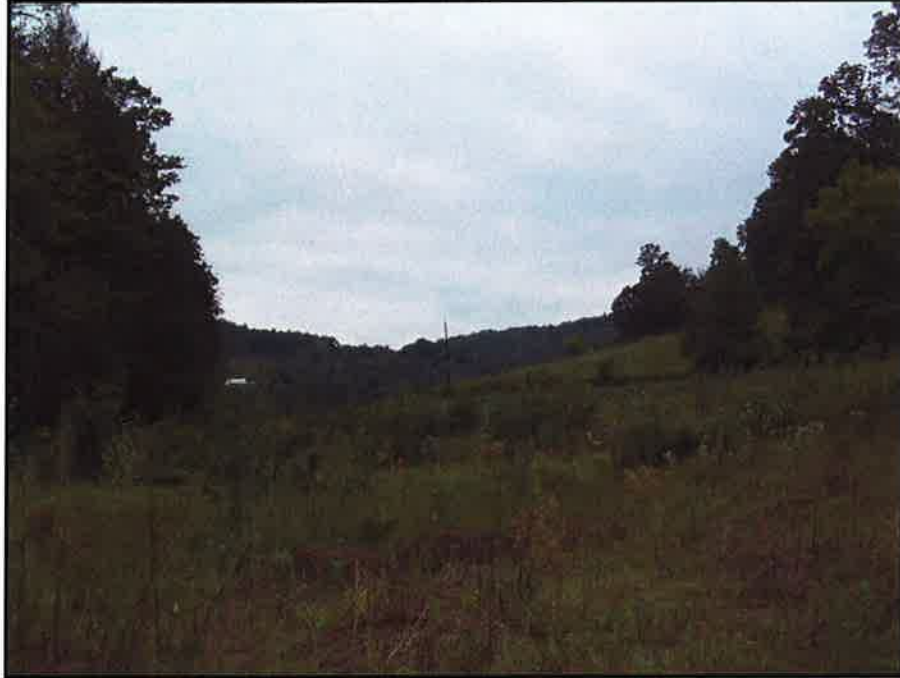
SPA 3

**Wetland vegetation forming within the stream channel on Thompsons Fork near station
8+75, causing a narrowing of the channel.
(EMH&T, Inc. 9/18/09)**

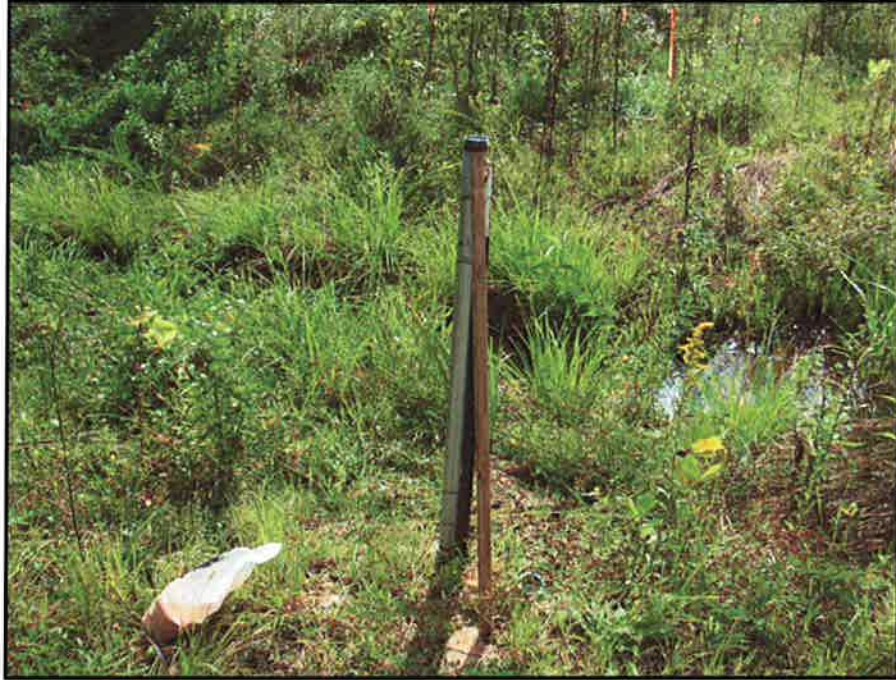
BF 1
Crest Gage at XS-6 on UT.
(EMH&T, Inc. 9/21/09)

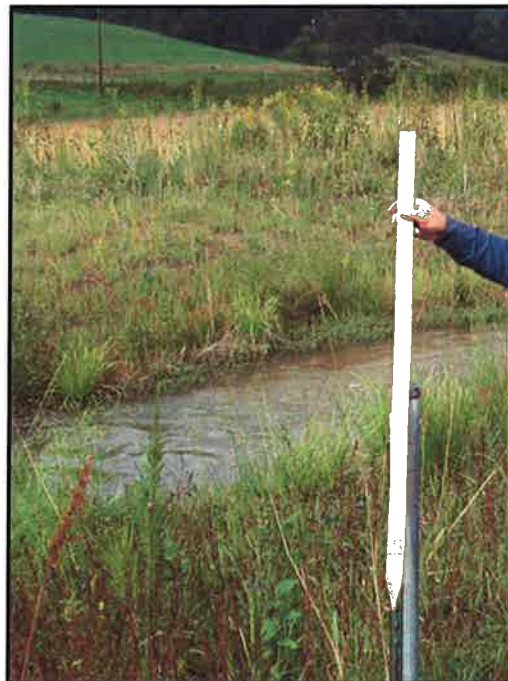
BF 2
Crest Gage at XS-7 on Mainstem.
(EMH&T, Inc. 9/21/09)
