Subject: Year 2 Monitoring Report for Stream Mitigation of Thompsons Fork
SCO# D06030-A

Year 2 Monitoring Report for Stream Restoration of Thompsons Fork and Unnamed Tributary

McDowell County, NC
SCO # D06030-A

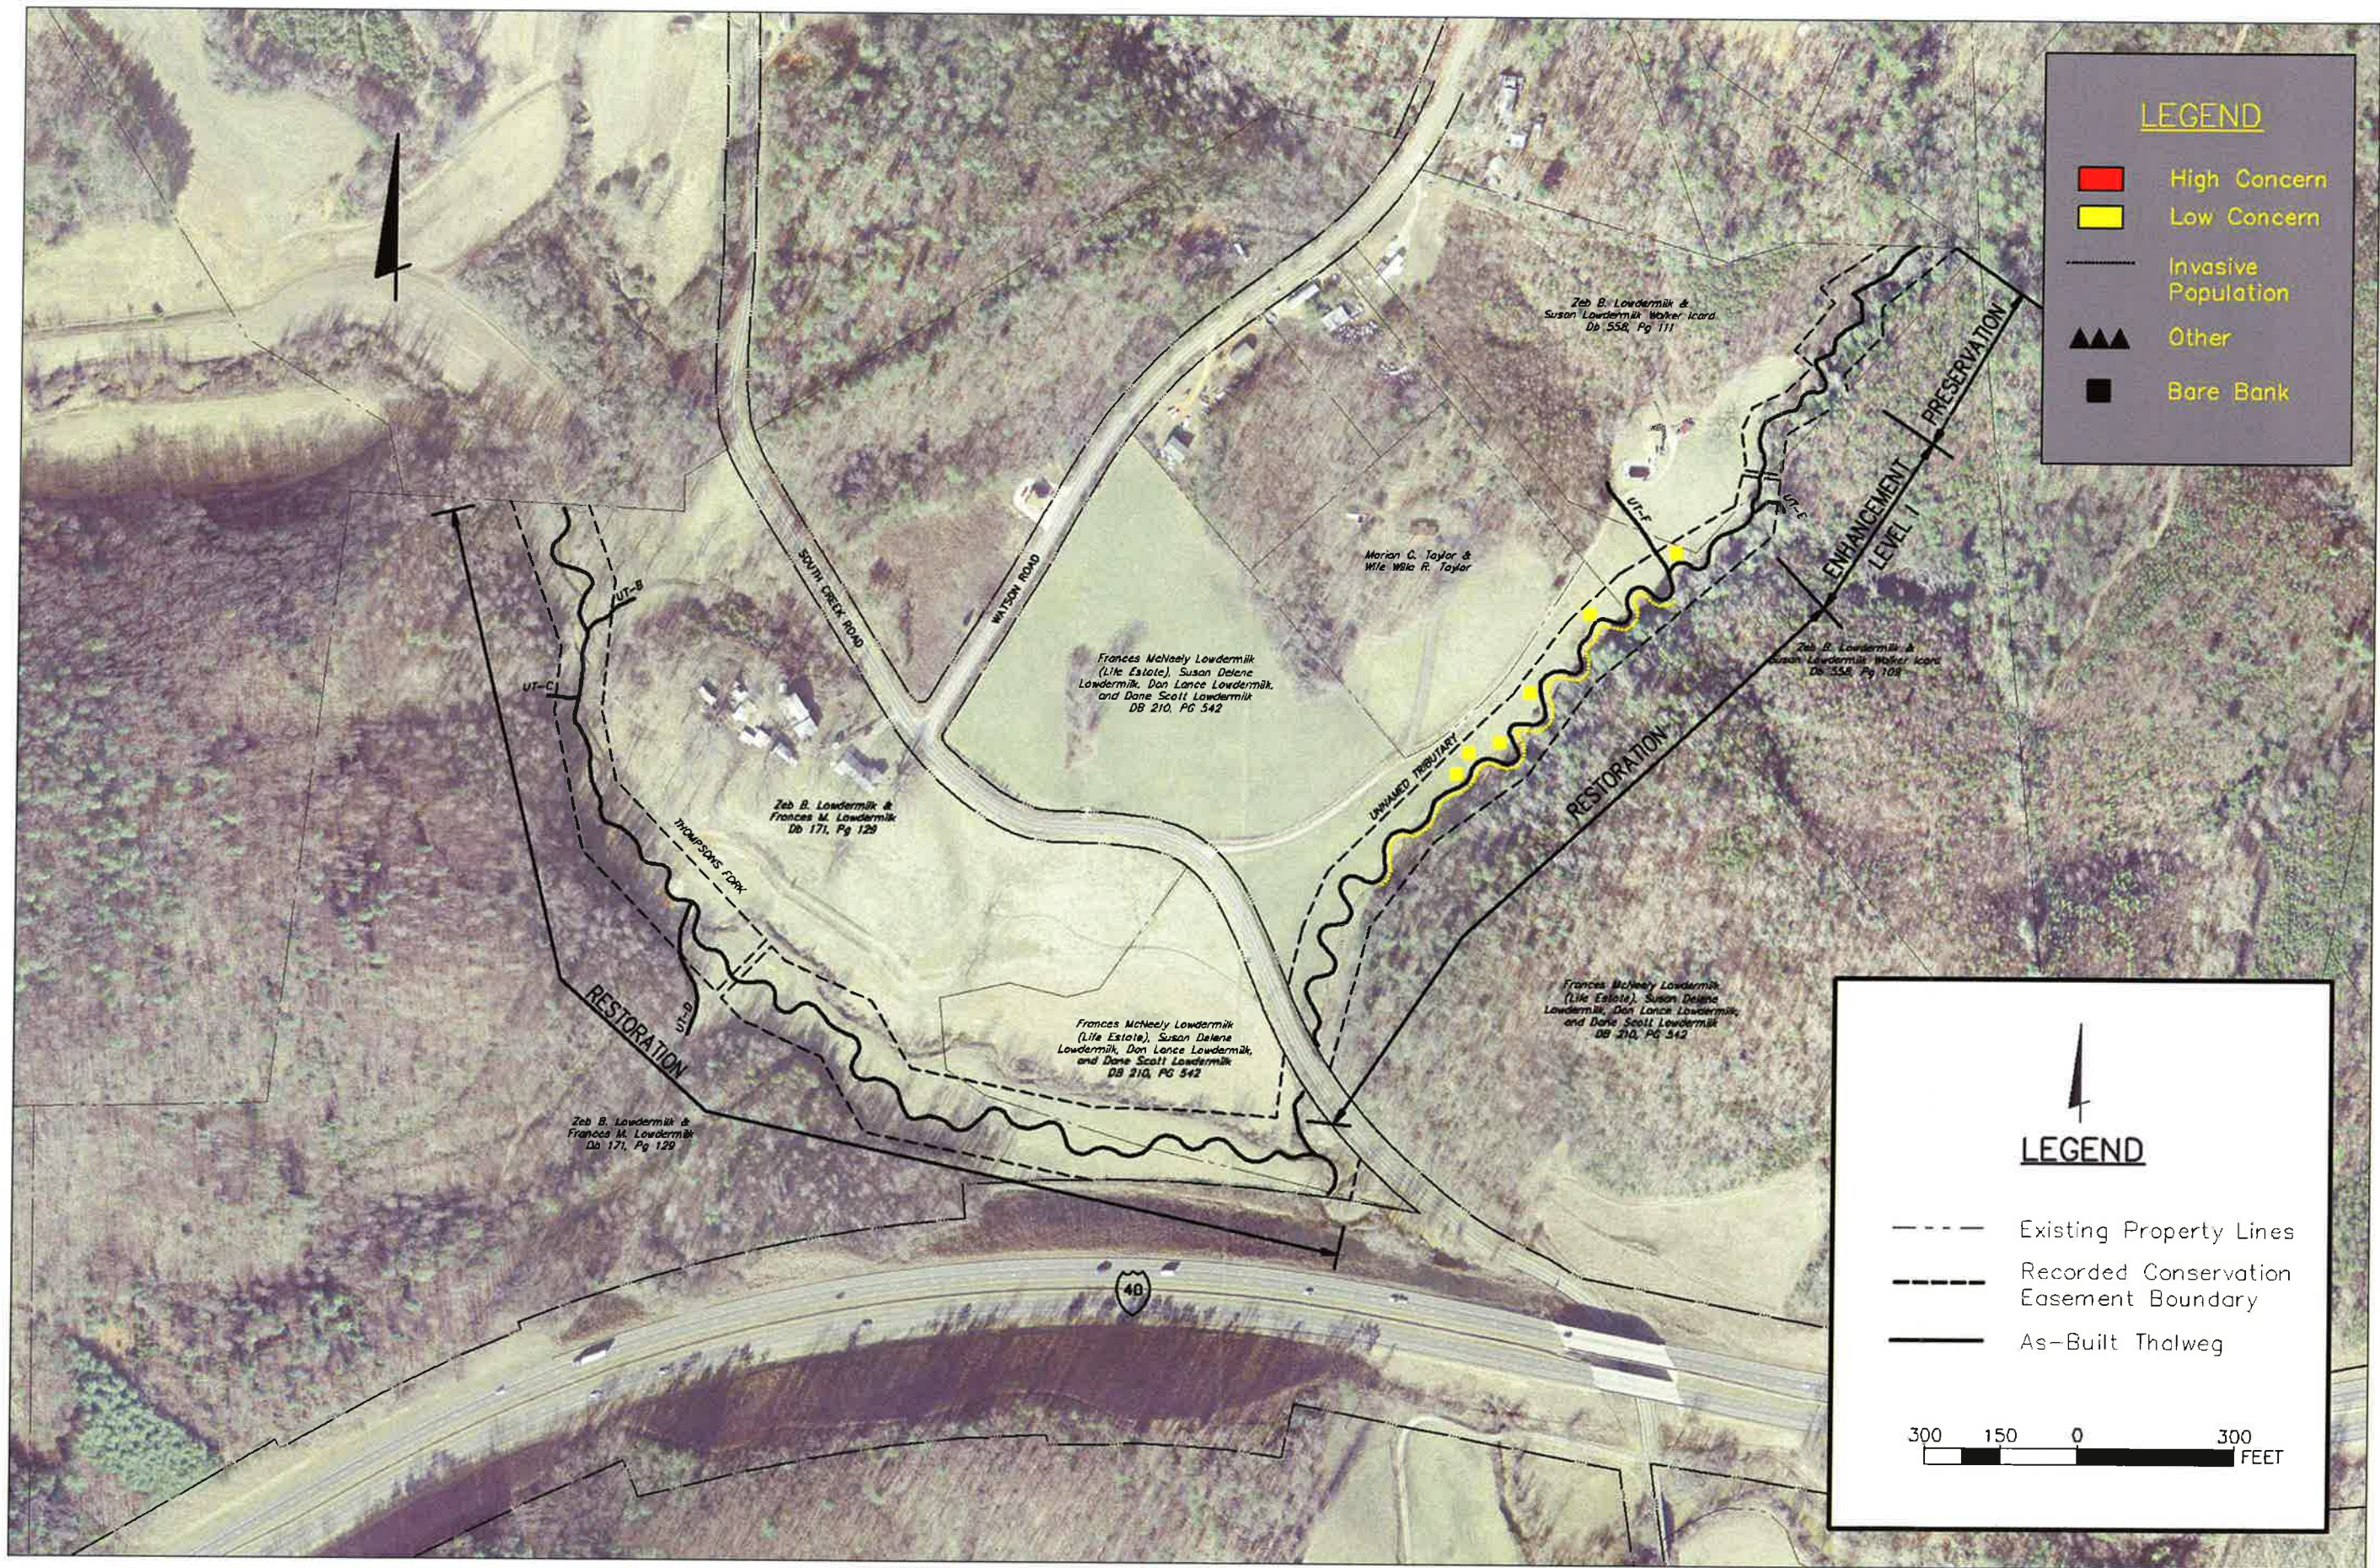
of the patchy vegetation along the right bank of UT1. This is only considered a problem due to the threat of spread by invasives in the same area of the project.

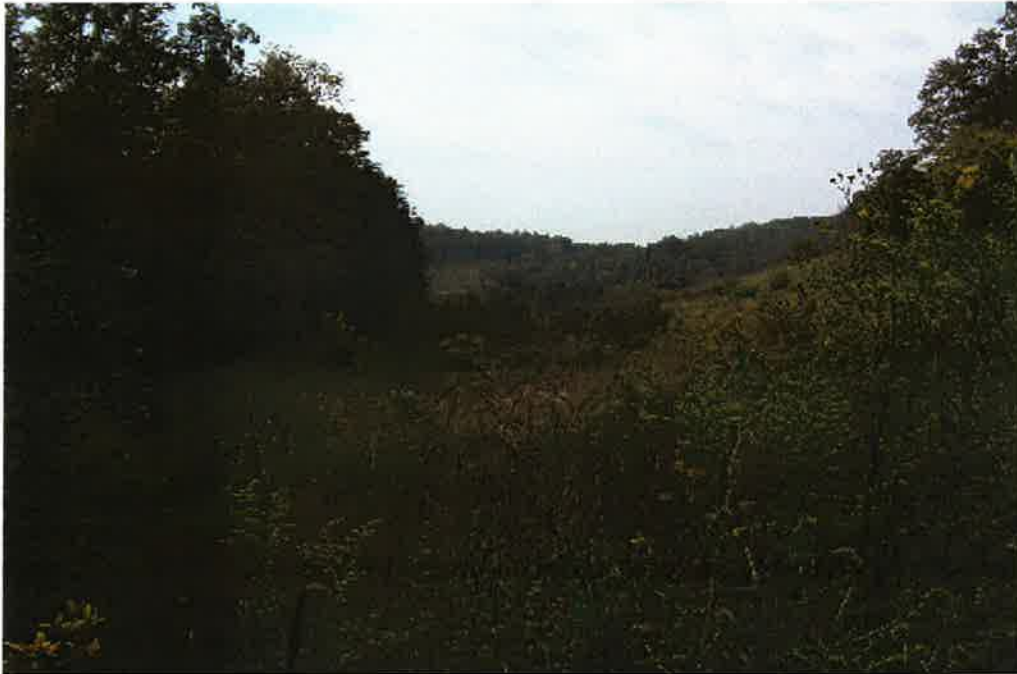
Fixed Station 1

Overview of valley along UT1 near the upstream terminus of the project, approximately Station 4+00, facing downstream.

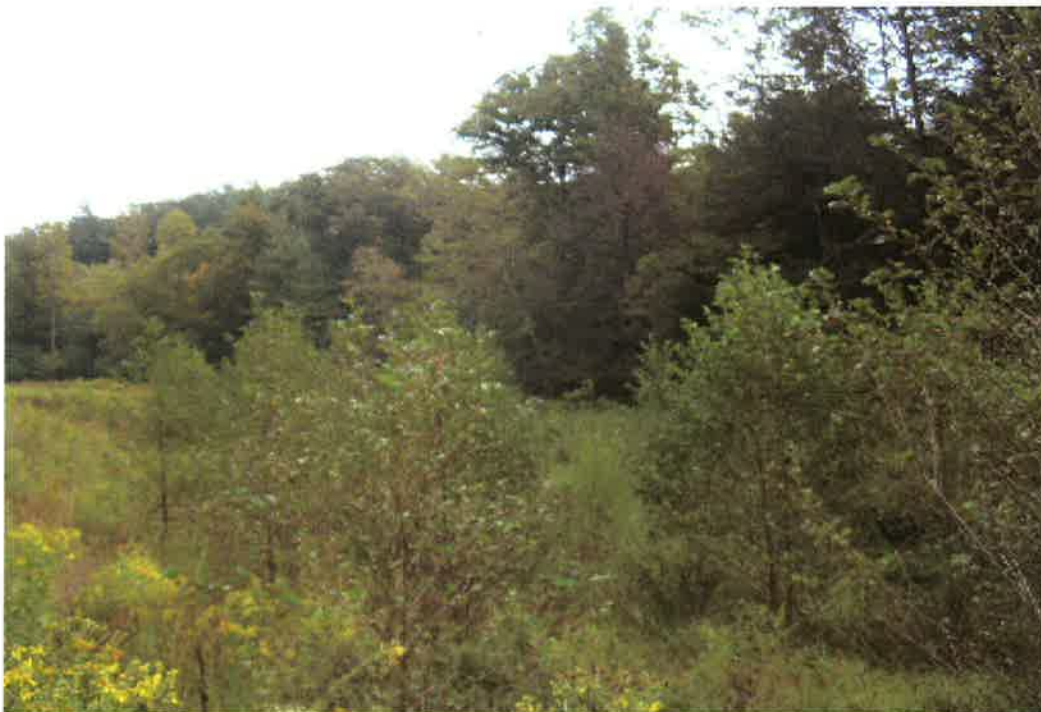
Fixed Station 2

Overview of valley along UT1 near the midpoint of the project, approximately Station 10+75, facing upstream.

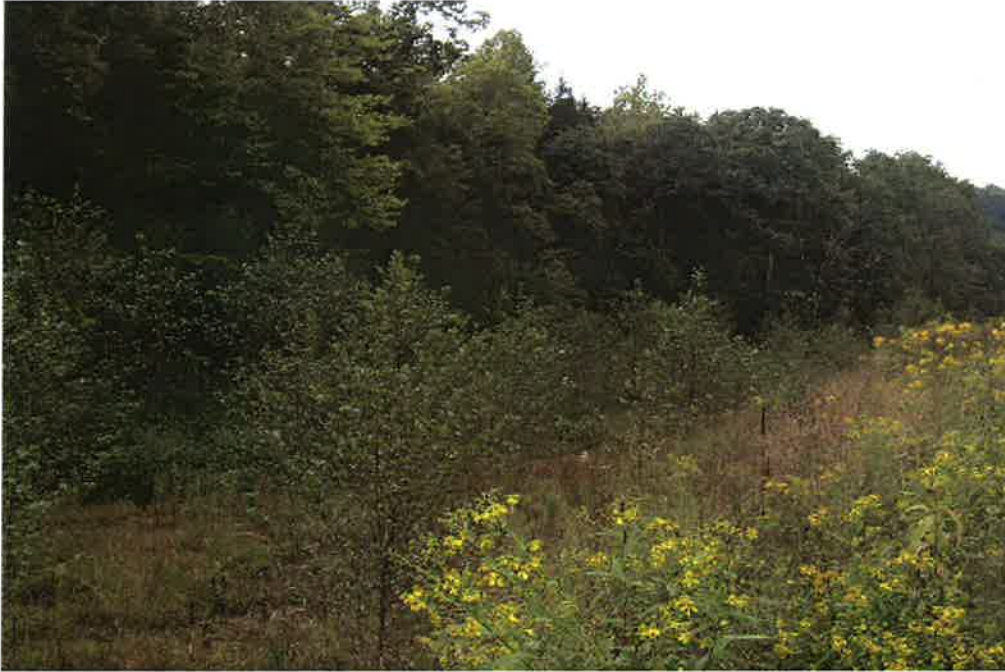
Fixed Station 3
Overview of valley along UT1 near the midpoint of the project, approximately Station 10+75, facing downstream.
(EMH&T, Inc. 9/18/10)

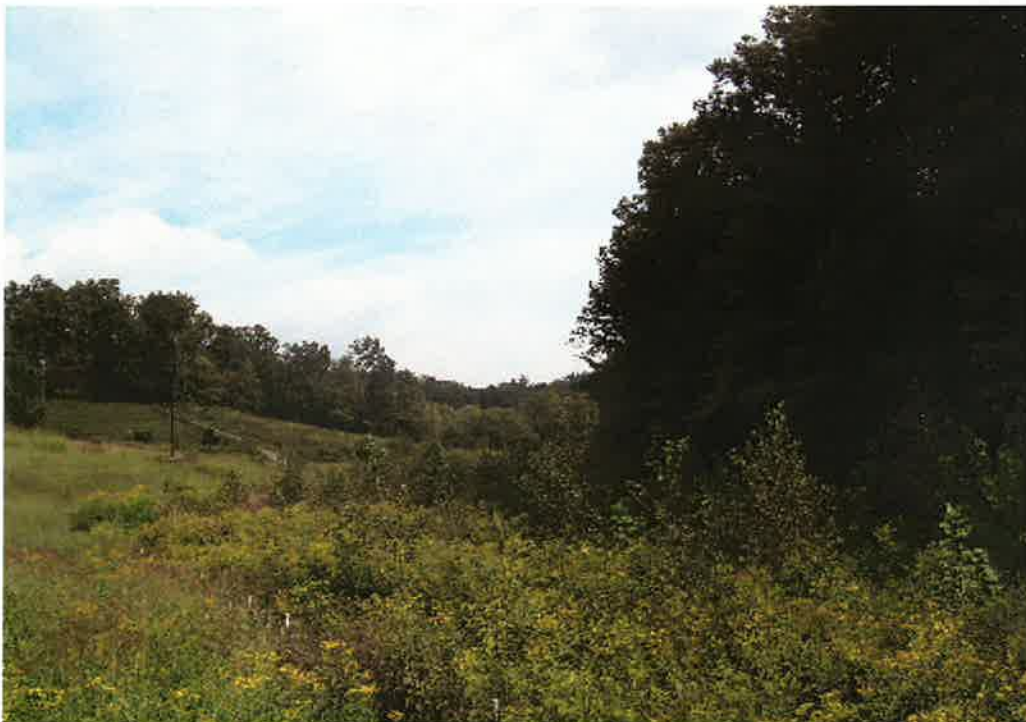
Fixed Station 4
Overview of valley along UT1 near the downstream terminus of the project, just north of South Creek Road, facing upstream.
(EMH&T, Inc. 9/18/10)

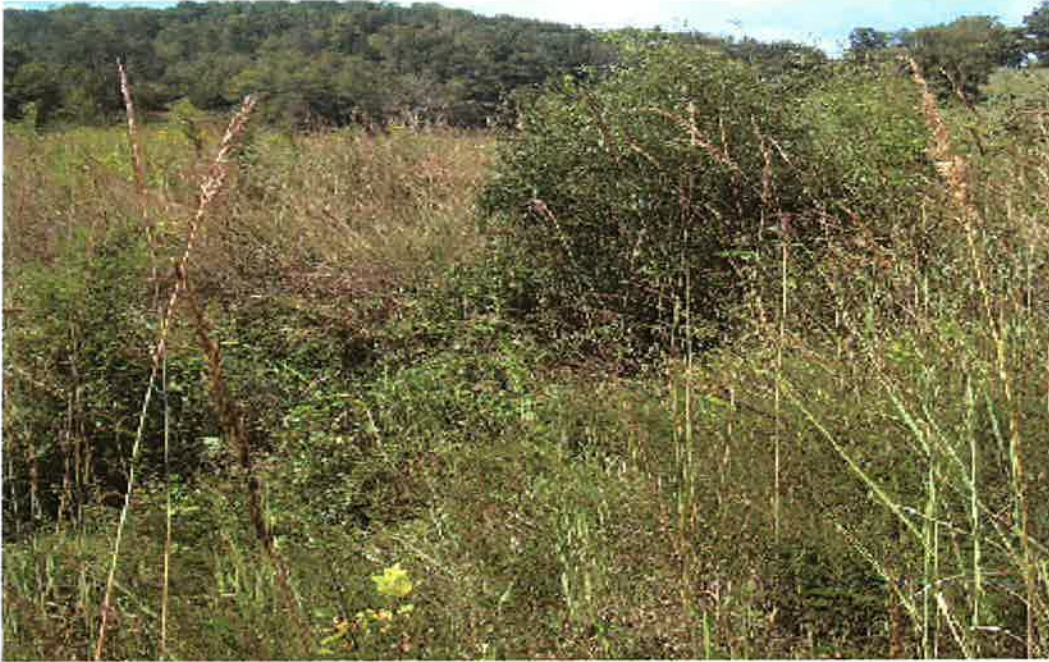
Fixed Station 5

**Overview of valley along UT1 at the downstream terminus of the project, facing upstream.
(EMH&T, Inc. 9/18/10)**

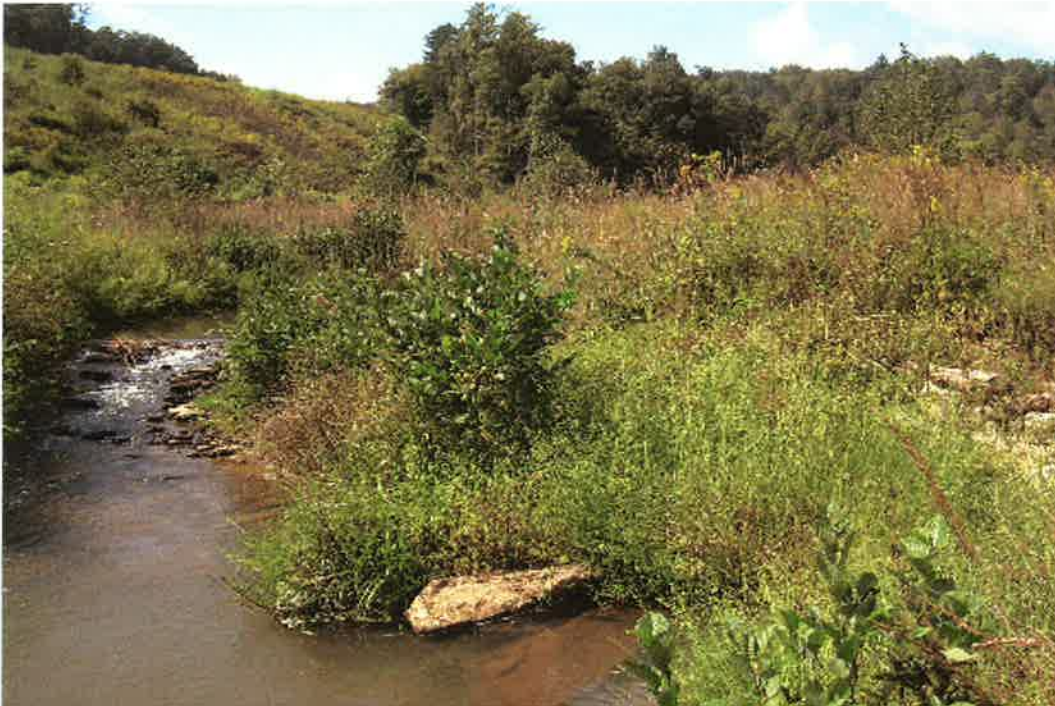
Fixed Station 6

**Overview of valley along the mainstem near the downstream terminus of the project, facing
upstream.
(EMH&T, Inc. 9/18/10)**

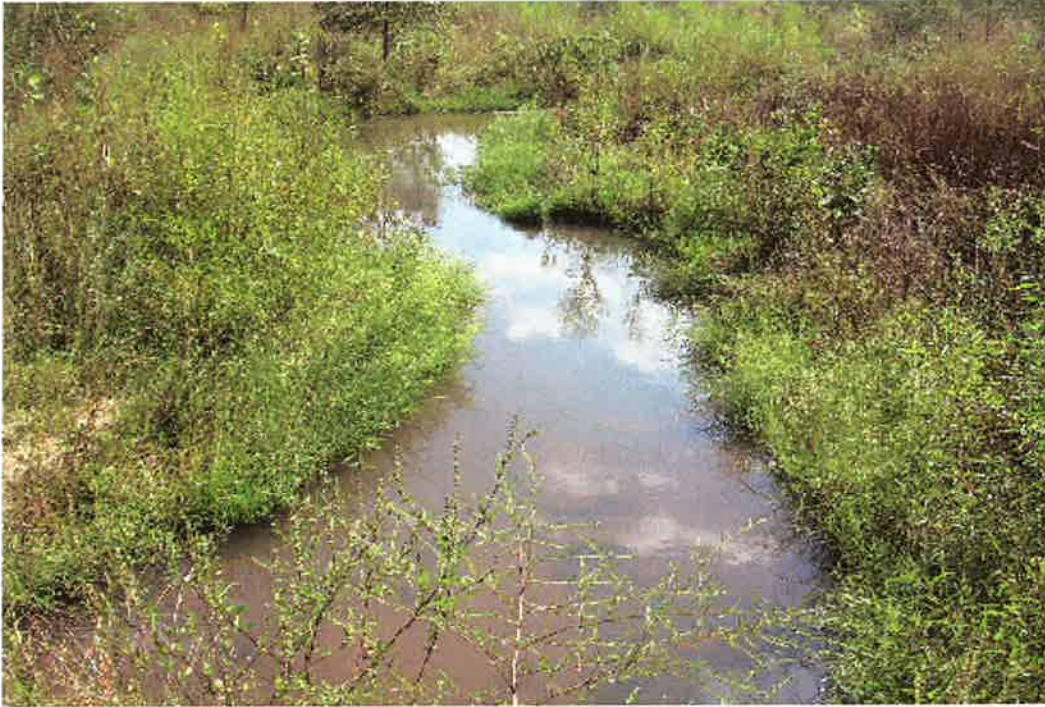
Fixed Station 7

Overview of valley along the mainstem near the midpoint of the project, approximately Station 12+00, facing downstream.

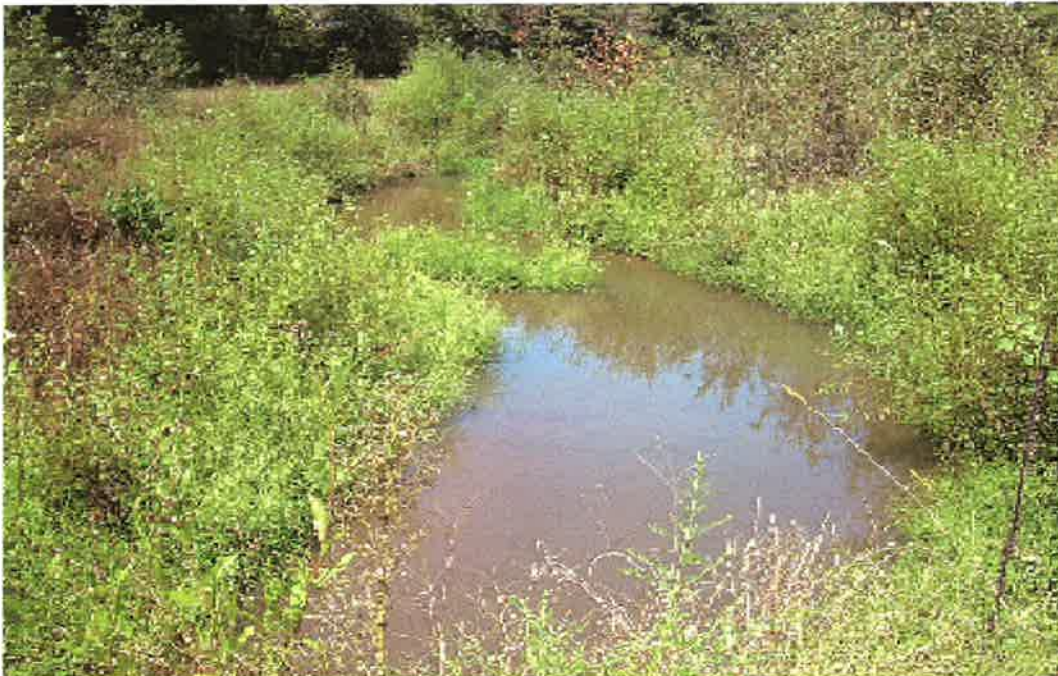
Fixed Station 8

Overview of valley along the mainstem near the midpoint of the project, approximately Station 11+50, facing upstream.

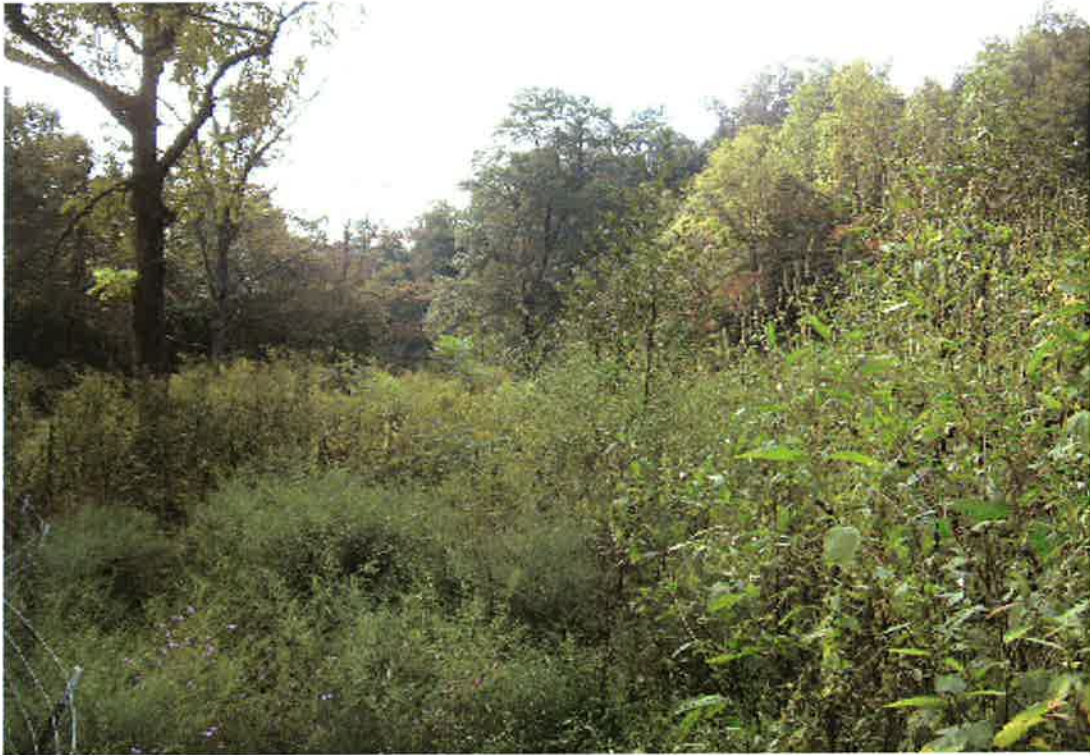
Fixed Station 9
Overview of valley along the mainstem near the upstream terminus of the project, facing
downstream.
(EMH&T, Inc. 9/18/10)

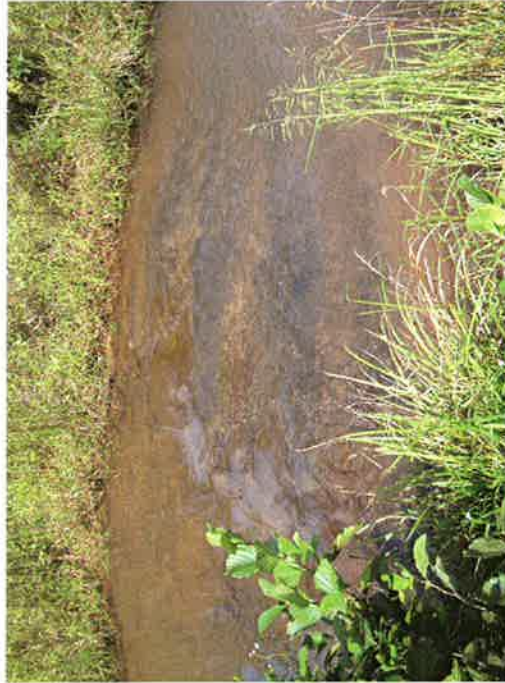
CROSS SECTION: 7

Cross-section photo – looking from right to left bank

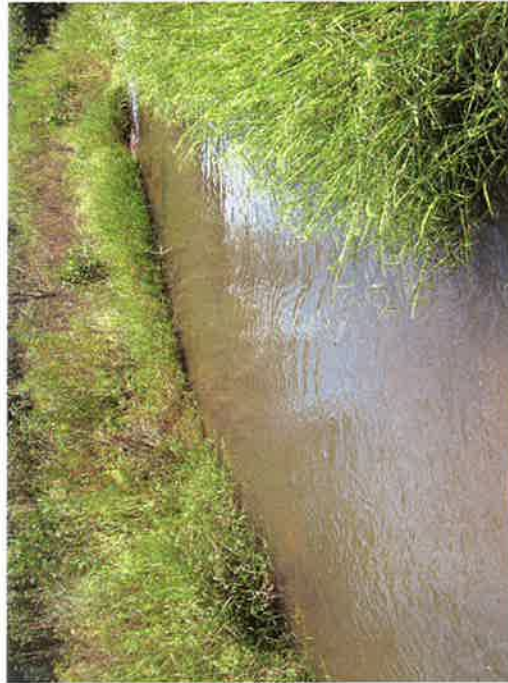
CROSS SECTION: 8

Cross-section photo – looking upstream

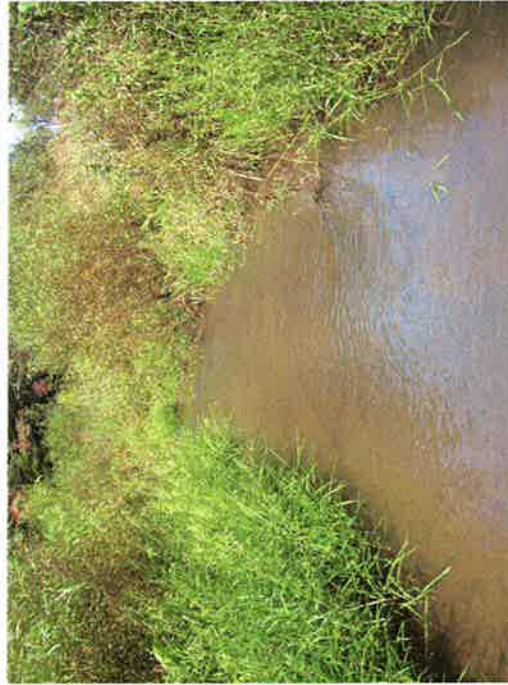
CROSS SECTION: 9
FEATURE: Riffle

Cross-section photo – looking upstream

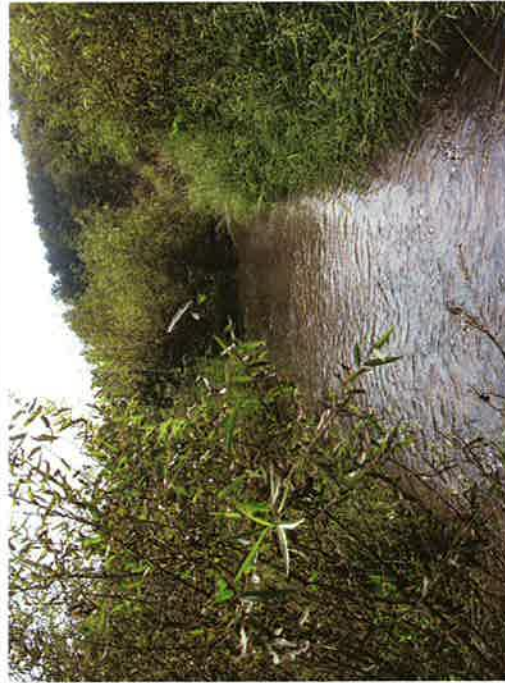
CROSS SECTION: 10

Cross-section photo – looking downstream
