Subject: Year 2 Monitoring Report for Stream Mitigation of Thompsons Fork
SCO# D06030-A

Year 2 Monitoring Report for Stream Restoration of Thompsons Fork and Unnamed Tributary

McDowell County, NC
SCO # D06030-A

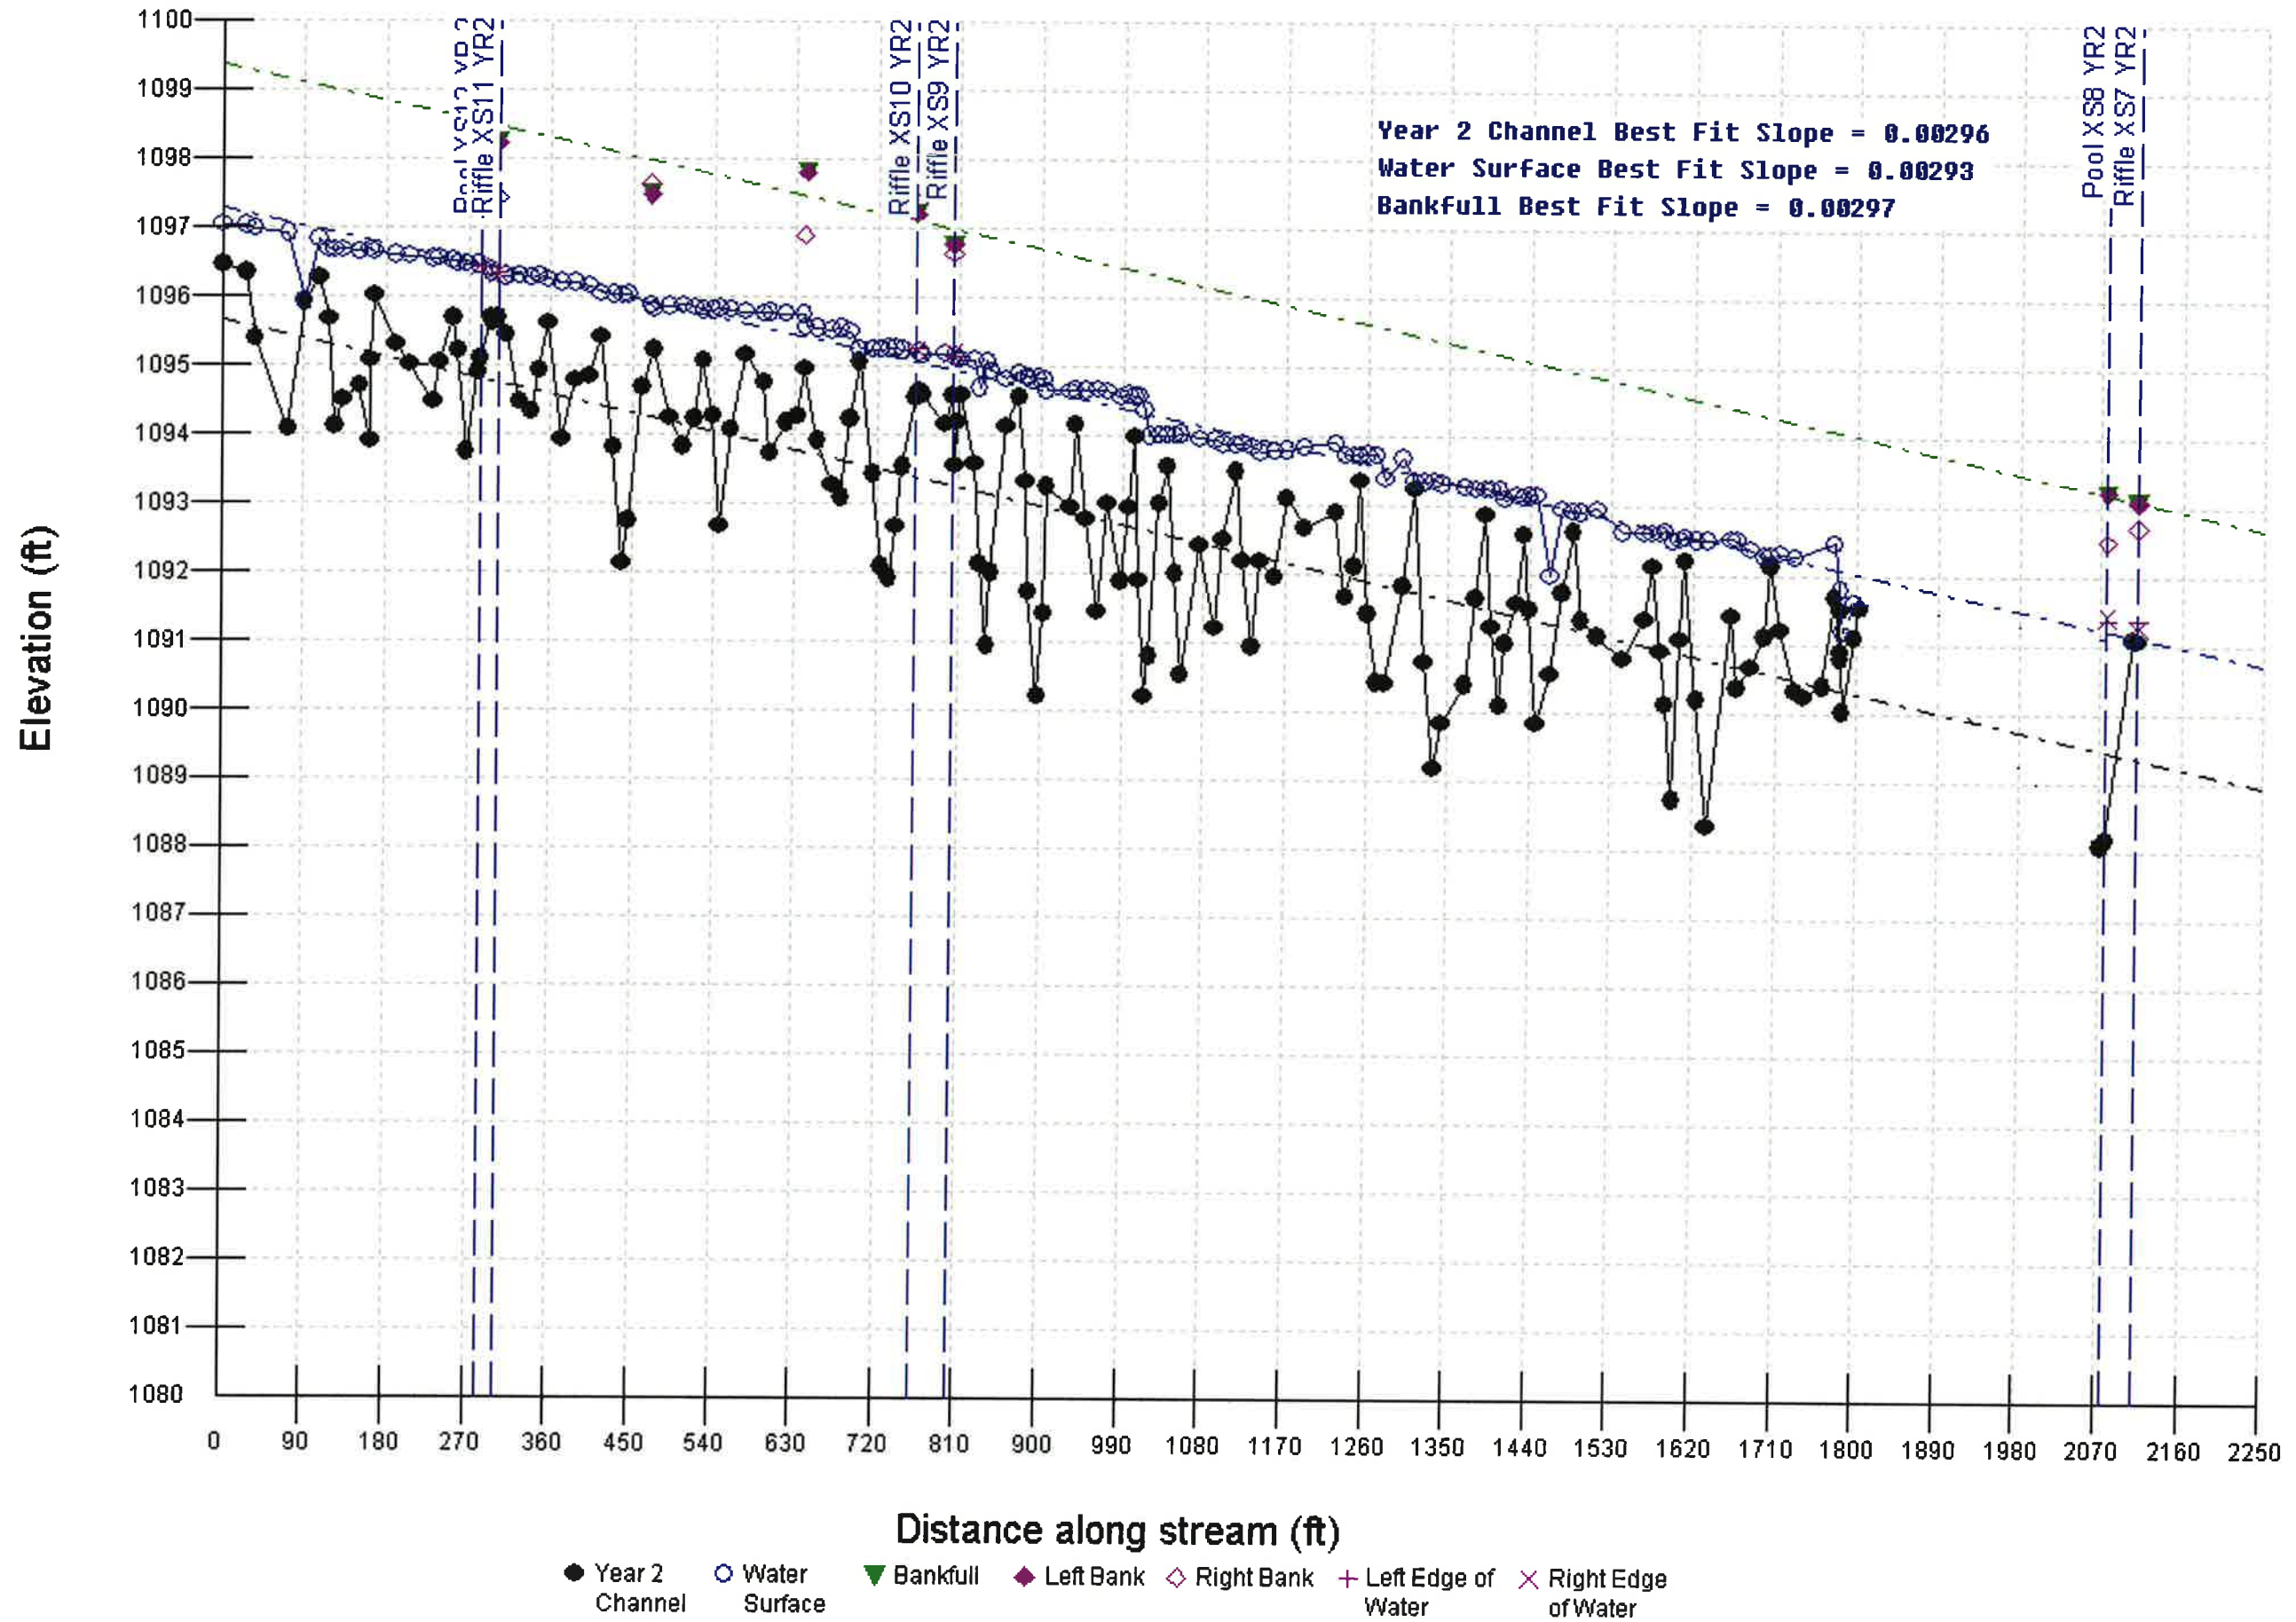
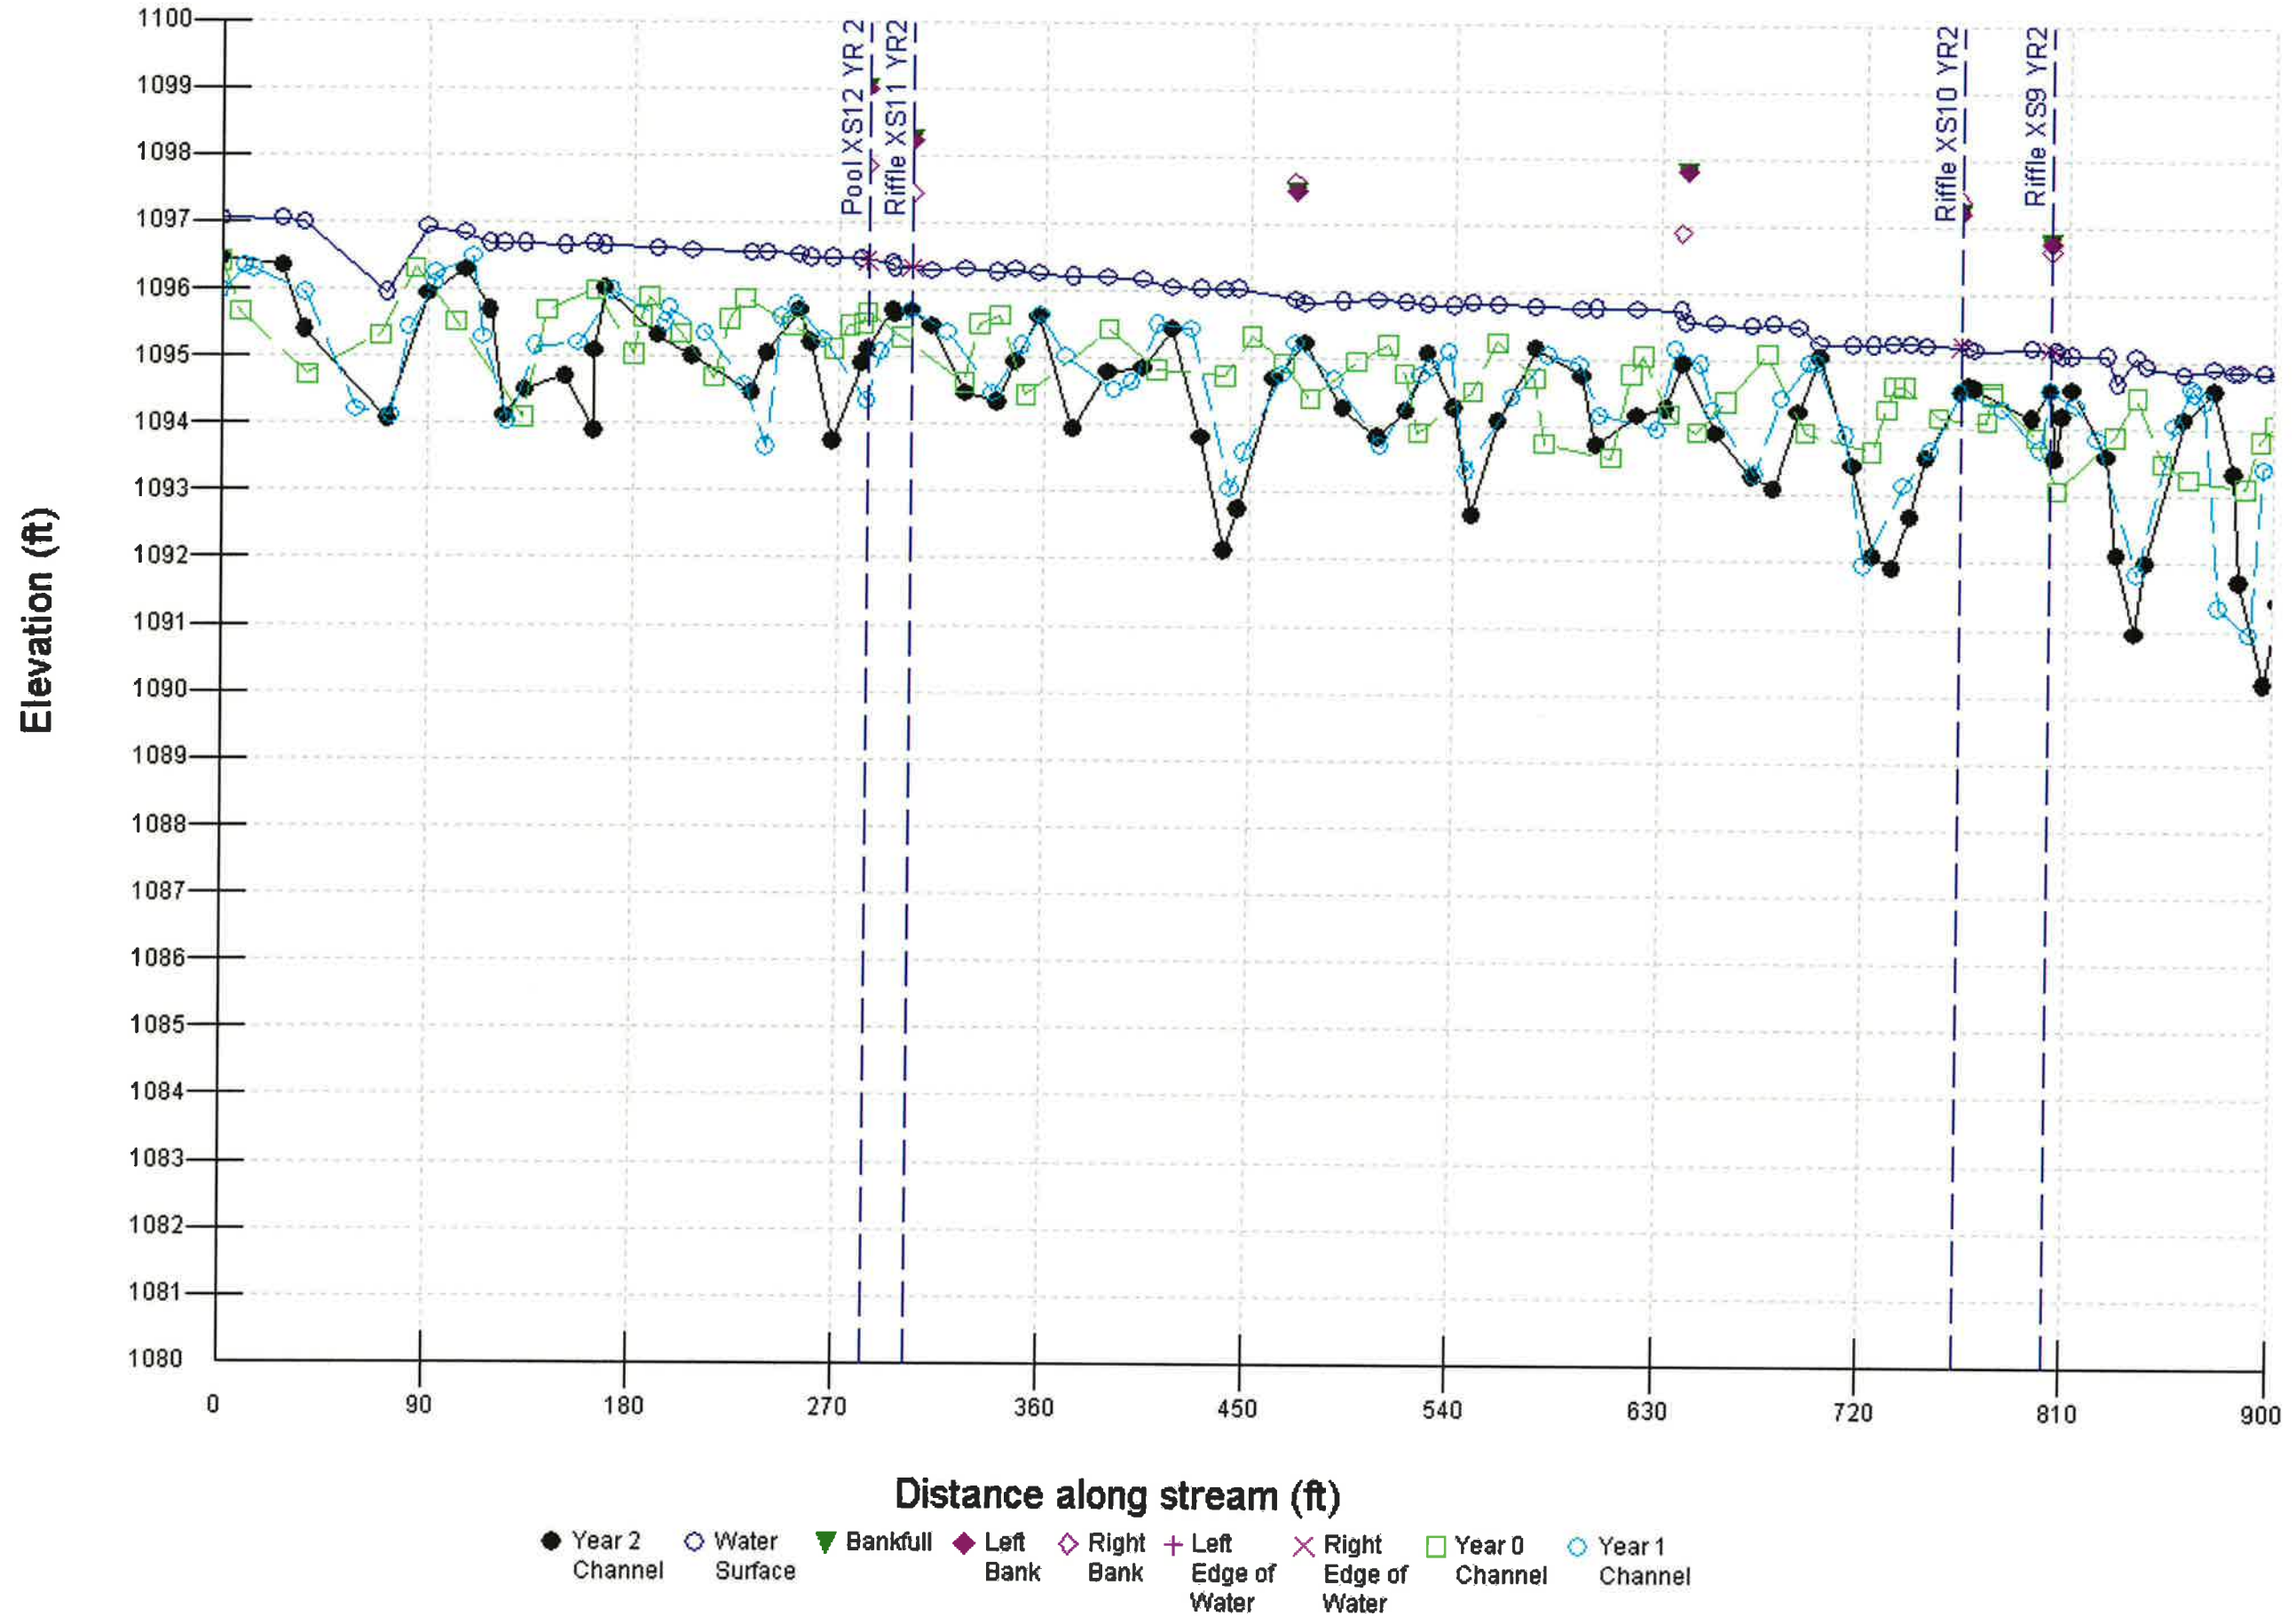
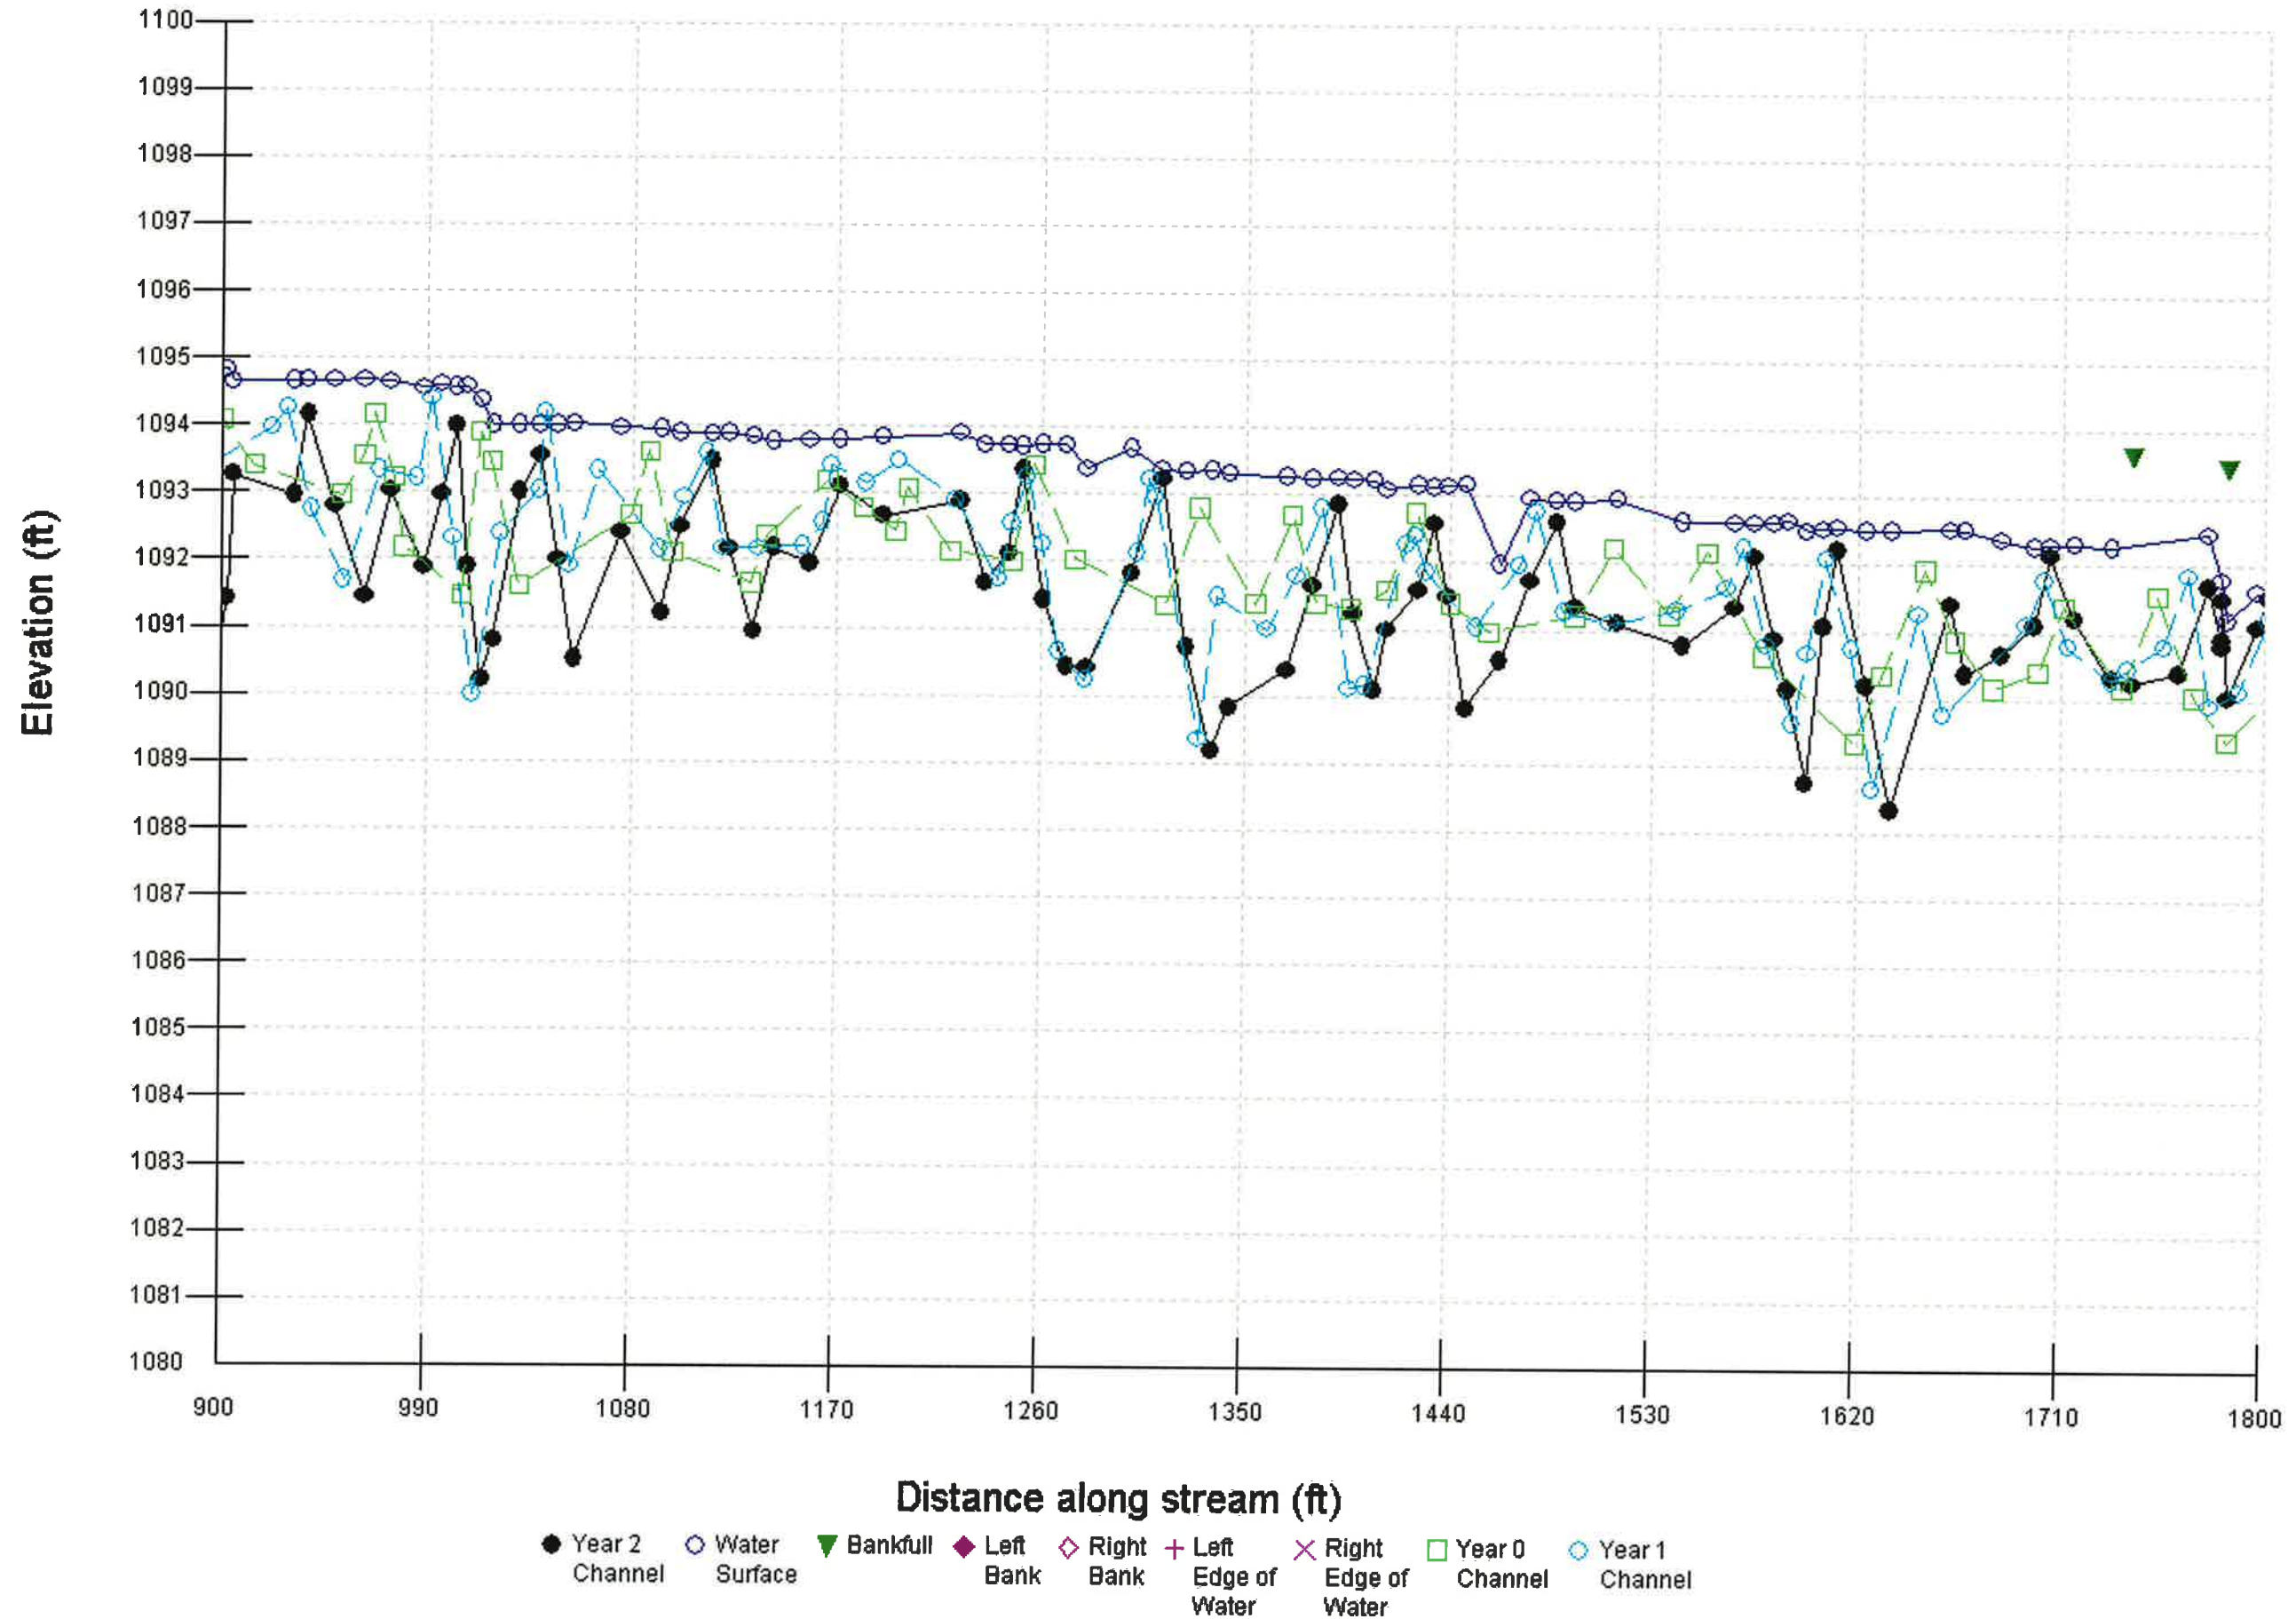
Thompsons Fork Mainstem Longitudinal Profile - Year 2 (May 12, 2010)

Bedform features continue to evolve along the restored reaches as shown on the long-term longitudinal profiles. Dimensional measurements of the monumented cross-sections from year 2 remain generally stable when compared to as-built conditions. The comparison of the As-Built and Year 1 long-term stream monitoring profile data with Year 2 data shows stability with minimal change from as-built conditions. RiverMorph uses the shortest straight line distance between the consecutive survey points to create the stationing for the profile. The Year 2 survey represents a slightly smaller number of collected survey points along Thompsons Fork mainstem, which will lead to a lower cumulative length of stream profile, which also affects the locations of each pool and riffle with respect to Years 0 & 1 profiles. In fact, the pool and riffle features remain in the same locations shown on the as-built mitigation plan, with only slight adjustments. As such, we have evaluated stability from the standpoint of comparing features between Years 0,1 and 2 profiles with the understanding of the 'shift' in these features between the profiles.

For the unnamed tributary, riffle lengths and slopes are stable. The median pool to pool spacing for the Mainstem appeared to decrease from the as-built condition in Year 1, but has returned to values closer to the as-built condition in Year 2. For UT-1, the trend of reduced pool to pool spacing has continued from the as-built condition to Year 1, and then Year 1 to Year 2. None of these changes are significant and no signs of channel instability are evident in correlation to these changing values.

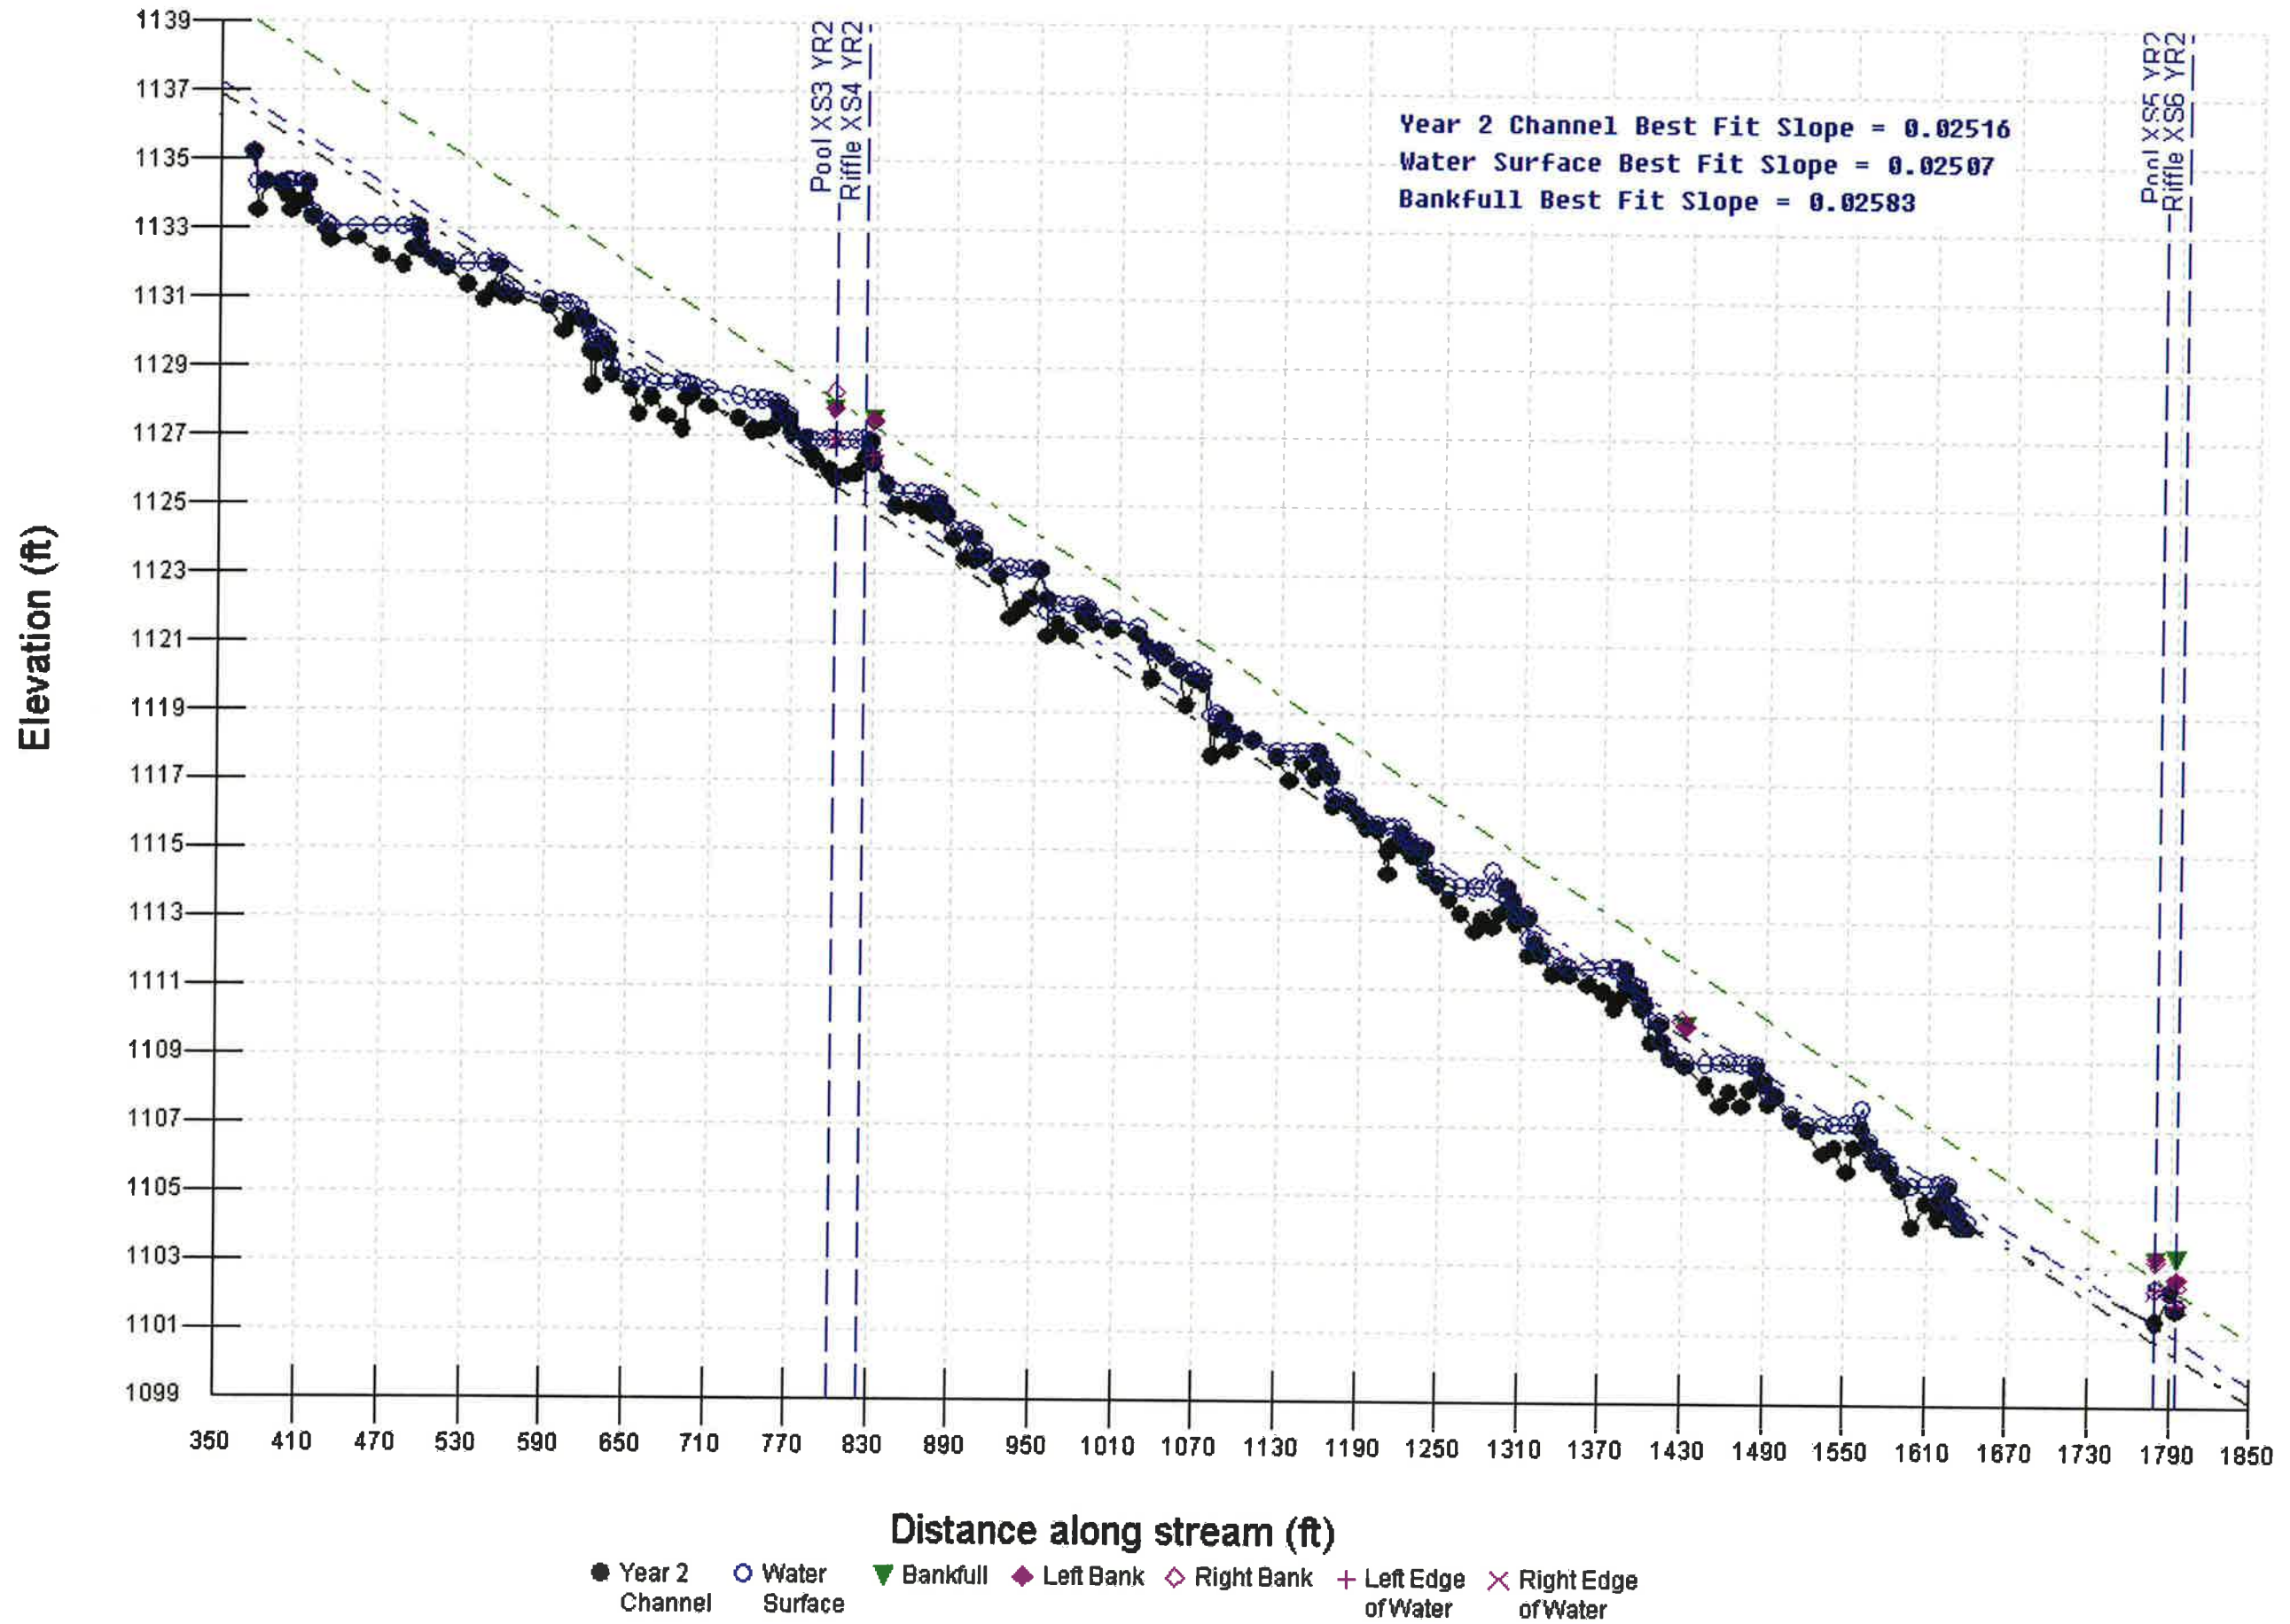
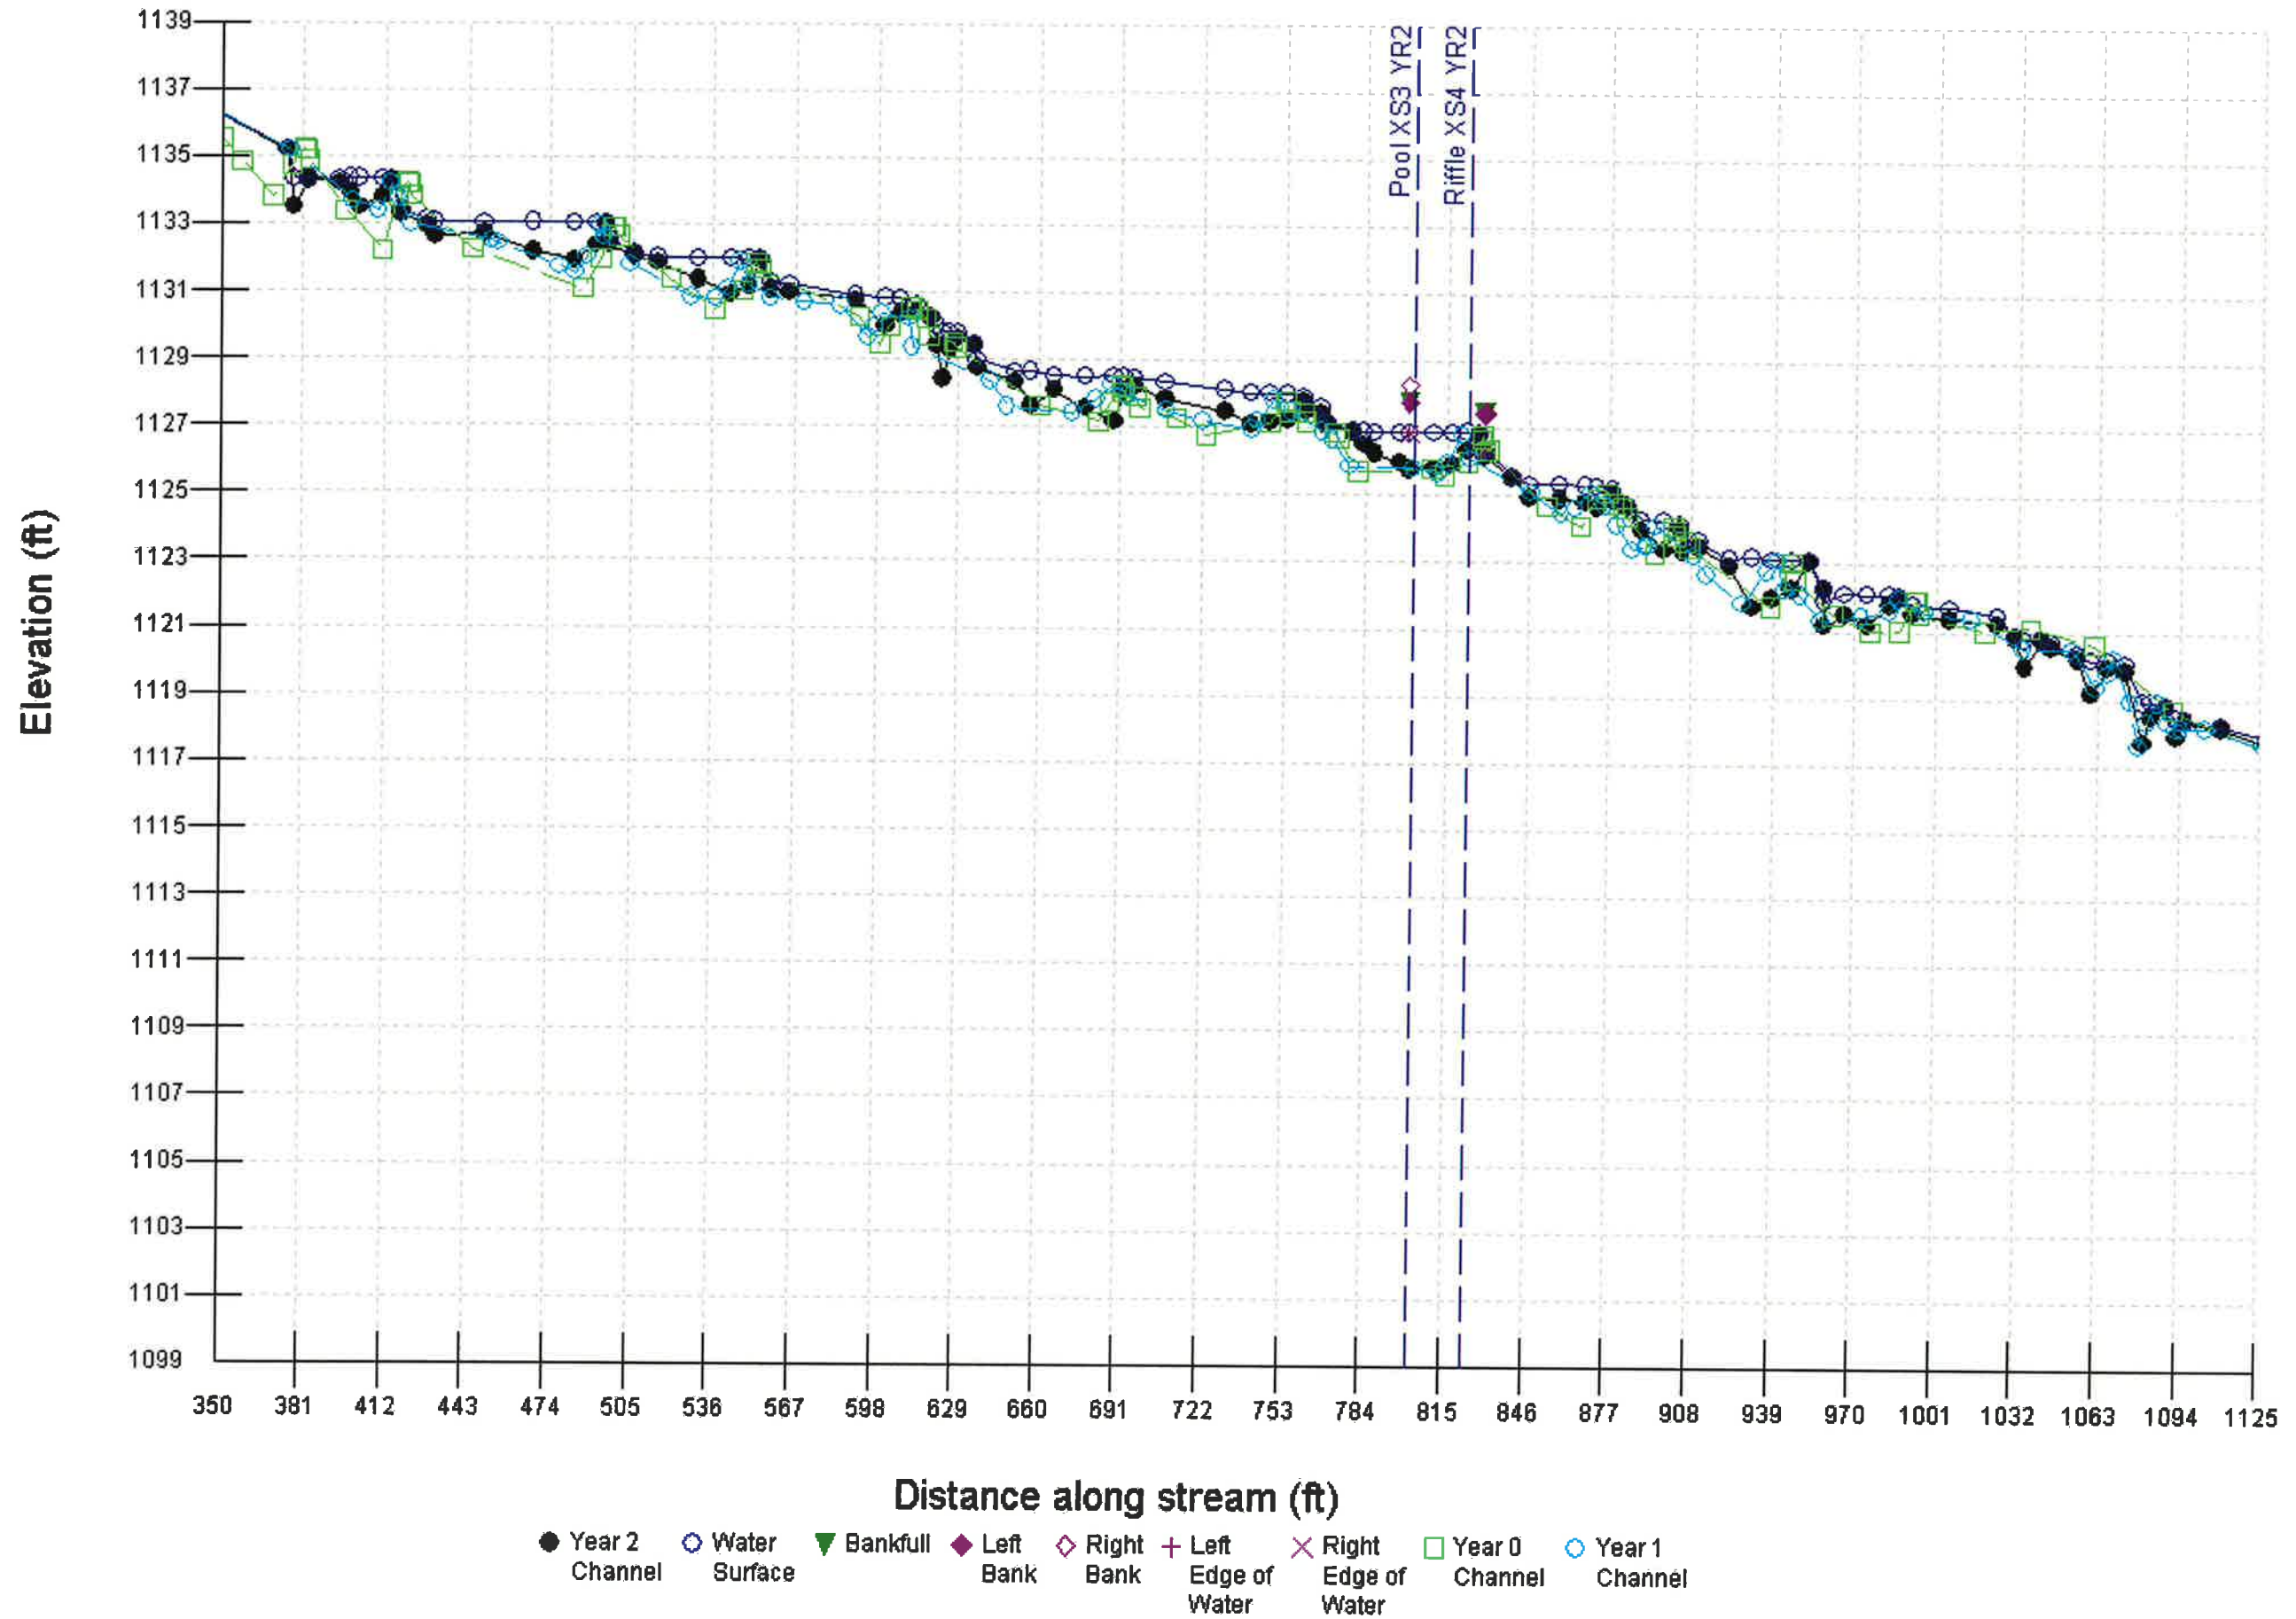
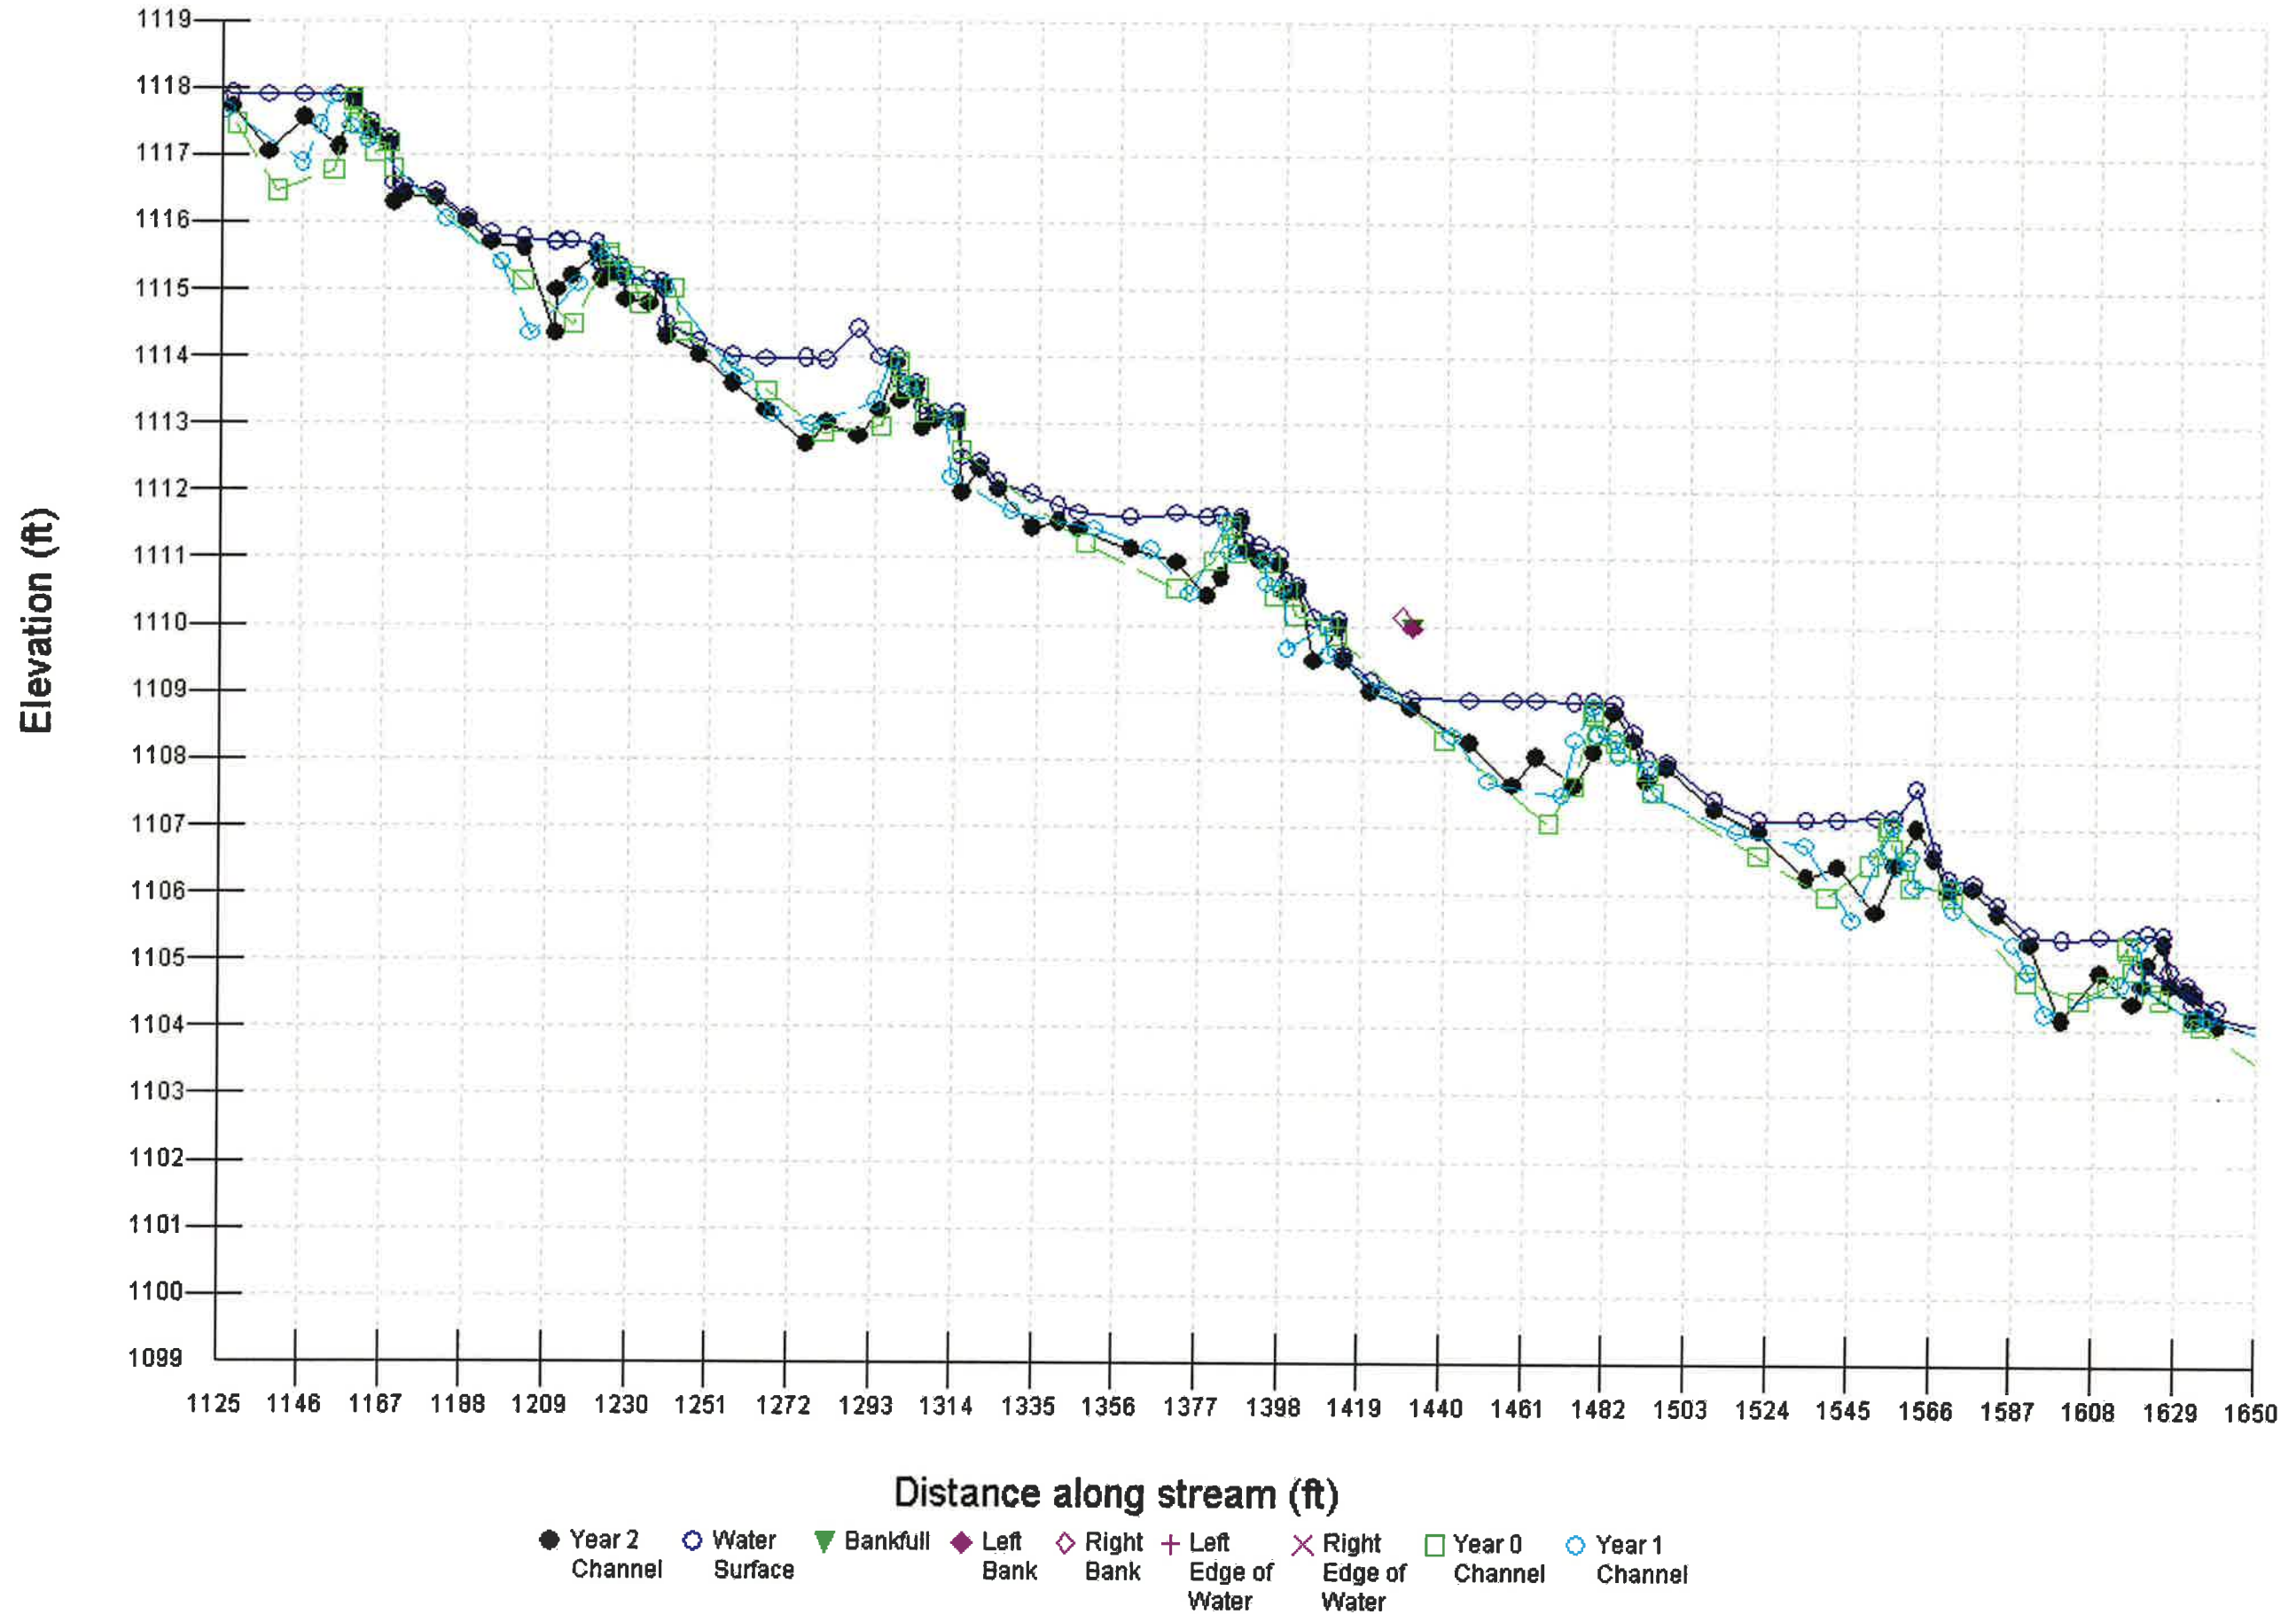
Thompsons Fork - UT1 - Longitudinal Profile - Year 2 (May 12, 2010)

Aggradation is also occurring along the unnamed tributary to Thompsons Fork. Sedimentation has occurred in some of the pools located near the log sills installed for grade control, thus decreasing the maximum pool depth. All pools and associated log sills are still present and functional throughout the stream channel, including those with noted sedimentation. Maintenance activities to be performed over the winter months to remove certain sediment deposits will further improve the performance of the unnamed tributary.
