Subject: Year 2 Monitoring Report for Stream Mitigation of Thompsons Fork
SCO# D06030-A

Year 2 Monitoring Report for Stream Restoration of Thompsons Fork and Unnamed Tributary

McDowell County, NC
SCO # D06030-A

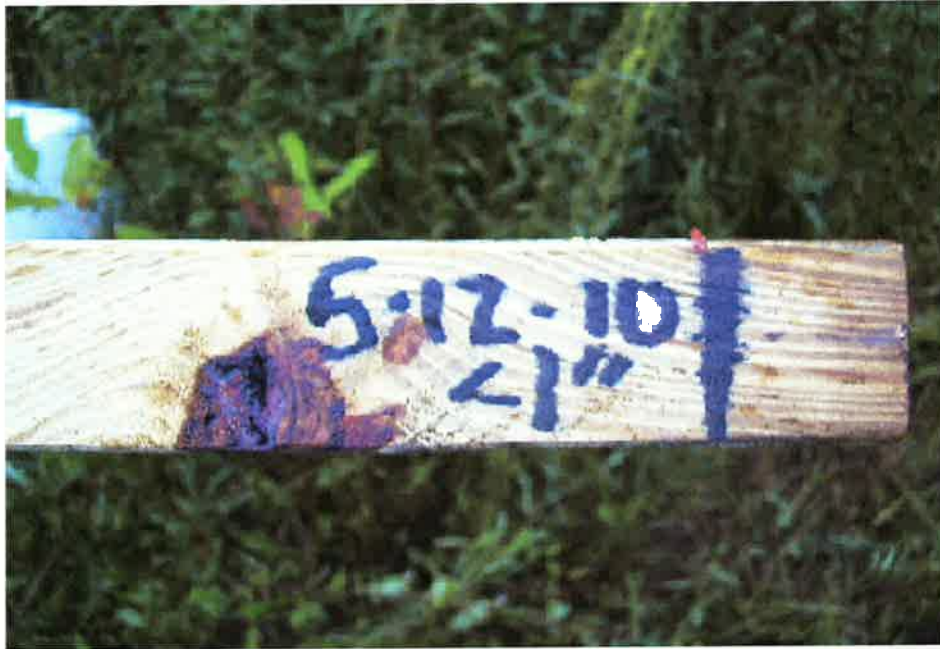
BF 1
Crest Gage at XS-6 on UT.
(EMH&T, Inc. 5/12/10)

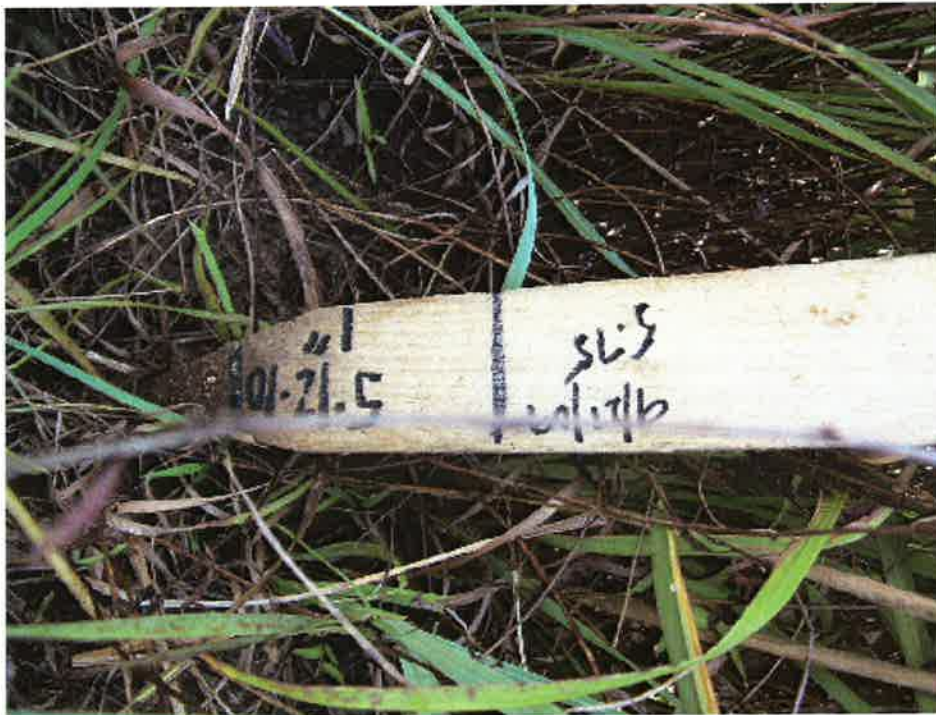
BF 2
Crest Gage at XS-7 on Mainstem.
(EMH&T, Inc. 5/12/10)
