Year 3 Monitoring Report for Stream Restoration of Thompsons Fork and Unnamed Tributary

McDowell County, NC
SCO # D06030-A

Submitted: December, 2011

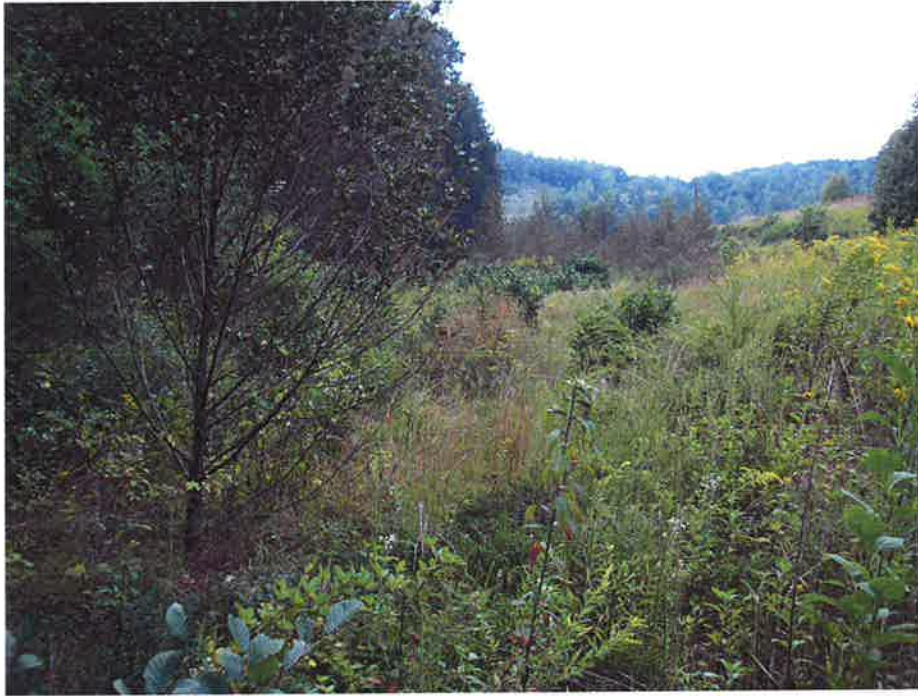
Fixed Station 1
Overview of valley along UT1 near the upstream terminus of the project, approximately Station 4+00, facing downstream.
(EMH&T, 9/15/11)

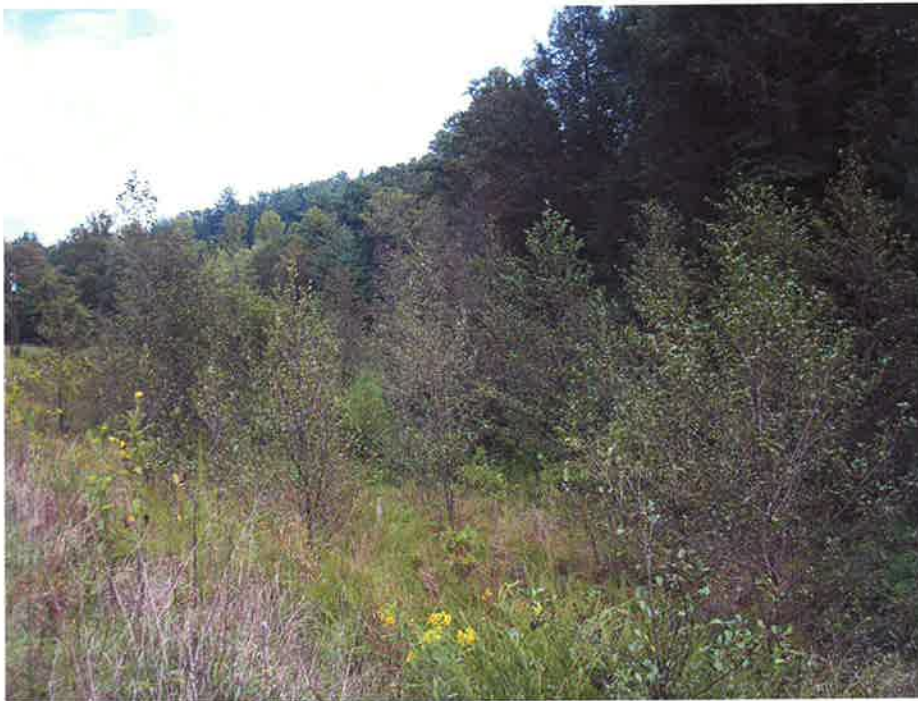
Fixed Station 2
Overview of valley along UT1 near the midpoint of the project, approximately Station 10+75, facing upstream.
(EMH&T, 9/15/11)

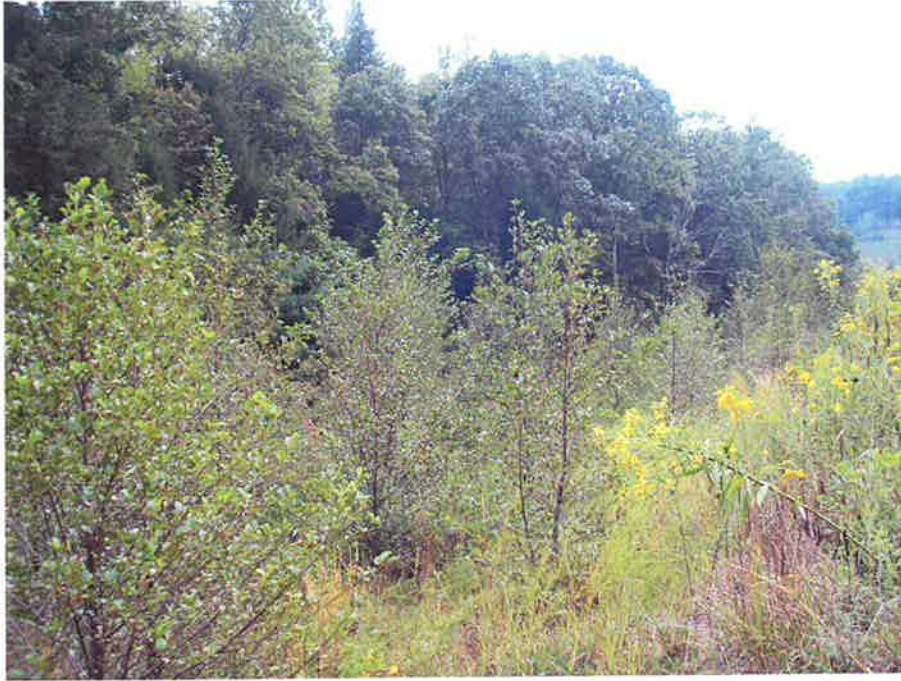
Fixed Station 3
Overview of valley along UT1 near the midpoint of the project, approximately Station 10+75, facing downstream.
(EMH&T, 9/15/11)

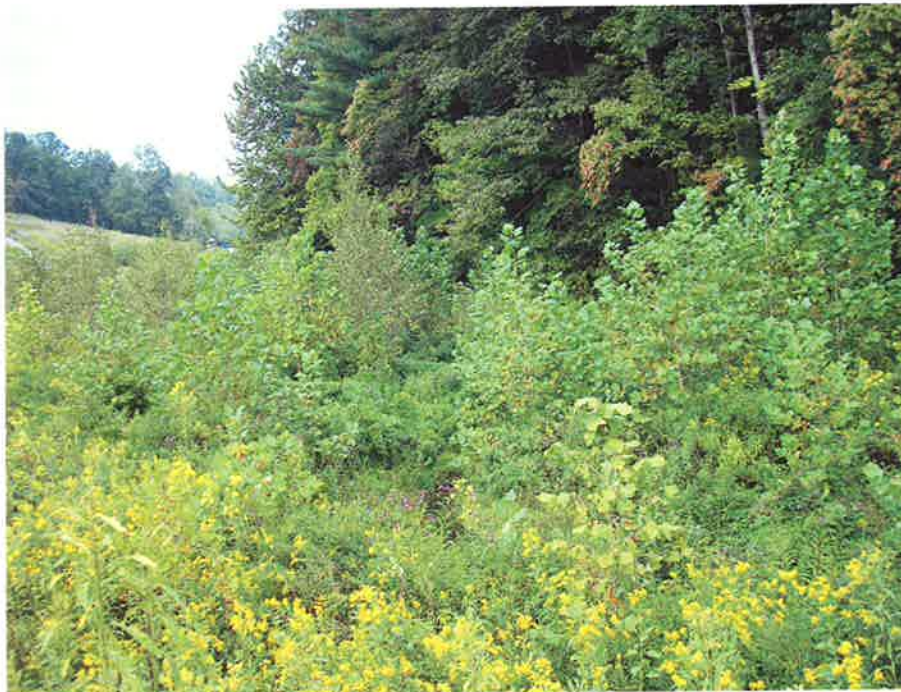
Fixed Station 4
Overview of valley along UT1 near the downstream terminus of the project, just north of South Creek Road, facing upstream.
(EMH&T, 9/15/11)

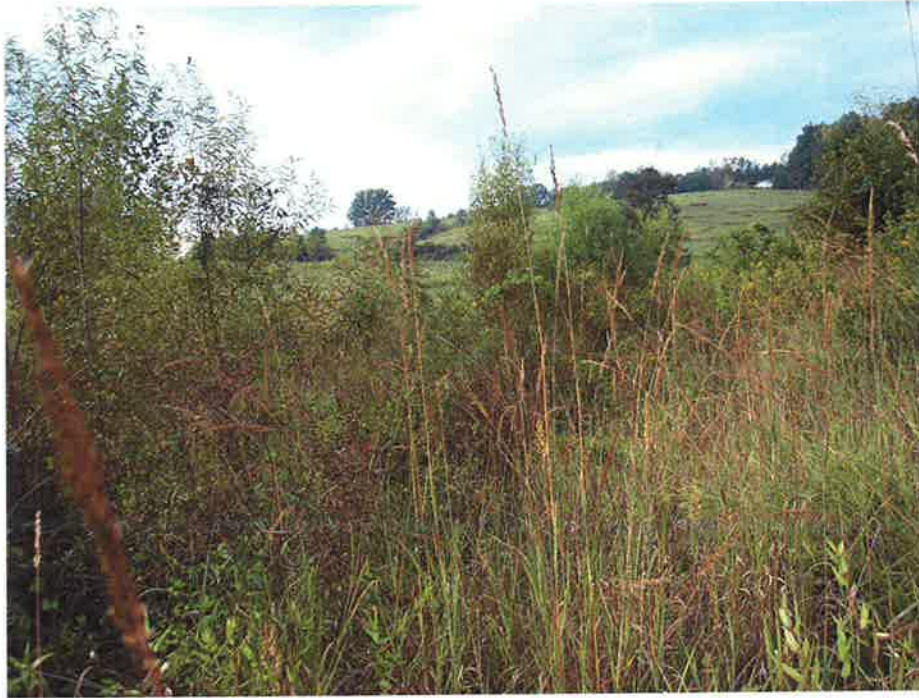
Fixed Station 5
Overview of valley along UT1 at the downstream terminus of the project, facing upstream.
(EMH&T, 9/15/11)

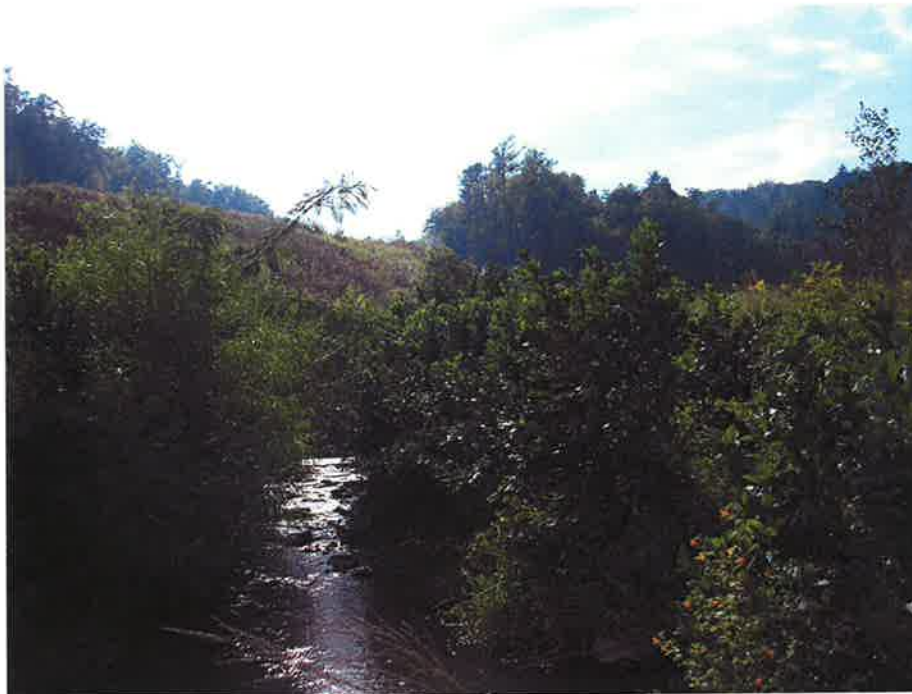
Fixed Station 6
Overview of valley along the mainstem near the downstream terminus of the project, facing upstream.
(EMH&T, 9/15/11)

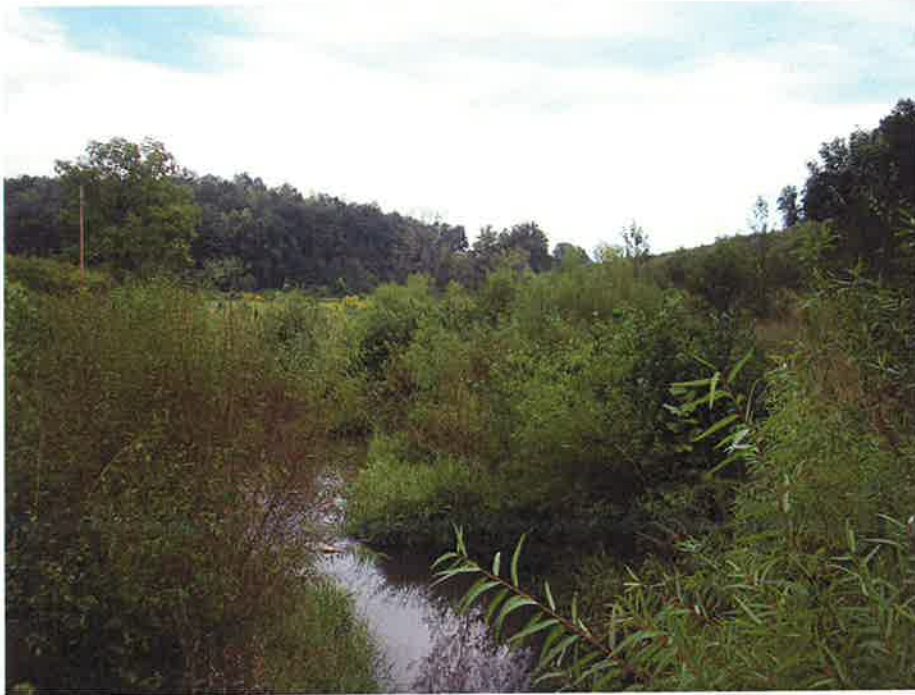
Fixed Station 7

Overview of valley along the mainstem near the midpoint of the project, approximately Station 12+00, facing downstream.
(EMH&T, 9/15/11)

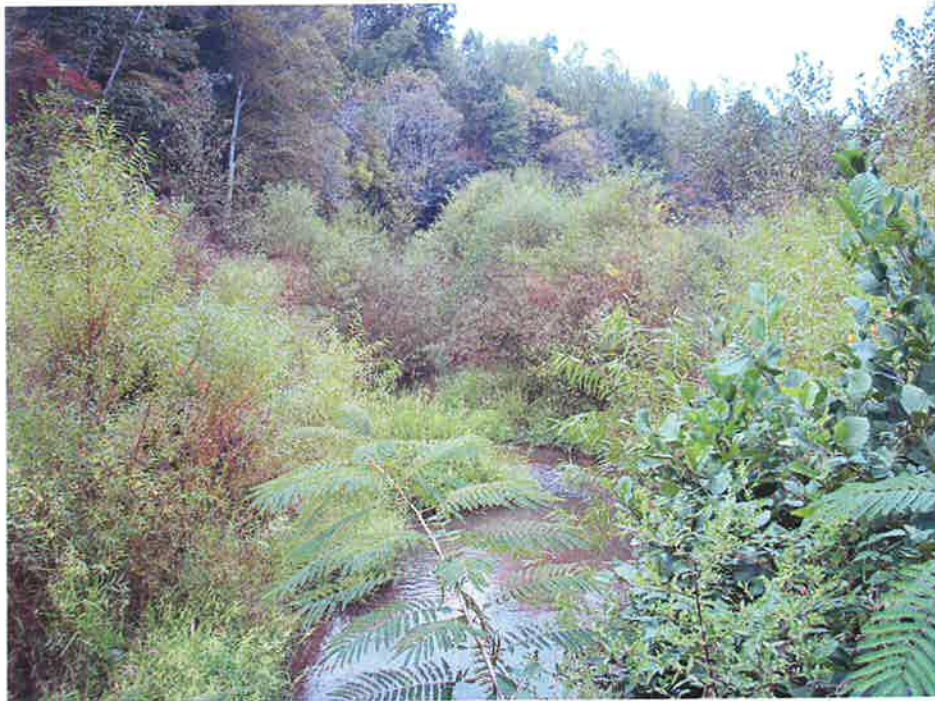
Fixed Station 8

Overview of valley along the mainstem near the midpoint of the project, approximately Station 11+50, facing upstream.
(EMH&T, 9/15/11)

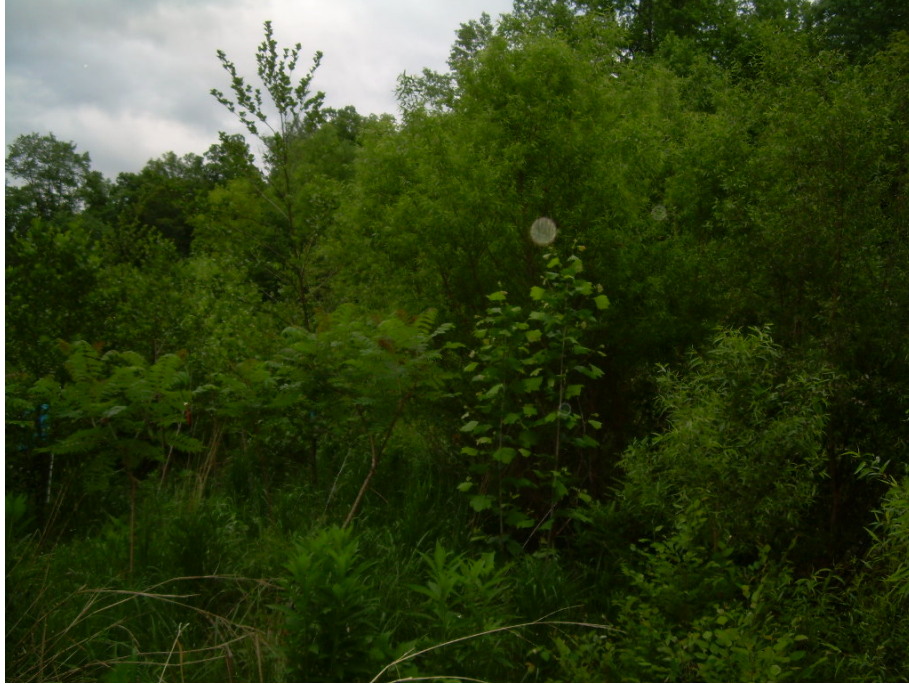
Fixed Station 9
Overview of valley along the mainstem near the upstream terminus of the project, facing
downstream.
(EMH&T, 9/15/11)

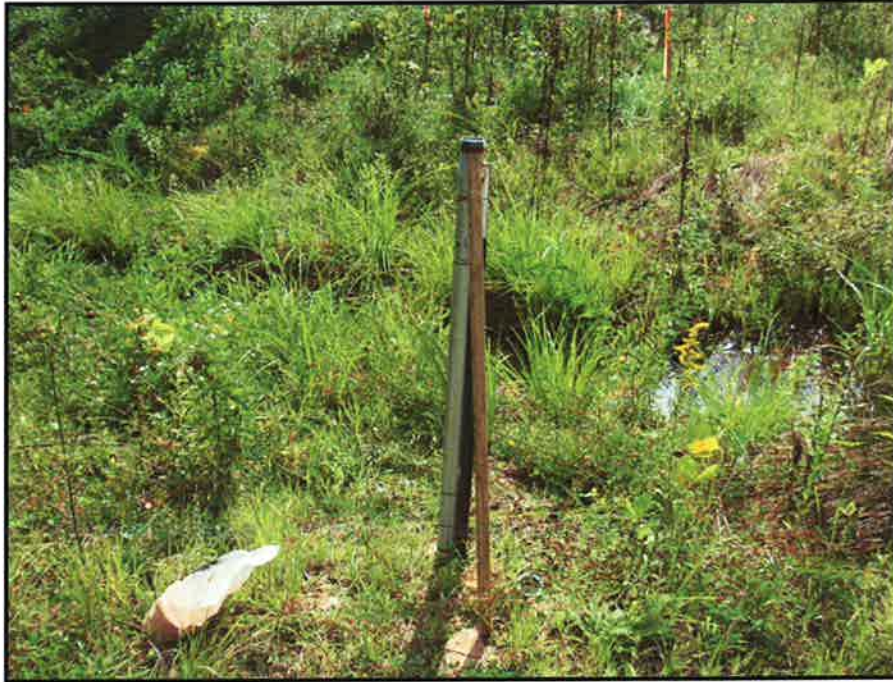
BF 1
Crest Gage at XS-6 on UT (Year 1).
(EMH&T, 9/21/09)

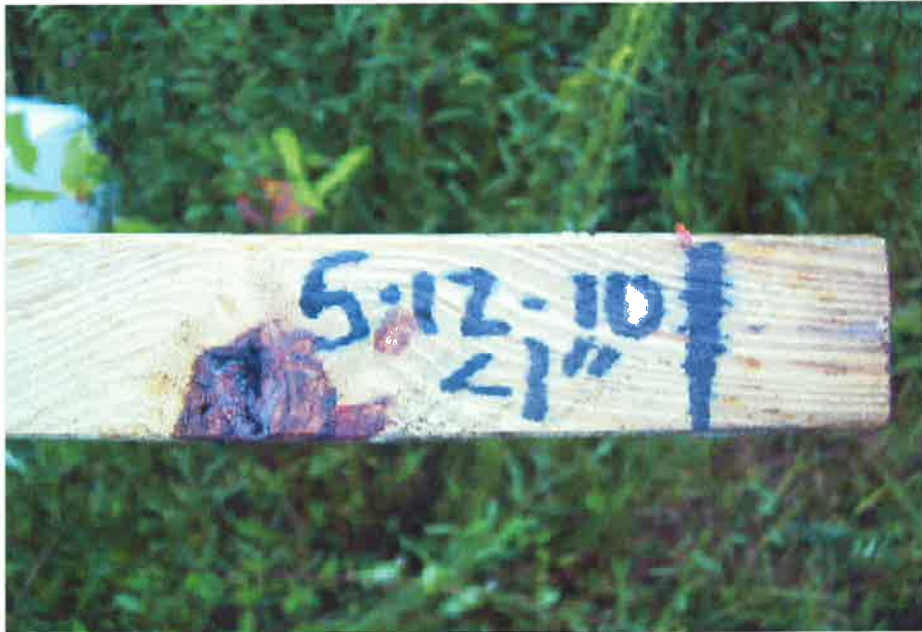
BF 2
Crest Gage at XS-6 on UT (Year 2).
(EMH&T, 5/12/10)

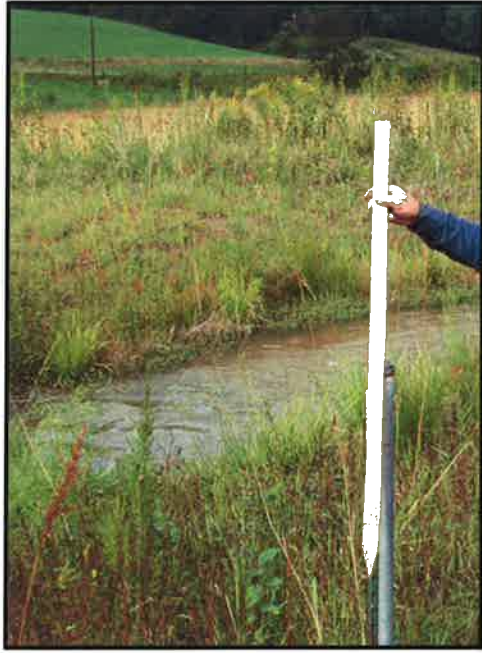
BF 3
Crest Gage at XS-7 on Mainstem (Year 1).
(EMH&T, 9/21/09)

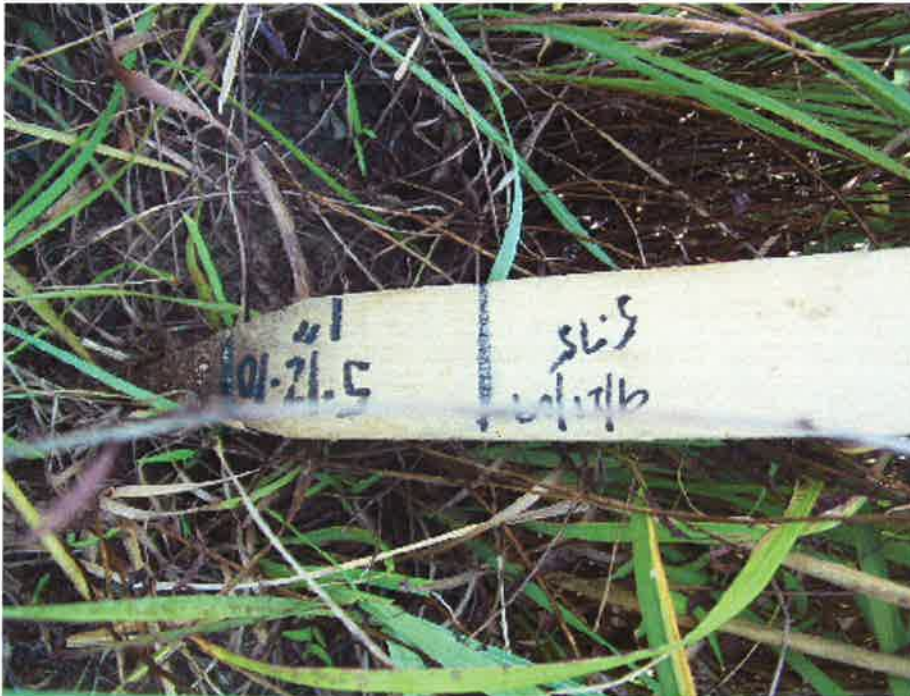
BF 5
Crest Gage at XS-7 on Mainstem (Year 2).
(EMH&T, 5/12/10)

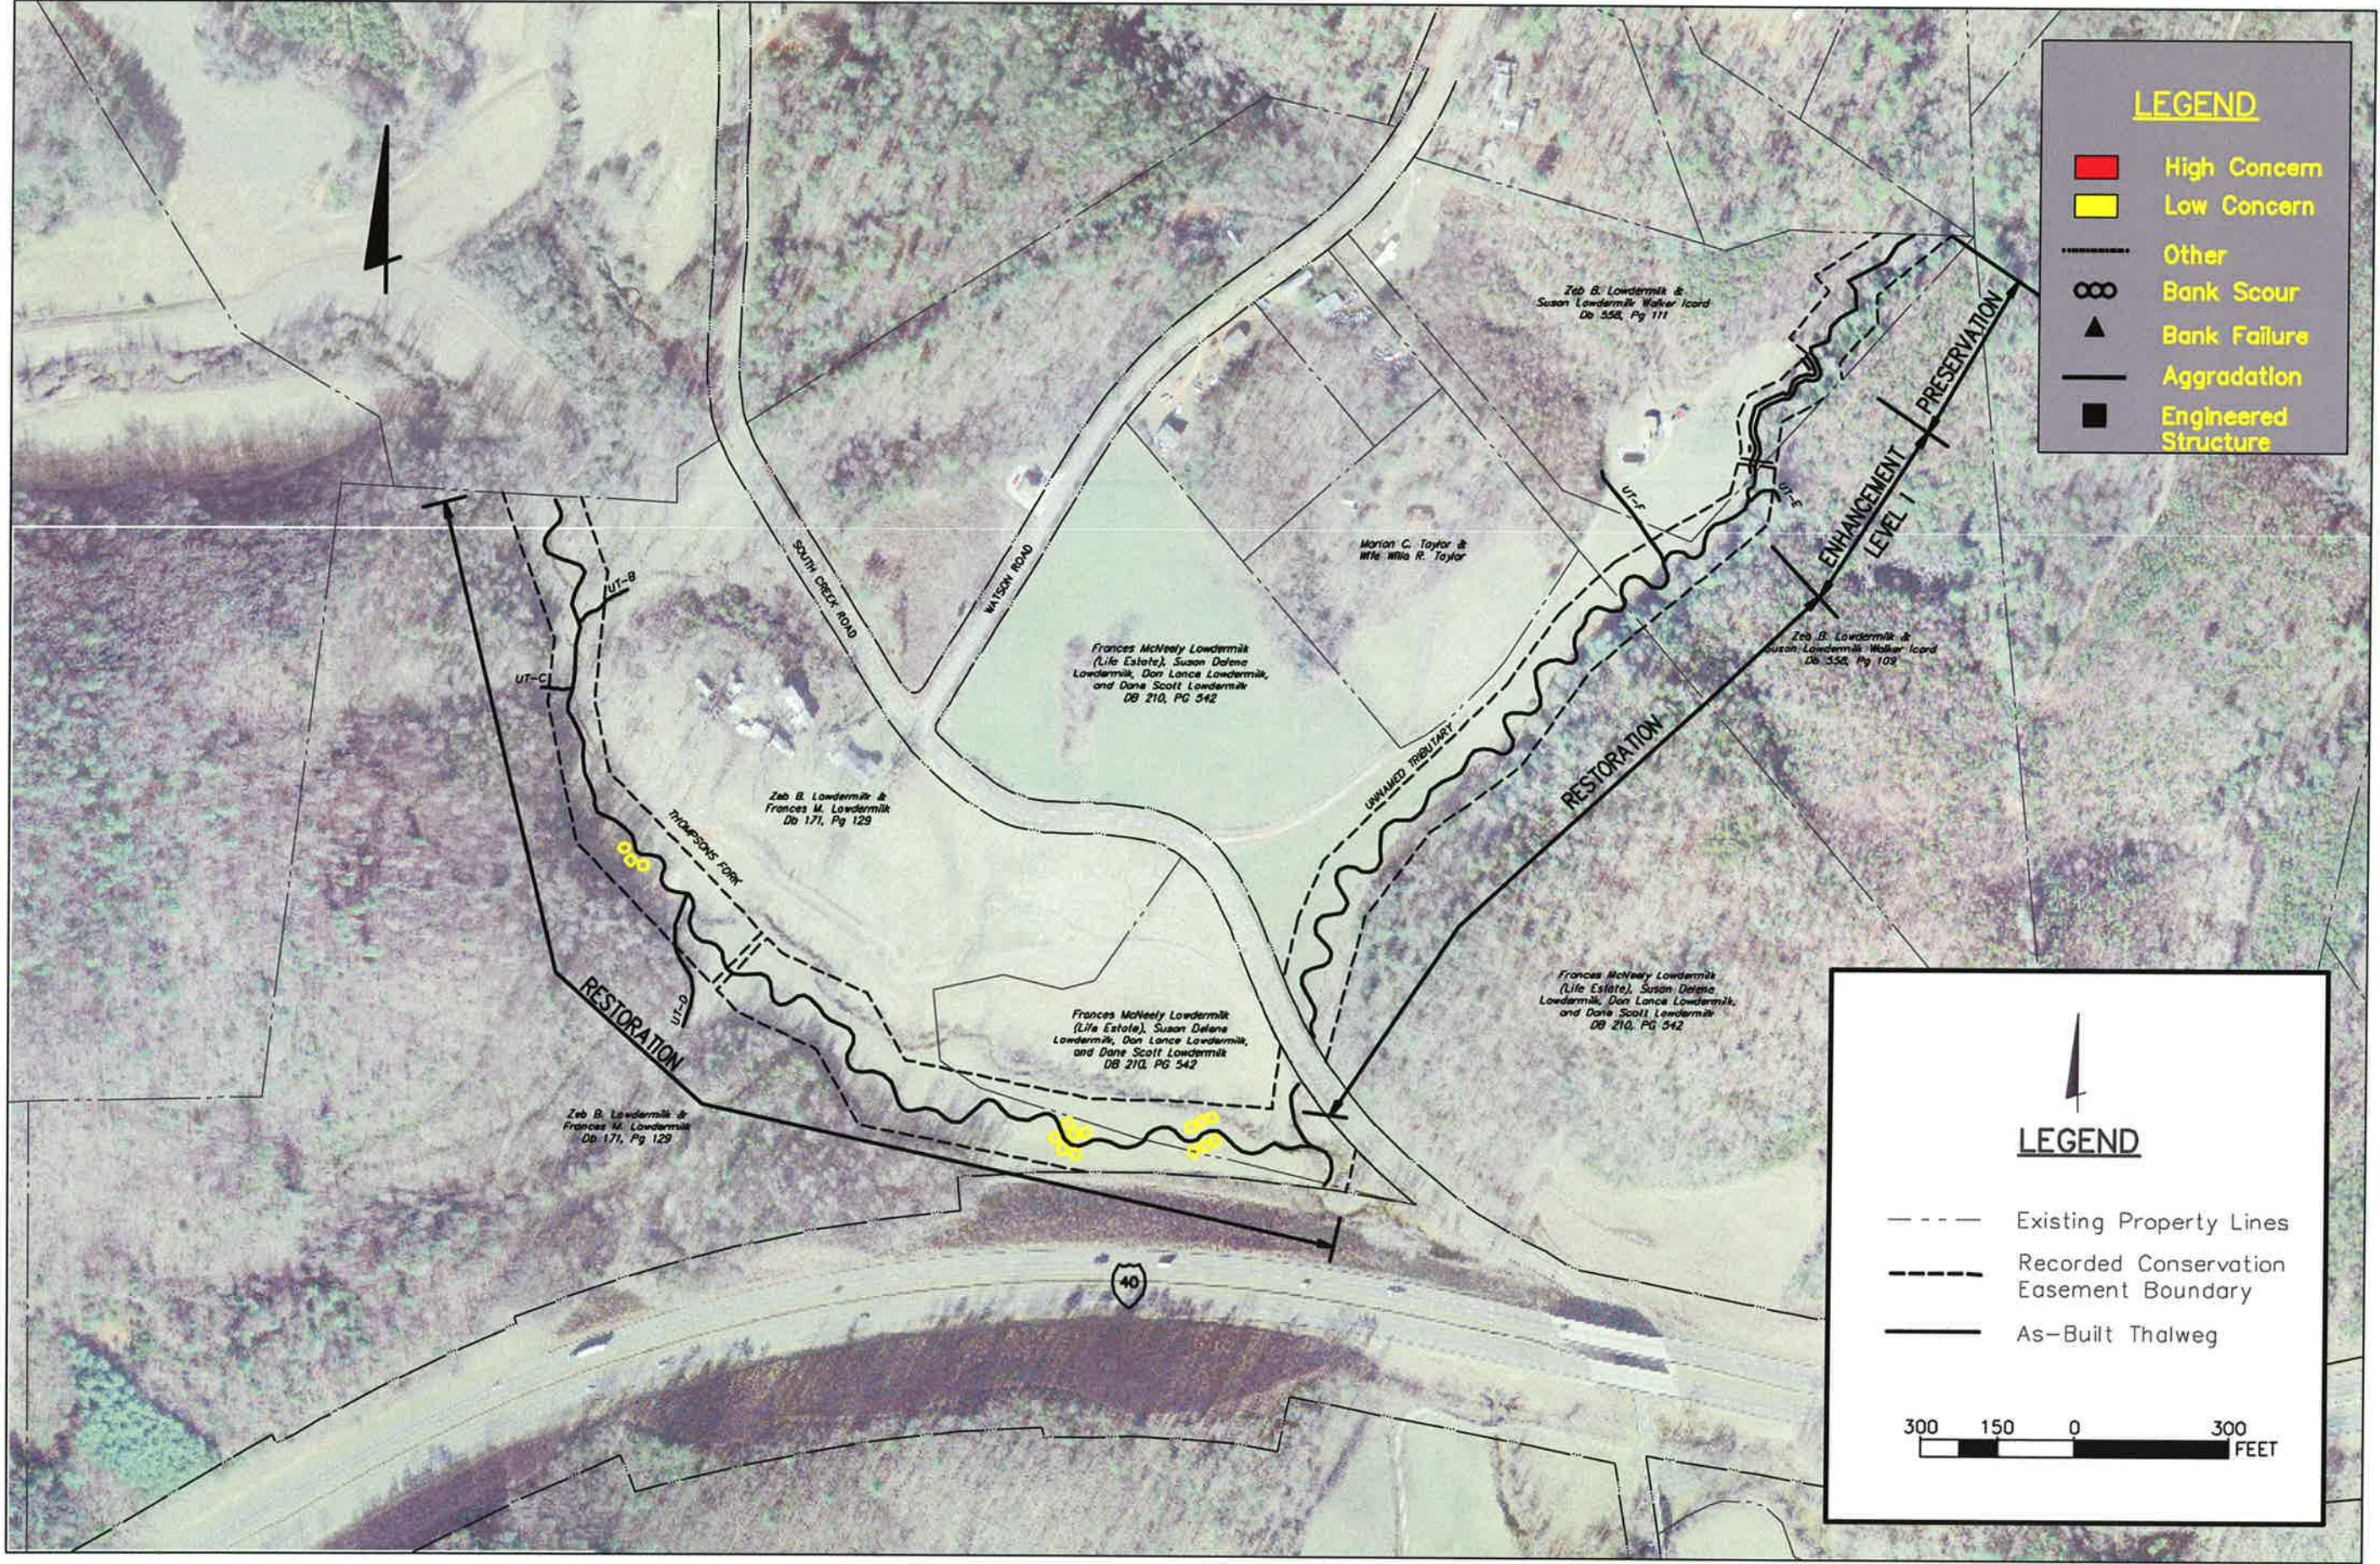
1. Maintenance Map for UT-1 (spring, 2011)

An example of the aggradation which was noted throughout the length of UT-1 in 2010 (top photo). Stream maintenance was completed in the spring of 2011 which cleared the channel of accumulated sediment and the majority of infiltrating wetland vegetation (bottom photo).
