Subject: Year 4 Monitoring Report for Stream Mitigation of Thompsons Fork
SCO# D06030-A

Year 4 Monitoring Report for Stream Restoration of Thompsons Fork and Unnamed Tributary

McDowell County, NC
SCO # D06030-A

Submitted: December, 2012

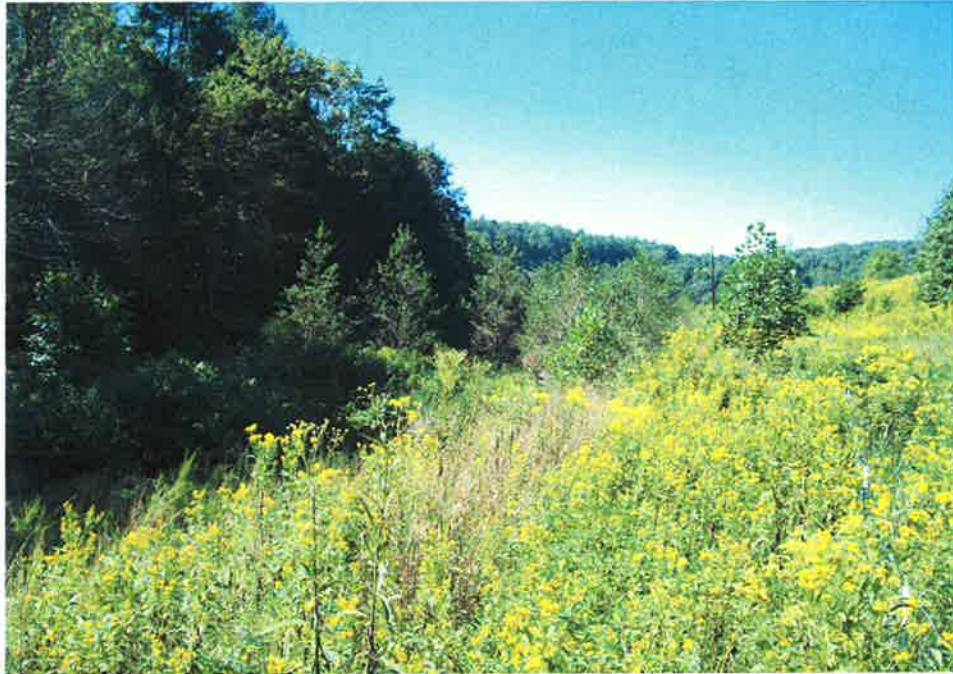
Fixed Station 1
Overview of valley along UT1 near the upstream terminus of the project, approximately
Station 4+00, facing downstream.
(EMH&T, 9/10/12)

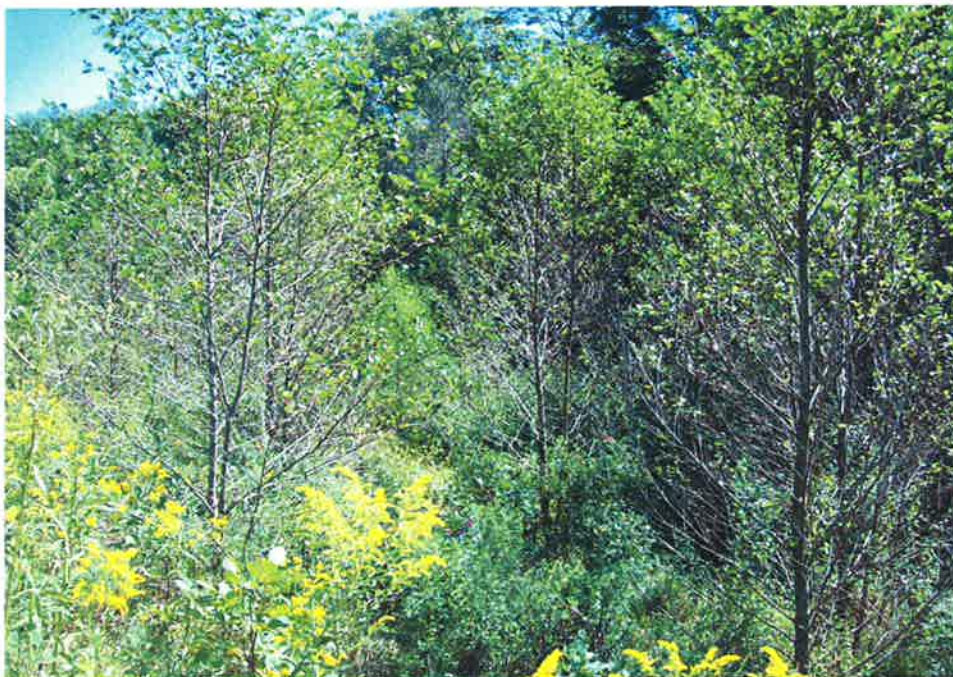
Fixed Station 2
Overview of valley along UT1 near the midpoint of the project, approximately Station
10+75, facing upstream.
(EMH&T, 9/10/12)

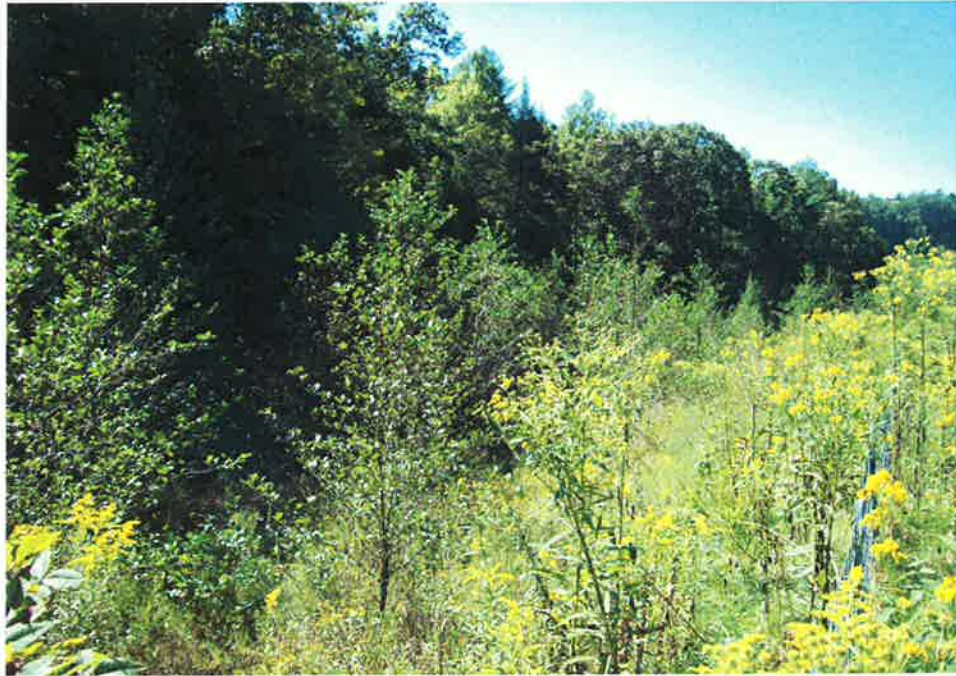
Fixed Station 3
Overview of valley along UT1 near the midpoint of the project, approximately Station 10+75, facing downstream.
(EMH&T, 9/10/12)

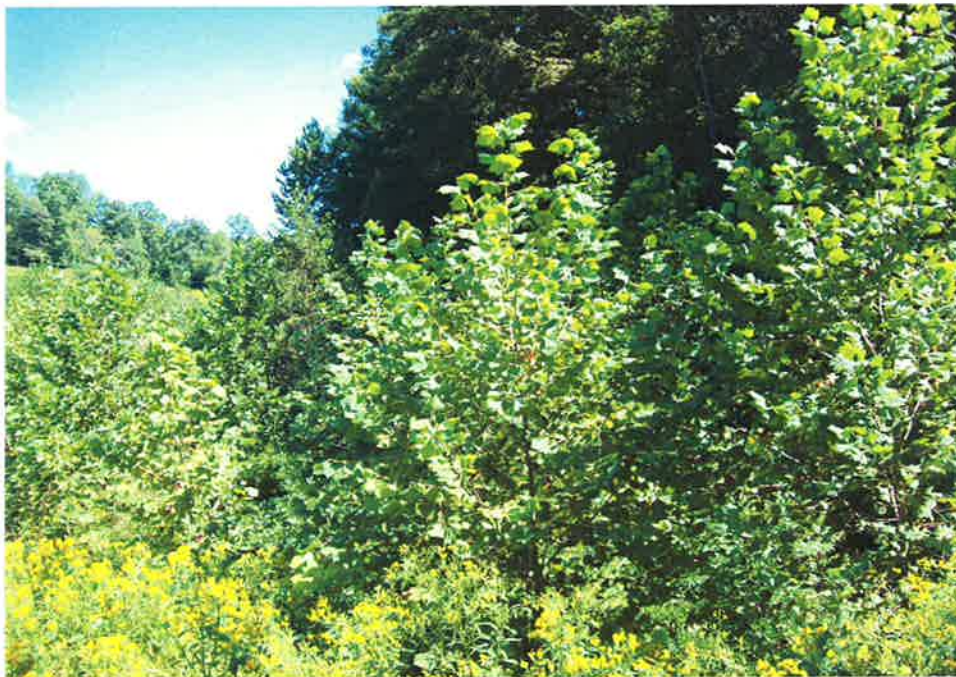
Fixed Station 4
Overview of valley along UT1 near the downstream terminus of the project, just north of South Creek Road, facing upstream.
(EMH&T, 9/10/12)

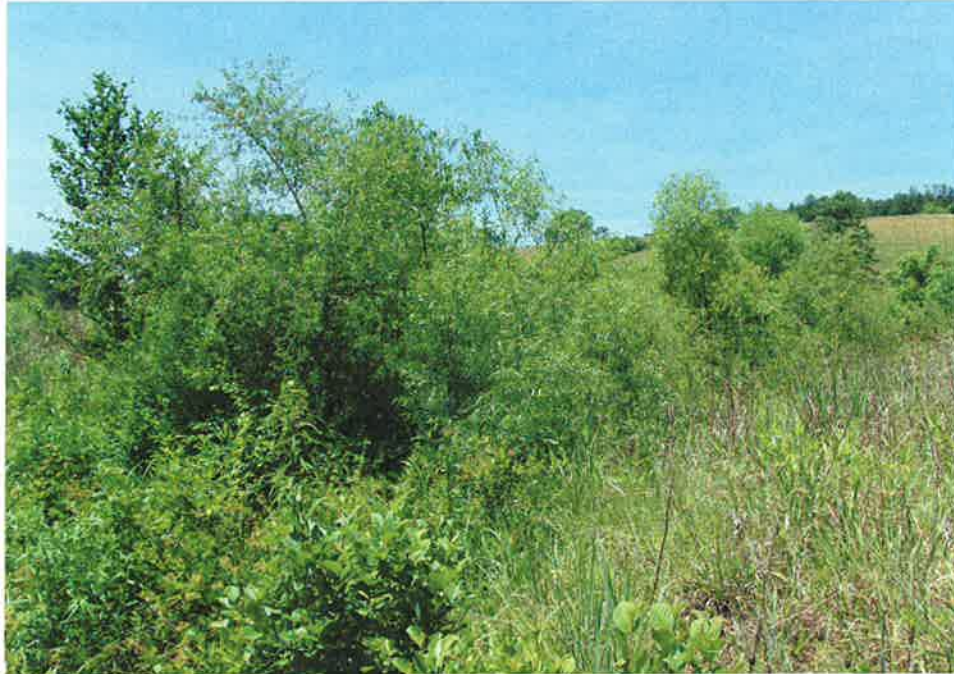
Fixed Station 5
Overview of valley along UT1 at the downstream terminus of the project, facing upstream.
(EMH&T, 9/10/12)

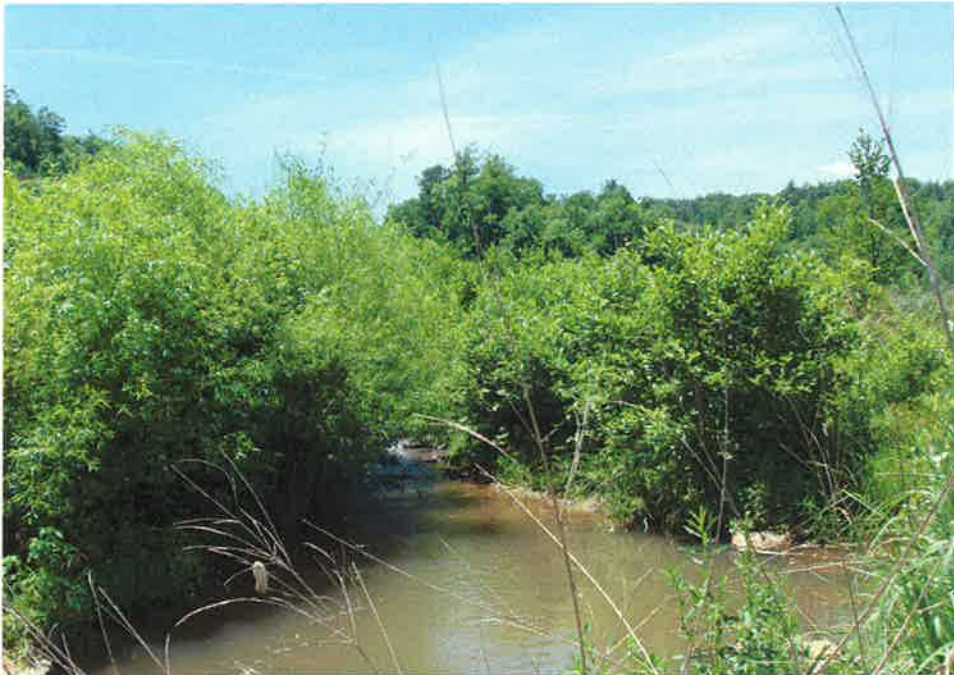
Fixed Station 6
Overview of valley along the mainstem near the downstream terminus of the project, facing upstream.
(EMH&T, 9/10/12)

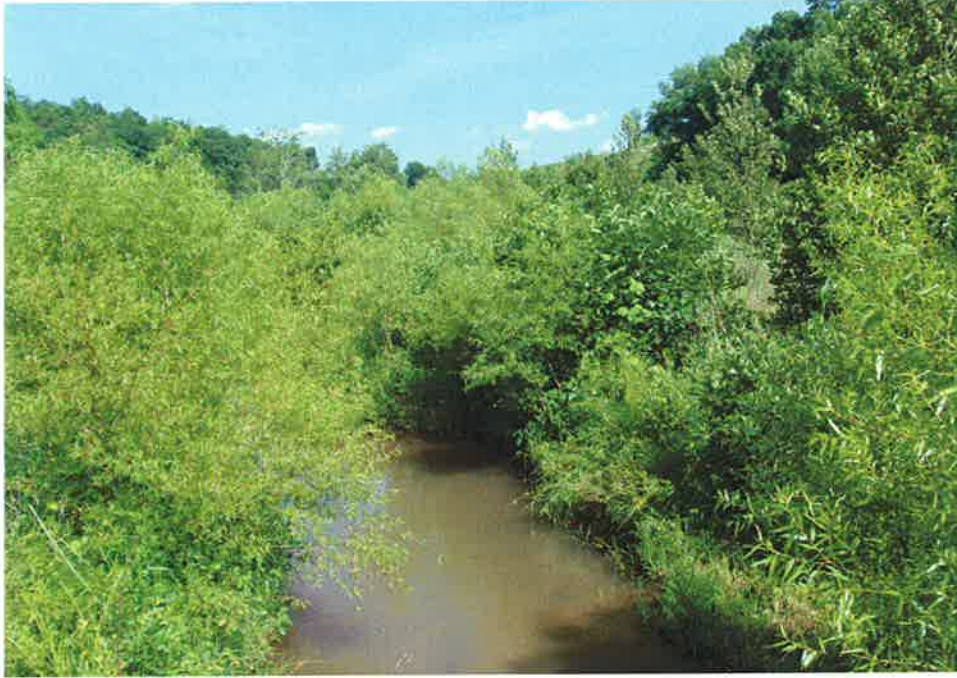
Fixed Station 7
Overview of valley along the mainstem near the midpoint of the project, approximately
Station 12+00, facing downstream.
(EMH&T, 9/10/12)

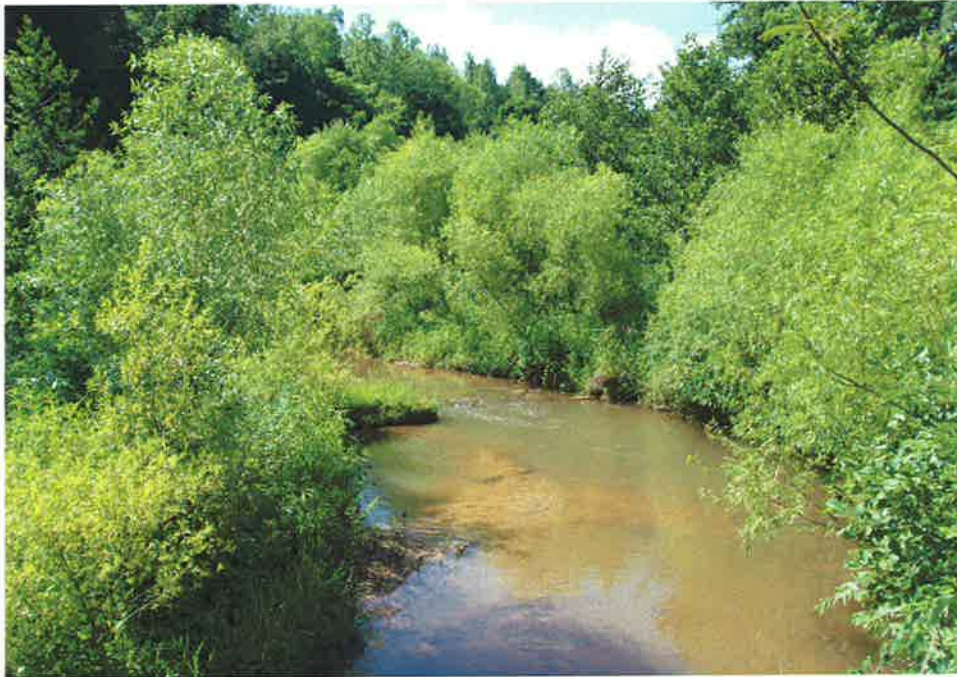
Fixed Station 8
Overview of valley along the mainstem near the midpoint of the project, approximately
Station 11+50, facing upstream.
(EMH&T, 9/10/12)

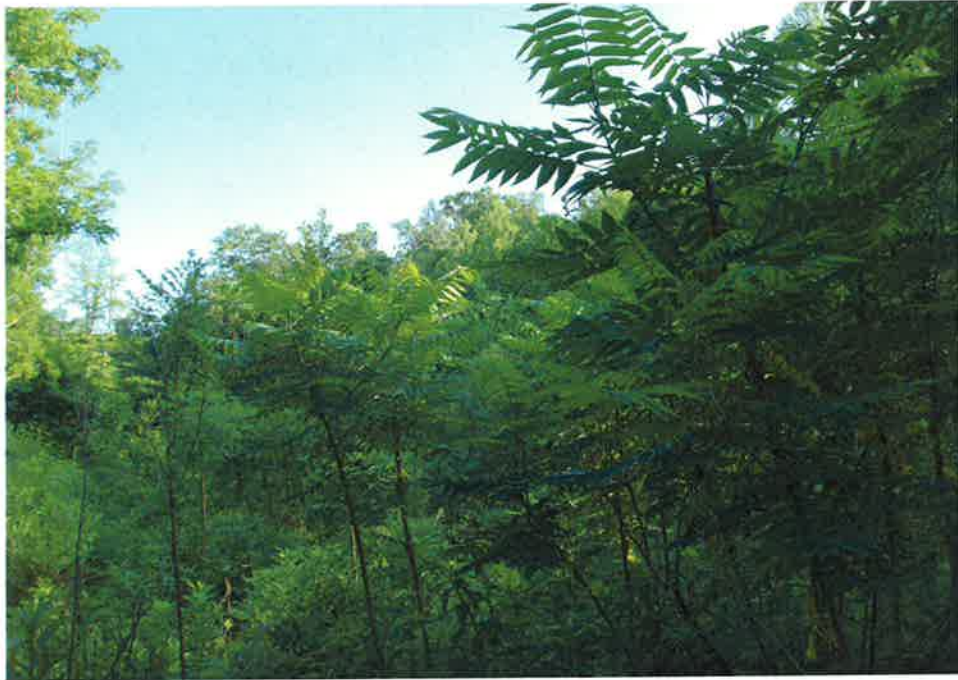
Fixed Station 9
Overview of valley along the mainstem near the upstream terminus of the project, facing
downstream.
(EMH&T, 9/10/12)

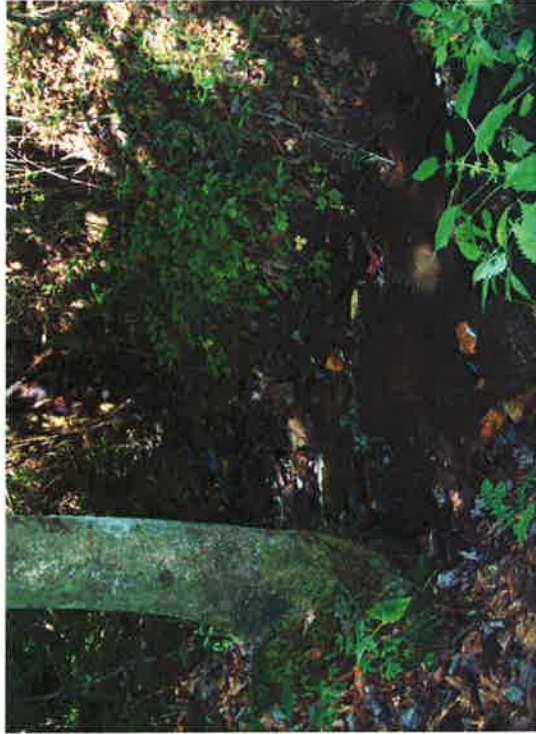
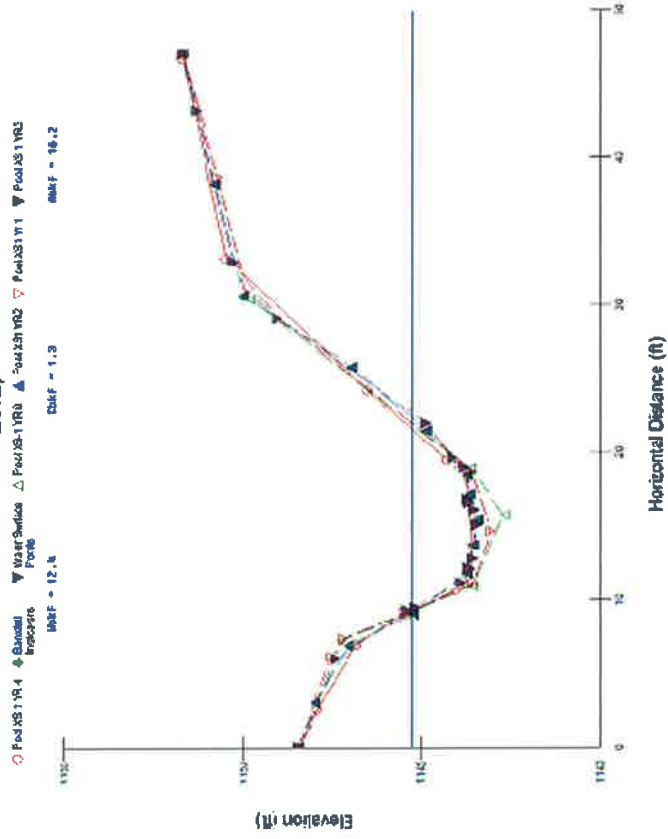
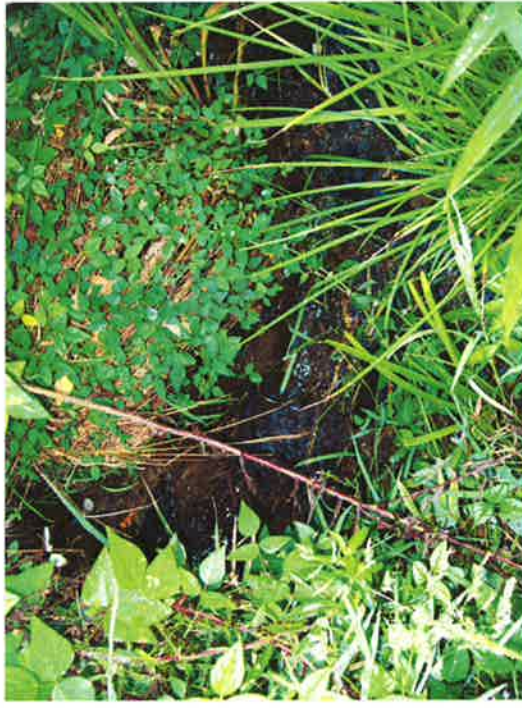
Unnamed Tributary (to Thompsons Fork) - Pool XS1 - Year 4 (May 31, 2012)

Bankfull Area 11.61 ft²
 Bankfull Width 16.12 ft
 Mean Depth 0.72 ft
 Maximum Depth 1.87 ft
 Width/Depth Ratio 22.29
 Entrenchment Ratio 5.78
 Classification C

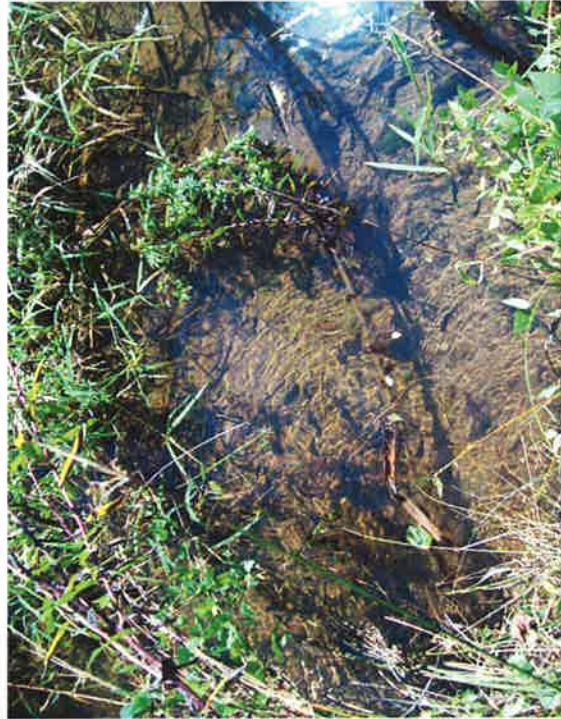
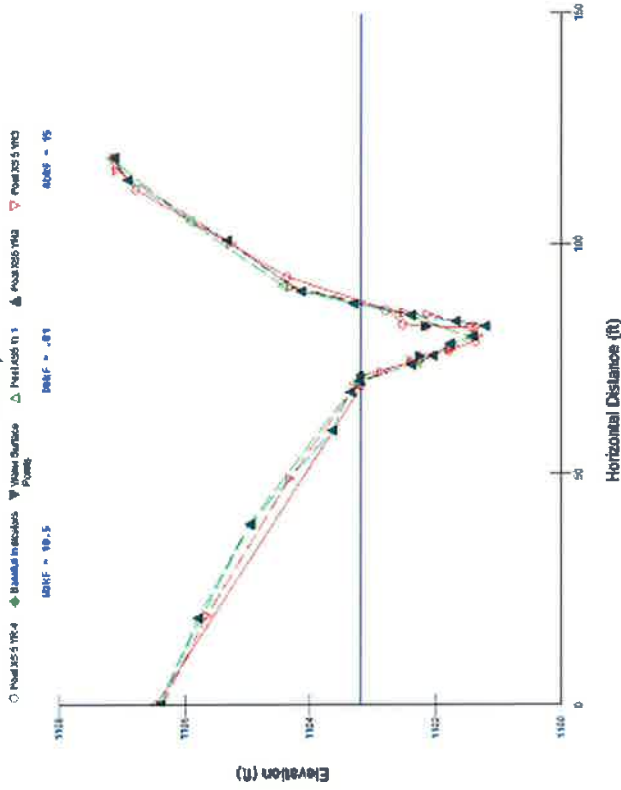
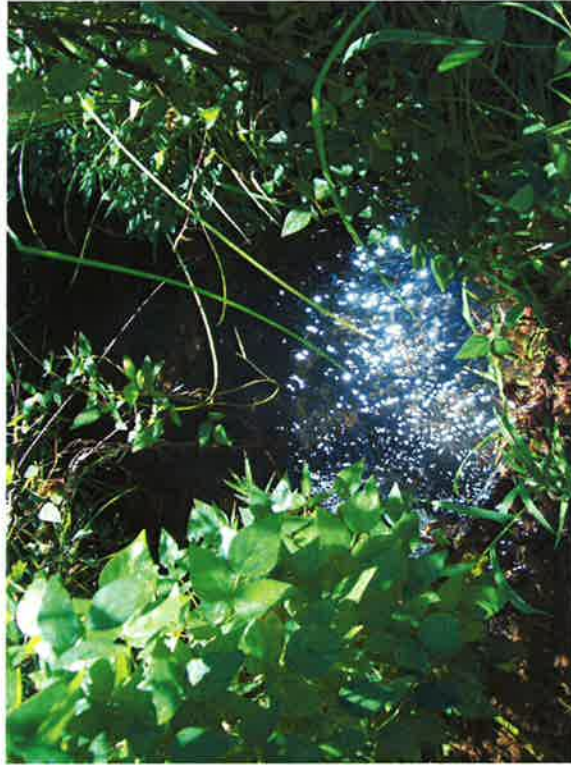
Unnamed Tributary (to Thompsons Fork) - Pool XSS - Year 4 (May 31, 2012)

Bankfull Area 13.76 ft²
 Bankfull Width 15.42 ft
 Mean Depth 0.89 ft
 Maximum Depth 2.4 ft
 Width/Depth Ratio 17.33
 Entrenchment Ratio 5.88
 Classification C
