YEAR 3 (2011)
ANNUAL MONITORING REPORT
THREE MILE CREEK RESTORATION SITE
AVERY COUNTY, NORTH CAROLINA
(Contract #16-D06125-A)

FULL DELIVERY PROJECT
TO PROVIDE STREAM AND WETLAND MITIGATION
IN THE FRENCH BROAD RIVER BASIN
CATALOGING UNIT 06010108

October 2011

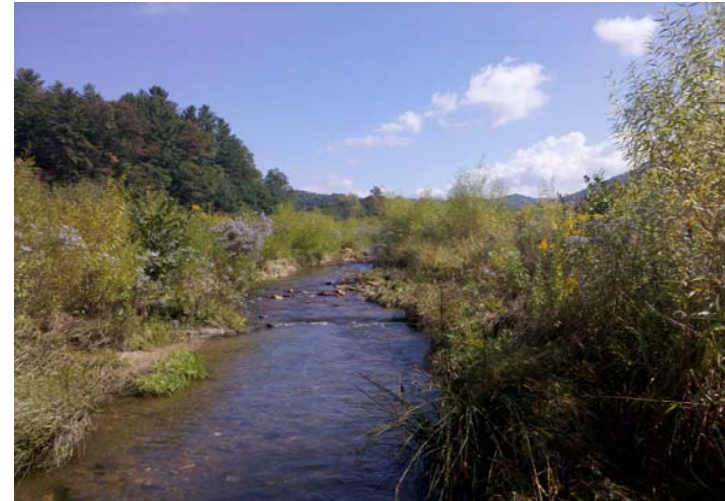
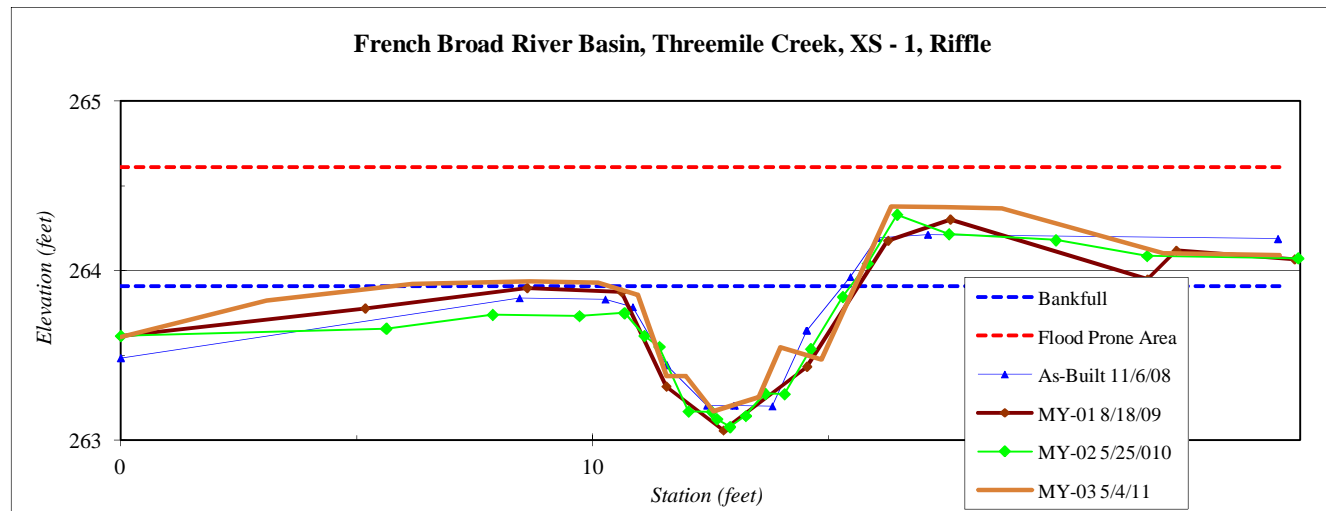
River Basin:	French Broad
Watershed:	Threemile Creek
XS ID	XS - 1, Riffle
Drainage Area (sq mi):	0.05
Date:	5/54/2011
Field Crew:	Dean, Thomas

SUMMARY DATA	
Bankfull Elevation:	263.9
Bankfull Cross-Sectional Area:	2.2
Bankfull Width:	5.2
Flood Prone Area Elevation:	264.6
Flood Prone Width:	>80
Max Depth at Bankfull:	0.7
Mean Depth at Bankfull:	0.4
W / D Ratio:	12.3
Entrenchment Ratio:	>5
Bank Height Ratio:	1.0

Stream Type	E
--------------------	---

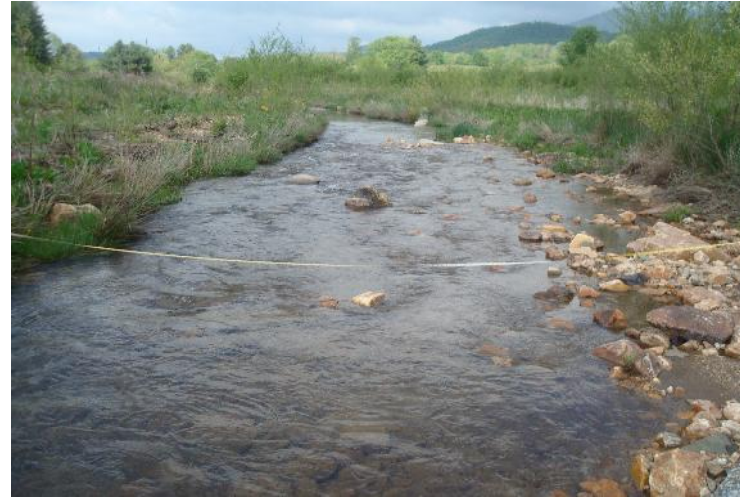
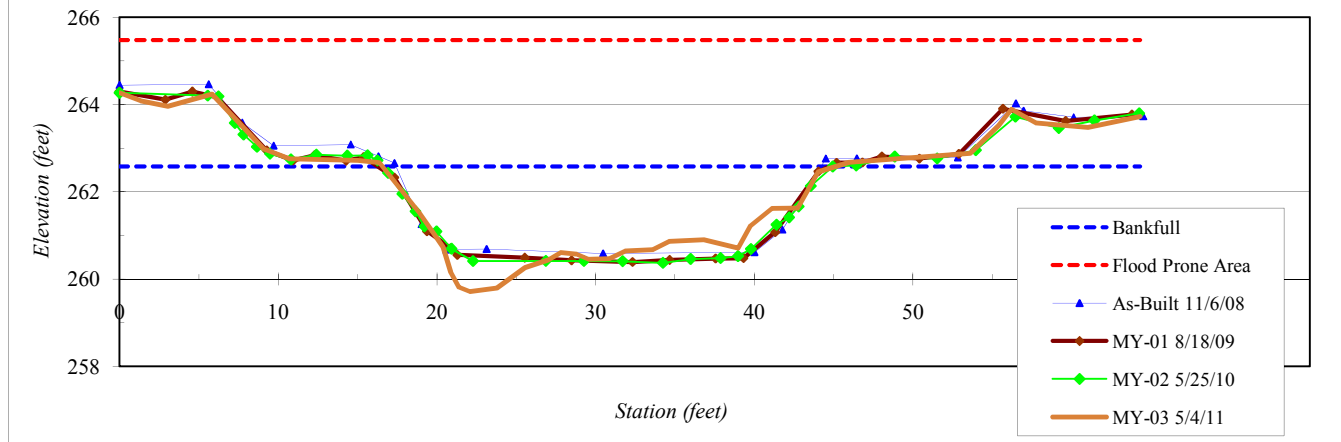
French Broad River Basin, Threemile Creek, XS - 3, Riffle

Stream Type	E/C
--------------------	-----

SUMMARY DATA	
Bankfull Elevation:	262.6
Bankfull Cross-Sectional Area:	48.1
Bankfull Width:	28.5
Flood Prone Area Elevation:	265.5
Flood Prone Width:	>65
Max Depth at Bankfull:	2.9
Mean Depth at Bankfull:	1.7
W / D Ratio:	16.9
Entrenchment Ratio:	>5
Bank Height Ratio:	1.0

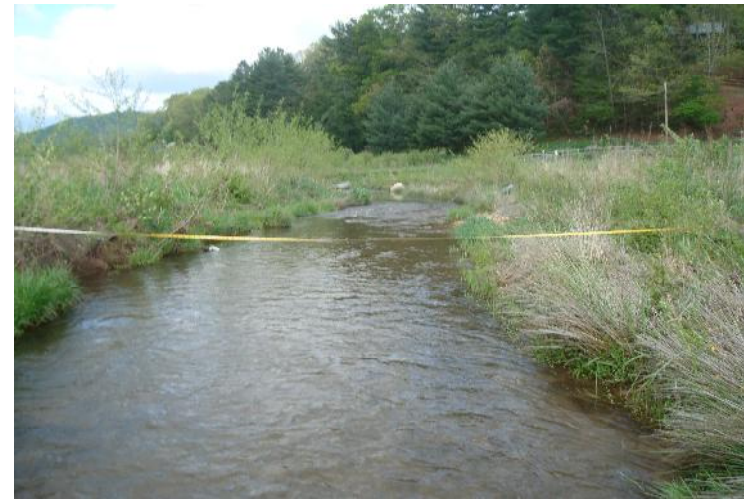
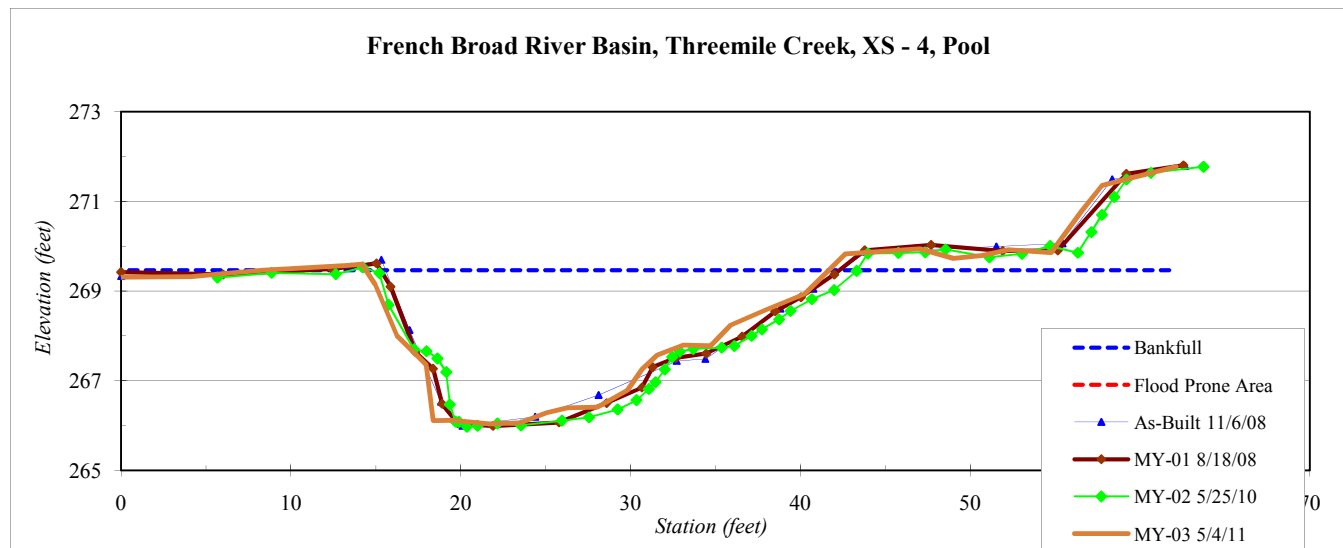
River Basin:	French Broad
Watershed:	Threemile Creek
XS ID	XS - 4, Pool
Drainage Area (sq mi):	4.7
Date:	5/4/2011
Field Crew:	Dean, Perkinson

Stream Type	E
--------------------	---

SUMMARY DATA	
Bankfull Elevation:	269.5
Bankfull Cross-Sectional Area:	57.4
Bankfull Width:	27.3
Flood Prone Area Elevation:	-
Flood Prone Width:	-
Max Depth at Bankfull:	3.4
Mean Depth at Bankfull:	2.1
W / D Ratio:	-
Entrenchment Ratio:	-
Bank Height Ratio:	-

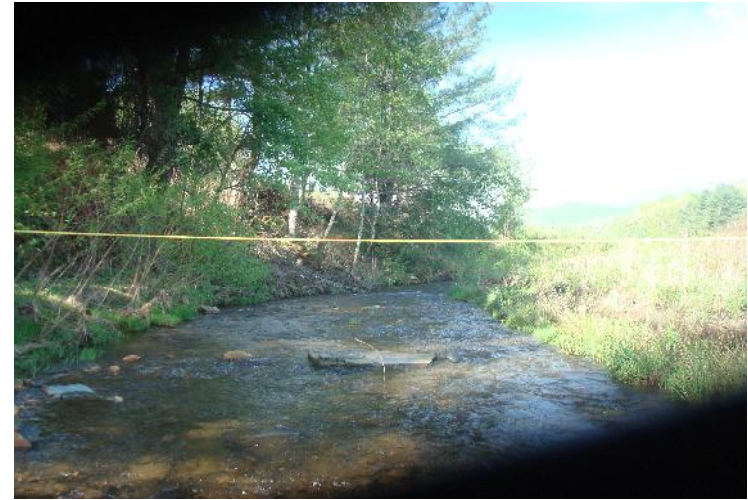
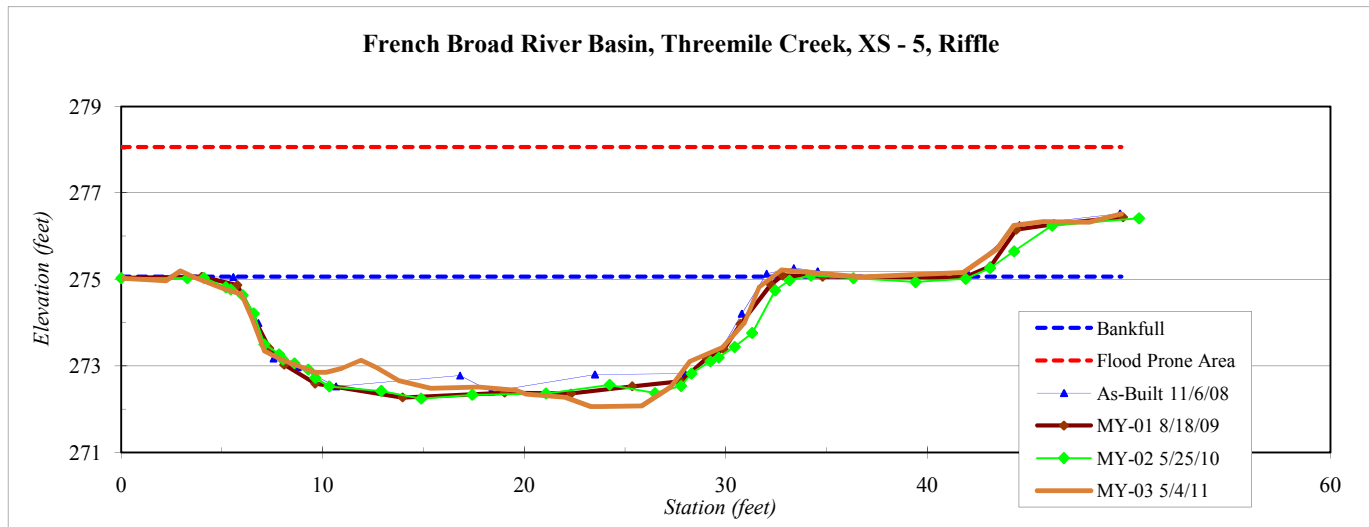
French Broad River Basin, Threemile Creek, XS - 5, Riffle

Stream Type E/C

SUMMARY DATA	
Bankfull Elevation:	275.1
Bankfull Cross-Sectional Area:	59.4
Bankfull Width:	29.0
Flood Prone Area Elevation:	278.1
Flood Prone Width:	>65
Max Depth at Bankfull:	3.0
Mean Depth at Bankfull:	2.0
W / D Ratio:	14.2
Entrenchment Ratio:	>5
Bank Height Ratio:	1.0

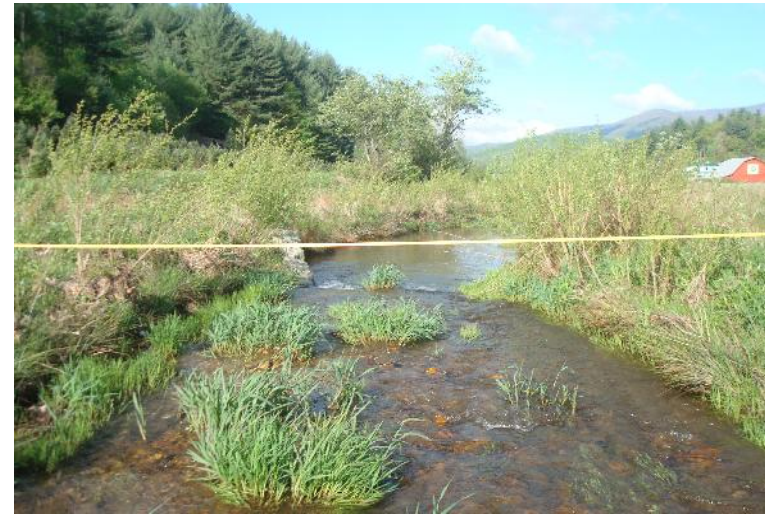
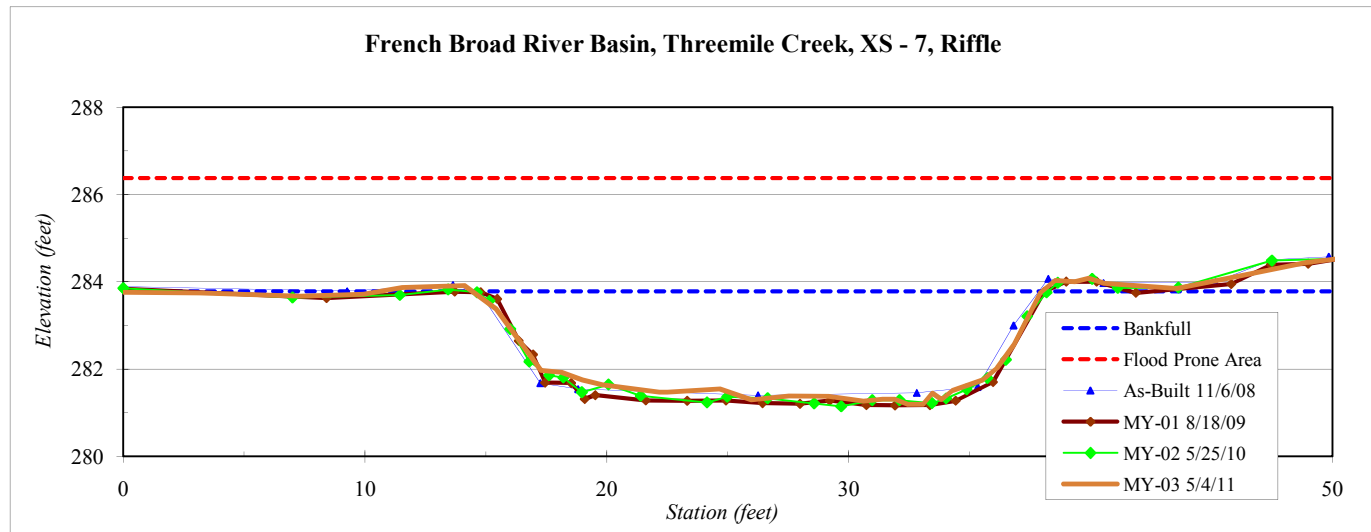
French Broad River Basin, Threemile Creek, XS - 7, Riffle

SUMMARY DATA	
Bankfull Elevation:	283.8
Bankfull Cross-Sectional Area:	47.1
Bankfull Width:	24.2
Flood Prone Area Elevation:	286.4
Flood Prone Width:	>65
Max Depth at Bankfull:	2.6
Mean Depth at Bankfull:	1.9
W / D Ratio:	12.4
Entrenchment Ratio:	>5
Bank Height Ratio:	1.0

Stream Type E/C

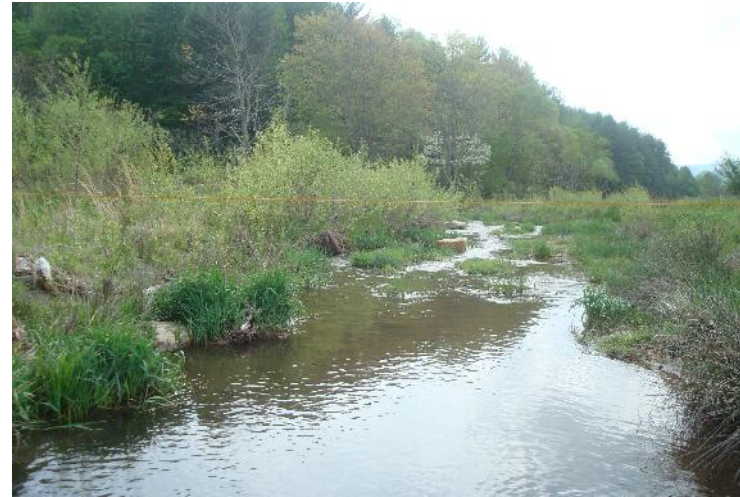
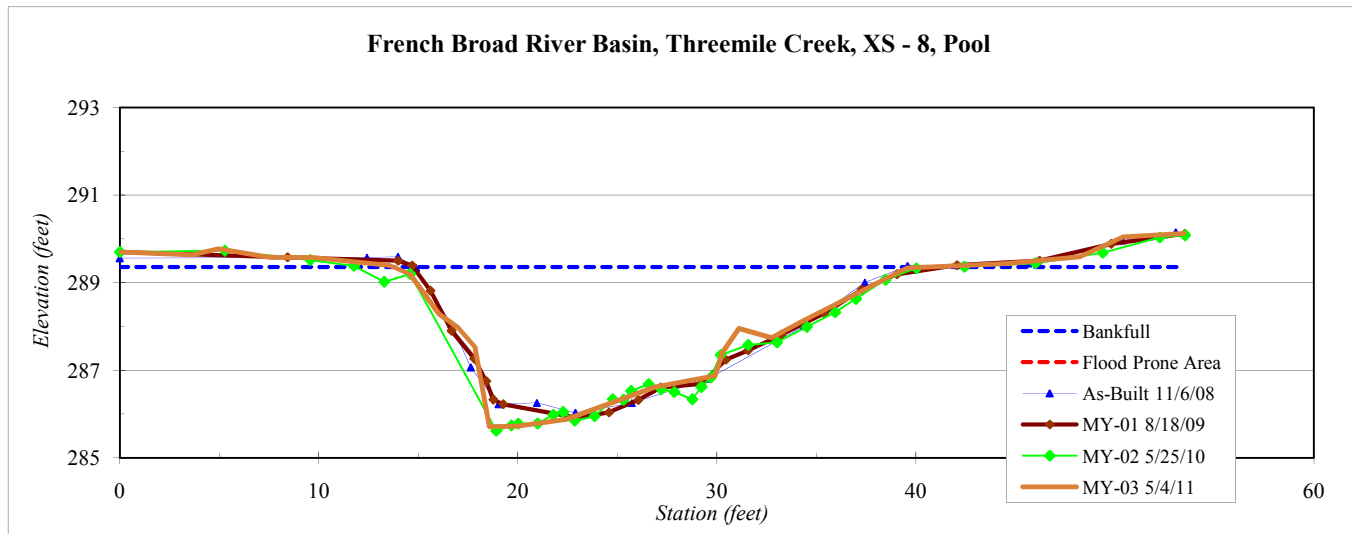
French Broad River Basin, Threemile Creek, XS - 8, Pool

SUMMARY DATA	
Bankfull Elevation:	289.4
Bankfull Cross-Sectional Area:	51.4
Bankfull Width:	27.1
Flood Prone Area Elevation:	-
Flood Prone Width:	-
Max Depth at Bankfull:	3.7
Mean Depth at Bankfull:	1.9
W / D Ratio:	-
Entrenchment Ratio:	-
Bank Height Ratio:	-

Stream Type E/C

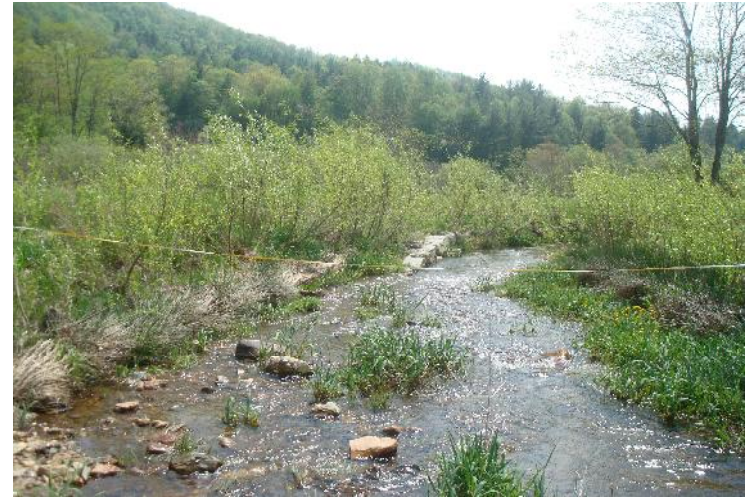
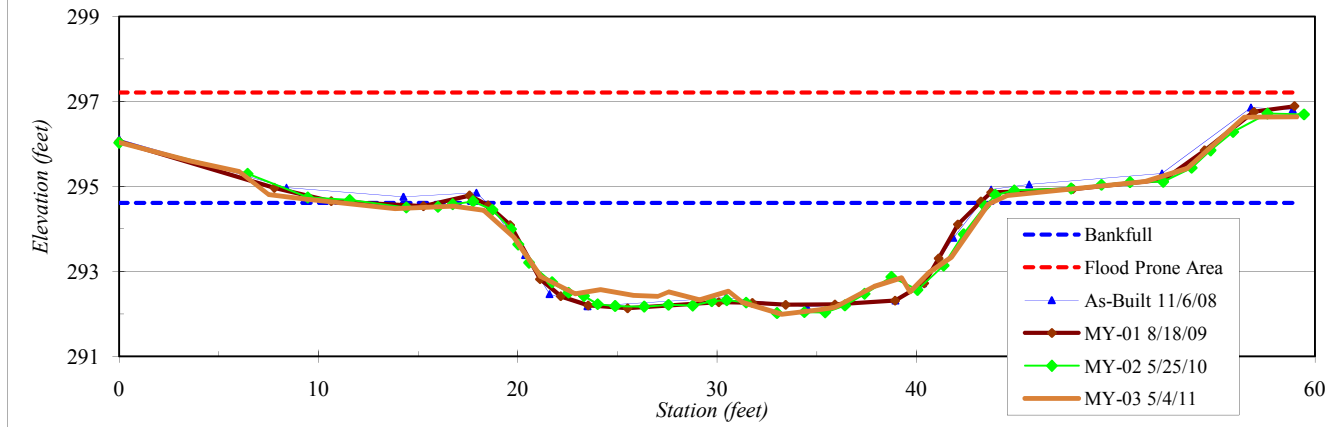
French Broad River Basin, Threemile Creek, XS - 9, Riffle

Stream Type	E/C
--------------------	-----

SUMMARY DATA	
Bankfull Elevation:	294.6
Bankfull Cross-Sectional Area:	48.0
Bankfull Width:	27.0
Flood Prone Area Elevation:	297.2
Flood Prone Width:	>65
Max Depth at Bankfull:	2.6
Mean Depth at Bankfull:	1.8
W / D Ratio:	15.2
Entrenchment Ratio:	>5
Bank Height Ratio:	1.0

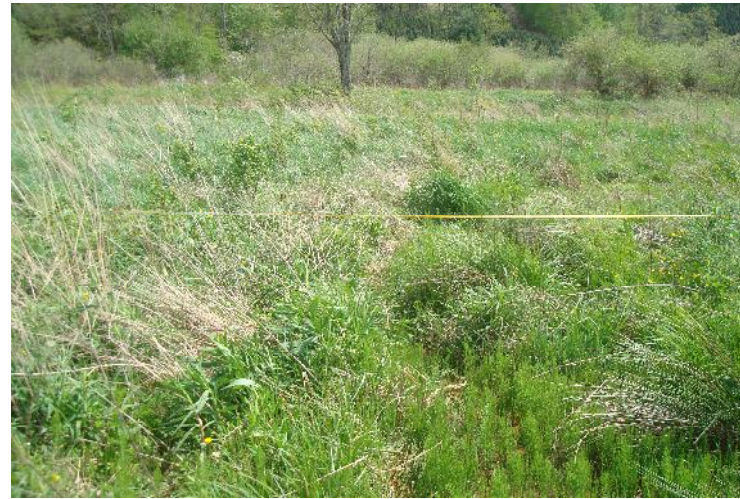
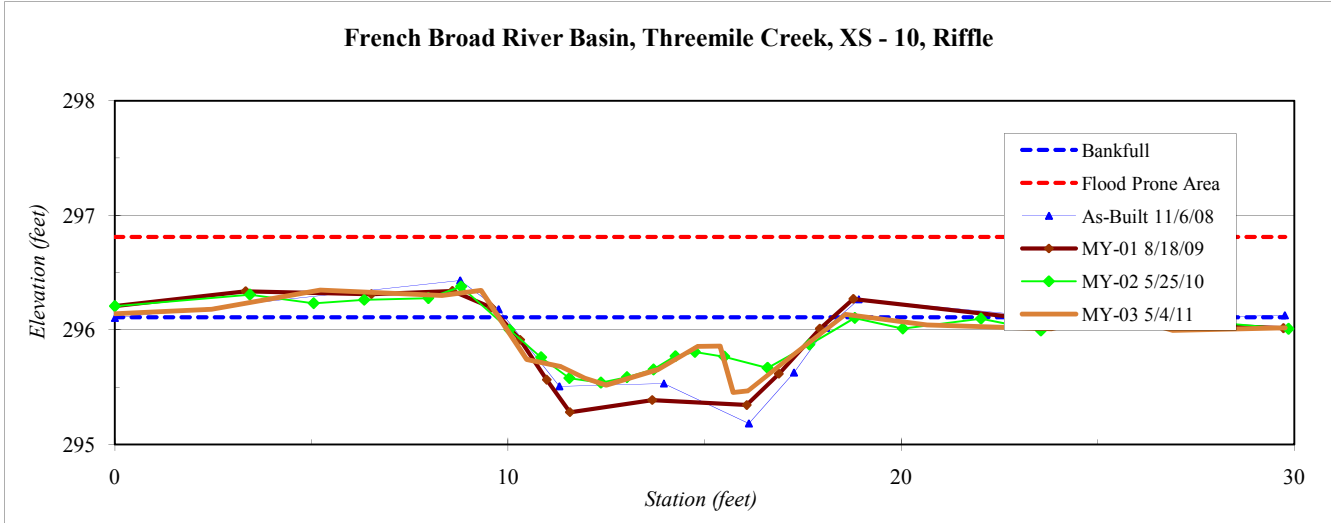
River Basin:	French Broad
Watershed:	Threemile Creek
XS ID	XS - 10, Riffle
Drainage Area (sq mi):	0.05
Date:	5/4/2011
Field Crew:	Dean, Thomas

SUMMARY DATA	
Bankfull Elevation:	296.1
Bankfull Cross-Sectional Area:	3.4
Bankfull Width:	8.7
Flood Prone Area Elevation:	296.8
Flood Prone Width:	>35
Max Depth at Bankfull:	0.7
Mean Depth at Bankfull:	0.4
W / D Ratio:	22.3
Entrenchment Ratio:	>5
Bank Height Ratio:	1.0

Stream Type E/C

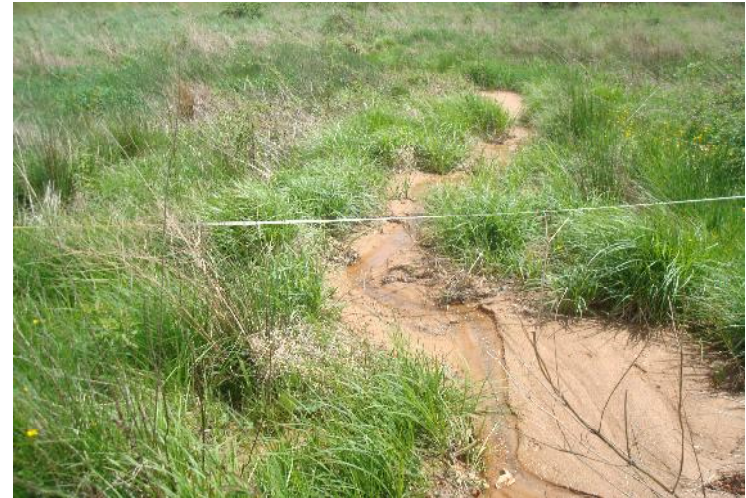
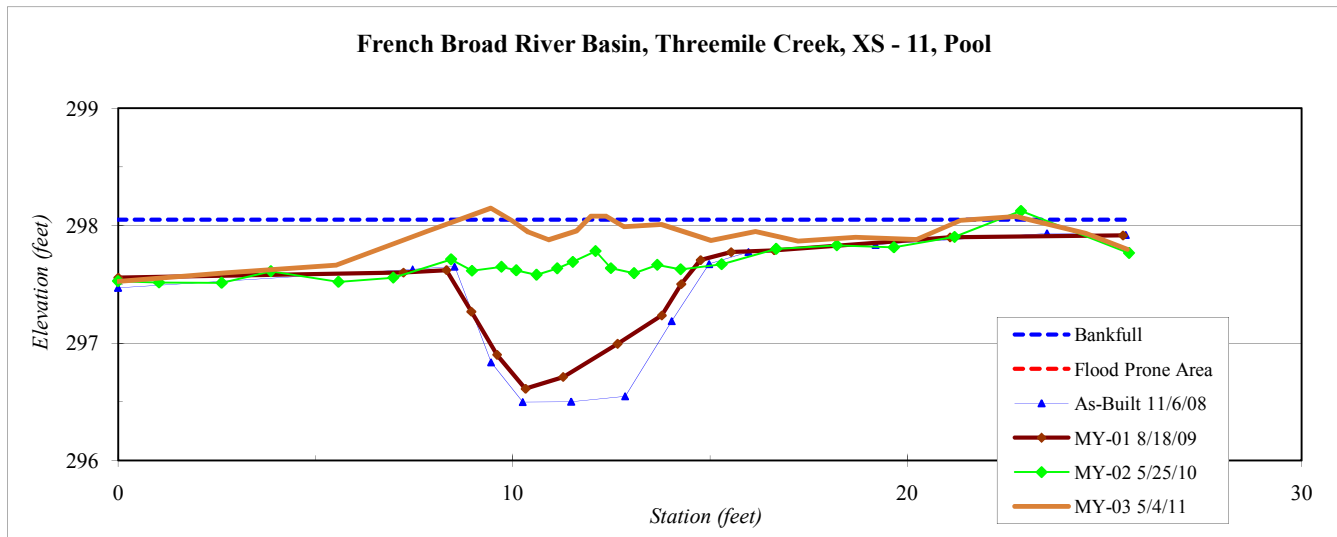
French Broad River Basin, Threemile Creek, XS - 11, Pool

Stream Type	E/C
--------------------	-----

SUMMARY DATA	
Bankfull Elevation:	298.1
Bankfull Cross-Sectional Area:	1.1
Bankfull Width:	8.8
Flood Prone Area Elevation:	-
Flood Prone Width:	-
Max Depth at Bankfull:	0.5
Mean Depth at Bankfull:	0.1
W / D Ratio:	-
Entrenchment Ratio:	-
Bank Height Ratio:	-

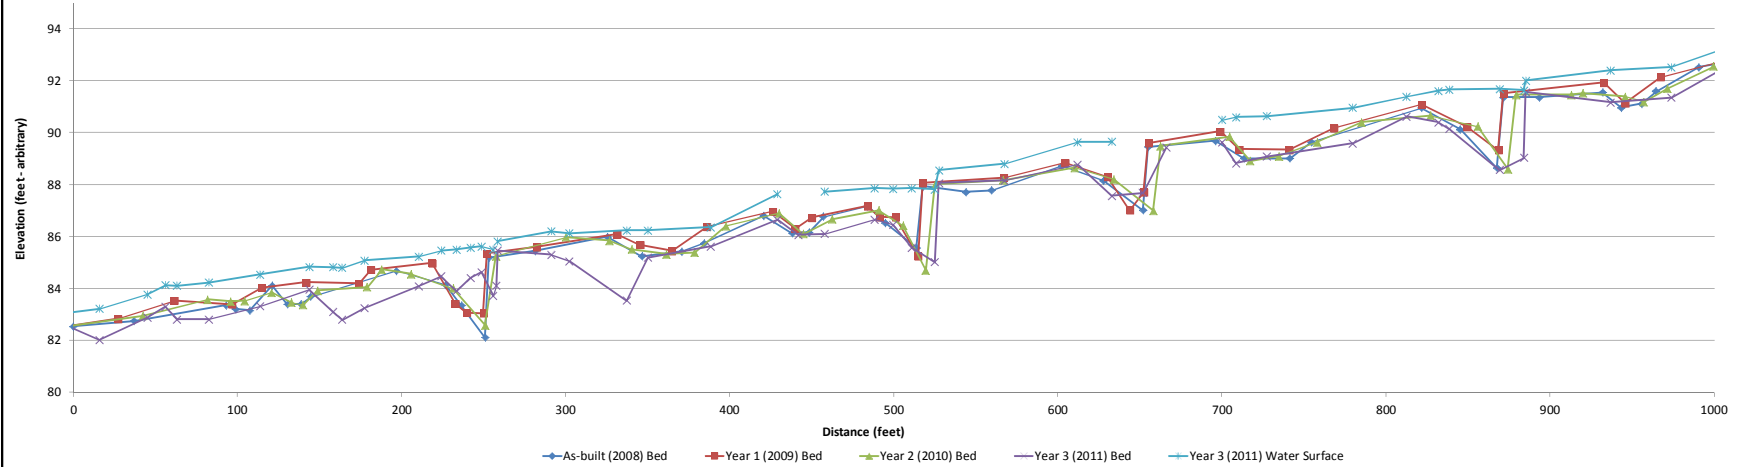
Threemile Creek Year 3 (2011) Profile - Reach 00+00 to 10+00

As-built	2009	2010	2011
Avg. Water Surface Slope	0.0098	0.0097	0.0098	0.0097
Riffle Length	51	53	51	50
Avg. Riffle Slope	0.0154	0.0143	0.0148	0.0173
Pool Length	46	38	44	46
Pool to Pool Spacing	-----	0.0008	0.0038	0.0052

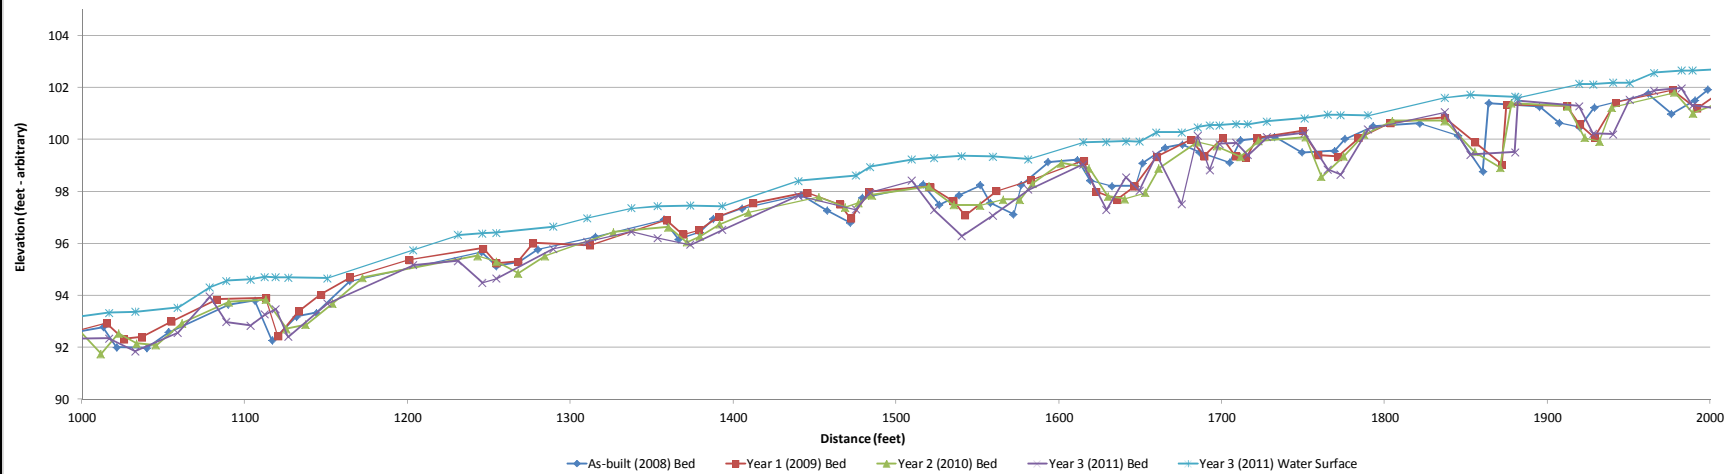
Threemile Creek Year 3 (2011) Profile - Reach 10+00 to 20+00

As-built	2009	2010	2011
Avg. Water Surface Slope	0.0098	0.0097	0.0098	0.0097
Riffle Length	51.0	52.9	51	50
Avg. Riffle Slope	0.0154	0.0143	0.0148	0.0173
Pool Length	46.0	38.0	44	46
Avg. Pool Slope	-----	0.0008	0.0038	0.0052

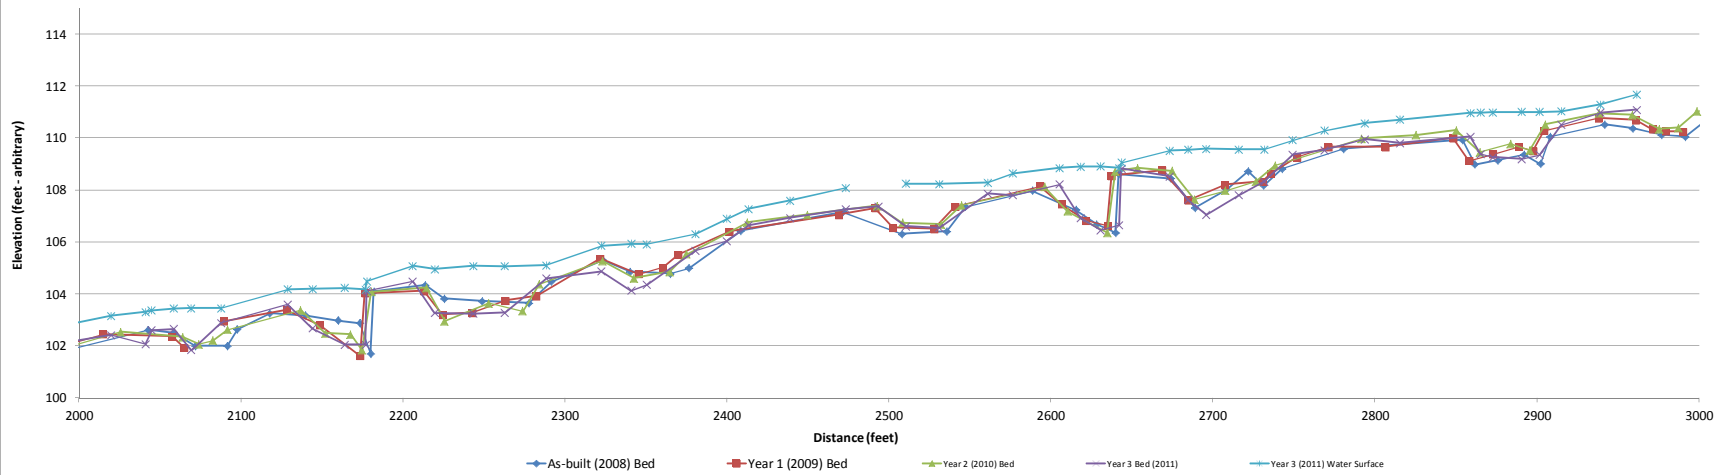
Threemile Creek Year 3 (2011) Profile - Reach 20+00 to 30+00

As-built	2009	2010	2011
Avg. Water Surface Slope	0.0098	0.0097	0.0098	0.0097
Riffle Length	51.0	52.9	51	50
Avg. Riffle Slope	0.0154	0.0143	0.0148	0.0173
Pool Length	46.0	38.0	44	46
Avg. Pool Slope	-----	0.0008	0.0038	0.0052

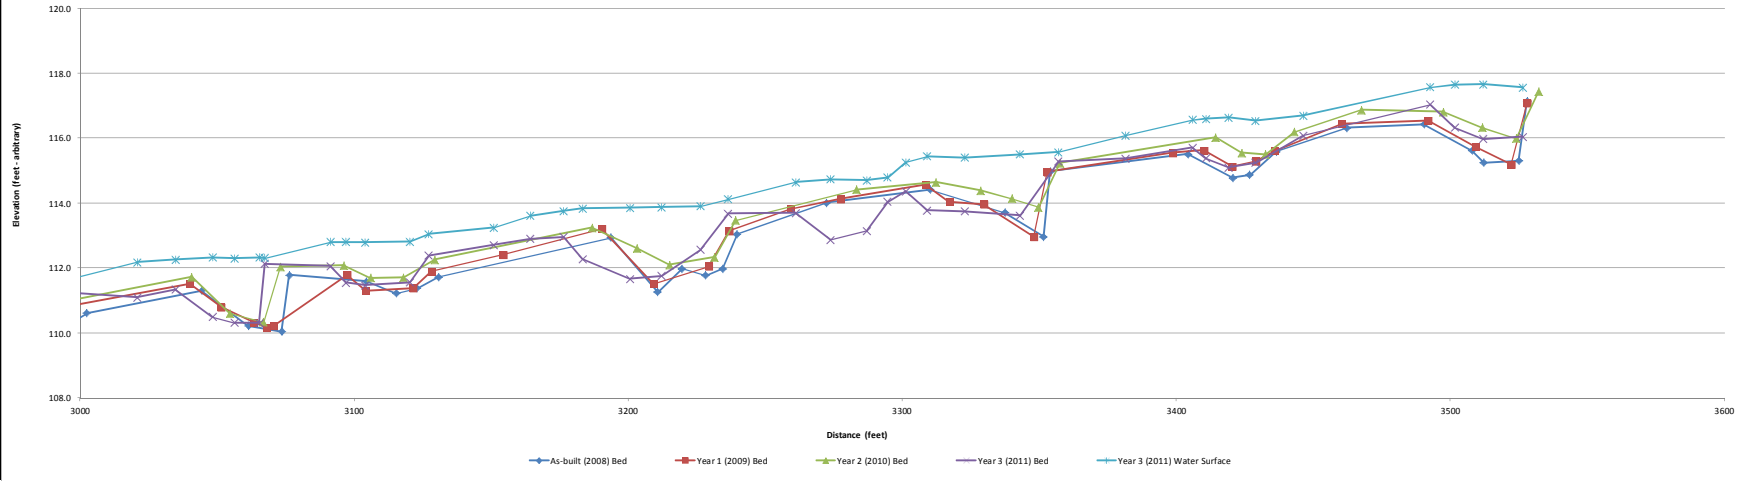
Threemile Creek Year 3 (2011) Profile - Reach 30+00 to 36+00

Avg. Water Surface Slope	As-built	2009	2010	2011
Rifle Length	0.0098	0.0097	0.0098	0.0097
Avg. Rifle Slope	51.0	52.9	51	50
Pool Length	0.0154	0.0143	0.0148	0.0173
Avg. Pool Slope	46.0	38.0	44	46
	-----	0.0008	0.0038	0.0052
