YEAR 5 (2013)
ANNUAL MONITORING REPORT
THREE MILE CREEK RESTORATION SITE
AVERY COUNTY, NORTH CAROLINA
(Contract #16-D06125-A)

FULL DELIVERY PROJECT
TO PROVIDE STREAM AND WETLAND MITIGATION
IN THE FRENCH BROAD RIVER BASIN
CATALOGING UNIT 06010108

November 2013

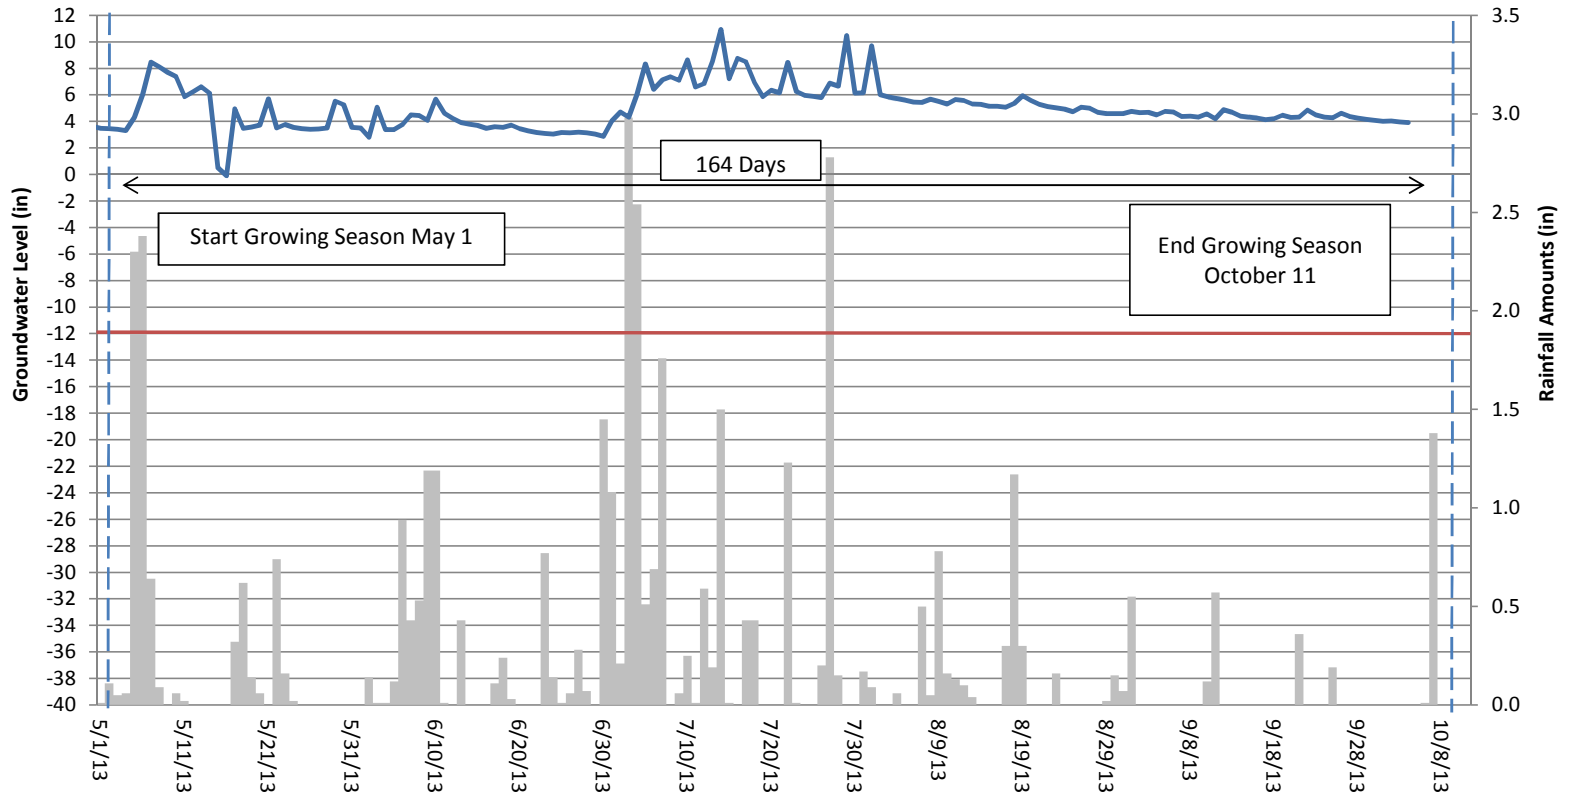
Three Mile Groundwater Gauge 1 Year 5 (2013 Data)

All three of the monitored gauges within restoration areas were inundated/saturated within 12 inches of the surface for greater than 12.5 percent of the growing season, which extends from May 1 to October 11 (163 days). Groundwater data presented in this document was collected through October 4, 2013; data will continue to be collected throughout the growing season and will be available upon request. Hydrographs containing groundwater and precipitation data for each gauge can be found in Appendix D.
