**Tick Creek Stream Restoration Project – Project # 379  
Chatham County, North Carolina**

**First Annual Monitoring Report - FINAL  
February 2006**

**TICK CREEK STREAM RESTORATION – Project # 379**  
**2006 MONITORING REPORT**

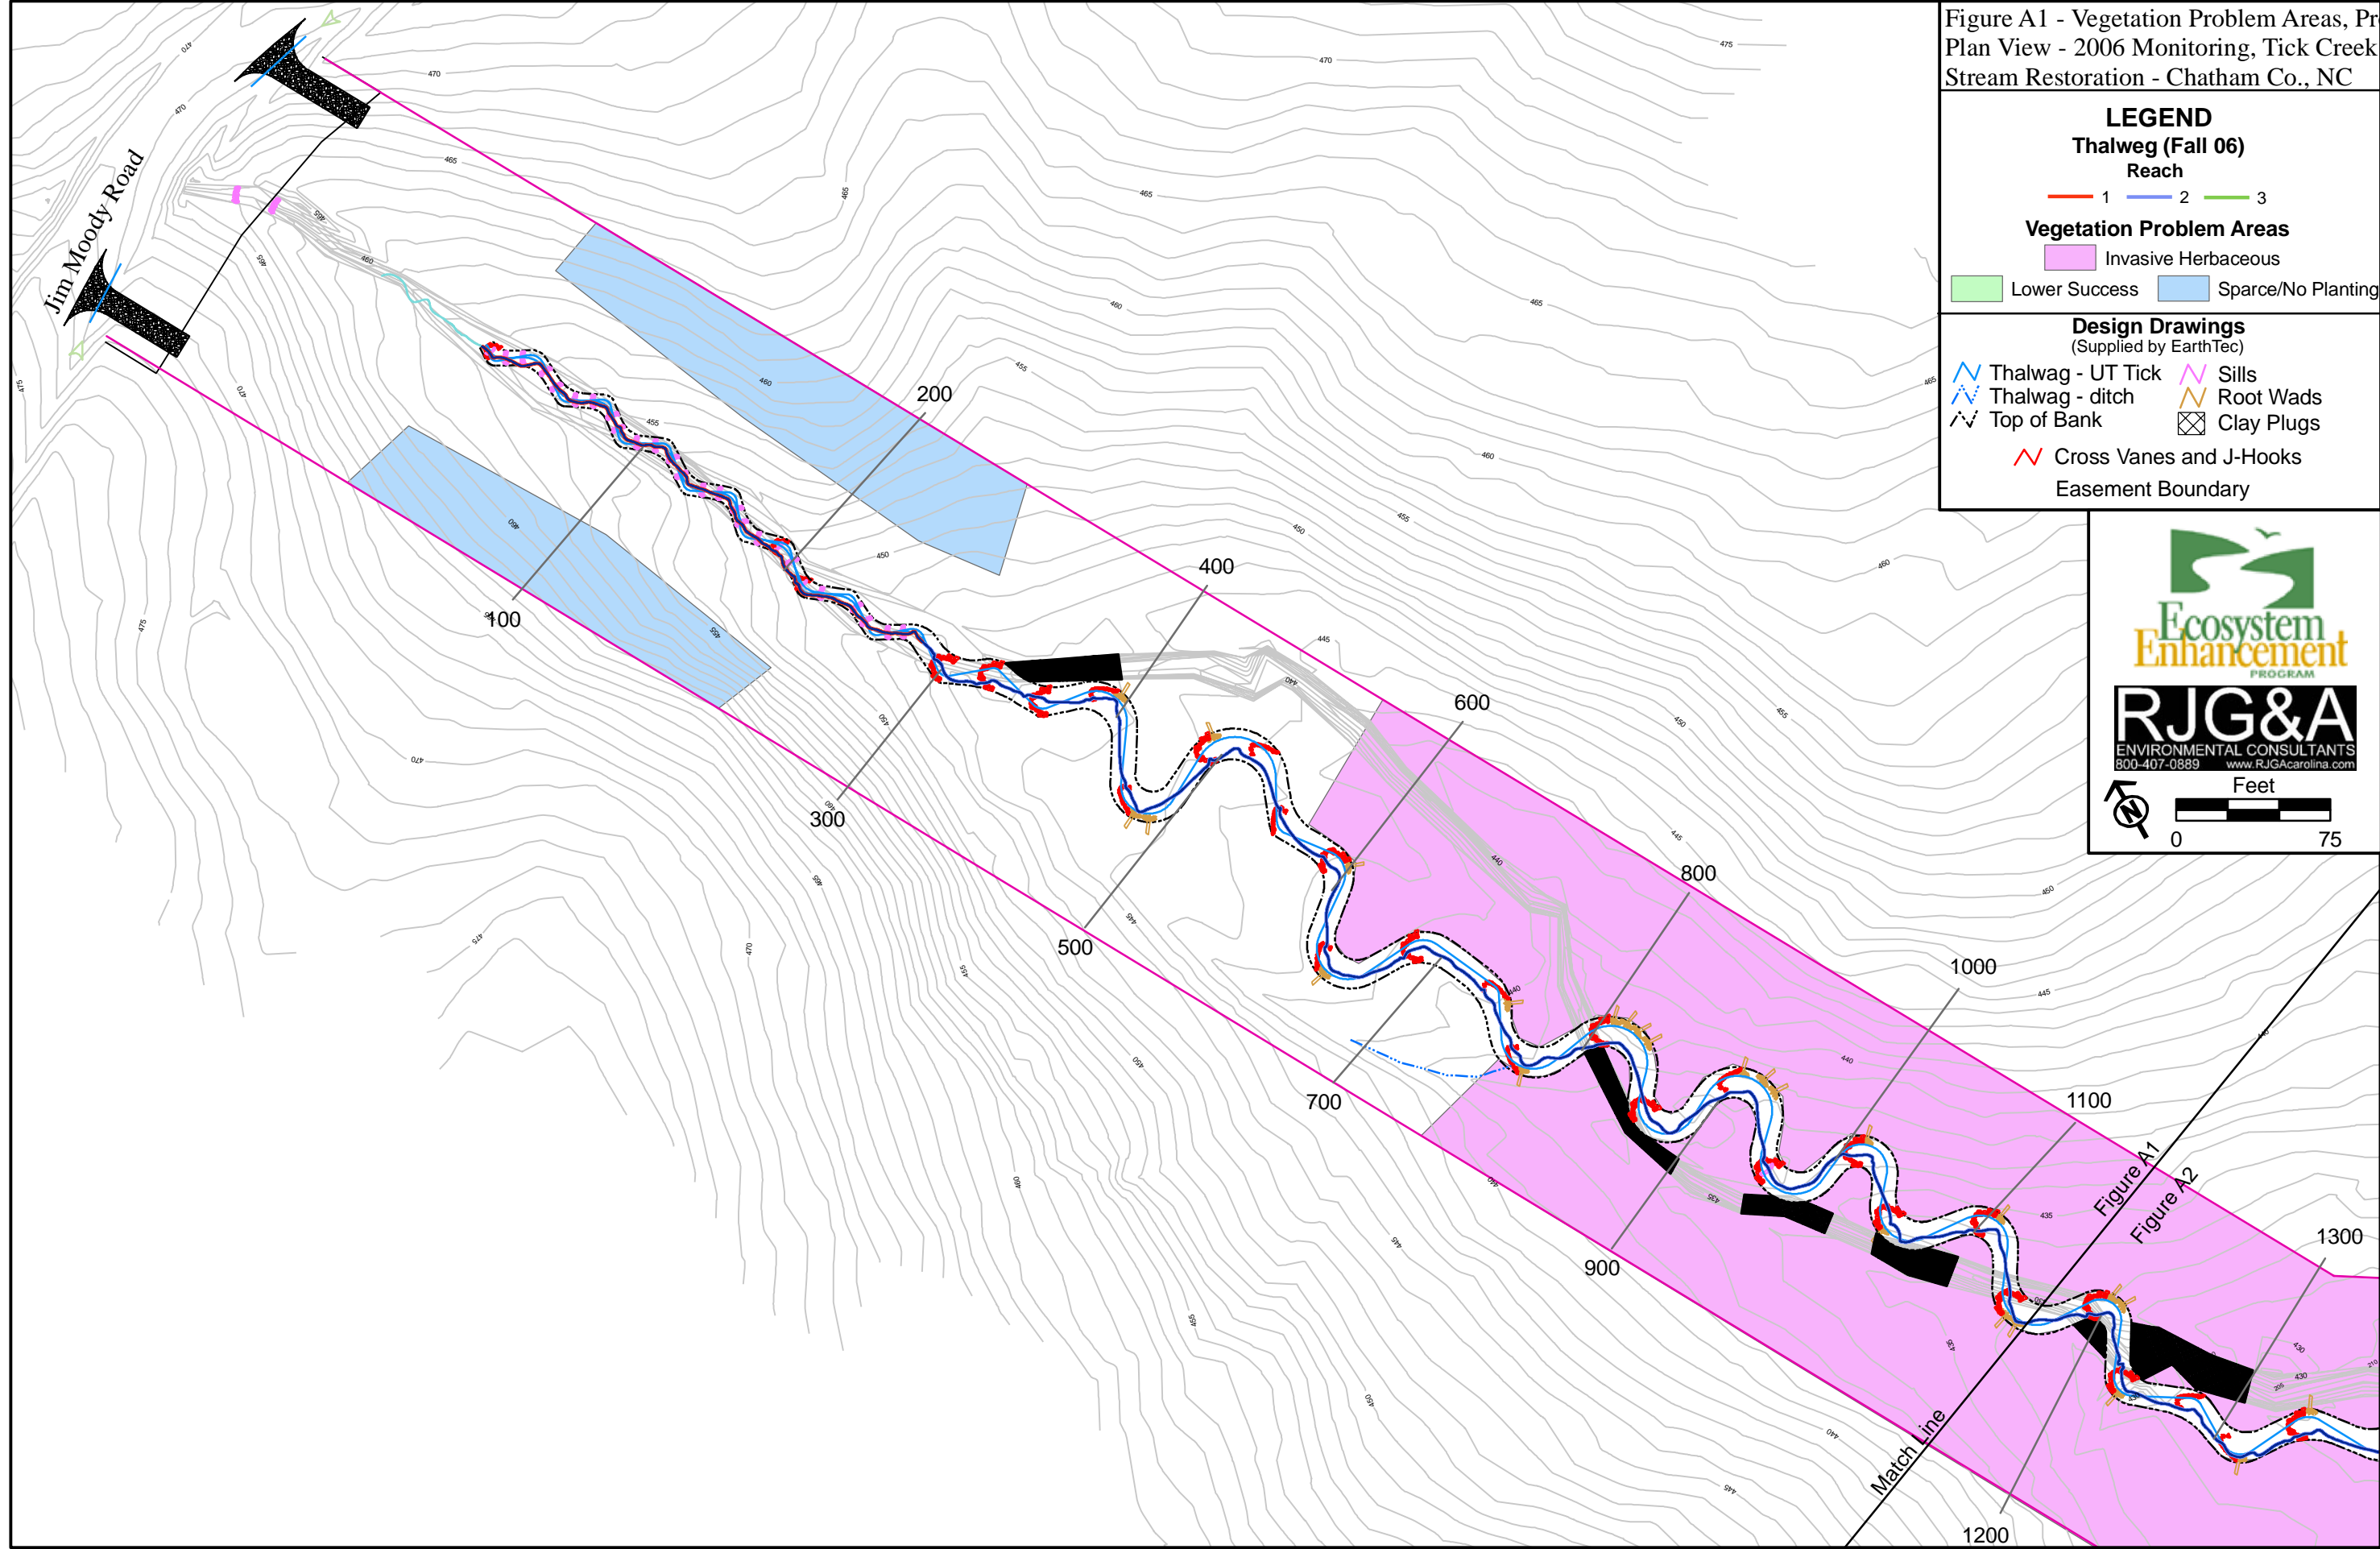
Figure A1 - Vegetation Problem Areas, Project #379  
 Plan View - 2006 Monitoring, Tick Creek  
 Stream Restoration - Chatham Co., NC

Feature/Issue	Station/Range	Probable Cause	Photo #
No/Limited Planting	00-320	Planting Crew Oversight	VP1
Dense herbaceous invasives	565-1525	Abundant groundwater	VP2
Lower planted woody stem success (relative to Reaches 1 and 2)	2300-2630	Soil Compaction During Construction	VP3

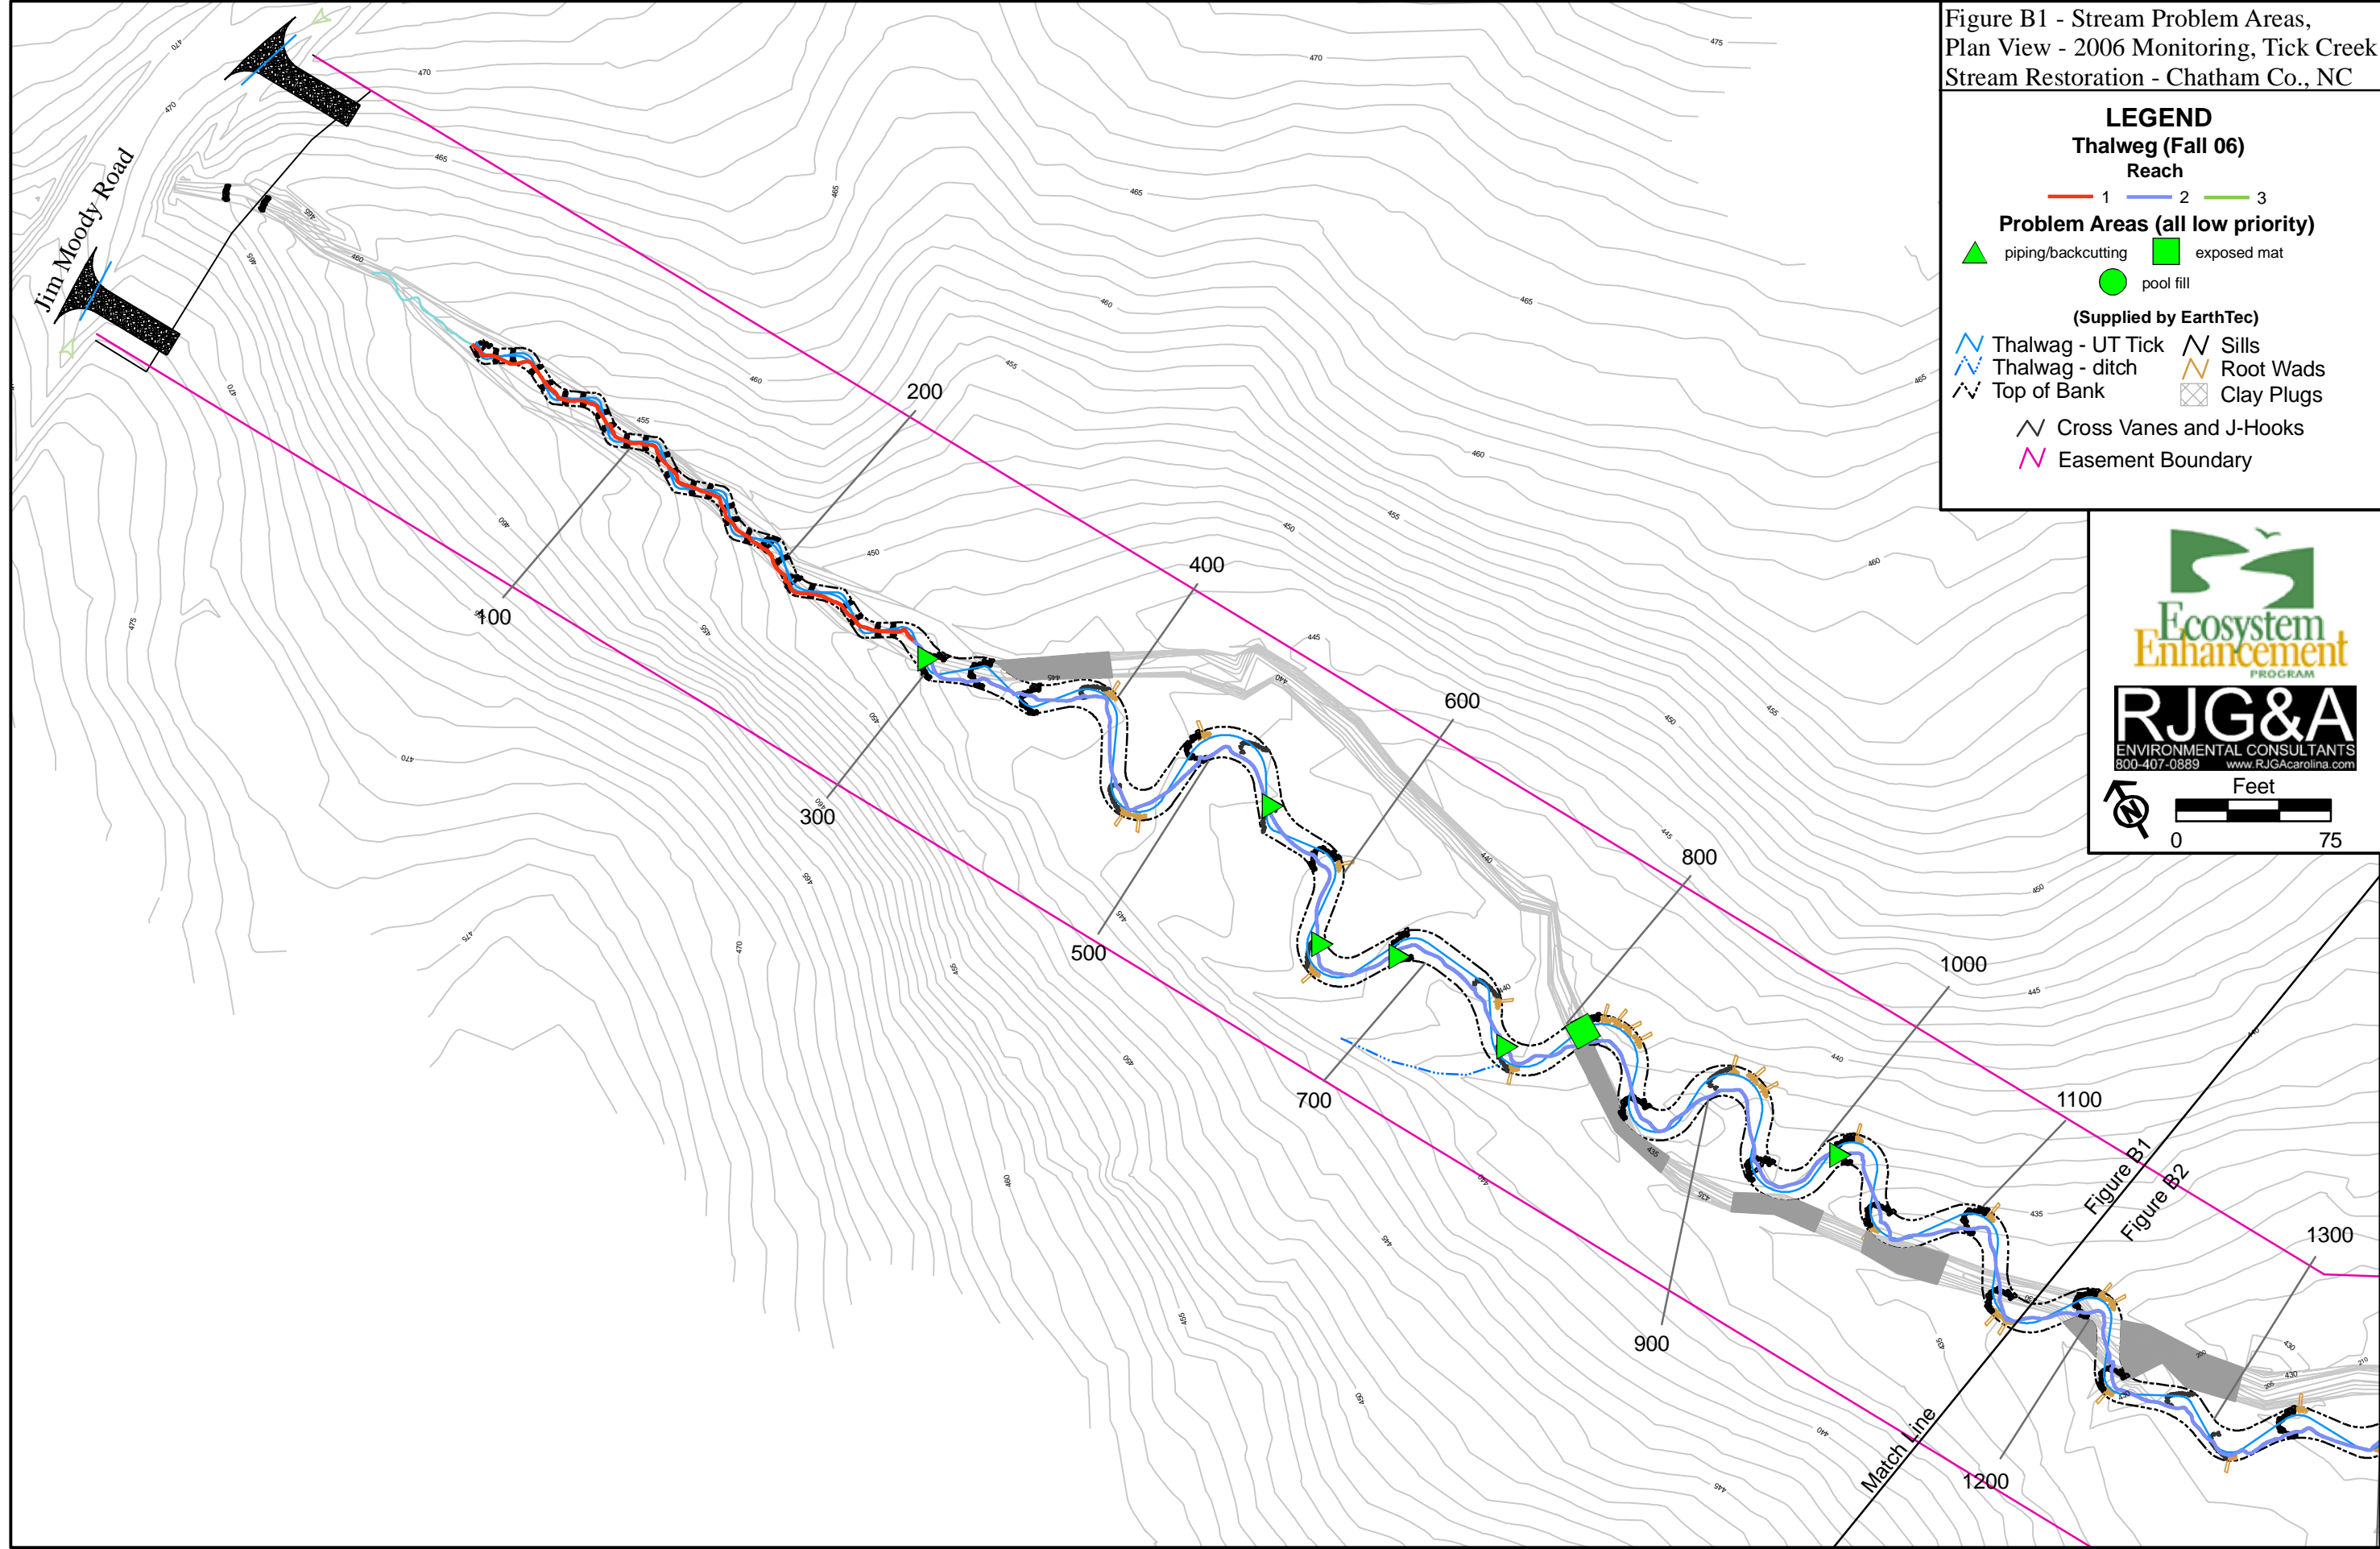
Figure B1 - Stream Problem Areas, Plan View - 2006 Monitoring, Tick Creek Stream Restoration - Chatham Co., NC

The only potential future structural problems observed were the 18 locations where, during low flow, water flows under, and through the surface rock cross vanes. Water usually *daylights* at or near the surface of downstream pools, above the supporting rock layer. These sites are not considered true *back cuts*, as they only occur between rocks, during extremely low flow conditions. Immediate remedial action is therefore not recommended but on-going observation is appropriate, particularly the downstream-most site (station 27+54), which appears to be growing.

<b>Exhibit Table X. Stream Problem Areas - Tick Creek Stream Restoration - EEP Project #379</b>			
<b>Feature/Issue</b>	<b>Station</b>	<b>Probable Cause</b>	<b>Photo #</b>
Cross Vane Piping/backcutting	290	No coarse backfill	SP1 & 2
Cross Vane Piping/backcutting	545	No coarse backfill	
Cross Vane Piping/backcutting	625	No coarse backfill

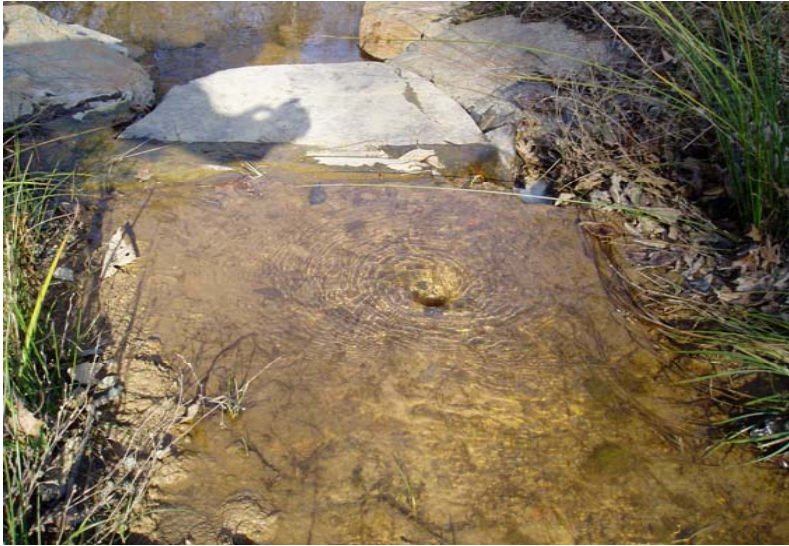
**SP1. Piping and minor backcutting (hook/vane)**
