**Tick Creek Stream Restoration Project – Project # 379
Chatham County, North Carolina**

**Second Annual Monitoring Report - FINAL
February 2008**

**TICK CREEK STREAM RESTORATION – Project # 379
2007 MONITORING REPORT**

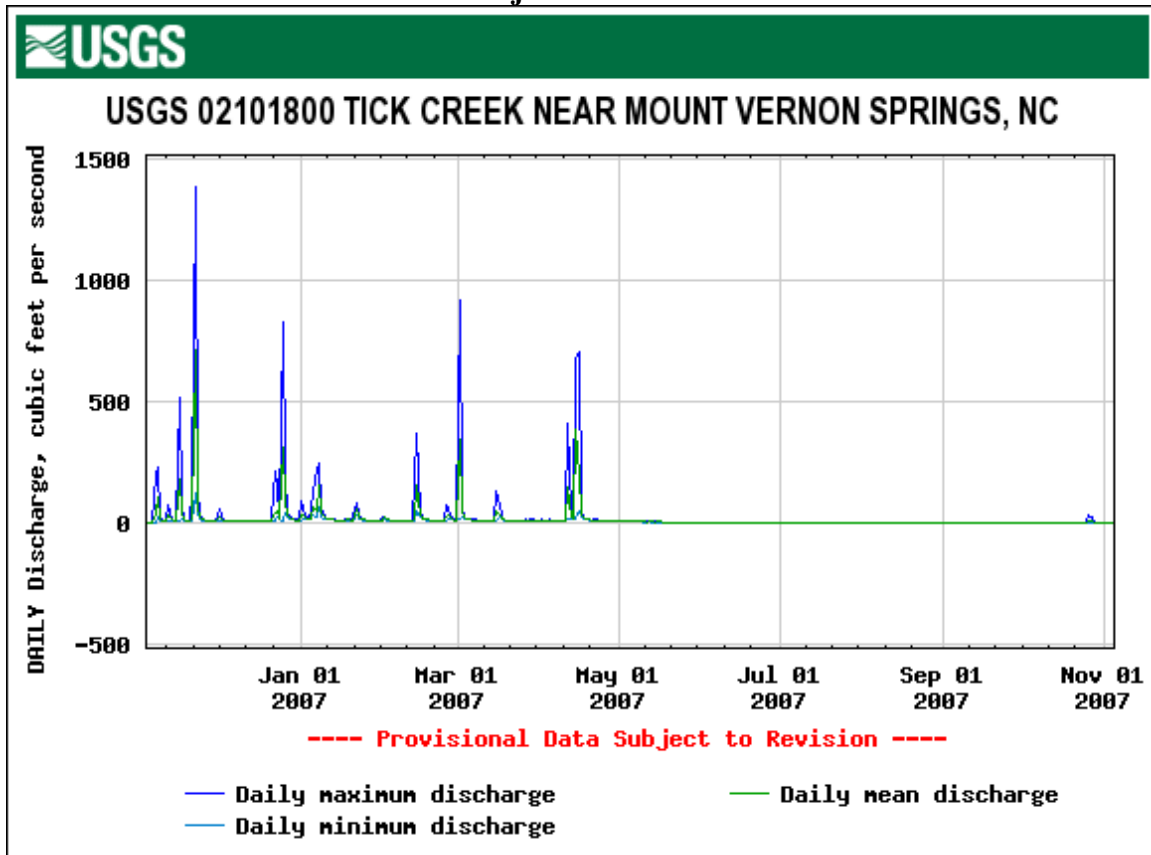
Figure 3. USGS Stream gauge data for Tick Creek upstream of US 421 - Tick Creek Stream Restoration - EEP Project #379

The USGS stream gauge on Tick Creek near Mount Vernon Springs (USGS 02101800) is located on Tick Creek, approximately 3 miles upstream from the restoration site's confluence. It has a drainage area of 15.5 square miles. Bankfull discharge at this gauge is 655.3 cubic feet per second (cfs) (Harmen, 1999). Based on USGS data for 2007 (Figure 3), there have been five bankfull events since 1 November 2006 (Figure 3 and Exhibit Table VIII).

Based on the dates of occurrence, the Tick Creek stream restoration site has received at least one bankfull event during both its first and second monitoring years.

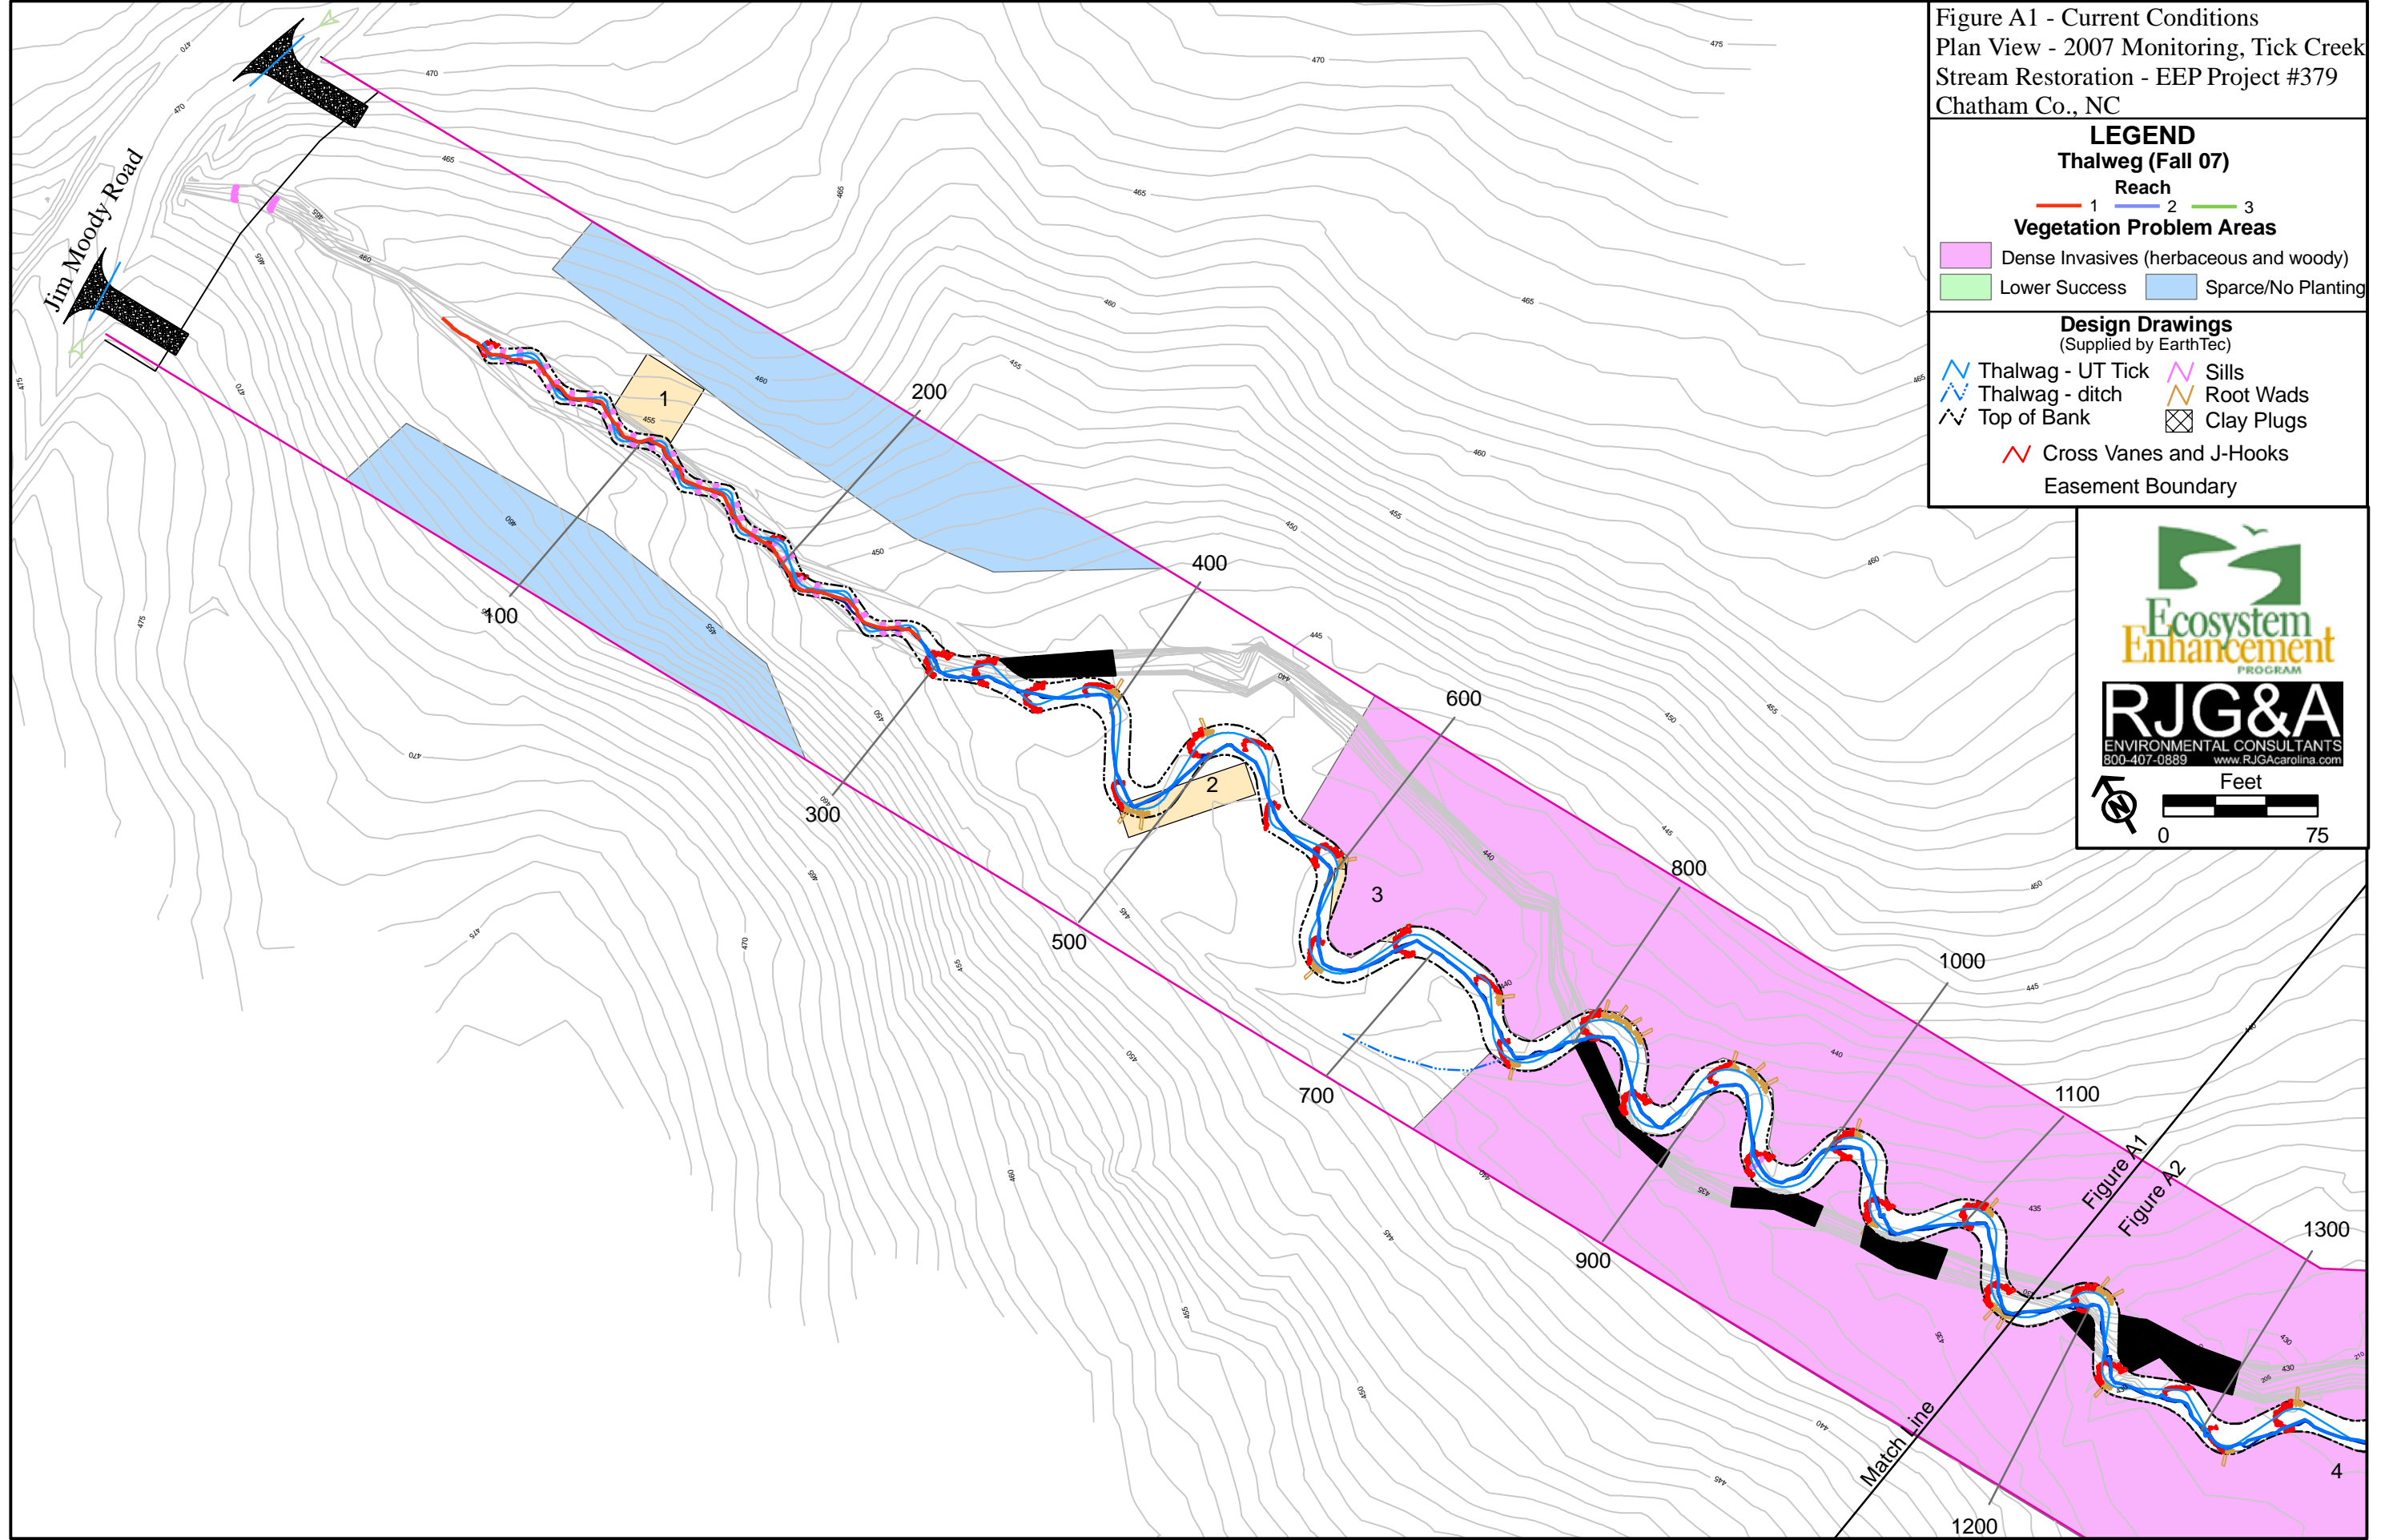
Figure A1 - Current Conditions
 Plan View - 2007 Monitoring, Tick Creek
 Stream Restoration - EEP Project #379
 Chatham Co., NC

As was observed in Reach 1 in 2006, woody stem planting in the areas furthest from the stream banks was sporadic, minimal, and absent in some places. Because of the lack of overstory from mature trees, which are present in Reach 2 and most of Reach 3, early successional herbaceous volunteer density and relative cover was again high (dog fennel (*Eupatorium capillofolium*), and horseweed (*Conyza canadensis*)). Natural succession of invasive perennials, primarily blackberry (*Rubus argutus*) has begun throughout Reach 1. This type of early successional herbaceous density is common in recently disturbed areas and can be beneficial to the planted stems by prolonging soil moisture in upland areas and reducing early evapotranspiration, provided invasive woody species don't also colonize, and the newly planted *understory* of woody stems remains successful, which it has after its second growing season. Invasive woody volunteers were not quantitatively observed in Reach 1's monitoring plot (plot 1). They are relatively sparse outside the plots.

Reach 2 had good success rates for planted individuals, but, invasion from autumn olive (*Eleagnus umbellata*), mimosa (*Albizia julibrissin*), and Chinese and Japanese privet (*Ligustrum sinense* and *L. japonicum*, respectively) appears to have increased since 2006. Similarly, native early-successional woody species density, particularly sweet gum (*Liquidambar styraciflua*), has significantly increased in Reach 2 since 2006. Because of

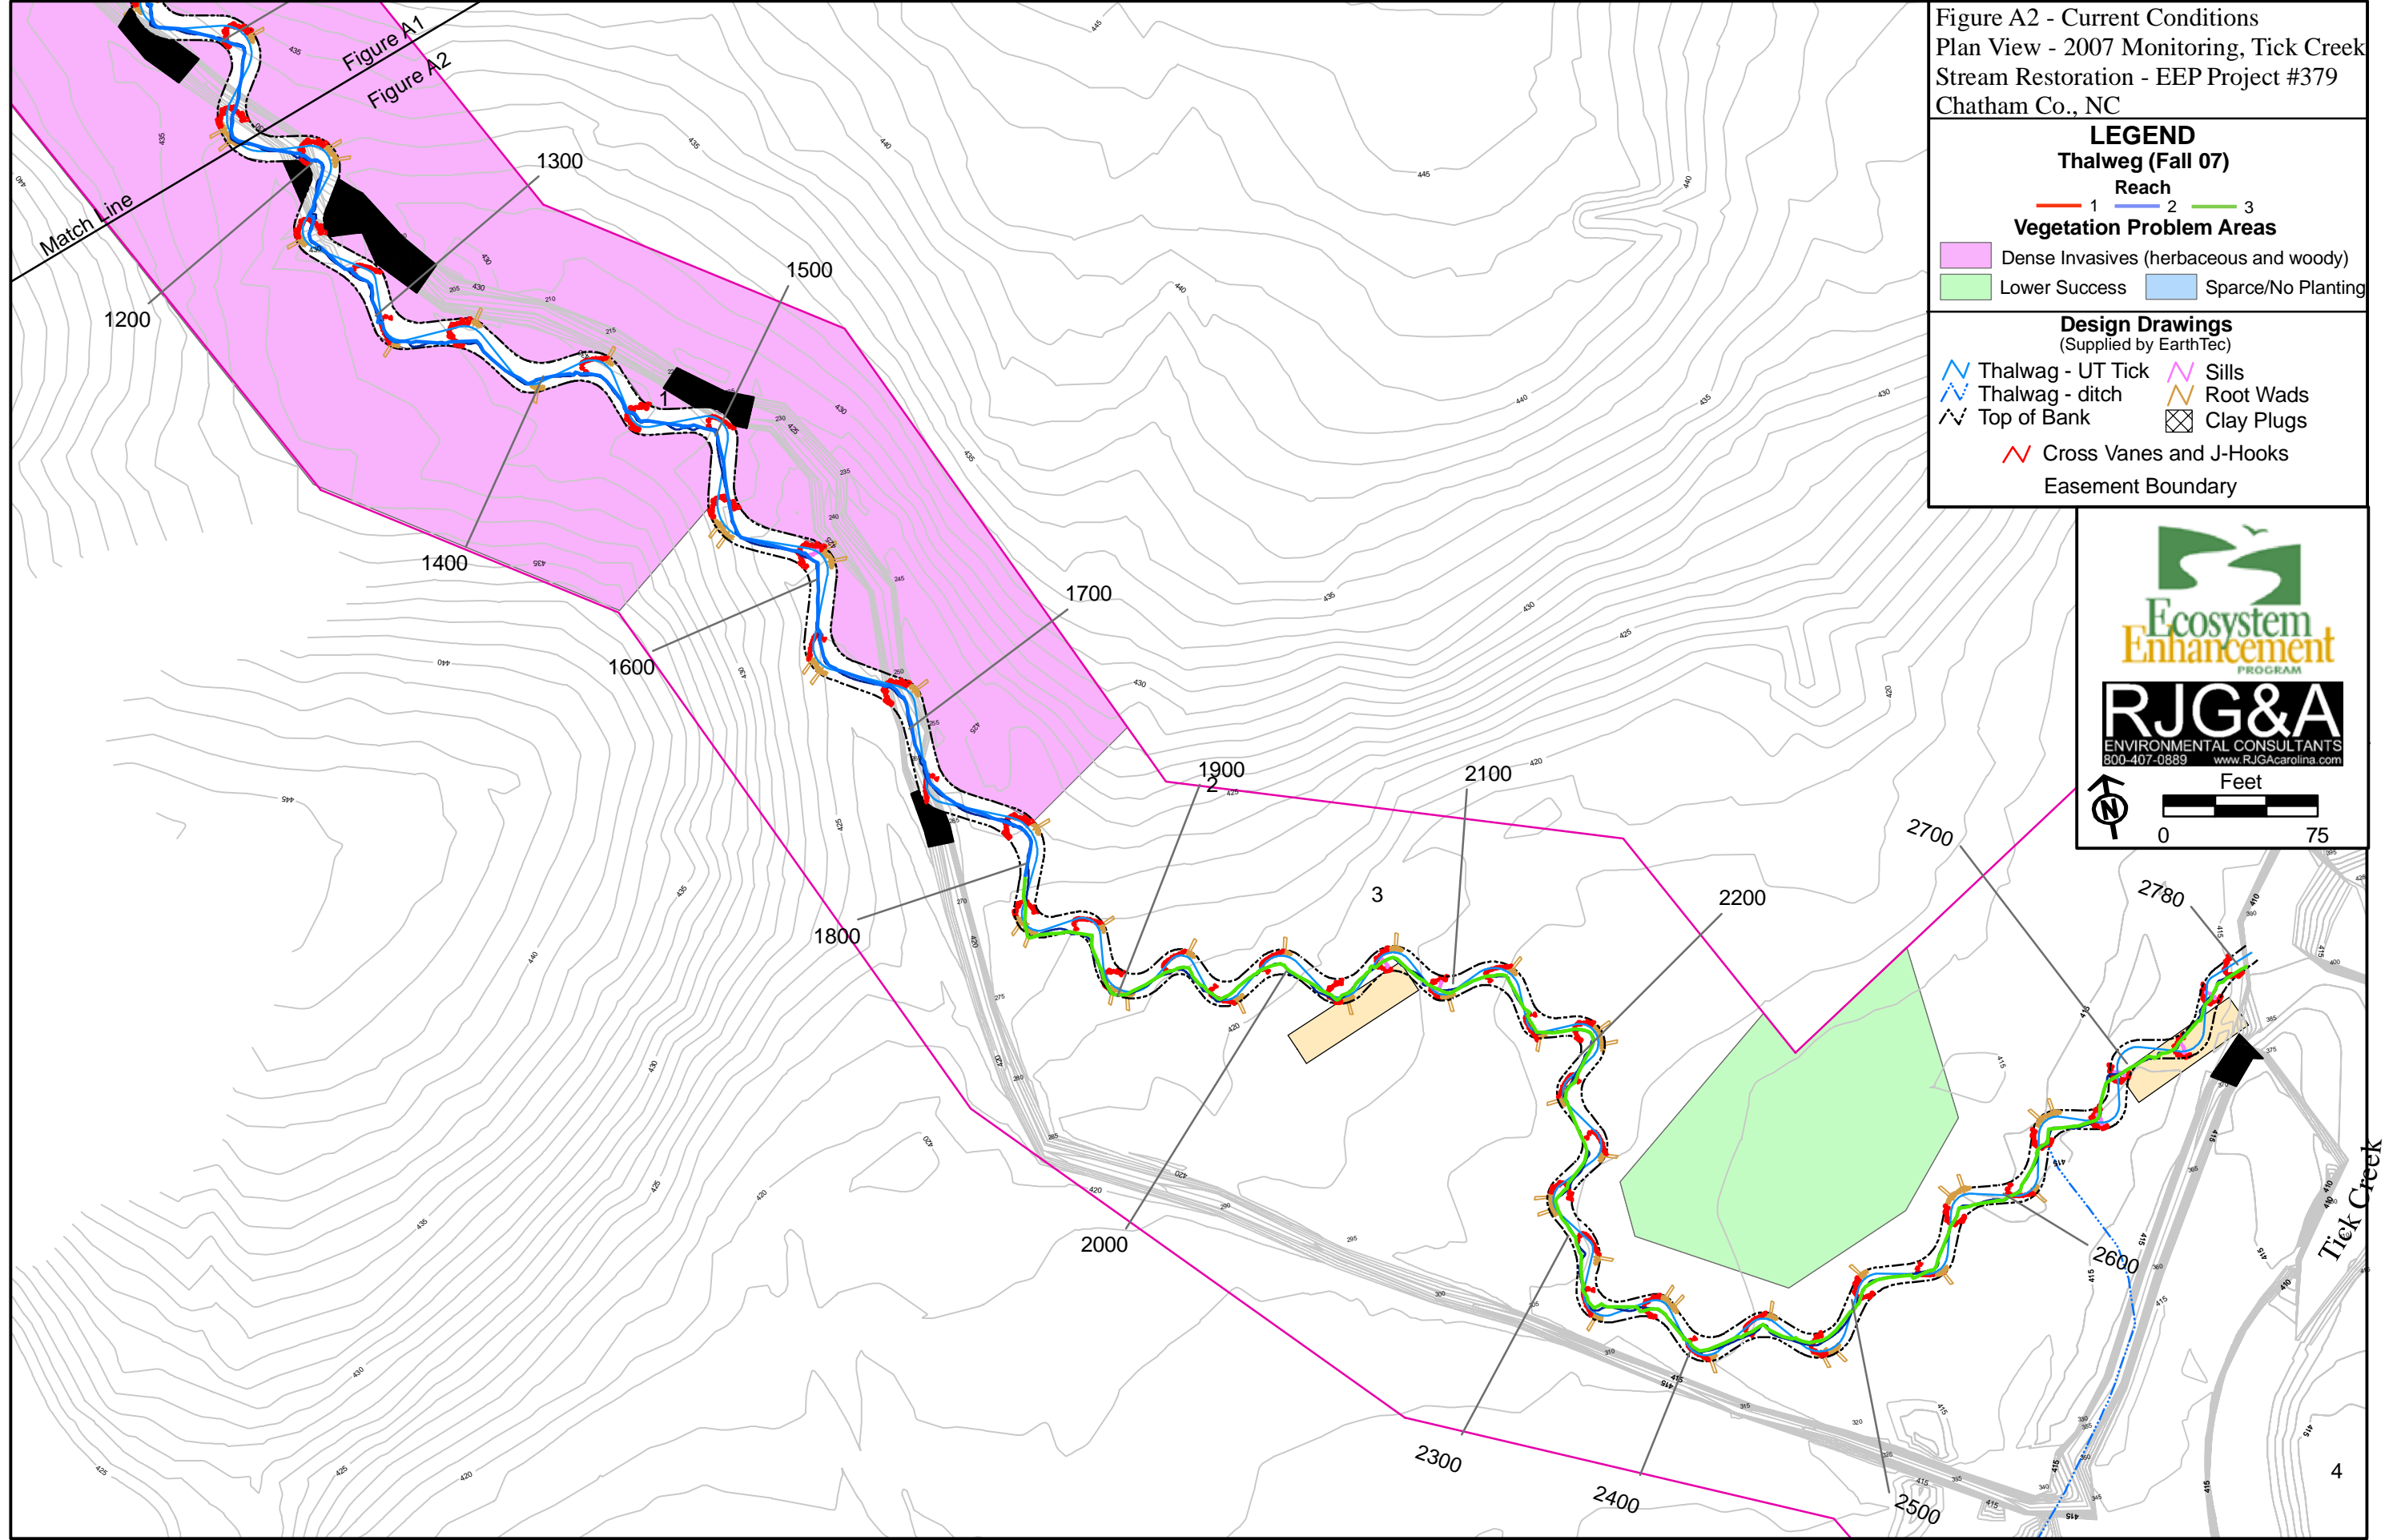
Figure A2 - Current Conditions
 Plan View - 2007 Monitoring, Tick Creek
 Stream Restoration - EEP Project #379
 Chatham Co., NC

As in 2006, Reach 3 had planted woody stem density well above the targeted 320 stems per acre, and relatively minimal invasive species problems. Invasive individuals were present, but much less dense than in either Reach 1 or Reach 2. A suspected cause of the relatively high mortality inside this large bend is substrate compaction. The Restoration Design Plan View map indicates that a relatively large *staging area* was located here during construction. Because of the adequate live planted stem density in plot 6 no remedial action is recommended at this time. Like in the Reach 1 and Reach 2 problem areas, continued observation is appropriate.

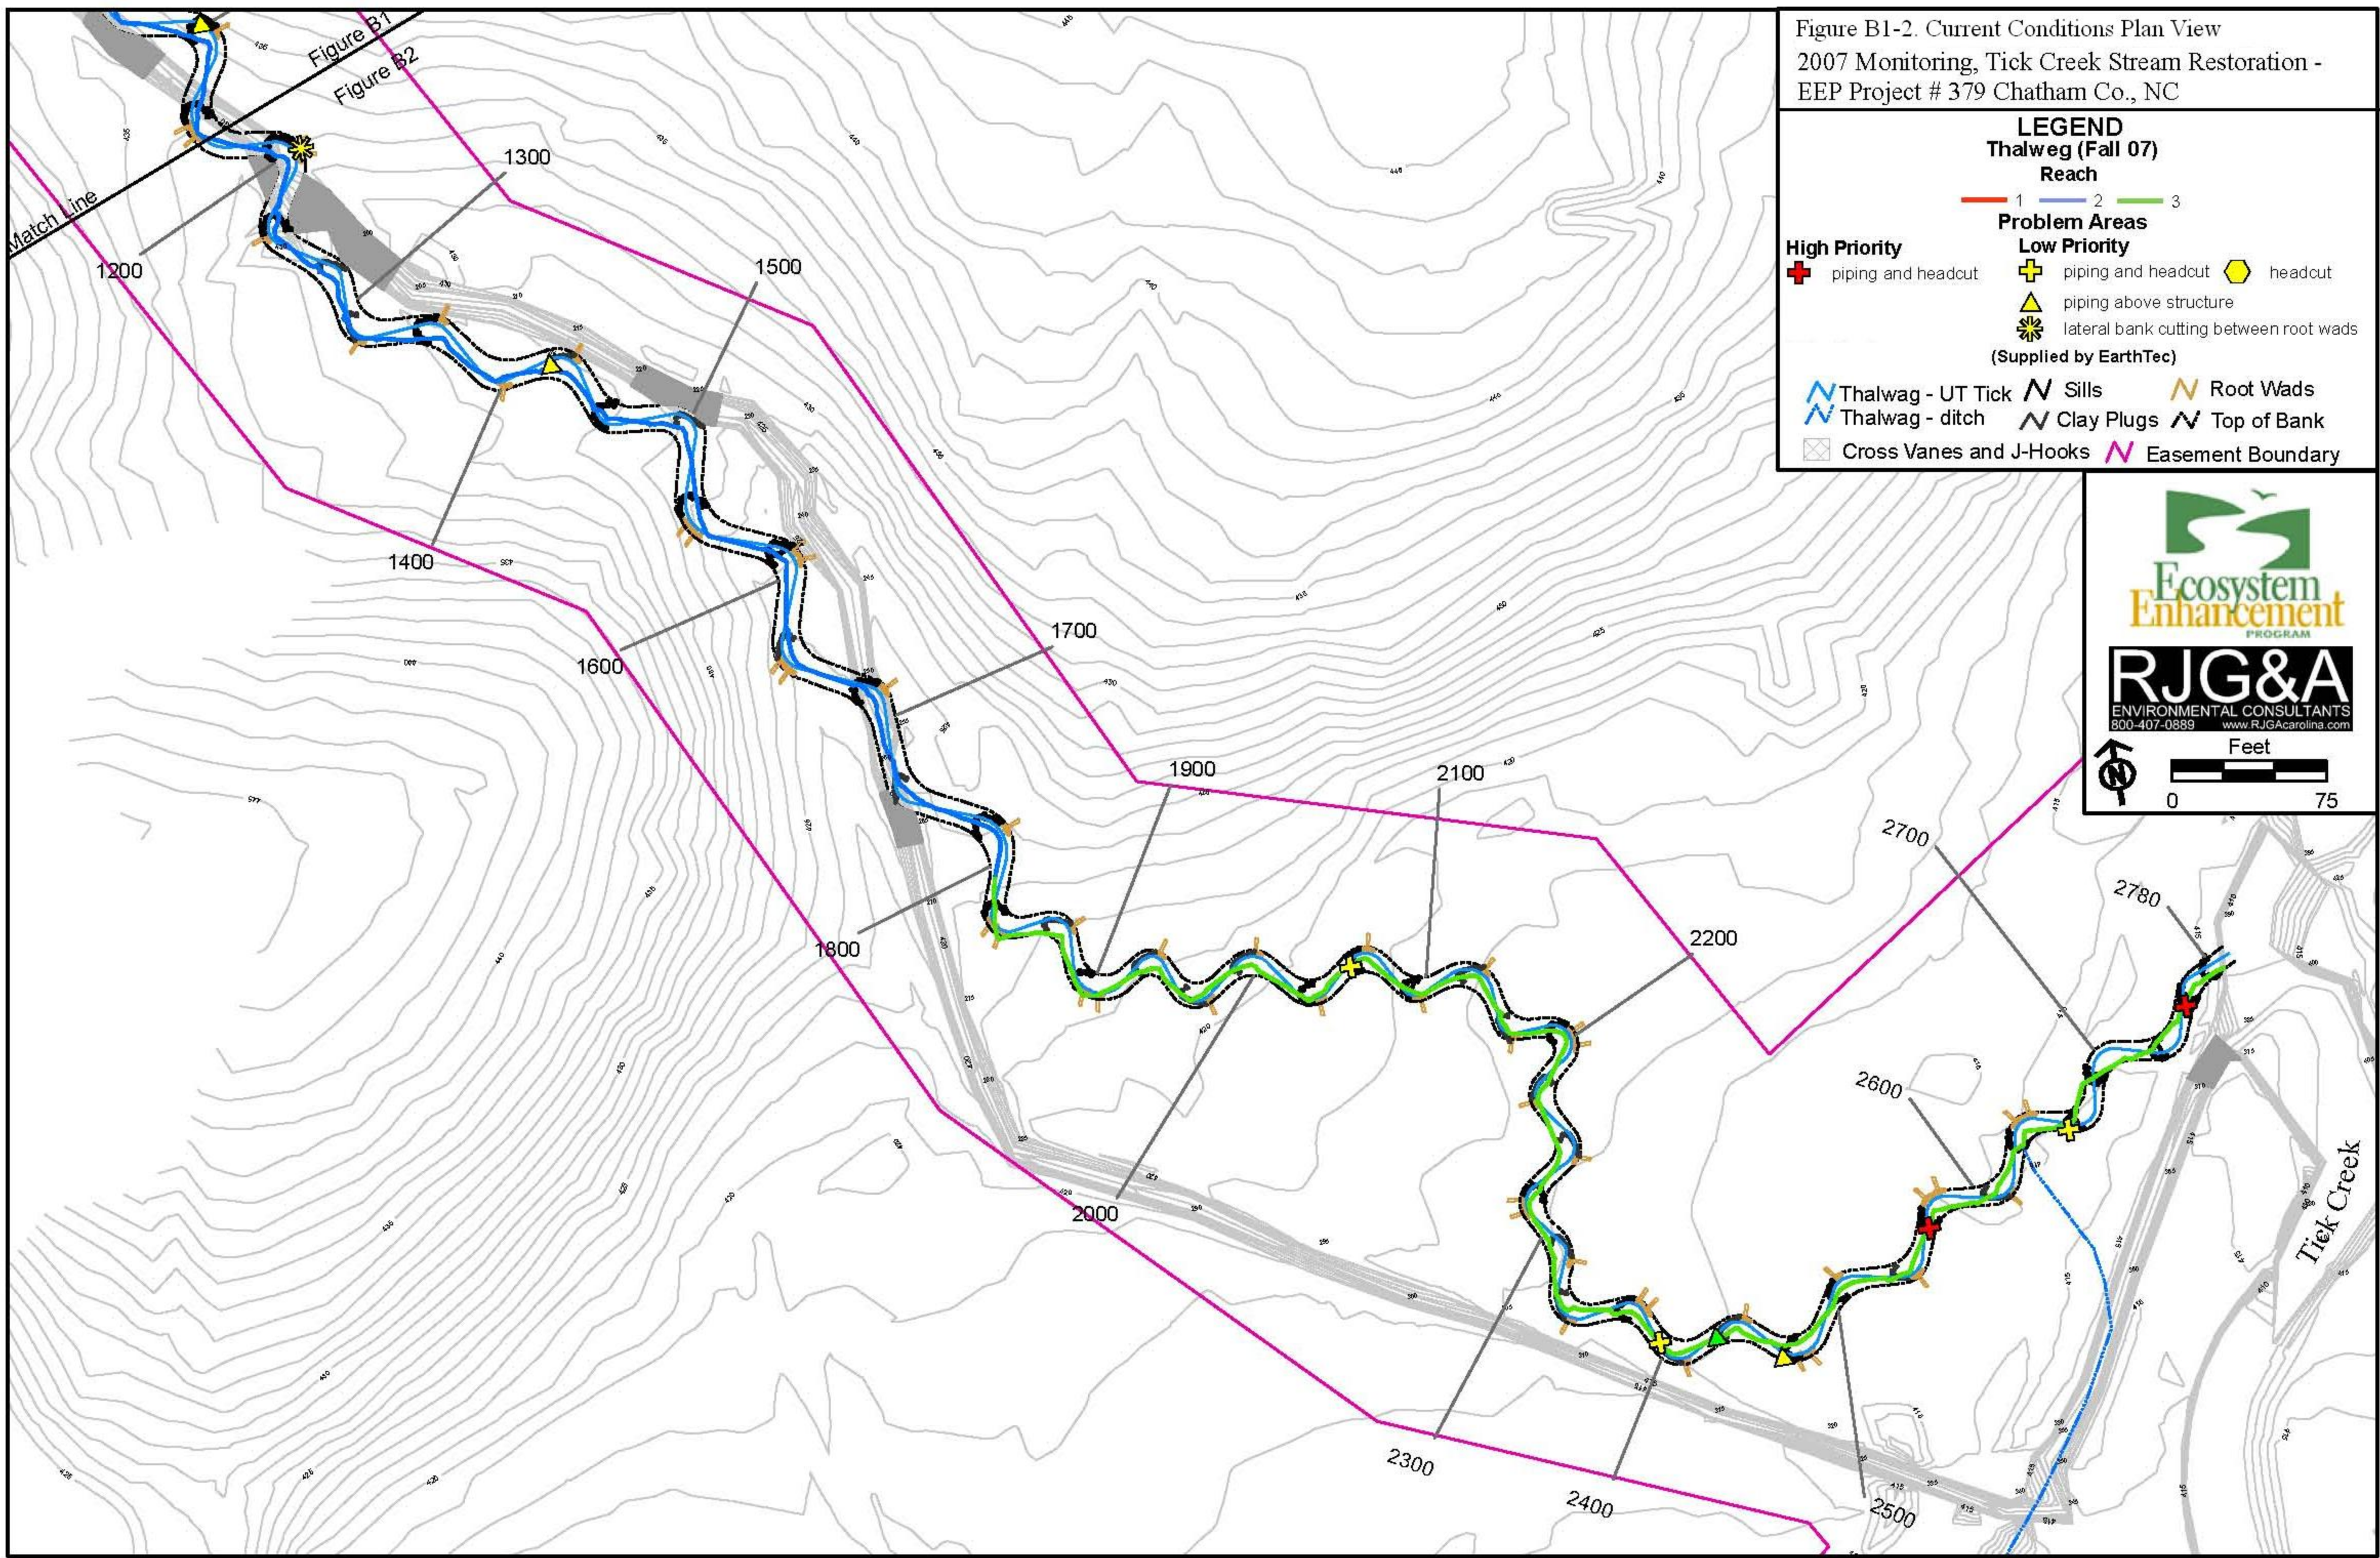
As shown in Appendix B2, 16 structural and substrate problem areas were identified during the 28 October 2007 qualitative evaluation. Two of these, as illustrated in B1 (Current Conditions Plan View (Streams)), have obviously worsened. They are both located in the final series of step pools above restoration Reach 3's confluence with Tick Creek. They warrant close and frequent observation to prevent them from becoming undermined, which could eliminate grade control.

With the exception of the channel headcut (station 396) and the lateral bank cut between rootwads (station 1203), the remaining 12 problem areas identified had been previously observed. Because of the lack of flowing water inside the restored channel, the condition of five of them (stations 290, 545,760, and 2,373) was not clear. Several problem areas identified as locations with moderate piping during April 2007 appeared to have stabilized.

B2. Stream Problem Areas Table - Tick Creek Stream Restoration - EEP Project #379			
Feature/Issue	Station	Suspected Cause	Photo #
Reach 1			
Piping above structure	290	Insufficient coarse backfill	SP1
Reach 2			
Headcut channel	396	Insufficient coarse backfill	SP3
Piping above structure	545	Insufficient coarse backfill	SP1
Piping above structure	625	Insufficient coarse backfill	SP1
Piping above structure	760	Insufficient coarse backfill	SP1
Piping with headcut	1001	Insufficient coarse backfill	SP2
Piping above structure	1104	Insufficient coarse backfill	SP1
Lateral bankcut between rootwads	1203	Insufficient coarse backfill	SP4
Piping above structure	1418	Insufficient coarse backfill	SP1
Reach 3			
Piping with headcut	2050	Insufficient coarse backfill	SP2
Piping above structure	2373	Insufficient coarse backfill	SP1
Piping with headcut	2396	Insufficient coarse backfill	SP2
Piping above structure	2463	Insufficient coarse backfill	SP1

Piping with headcut	2568	Insufficient coarse backfill	SP2
Piping with headcut	2662	Insufficient coarse backfill	SP2
Piping with headcut	2754	Insufficient coarse backfill	SP2
