**TICK CREEK STREAM RESTORATION – NCEEP Project #379**

**Third Annual Monitoring Report – FINAL**

**January 2009**

**TICK CREEK STREAM RESTORATION – Project # 379  
2008 MONITORING REPORT**

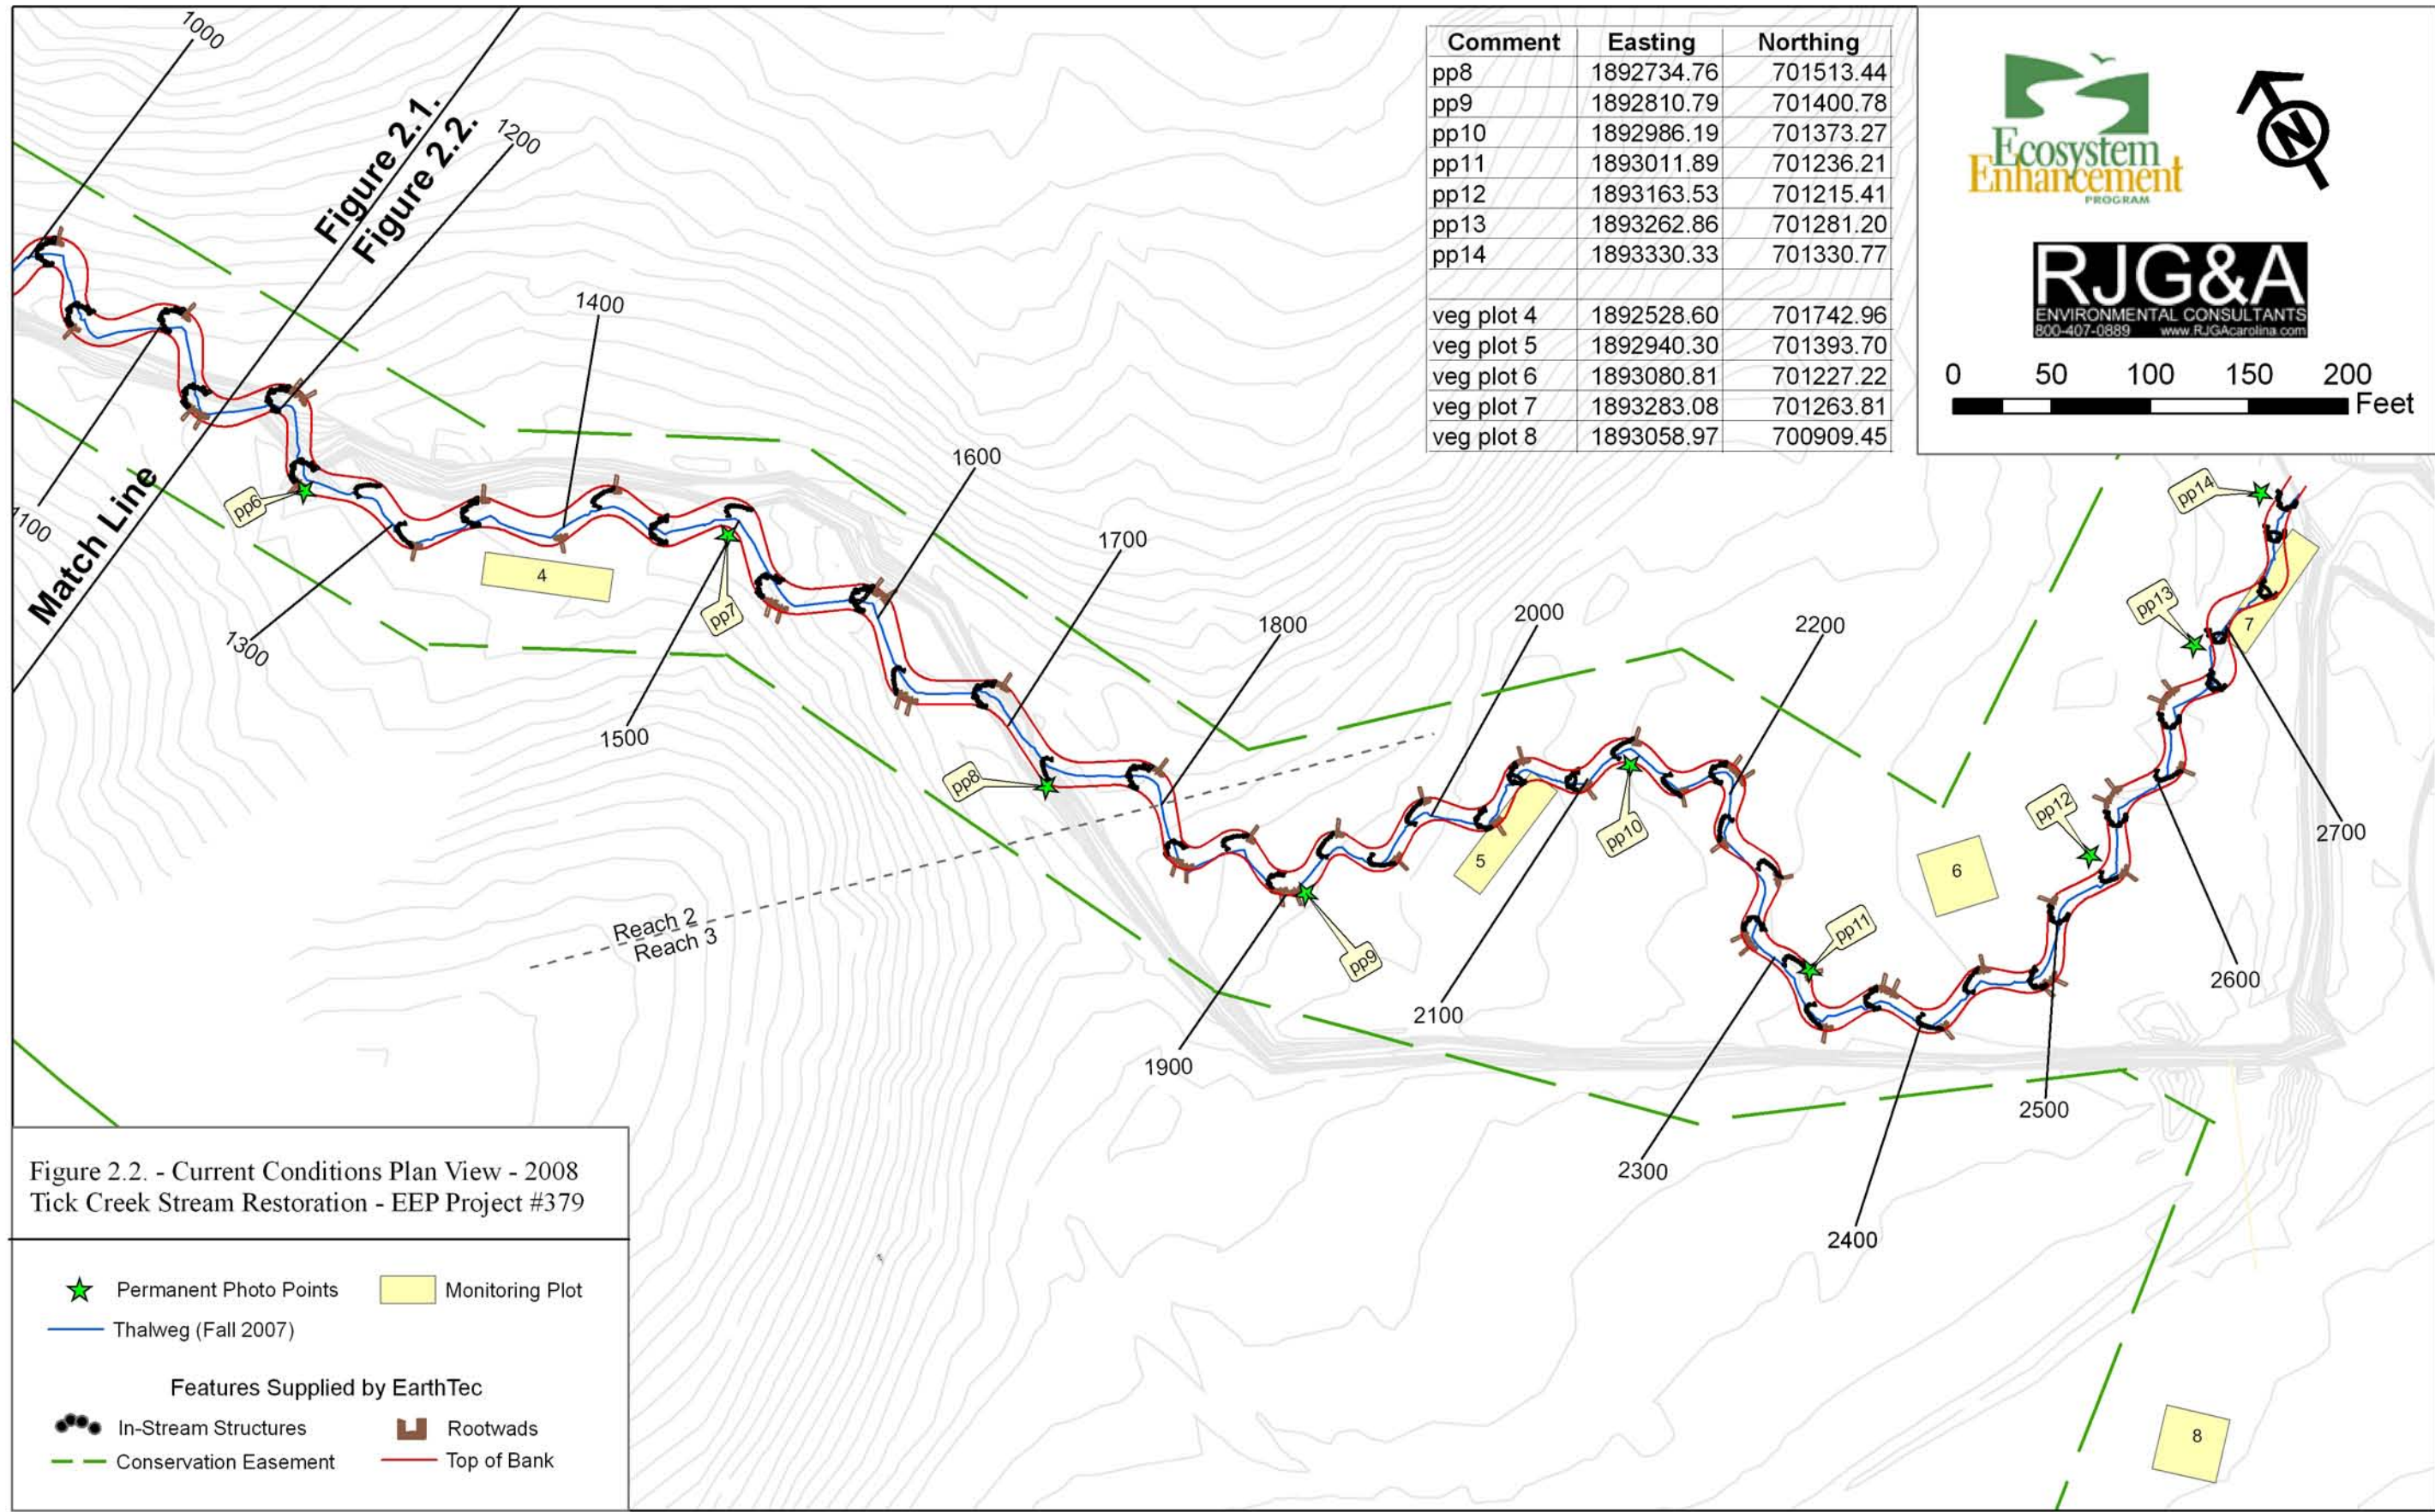
Figure 2.2. - Current Conditions Plan View - 2008  
Tick Creek Stream Restoration - EEP Project #379

Vegetation problem areas at the Tick Creek restoration site include sparse planting, invasive herbaceous cover, and relatively low planting success (Figures B.1.1. and B.1.2.). Reach 1 woody stem planting density was an issue in the areas furthest from the stream banks (Appendix A3-VP1). Natural succession of perennials, primarily blackberry (*Rubus argutus*) has begun throughout Reach 1. This type of early successional herbaceous density is common in recently disturbed areas and can be beneficial to the planted stems by prolonging soil moisture in upland areas and reducing early evapotranspiration.

Reach 3 continues to have relatively minimal invasive species problems. *Rubus argutus* has become more widespread around monitoring plot 8. Plot 6 continues to suffer from a lower success rate than the remaining plots in the restoration (Appendix A.3.-VP3). As noted in previous years, suspected cause is substrate compaction. The Restoration Design Plan View map indicates that a relatively large *staging area* was located here during construction. Because of the adequate live planted stem density in plot 6, no remedial action is recommended at this time.
