# **Town Creek Restoration Project – Option B Year 1 Monitoring Report**

**Stanly County, North Carolina**

**DMS Project ID Number – 95026; NC DEQ Contract No. 003990**

**Submission Date: December 2017**

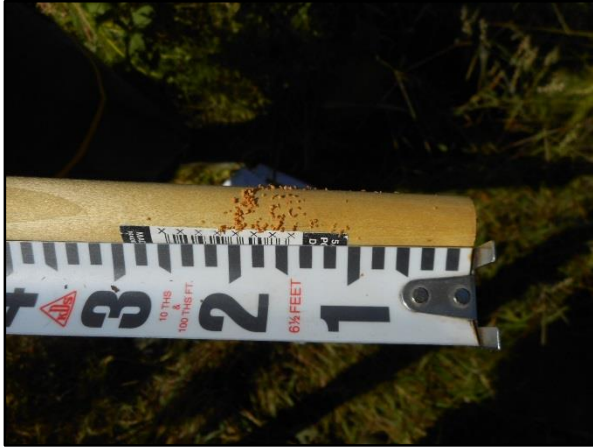
**Crest Gauge Photo 1 (10/12/16)**

<b>Table 12. Verification of Bankfull Events</b>					
<b>Town Creek Restoration Project: DMS Project ID No. 95026</b>					
<b>Date of Data Collection</b>	<b>Date of Occurrence</b>	<b>Method</b>	<b>Reach Location</b>	<b>Gauge Height (FT)</b>	<b>Photo # (if available)</b>
10/12/2016	Between 5/2016 and 10/12/2016	Crest Gauge	Reach 5 Station 42+50	0.2	Crest Gauge Photo 1

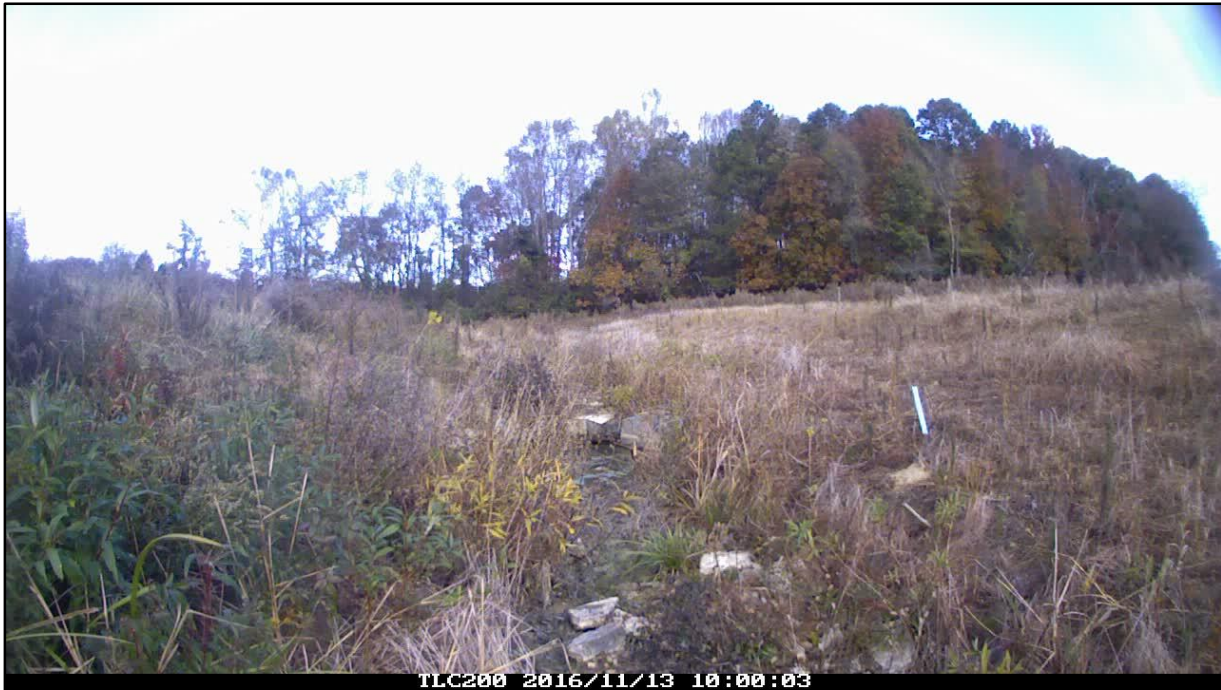
**Flow Documentation Photo - TC FL2 Photo (11/13/2016)**

<b>Table 13. Verification of In-stream Flow Conditions</b>			
<b>Town Creek Restoration Project: DMS Project ID No. 95026</b>			
<b>Flow Gauge ID</b>	<b>Reach Location</b>	<b>Consecutive Days of Flow<sup>1</sup></b>	<b>Cumulative Days of Flow<sup>2</sup></b>
TCFL1	Reach 1 Station 11+05	168	231
TCFL2	Reach 2 Station 13+02	150	195
