Town Creek Restoration Project – Option B Year 2 Monitoring Report

Stanly County, North Carolina

DMS Project ID Number – 95026; NC DEQ Contract No. 003990

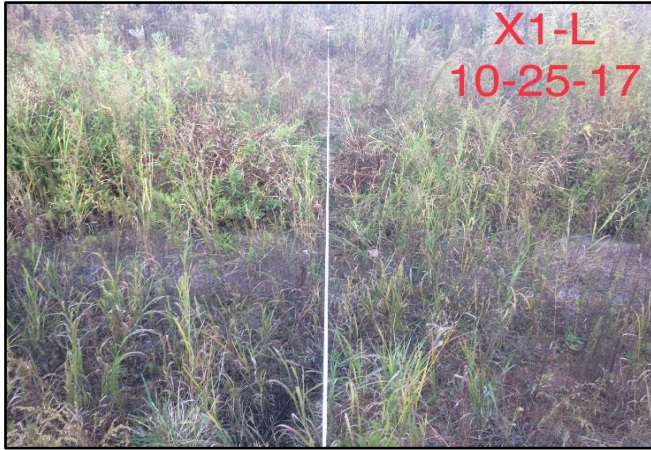
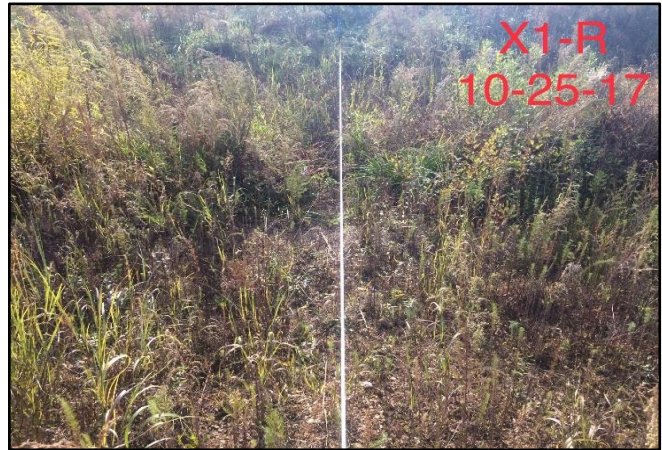
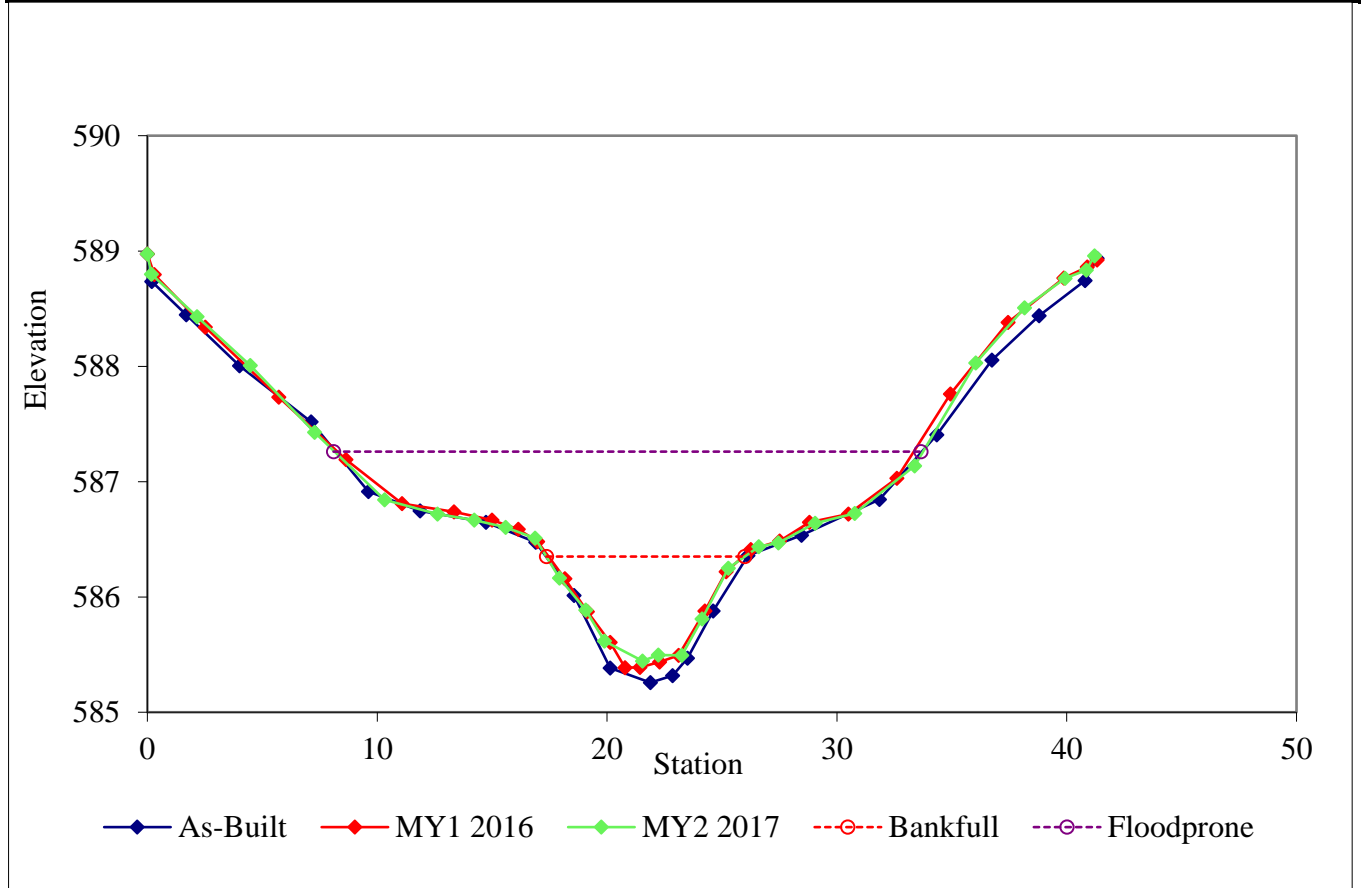
Permanent Cross-section
X1 - Reach 2
(Monitoring Year 2 - Collected October 2017)

Feature	Stream Type	BKF Area	BKF Width	BKF Depth	Max BKF Depth	W/D	BH Ratio	ER	BKF Elev	TOB Elev	WFPA
Riffle	C	4.76	8.64	0.55	0.91	15.71	1.00	2.96	586.35	586.44	25.56

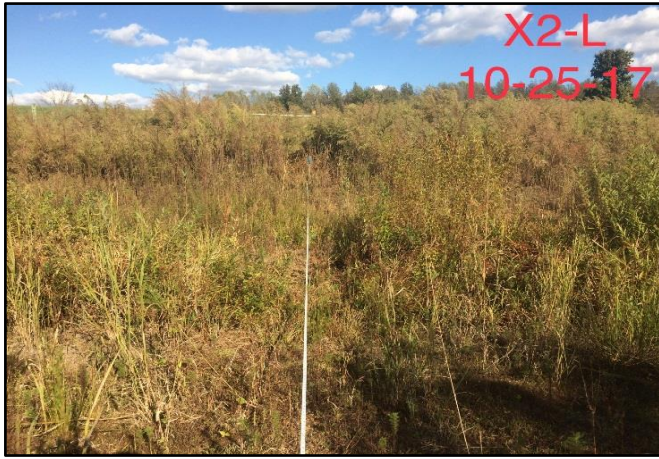
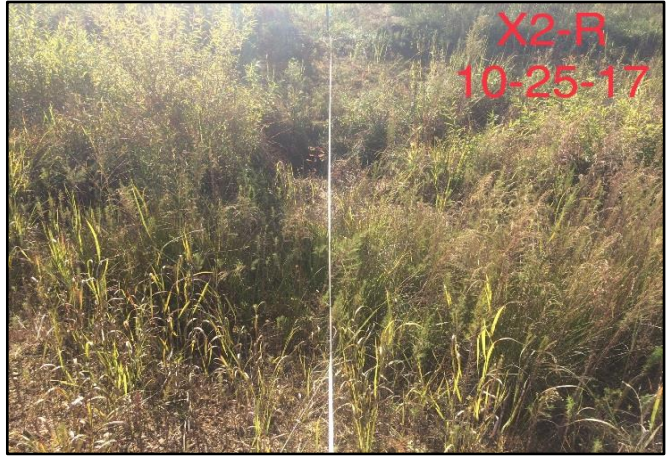
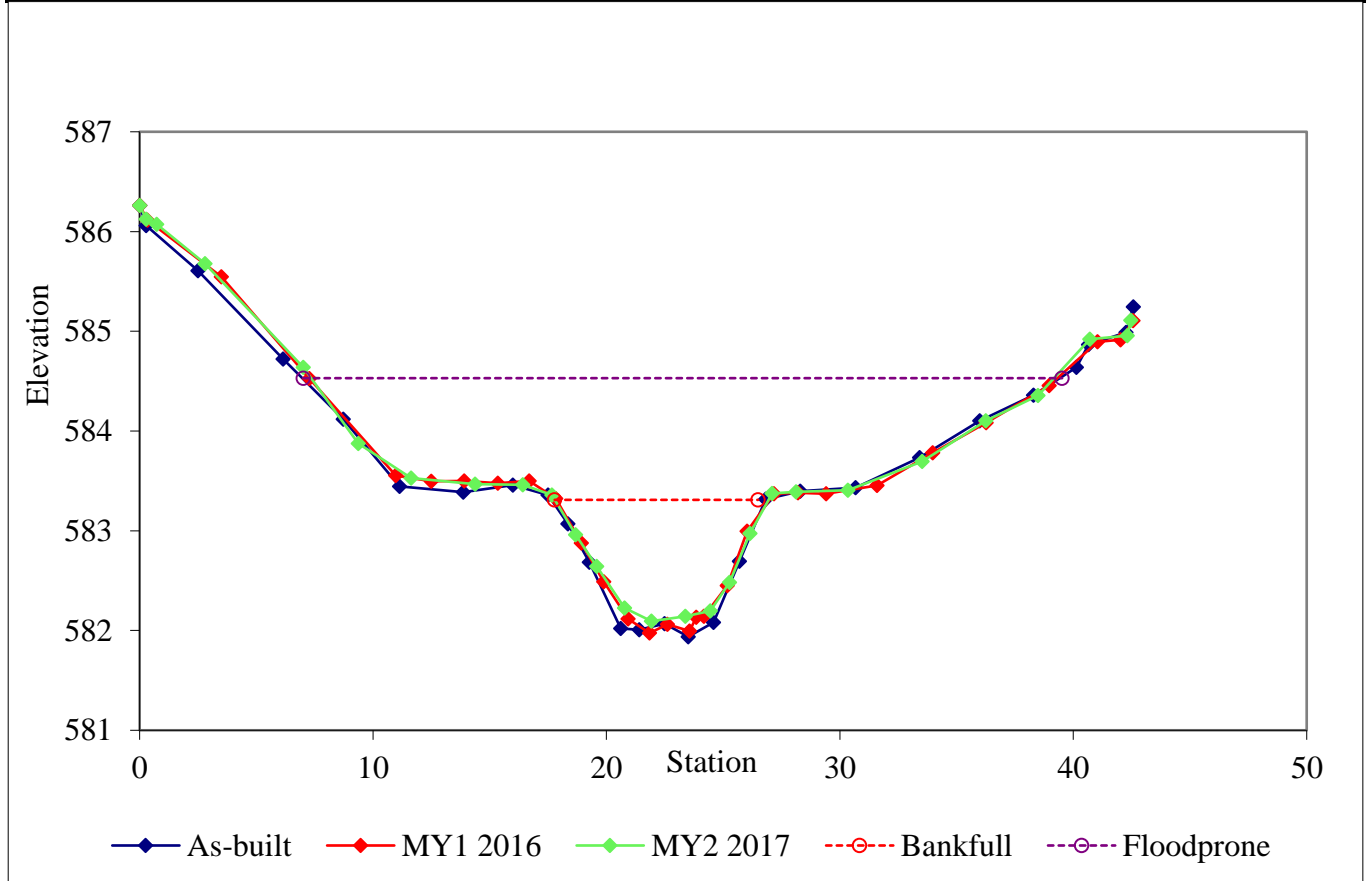
Permanent Cross-section
X2 - Reach 2
(Monitoring Year 2 - Collected October 2017)

Feature	Stream Type	BKF Area	BKF Width	BKF Depth	Max BKF Depth	W/D	BH Ratio	ER	BKF Elev	TOB Elev	WFPA
Riffle	E	7.31	8.72	0.84	1.22	10.38	1.00	3.65	583.31	583.36	31.80

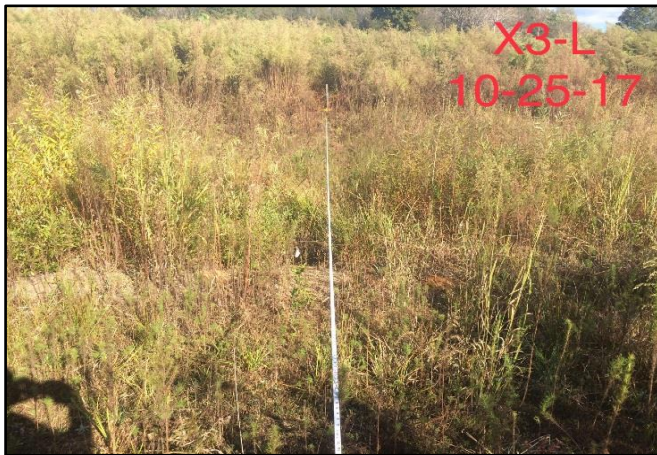
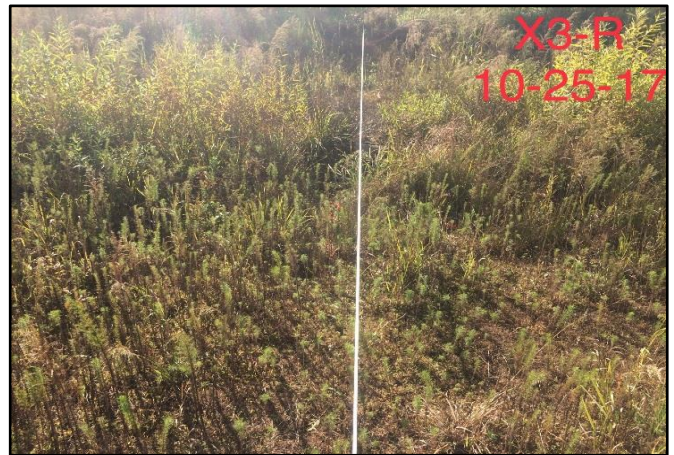
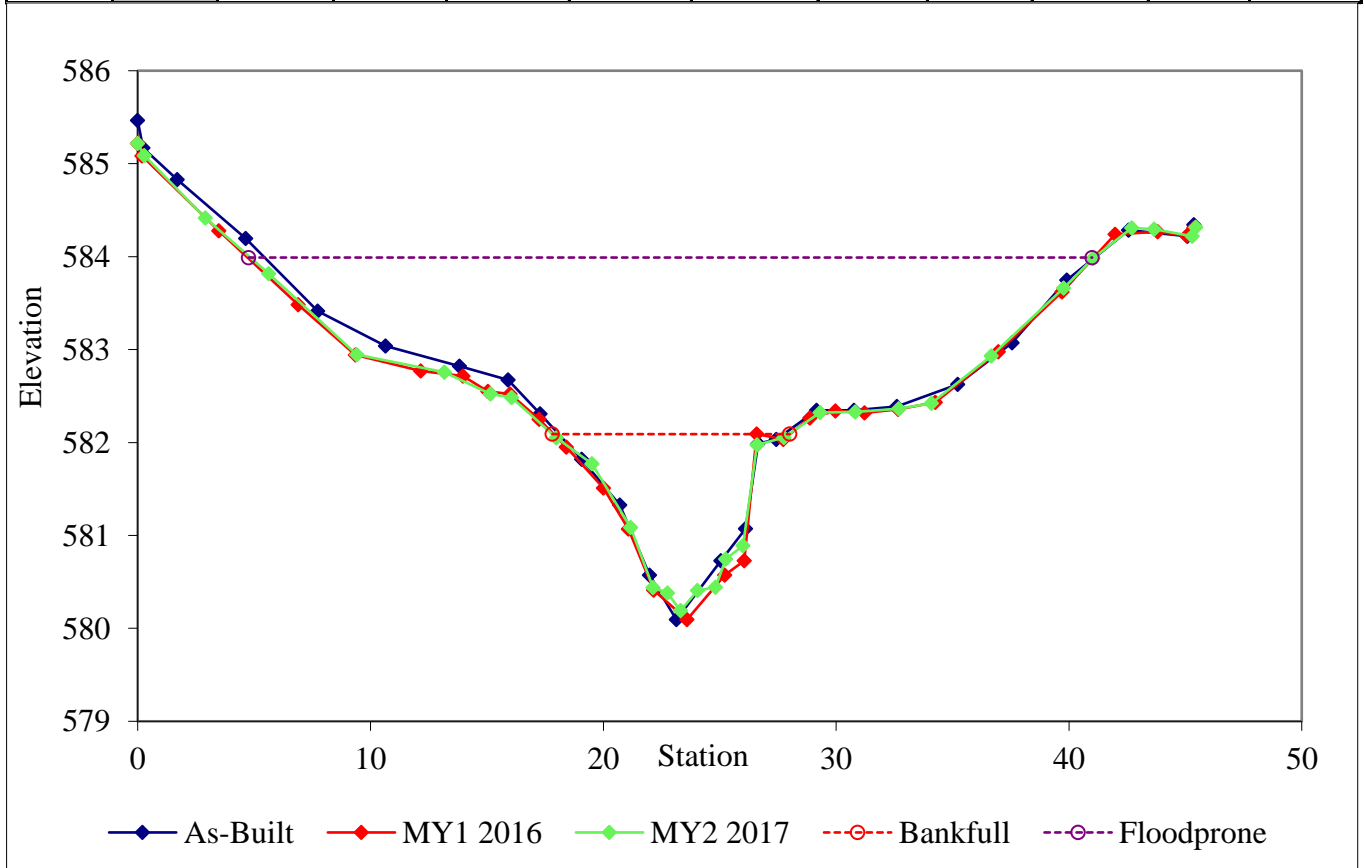
Permanent Cross-section
X3 - Reach 2
(Monitoring Year 2 - Collected October 2017)

Feature	Stream Type	BKF Area	BKF Width	BKF Depth	Max BKF Depth	W/D	BH Ratio	ER	BKF Elev	TOB Elev	WFPA
Pool		9.40	10.19	0.92	1.90	11.08	1.00	3.56	582.09	582.05	36.23

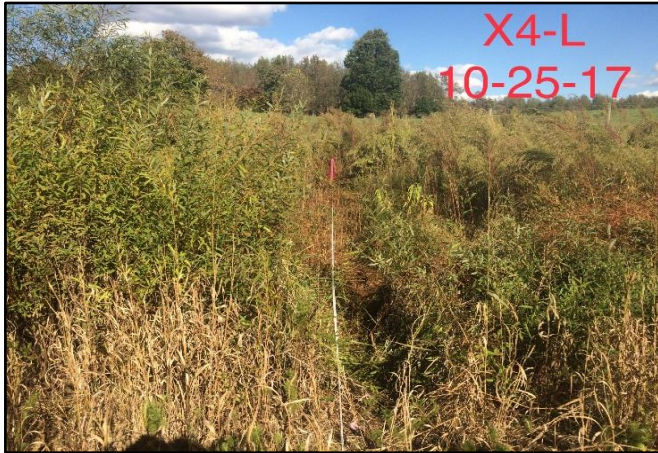
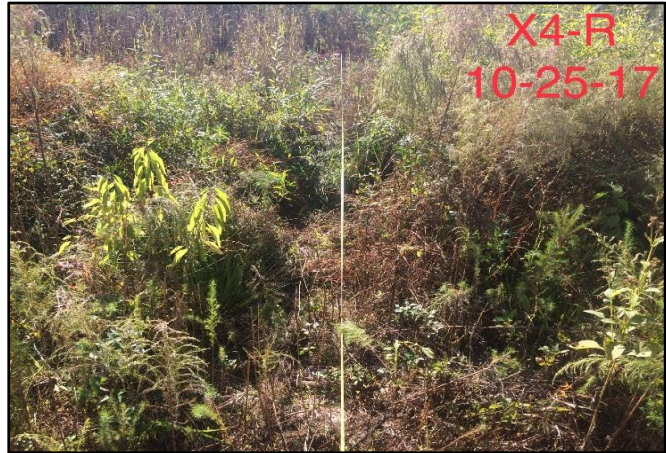
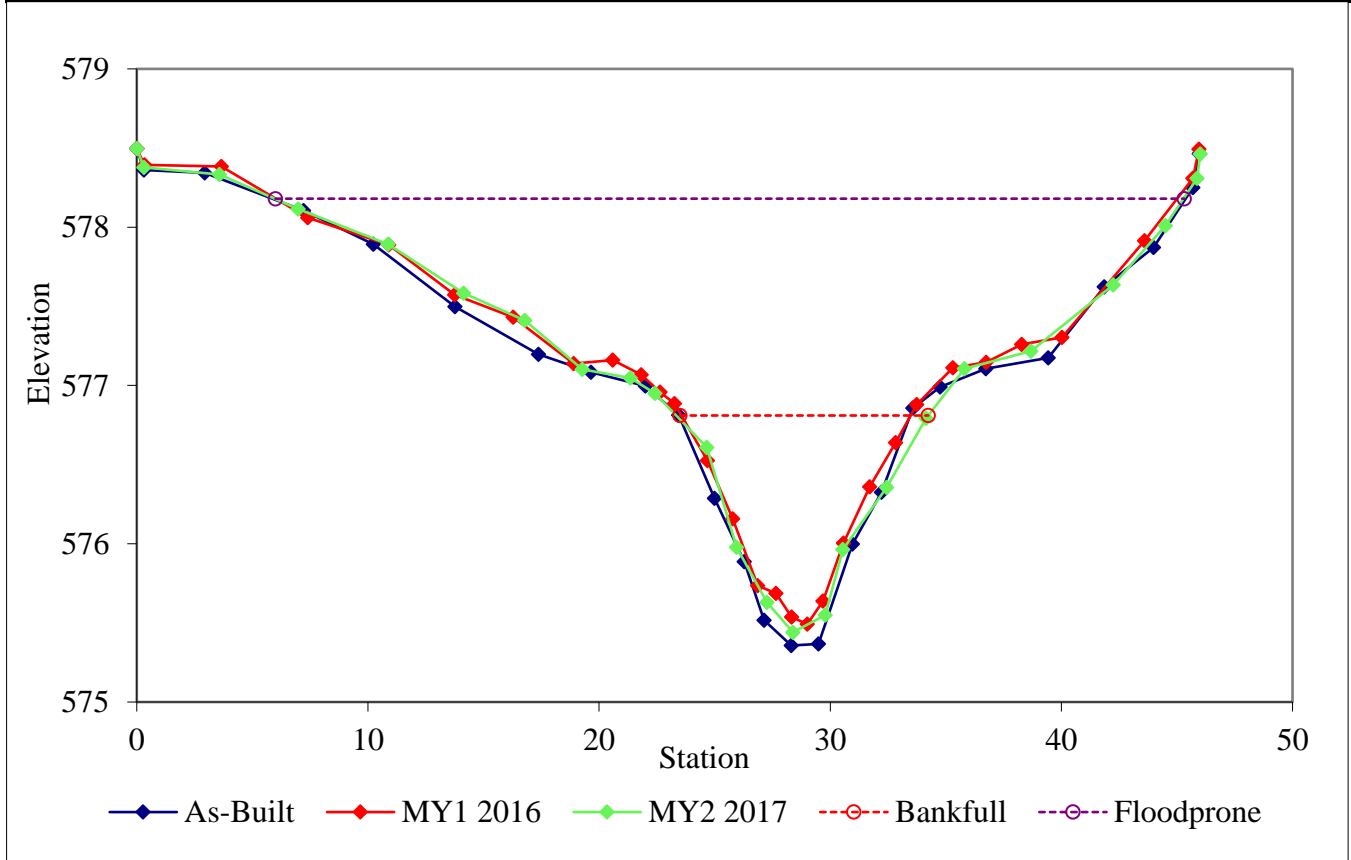
Permanent Cross-section
X4 - Reach 2
(Monitoring Year 2 - Collected October 2017)

Feature	Stream Type	BKF Area	BKF Width	BKF Depth	Max BKF Depth	W/D	BH Ratio	ER	BKF Elev	TOB Elev	WFPA
Riffle	C	7.82	10.74	0.73	1.37	14.71	1.00	3.66	576.81	577.05	39.31

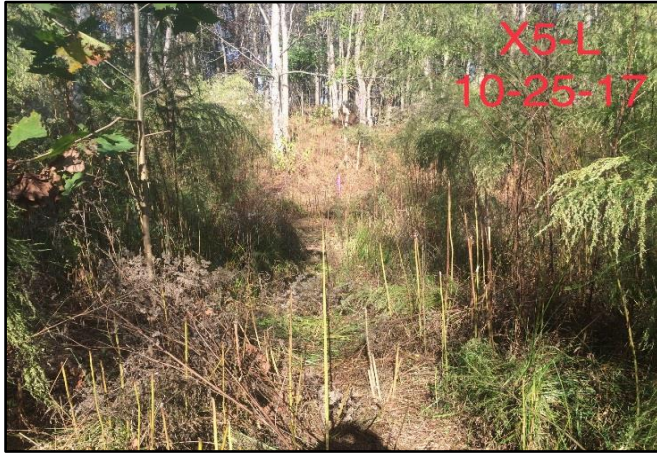
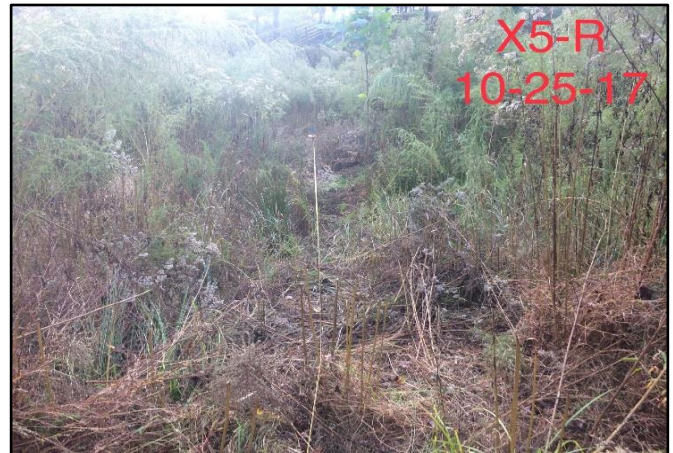
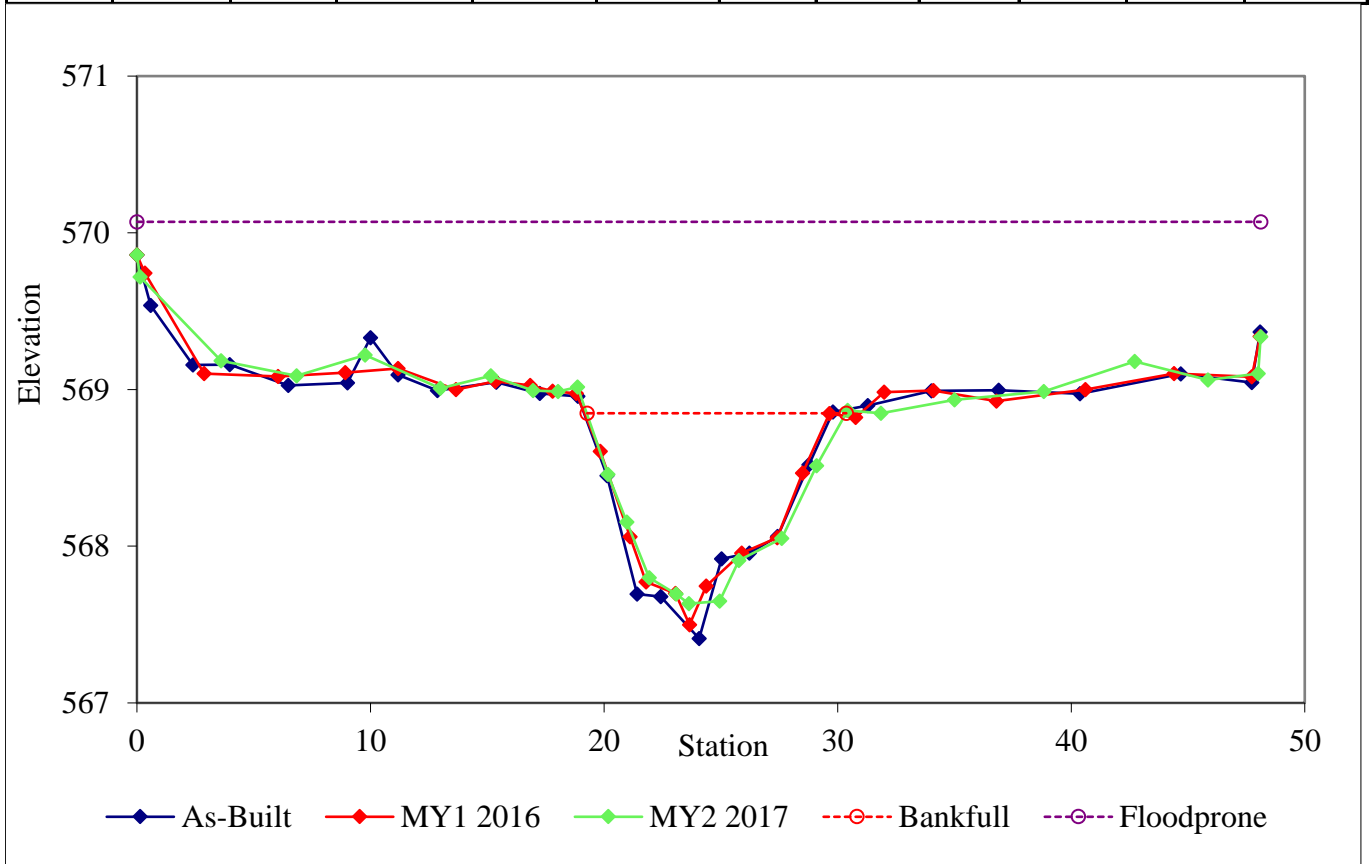
Permanent Cross-section
X5 - Reach 3
 (Monitoring Year 2 - Collected October 2017)

Feature	Stream Type	BKF Area	BKF Width	BKF Depth	Max BKF Depth	W/D	BH Ratio	ER	BKF Elev	TOB Elev	WFGPA
Riffle	C	8.50	11.09	0.77	1.22	14.40	1.00	4.34	568.85	568.87	48.11

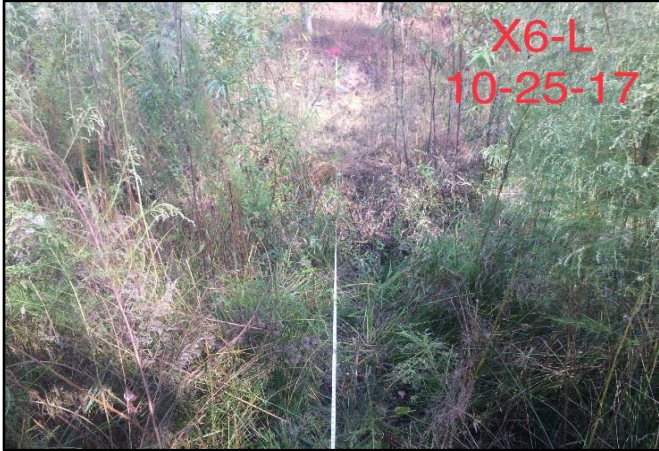
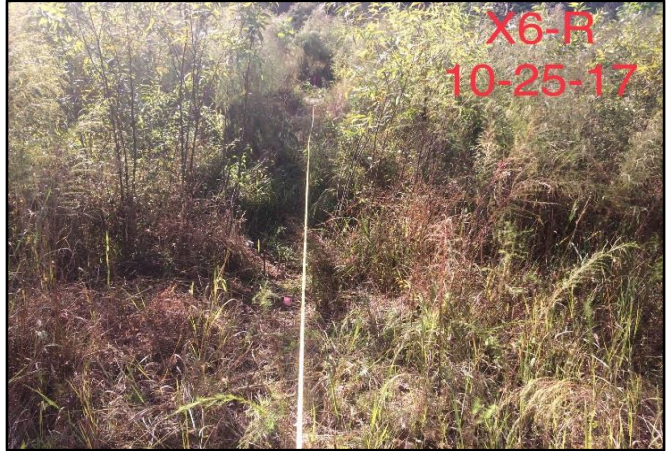
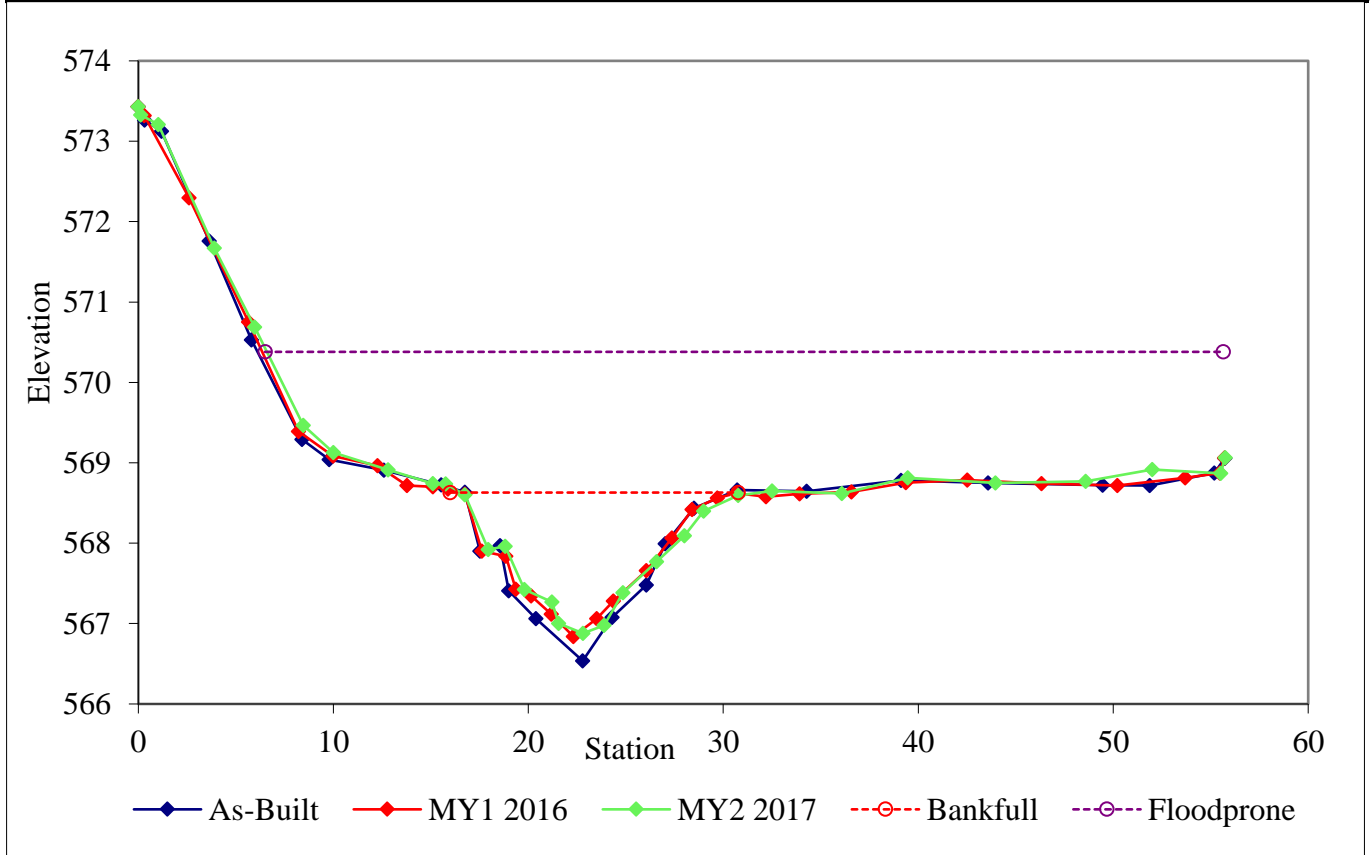
Permanent Cross-section
X6 - Reach 3
(Monitoring Year 2 - Collected October 2017)

Feature	Stream Type	BKF Area	BKF Width	BKF Depth	Max BKF Depth	W/D	BH Ratio	ER	BKF Elev	TOB Elev	WFPA
Pool		13.09	14.77	0.89	1.75	16.60	1.00	3.33	568.63	568.59	49.15

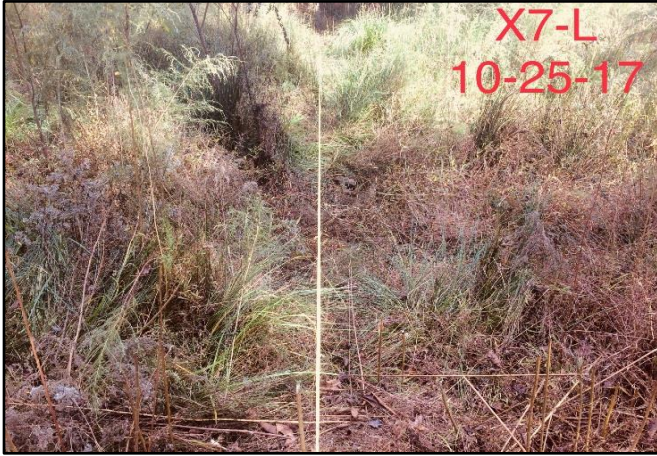
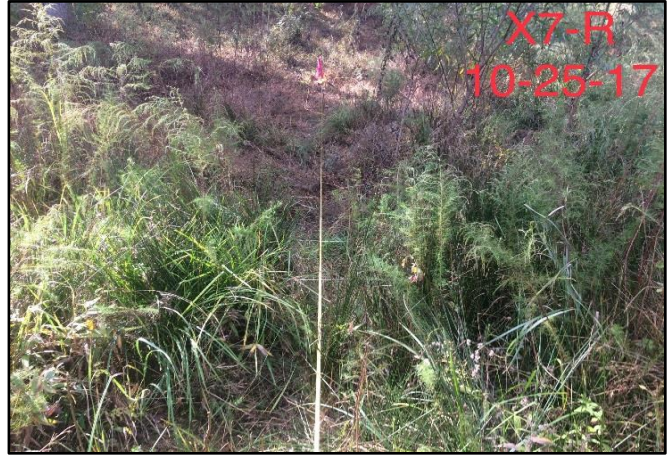
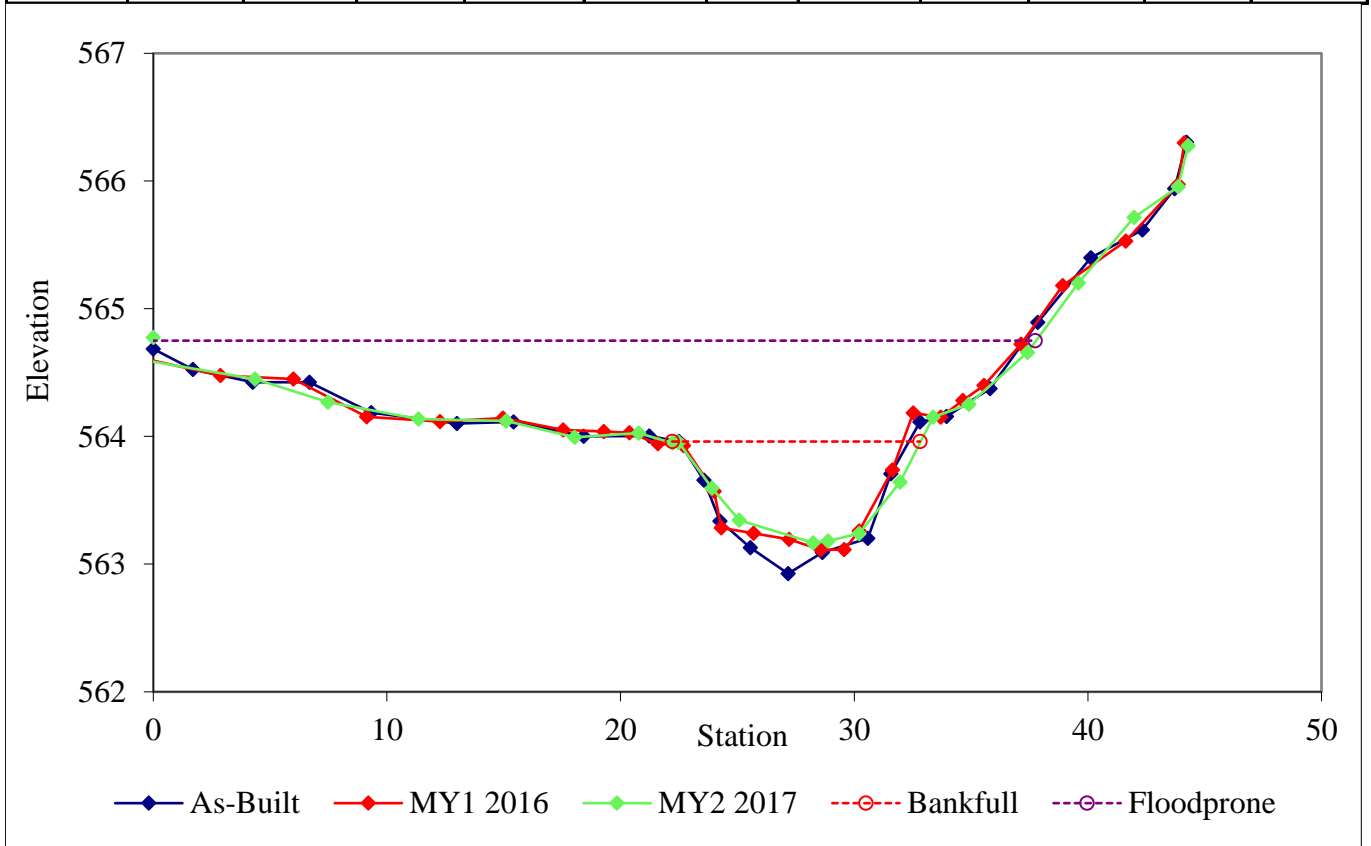
Permanent Cross-section
X7 - Reach 3
(Monitoring Year 2 - Collected October 2017)

Feature	Stream Type	BKF Area	BKF Width	BKF Depth	Max BKF Depth	W/D	BH Ratio	ER	BKF Elev	TOB Elev	WFPA
Riffle	C	5.53	10.26	0.54	0.79	19.00	1.00	3.77	563.96	563.95	38.74

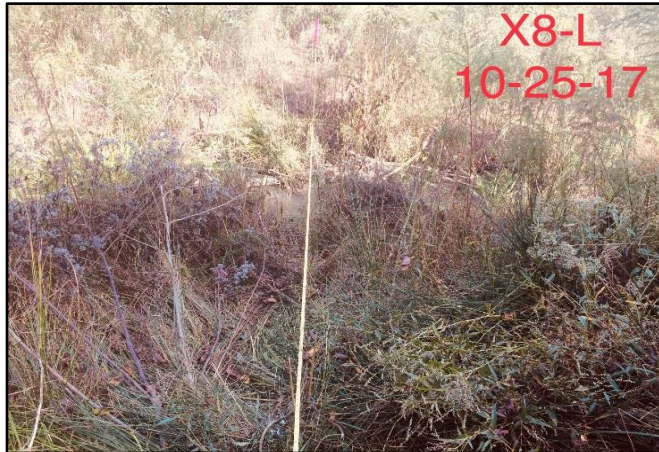
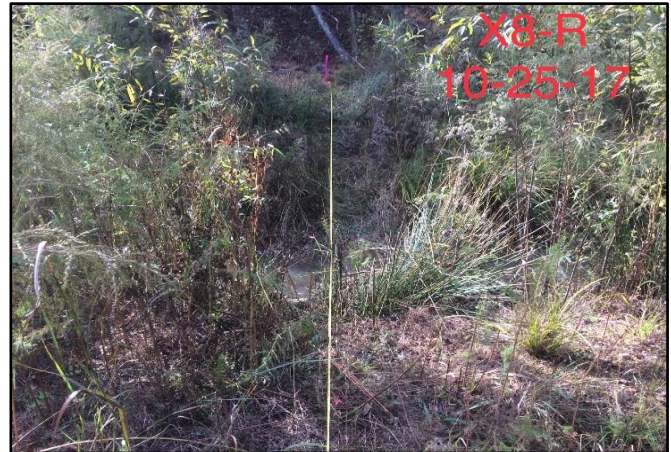
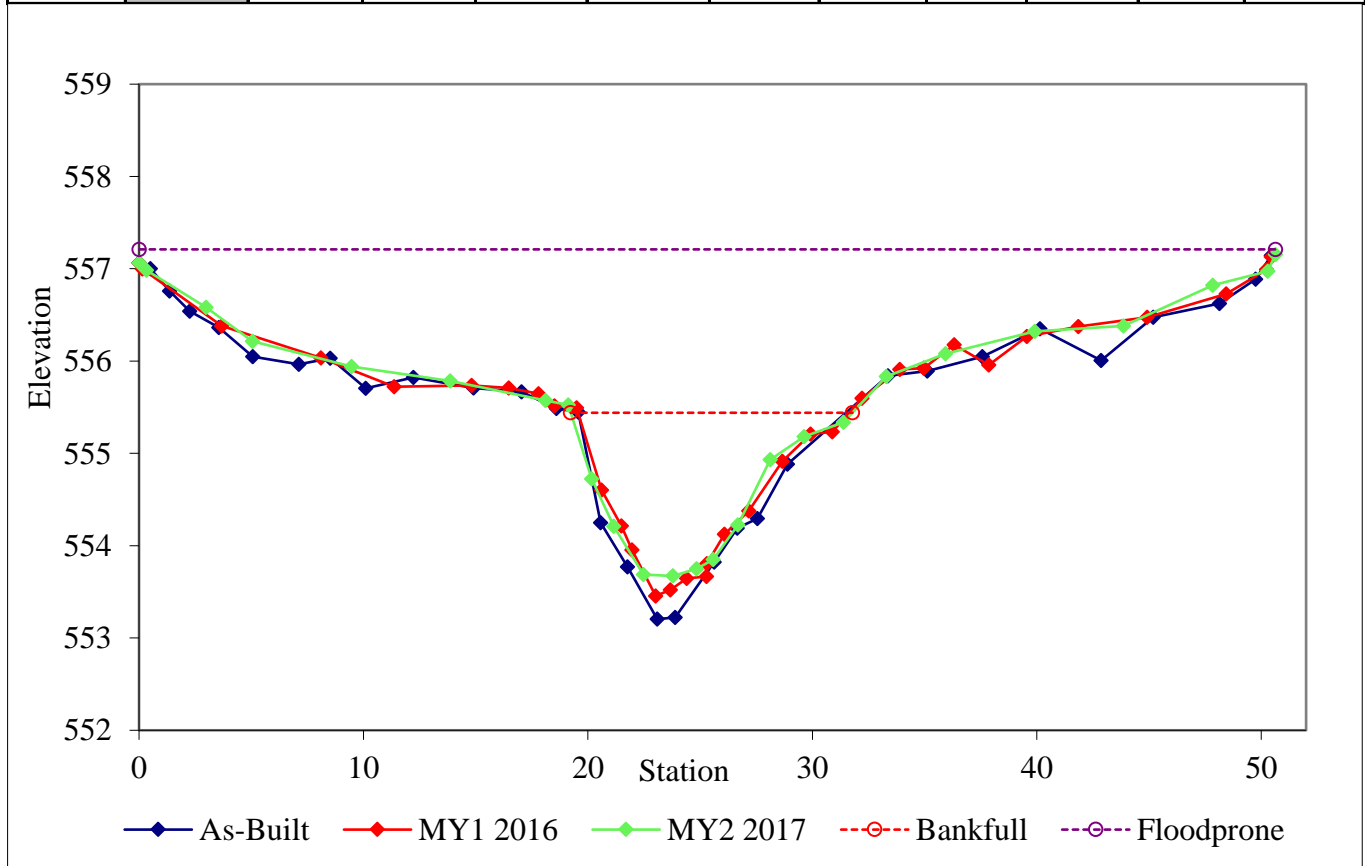
Permanent Cross-section
X8 - Reach 3
(Monitoring Year 2 - Collected October 2017)

Feature	Stream Type	BKF Area	BKF Width	BKF Depth	Max BKF Depth	W/D	BH Ratio	ER	BKF Elev	TOB Elev	WFOA
Pool		12.32	12.56	0.98	1.77	12.82	1.00	3.86	555.44	555.53	50.63

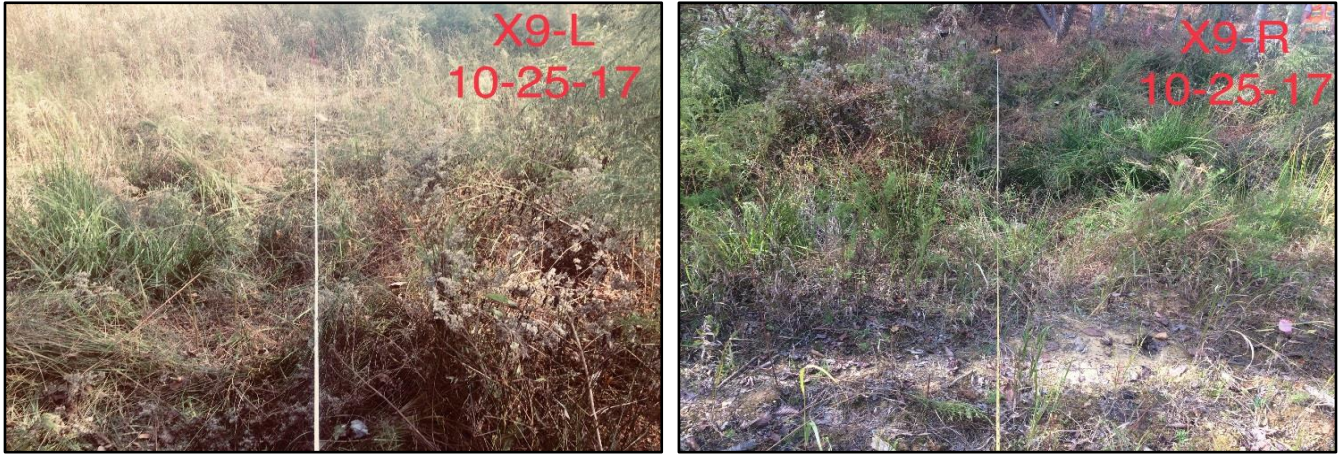
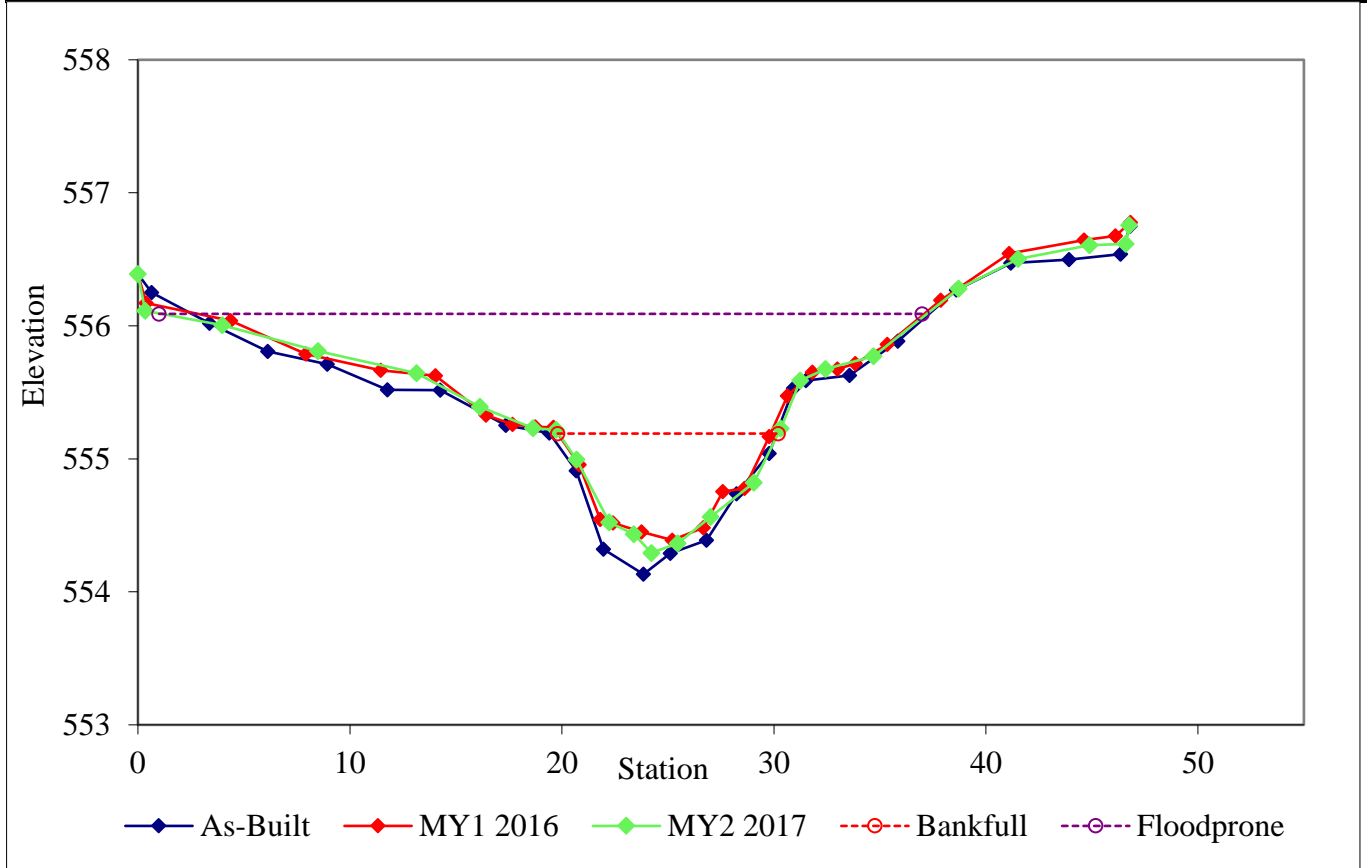
Permanent Cross-section
X9 - Reach 3
(Monitoring Year 2 - Collected October 2017)

Feature	Stream Type	BKF Area	BKF Width	BKF Depth	Max BKF Depth	W/D	BH Ratio	ER	BKF Elev	TOB Elev	WFPA
Riffle	C	5.68	10.41	0.55	0.90	18.93	1.00	3.46	555.19	555.22	36.00
