# **Town Creek Restoration Project – Option B Year 3 Monitoring Report**

**Stanly County, North Carolina**

**DMS Project ID Number – 95026; NC DEQ Contract No. 003990**

**Monitoring Year: 3 of 5**

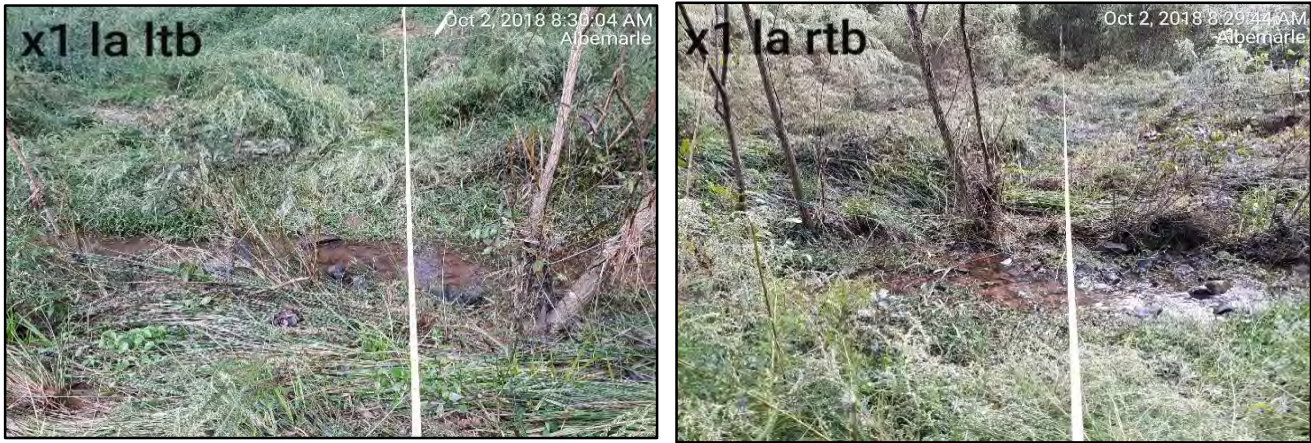
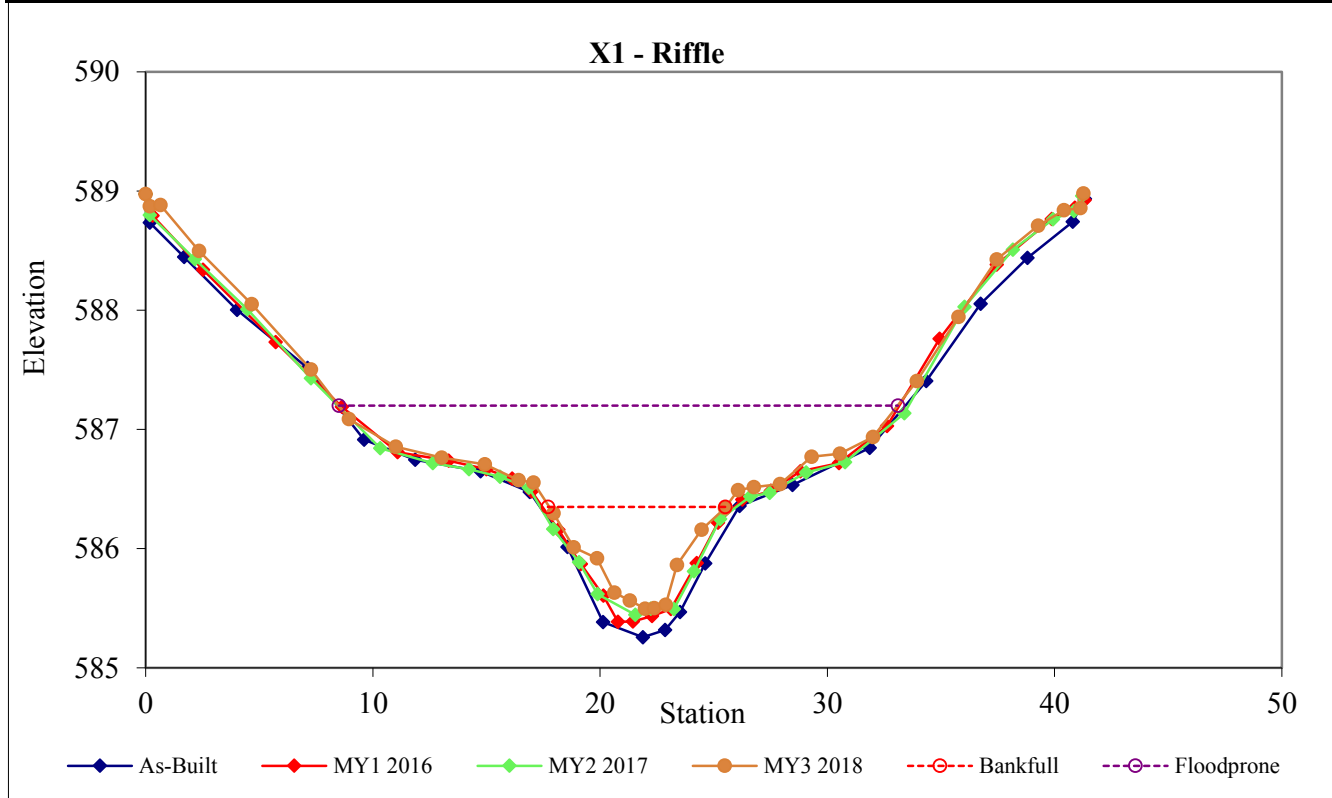
**Permanent Cross-section**  
**X1 Riffle - Reach 2**  
**(Monitoring Year 3 - Collected October 2018)**

Feature	Stream Type	BKF Area	BKF Width	BKF Depth	Max BKF Depth	W/D	BH Ratio*	ER	BKF Elev	TOB Elev	WFPA
Riffle	C	3.64	7.80	0.50	0.9	16.60	0.90	3.20	586.35	586.49	24.60

\*BHR=0.90 is based on asbuilt bkf area of 5.79 at an elevation of 586.586. Remainder of data based on actual bankfull elevation from as-built which is 586.35.

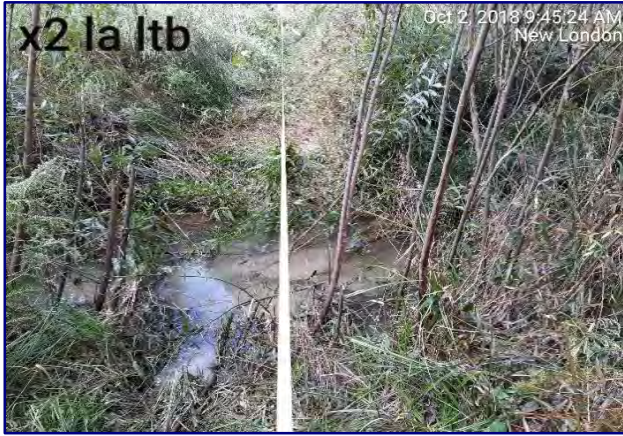
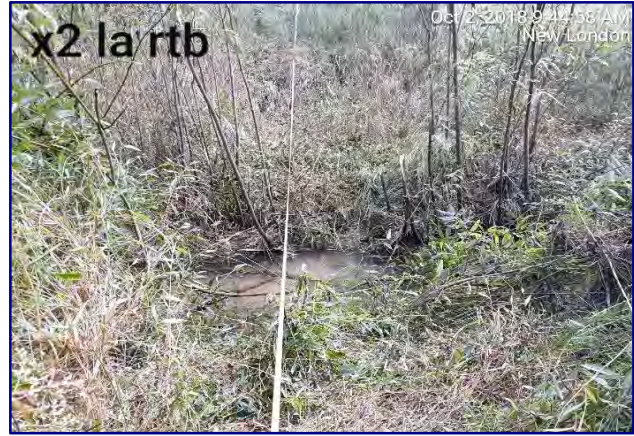
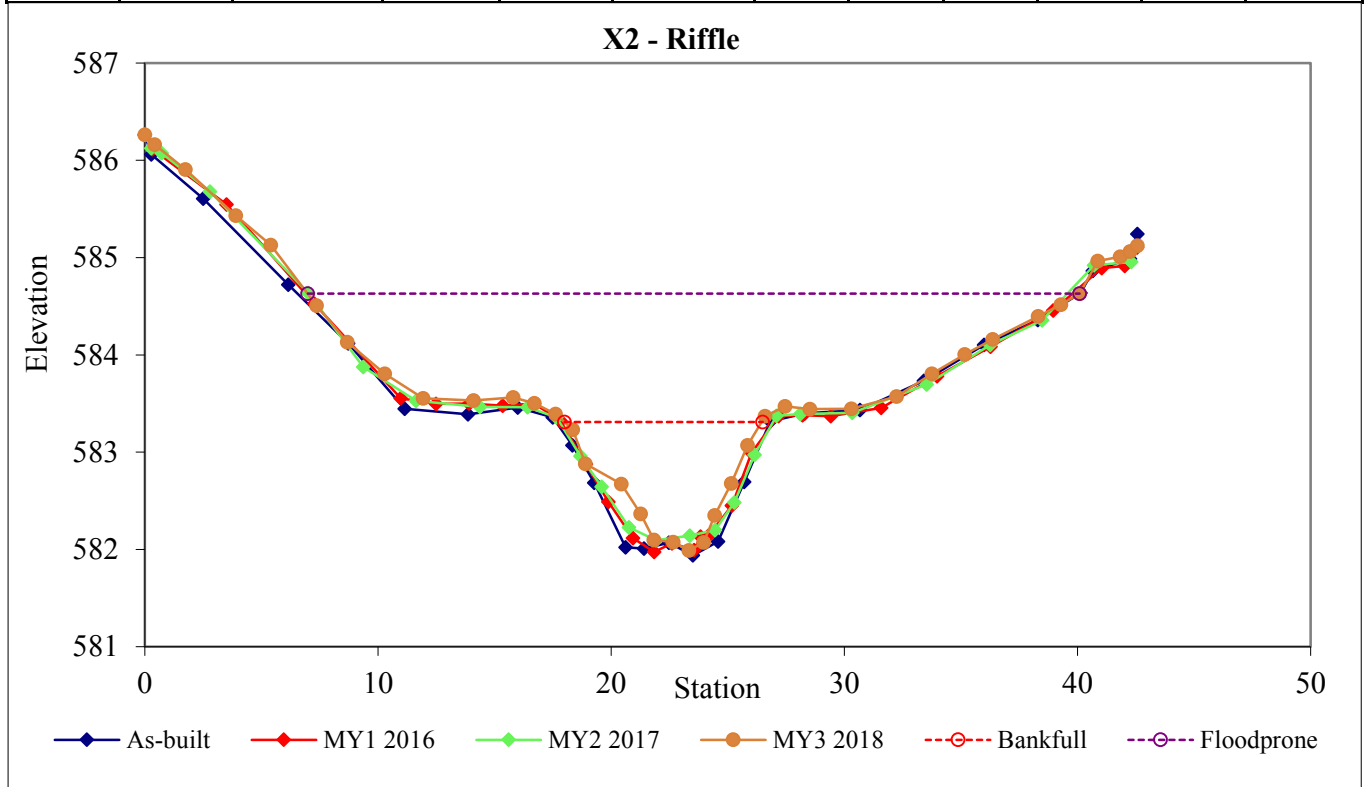
**Permanent Cross-section**  
**X2 Riffle - Reach 2**  
**(Monitoring Year 3 - Collected October 2018)**

Feature	Stream Type	BKF Area	BKF Width	BKF Depth	Max BKF Depth	W/D	BH Ratio*	ER	BKF Elev	TOB Elev	WFPA
Riffle	E	6.39	8.50	0.80	1.30	11.20	0.90	3.90	583.31	583.37	33.10

\*BHR=0.90 is based on asbuilt bkf area of 8.28 at an elevation of 583.508. Remainder of data based on actual bankfull elevation from as-built which is 583.31.

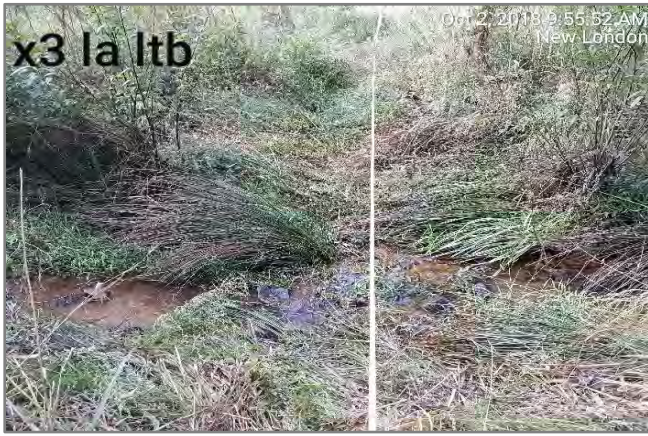
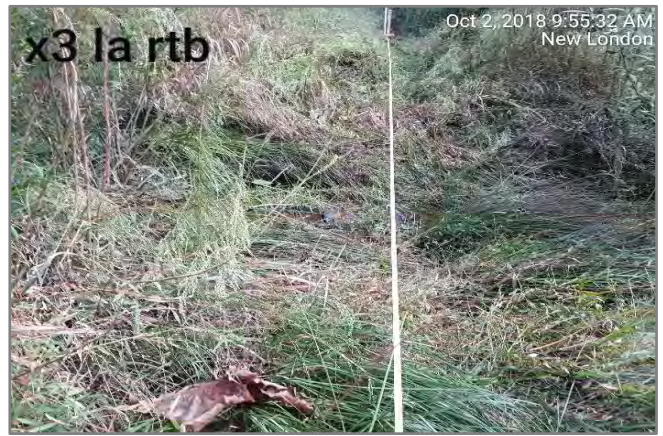
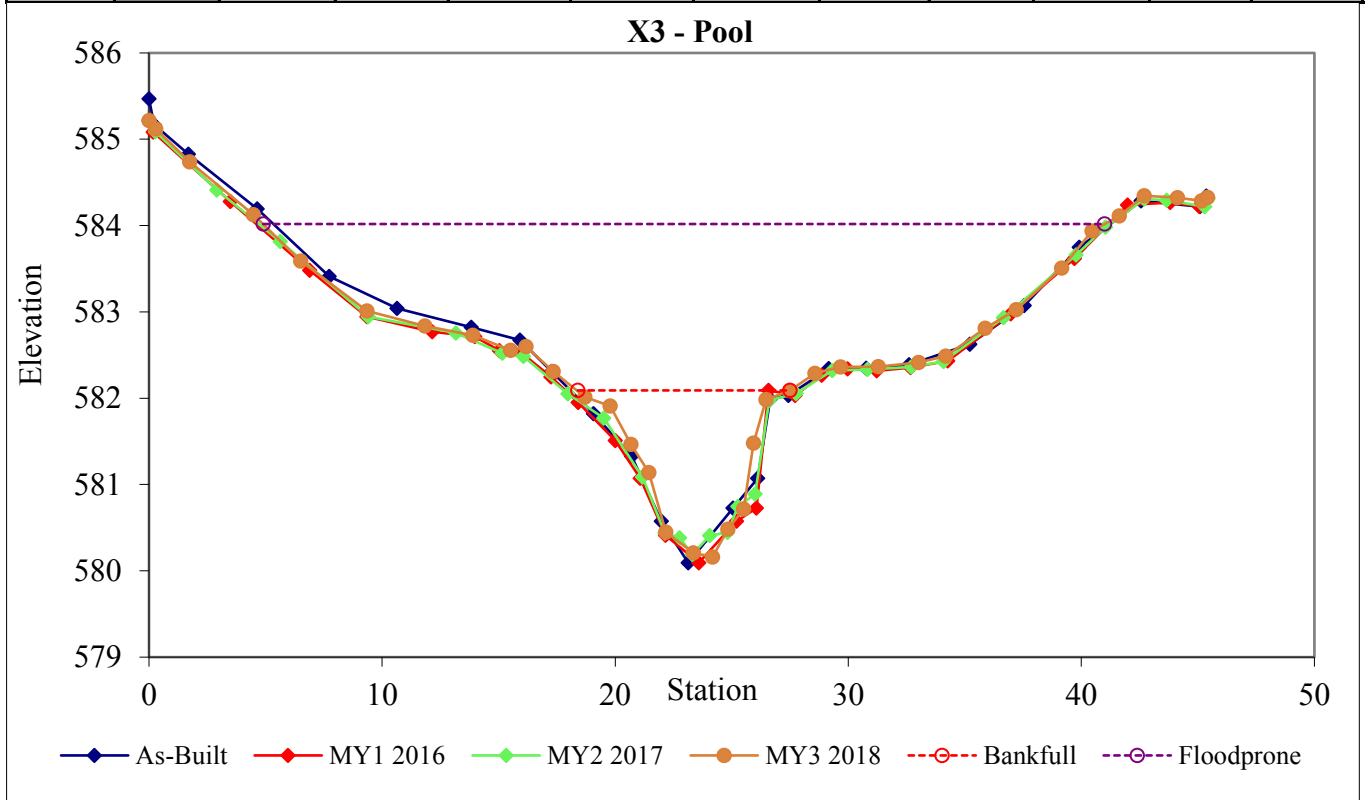
**Permanent Cross-section**  
**X3 Pool - Reach 2**  
**(Monitoring Year 3 - Collected October 2018)**

Feature	Stream Type	BKF Area	BKF Width	BKF Depth	Max BKF Depth	W/D	BH Ratio	ER	BKF Elev	TOB Elev	WFGPA
Pool		8.56	9.10	0.90	1.90	9.80	1.00	4.00	582.09	582.29	36.10

\*BHR=1.0 is based on asbuilt bkf area of 12.01 at an elevation of 582.401. Remainder of data based on actual bankfull elevation from as-built which is 582.09.

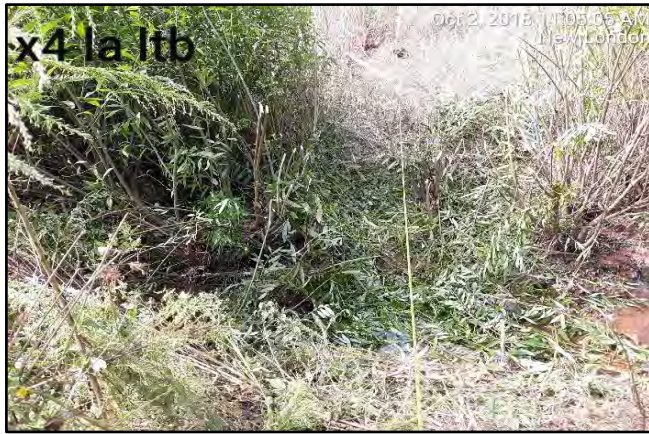
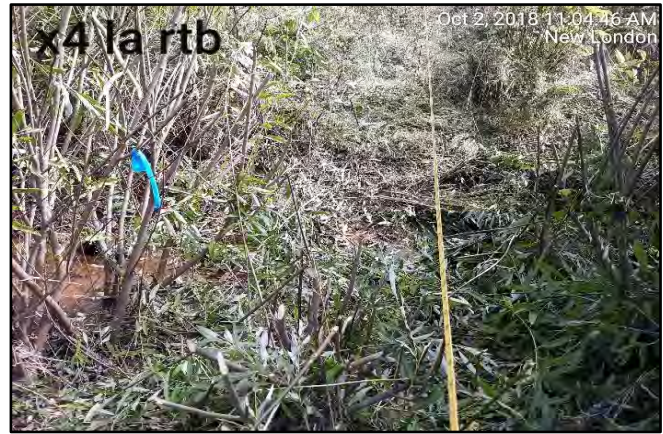
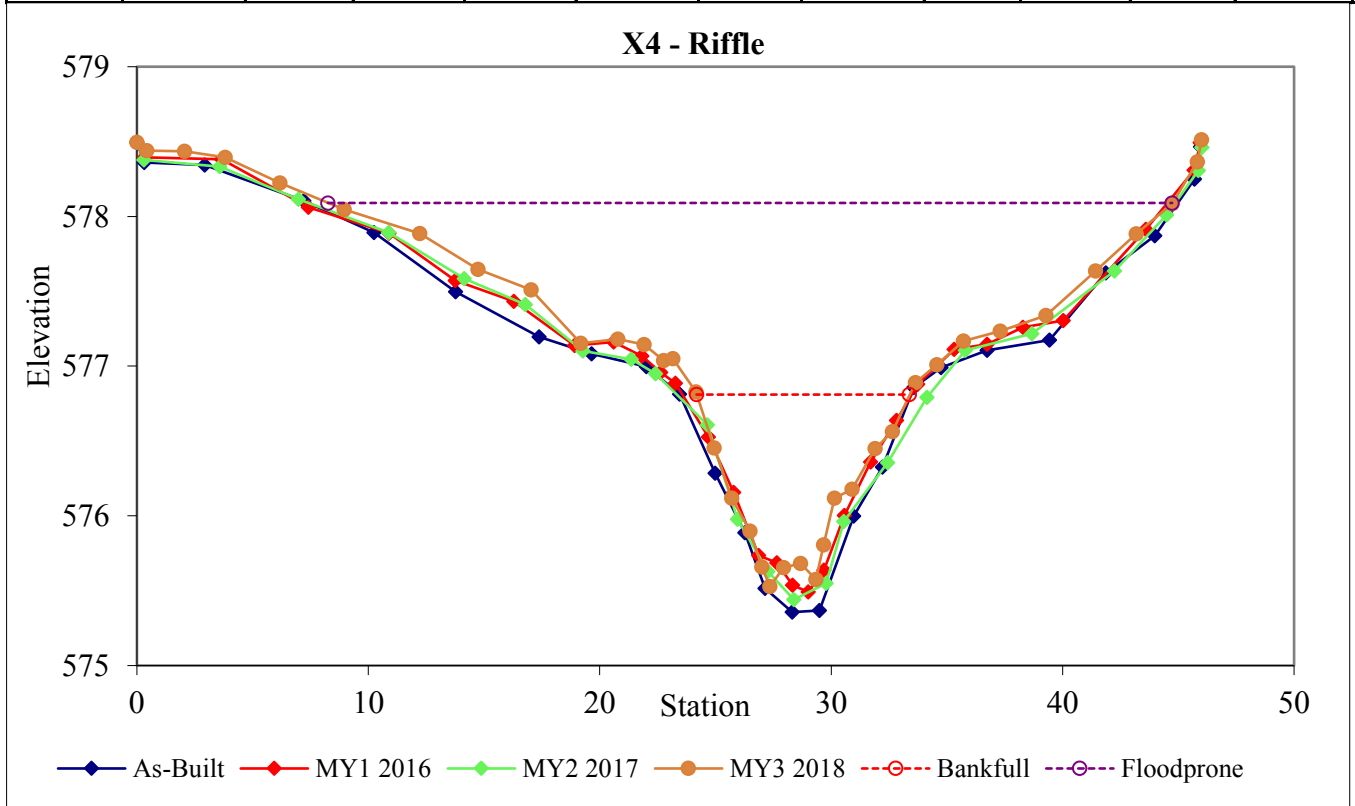
**Permanent Cross-section**  
**X4 Riffle - Reach 2**  
**(Monitoring Year 3 - Collected October 2018)**

Feature	Stream Type	BKF Area	BKF Width	BKF Depth	Max BKF Depth	W/D	BH Ratio	ER	BKF Elev	TOB Elev	WFGPA
Riffle	C	6.55	9.20	0.70	1.30	12.90	0.90	4.00	576.81	576.89	36.48

\*BHR = 0.9 is based on as-built bkf area of 8.38 at an elevation of 576.994. Remainder of data based on actual bankfull elevation from as-built which is 576.81

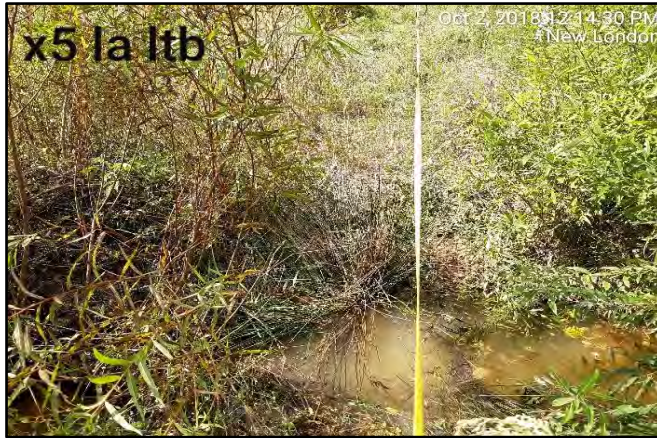
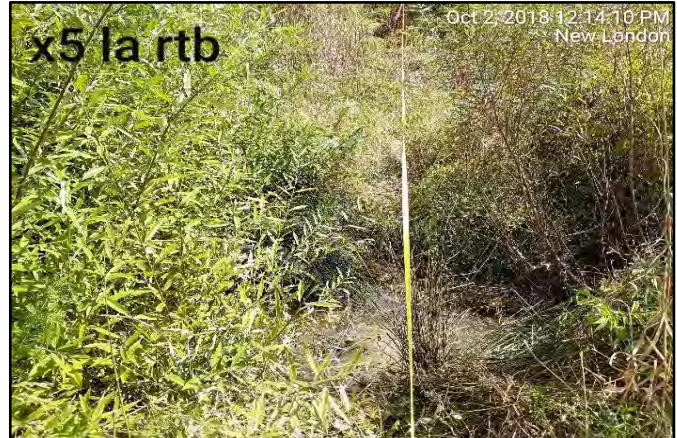
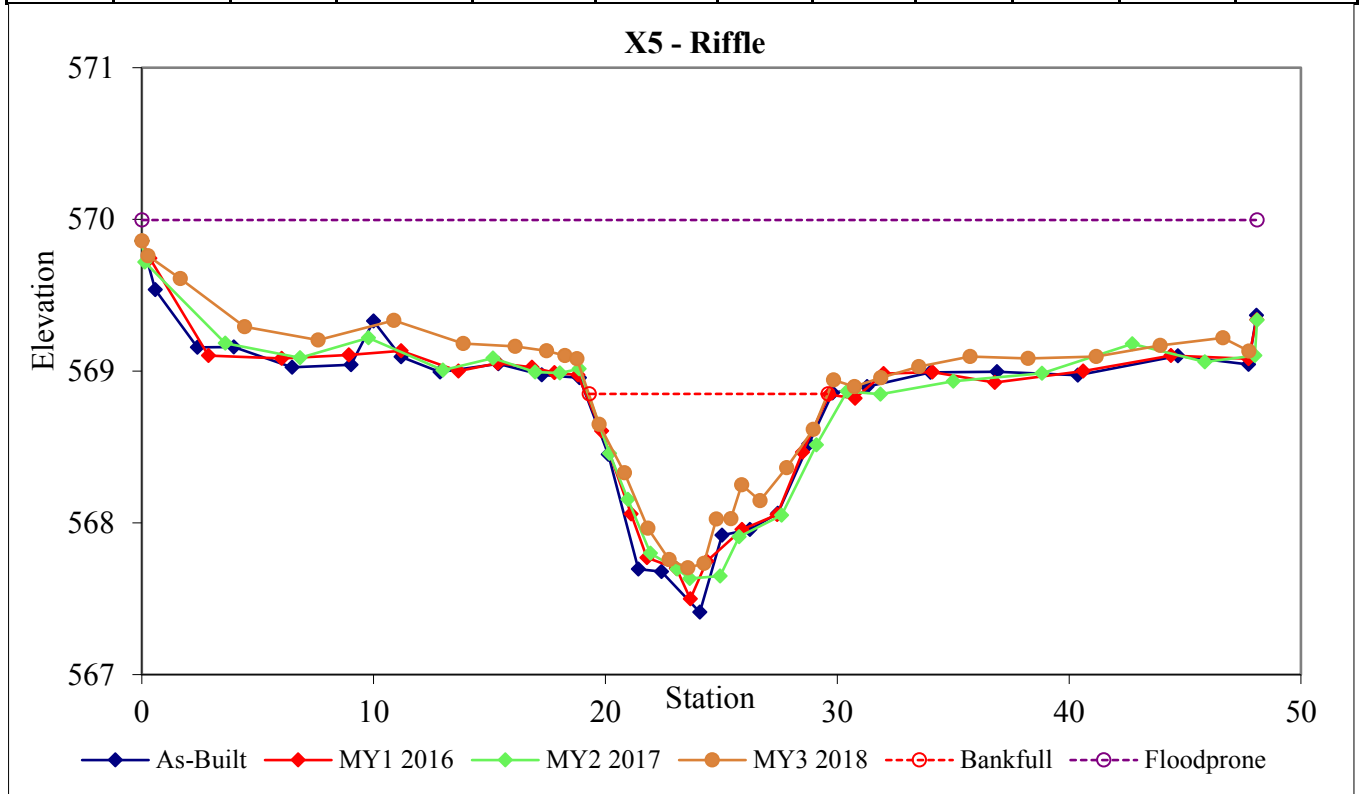
**Permanent Cross-section**  
**X5 Riffle - Reach 3**  
**(Monitoring Year 3 - Collected October 2018)**

Feature	Stream Type	BKF Area	BKF Width	BKF Depth	Max BKF Depth	W/D	BH Ratio	ER	BKF Elev	TOB Elev	WFPA
Riffle	C	6.80	10.30	0.70	1.10	15.60	0.90	4.70	568.85	568.94	48.11

\*BHR = 0.9 is based on as-built bkf area of 8.68 at an elevation of 569.0075. Remainder of data based on actual bankfull elevation from as-built which is 568.85.

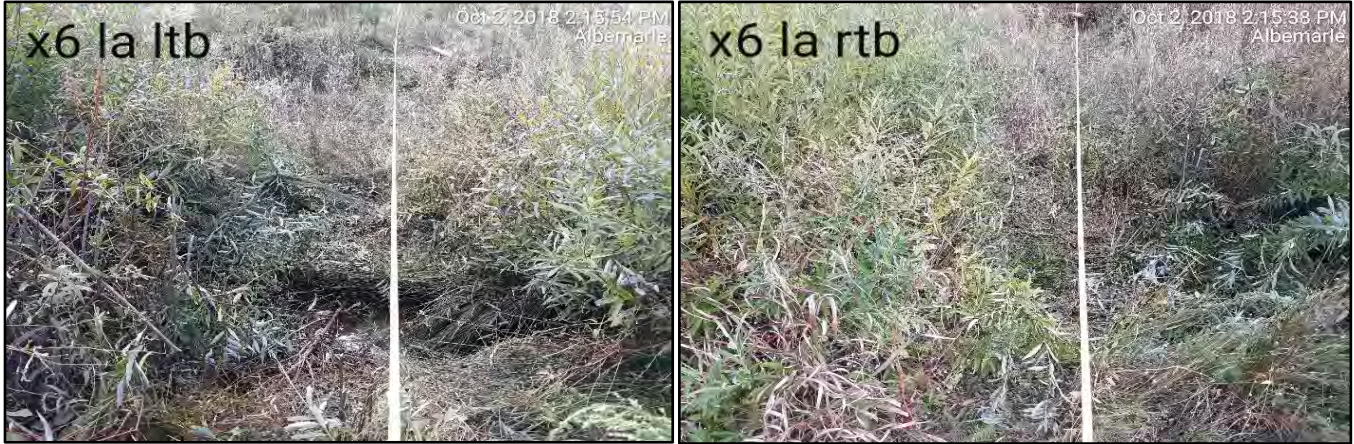
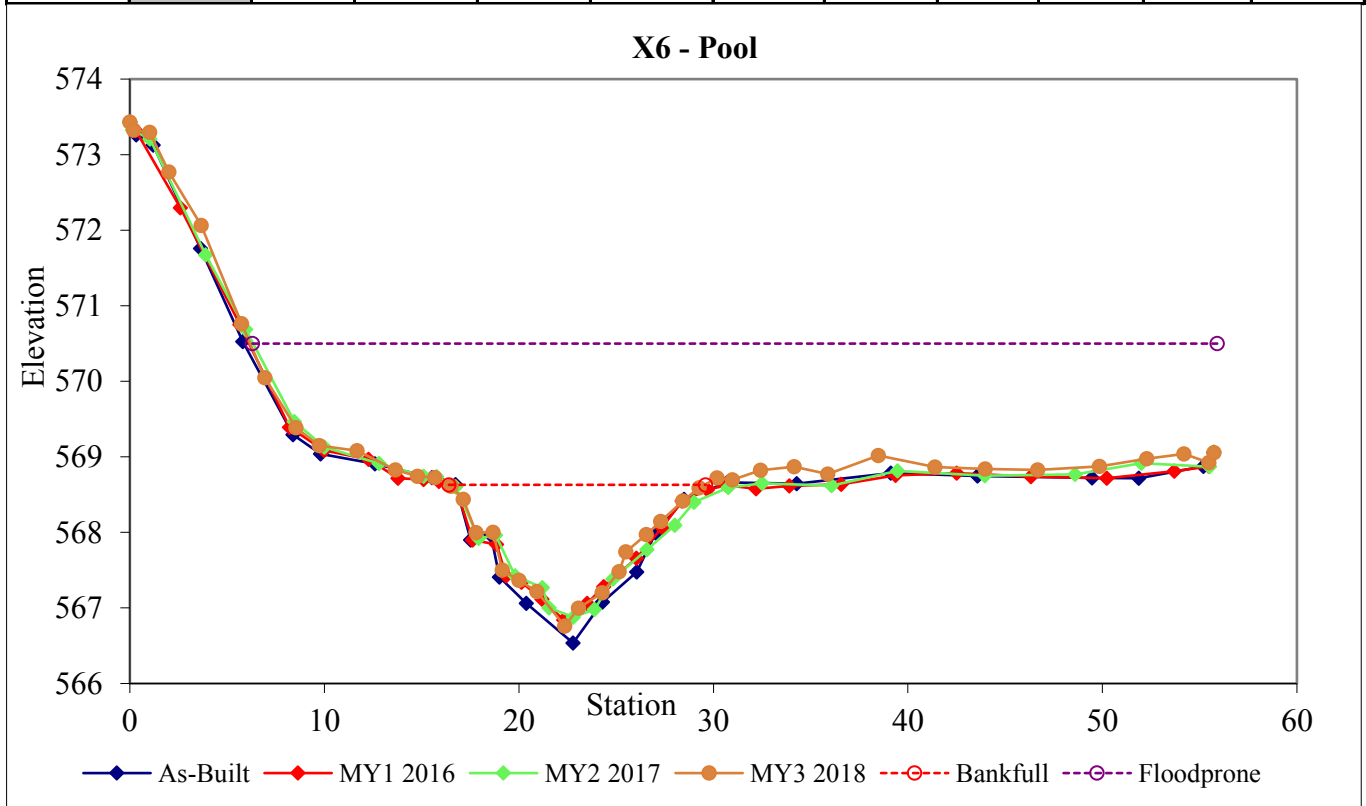
**Permanent Cross-section**  
**X6 Pool - Reach 3**  
**(Monitoring Year 3 - Collected October 2018)**

Feature	Stream Type	BKF Area	BKF Width	BKF Depth	Max BKF Depth	W/D	BH Ratio	ER	BKF Elev	TOB Elev	WFGPA
Pool		12.23	13.20	0.90	1.90	14.10	1.00	3.80	568.63	568.72	49.60

\*BHR = 1.0 is based on as-built bkf area of 14.54 at an elevation of 568.783. Remainder of data based on actual bankfull elevation from as-built which is 568.63.

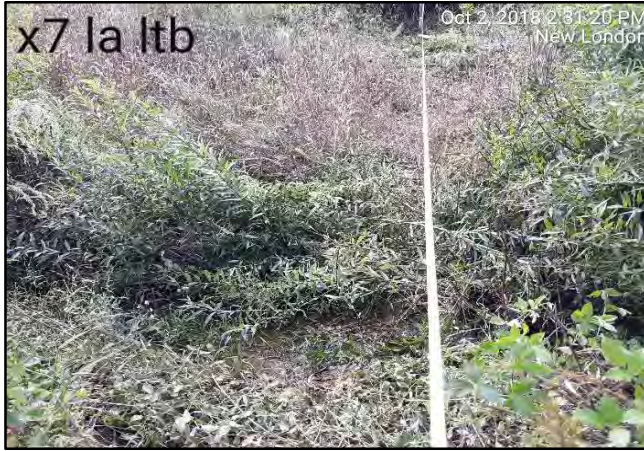
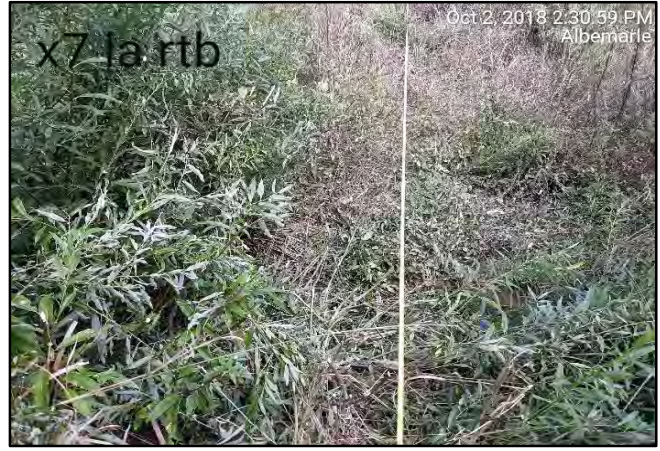
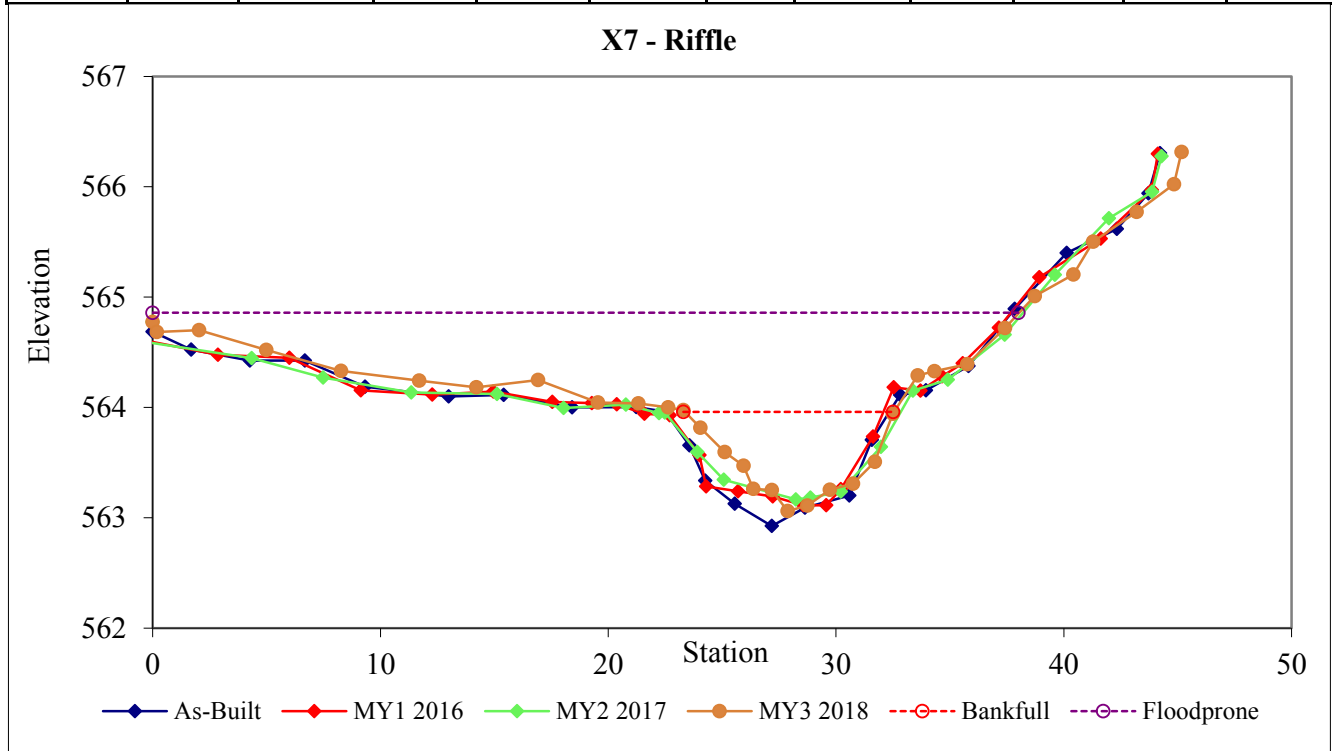
**Permanent Cross-section**  
**X7 Riffle - Reach 3**  
**(Monitoring Year 3 - Collected October 2018)**

Feature	Stream Type	BKF Area	BKF Width	BKF Depth	Max BKF Depth	W/D	BH Ratio	ER	BKF Elev	TOB Elev	WFPA
Riffle	C	4.99	9.20	0.50	0.90	16.90	0.90	4.10	563.96	563.98	38.00

\*BHR = 0.9 is based on as-built bkf area of 6.51 at an elevation of 564.0925. Remainder of data based on actual bankfull elevation from as-built which is 563.96.

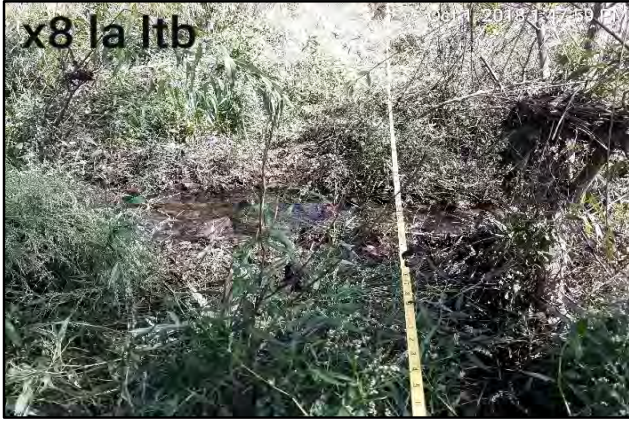
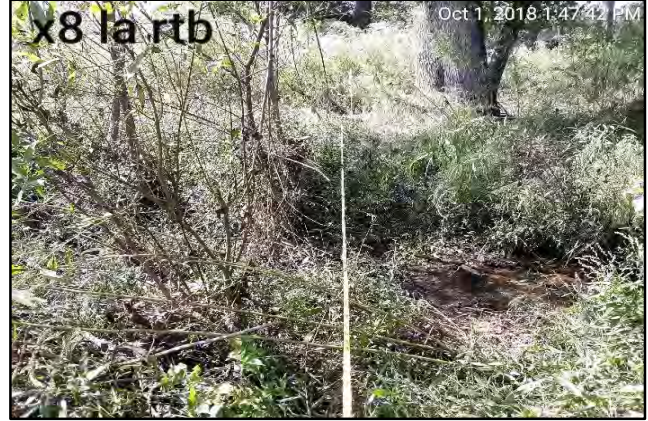
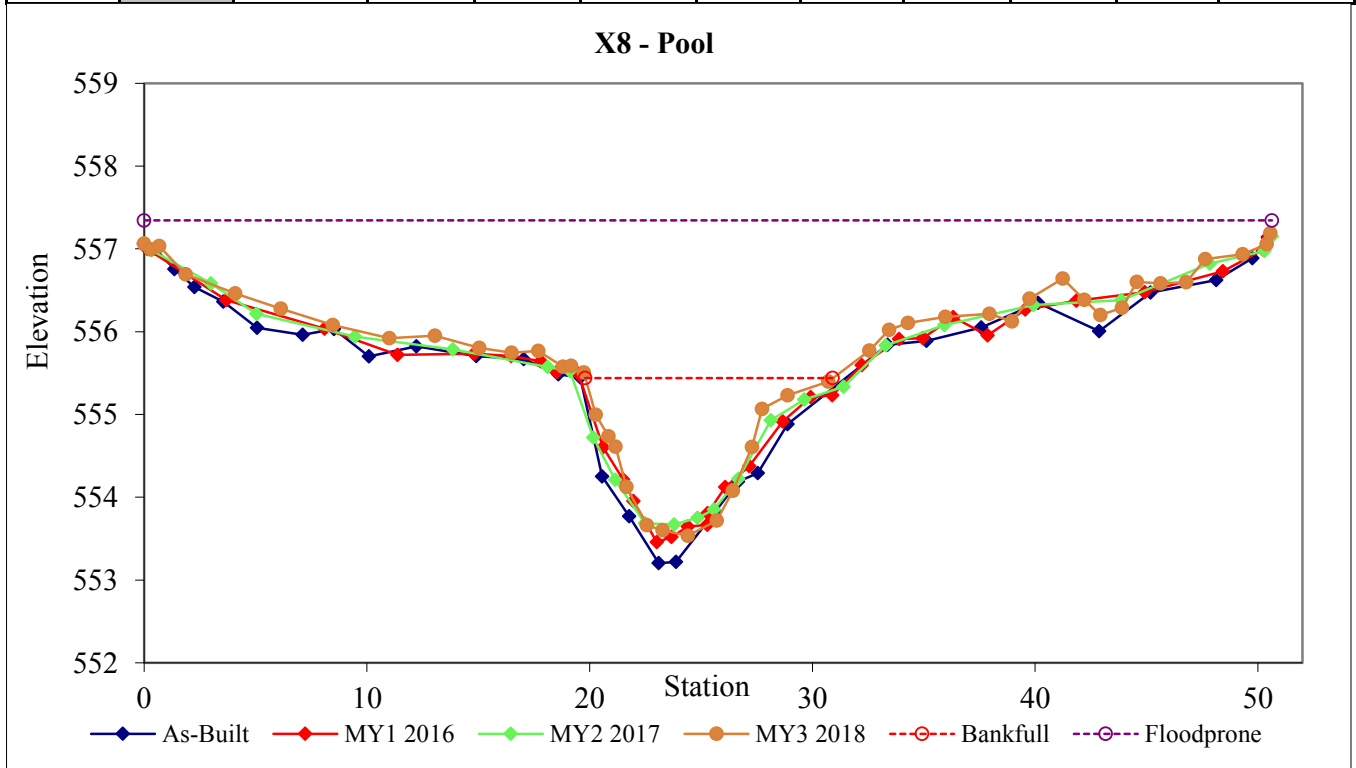
**Permanent Cross-section**  
**X8 Pool - Reach 3**  
**(Monitoring Year 3 - Collected October 2018)**

Feature	Stream Type	BKF Area	BKF Width	BKF Depth	Max BKF Depth	W/D	BH Ratio	ER	BKF Elev	TOB Elev	WFGPA
Pool		11.26	11.10	1.00	1.90	11.00	0.90	4.60	555.44	555.51	50.60

\*BHR = 0.9 is based on as-built bkf area of 14.42 at an elevation of 555.6939. Remainder of data based on actual bankfull elevation from as-built which is 555.44.

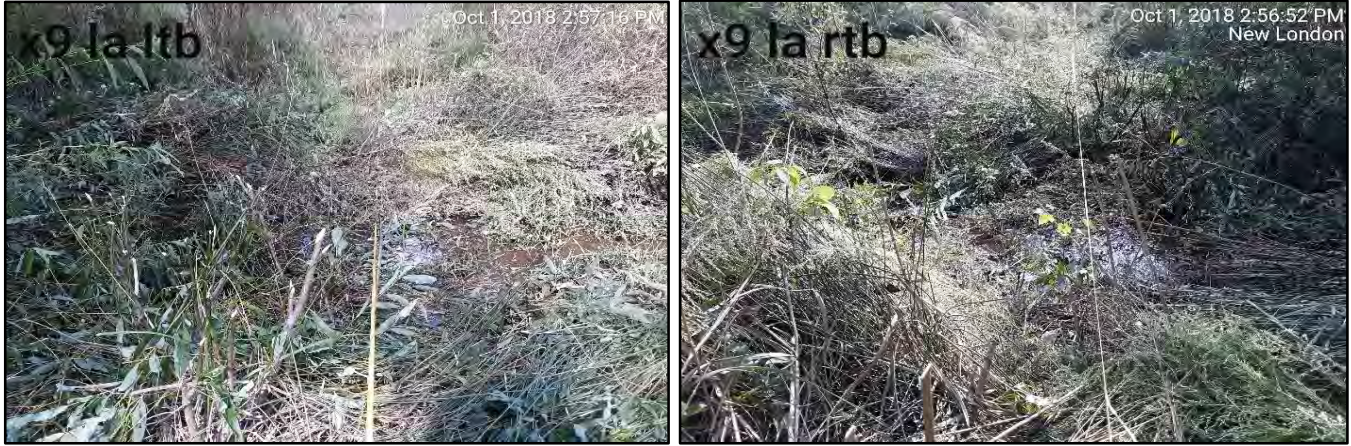
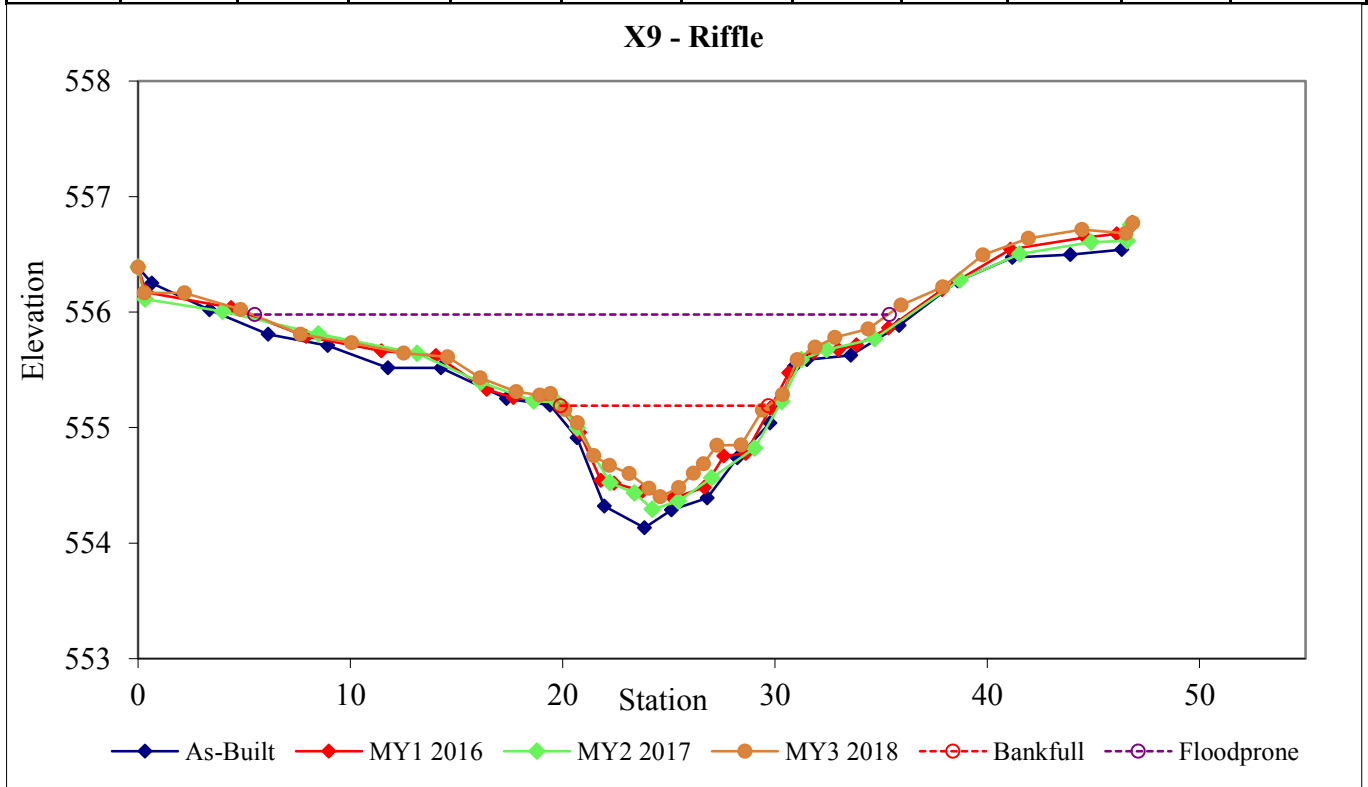
**Permanent Cross-section**  
**X9 Riffle - Reach 3**  
**(Monitoring Year 3 - Collected October 2018)**

Feature	Stream Type	BKF Area	BKF Width	BKF Depth	Max BKF Depth	W/D	BH Ratio	ER	BKF Elev	TOB Elev	WFPA
Riffle	C	4.37	9.80	0.40	0.80	21.80	0.90	3.10	555.19	555.29	29.90

\*BHR = 0.9 is based on as-built bkf area of 6.79 at an elevation of 555.3955. Remainder of data based on actual bankfull elevation from as-built which is 555.19.

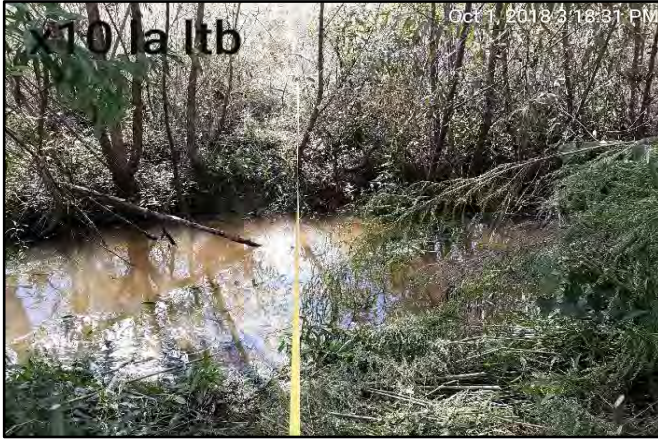
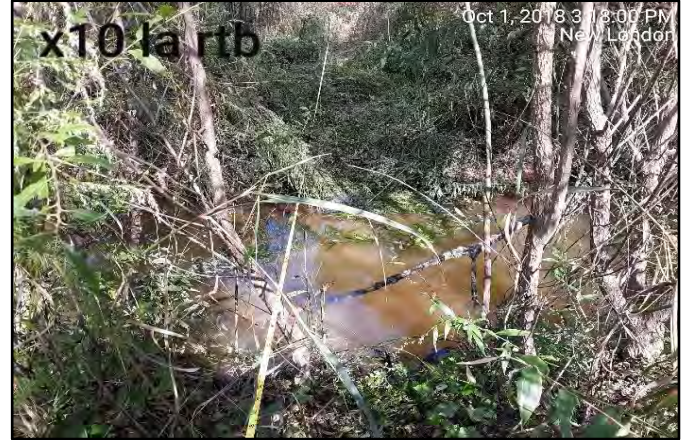
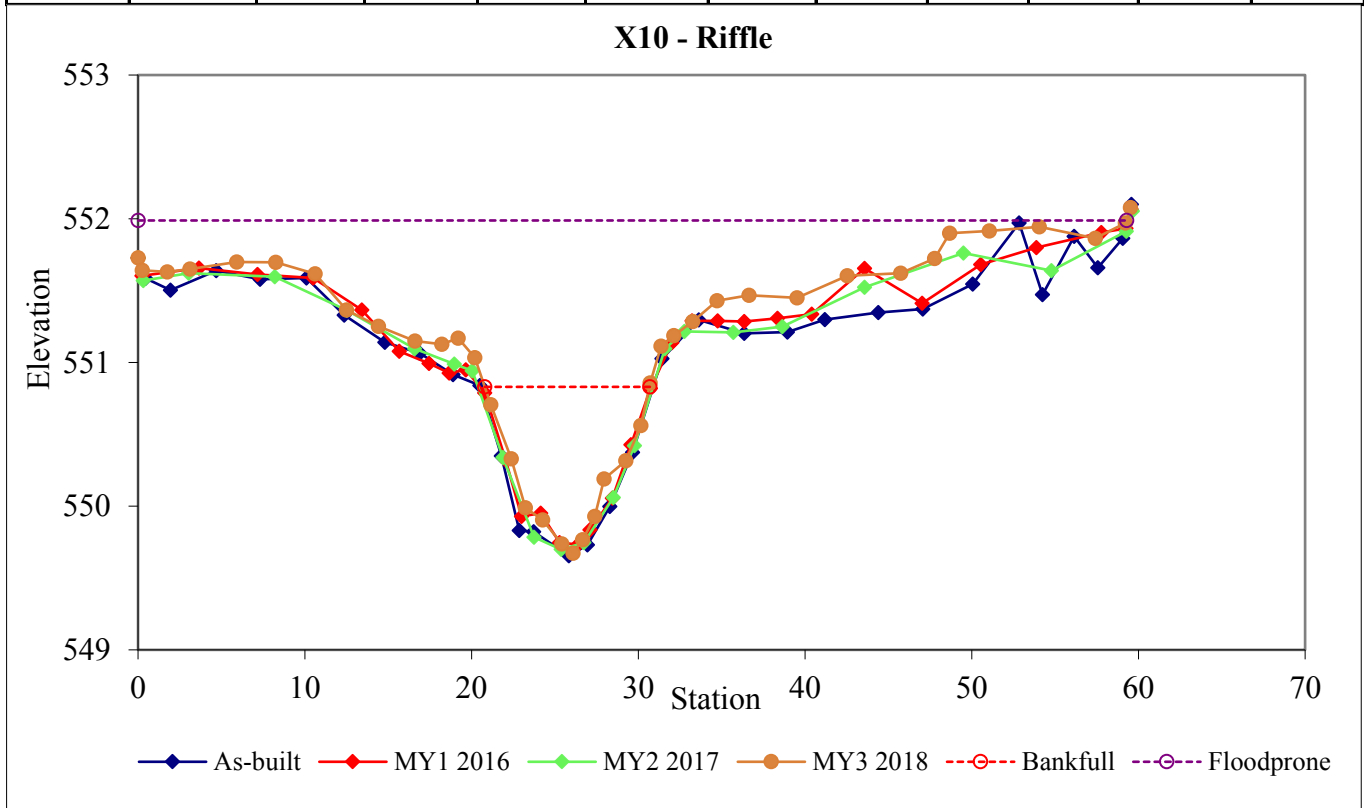
**Permanent Cross-section**  
**X10 Riffle - Reach 5**  
**(Monitoring Year 3 - Collected October 2018)**

Feature	Stream Type	BKF Area	BKF Width	BKF Depth	Max BKF Depth	W/D	BH Ratio	ER	BKF Elev	TOB Elev	WFGPA
Riffle	C	6.77	9.90	0.70	1.20	14.40	1.10	6.00	550.83	551.03	59.30

\*BHR = 1.1 is based on as-built bkf area of 8.0 at an elevation of 550.951. Remainder of data based on actual bankfull elevation from as-built which is 550.83.

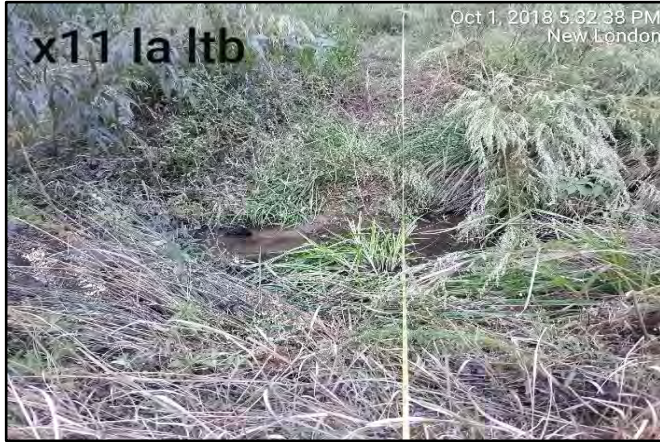
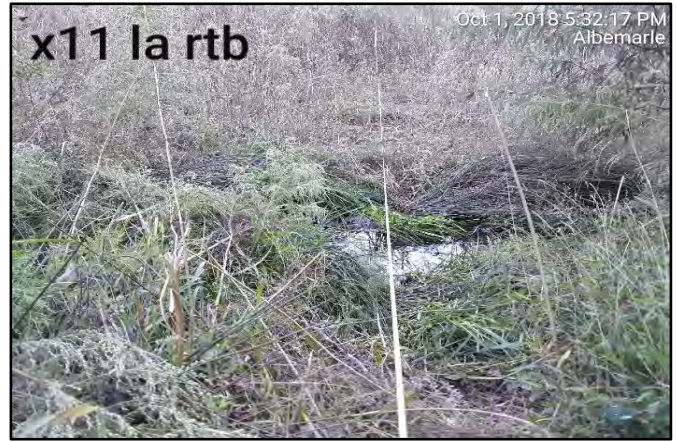
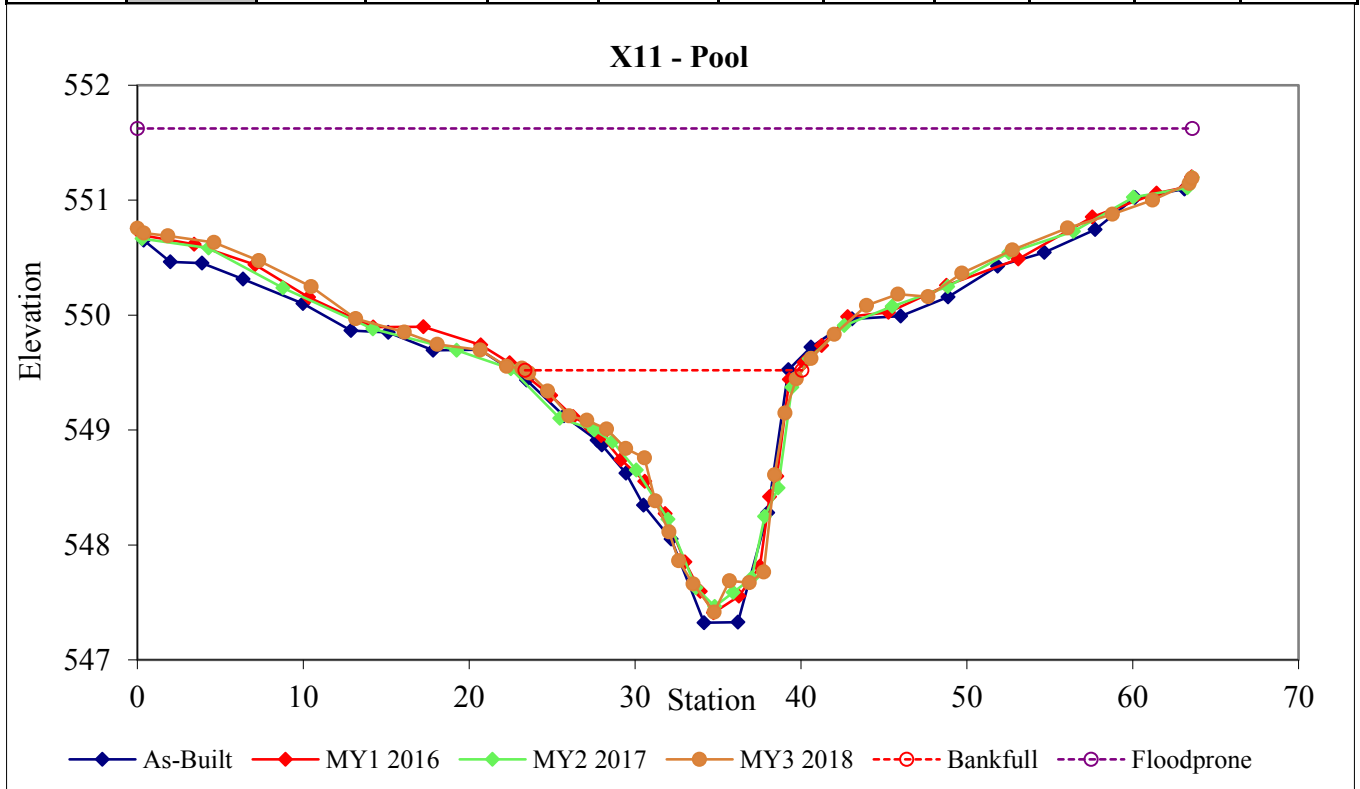
**Permanent Cross-section**  
**X11 Pool - Reach 5**  
**(Monitoring Year 3 - Collected October 2018)**

Feature	Stream Type	BKF Area	BKF Width	BKF Depth	Max BKF Depth	W/D	BH Ratio	ER	BKF Elev	TOB Elev	WFPA
Pool		16.65	16.70	1.00	2.10	16.80	0.90	3.80	549.52	549.45	63.60

\*BHR = 0.9 is based on as-built bkf area of 18.19 at an elevation of 549.606. Remainder of data based on actual bankfull elevation from as-built which is 549.52.

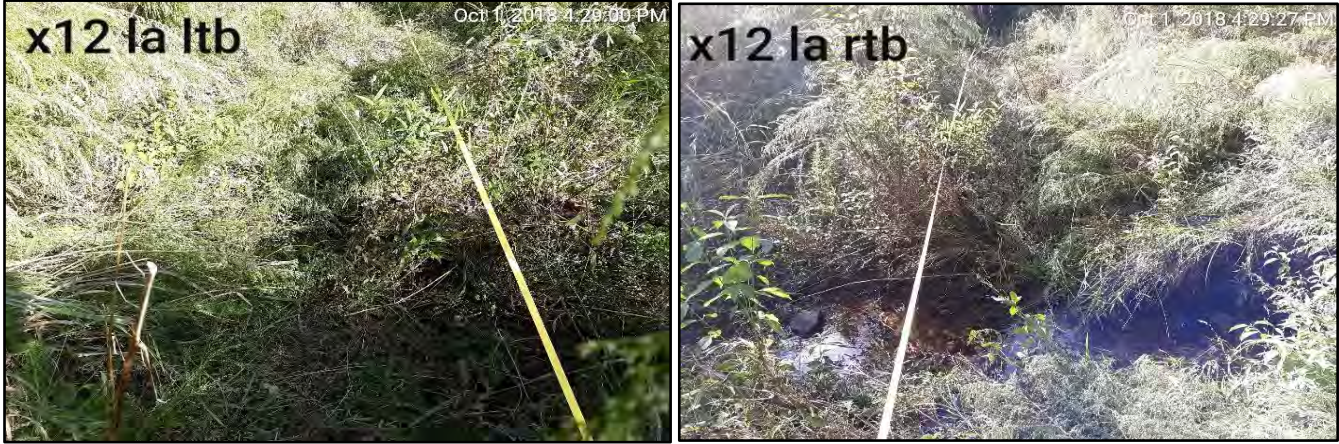
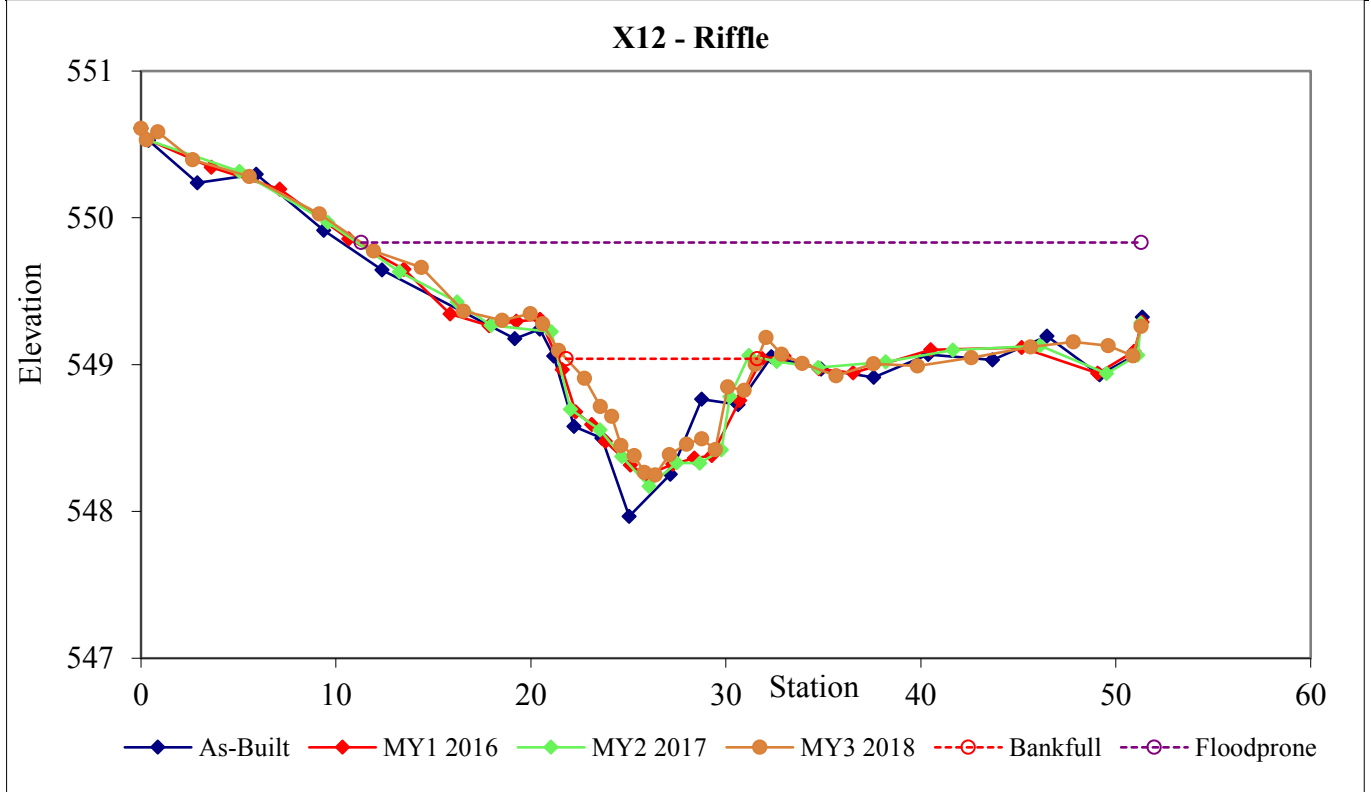
**Permanent Cross-section**  
**X12 Riffle - Reach 5**  
**(Monitoring Year 3 - Collected October 2018)**

Feature	Stream Type	BKF Area	BKF Width	BKF Depth	Max BKF Depth	W/D	BH Ratio	ER	BKF Elev	TOB Elev	WFGPA
Riffle	C	4.34	9.80	0.40	0.80	22.10	1.00	4.10	549.04	549.184	40

\*BHR = 1.0 is based on as-built bkf area of 5.71 at an elevation of 549.1685. Remainder of data based on actual bankfull elevation from as-built which is 549.04.

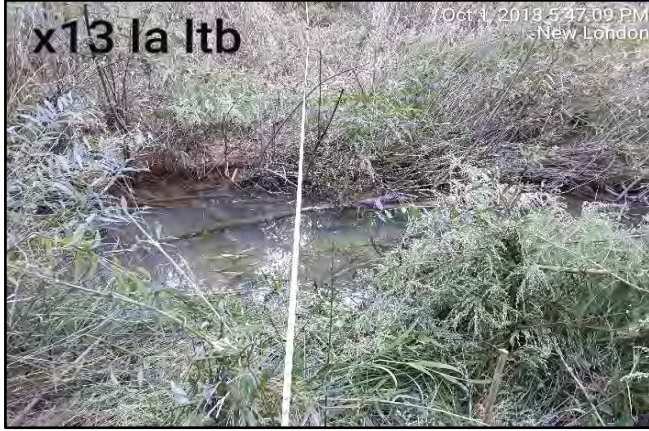
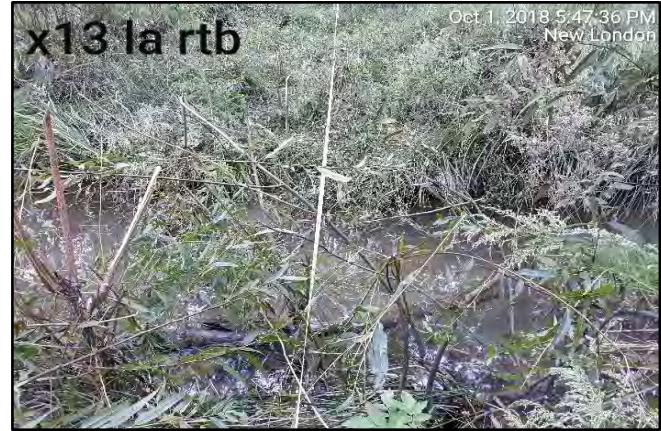
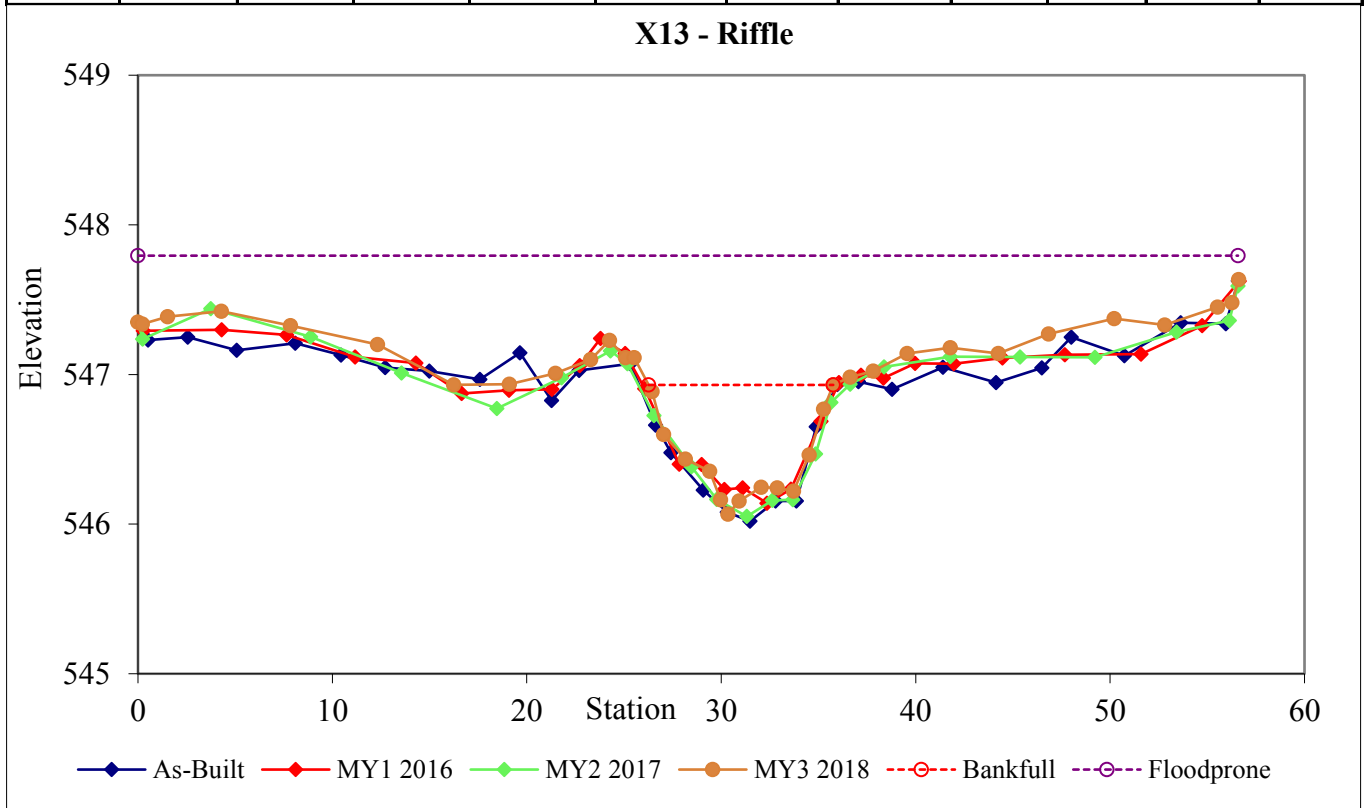
**Permanent Cross-section**  
**X13 Riffle - Reach 5**  
**(Monitoring Year 3 - Collected October 2018)**

Feature	Stream Type	BKF Area	BKF Width	BKF Depth	Max BKF Depth	W/D	BH Ratio	ER	BKF Elev	TOB Elev	WFOA
Riffle	C	5.13	9.50	0.50	0.90	17.50	0.90	6.00	546.93	546.93	56.6

\*BHR = 0.9 is based on as-built bkf area of 5.97 at an elevation of 547.011. Remainder of data based on actual bankfull elevation from as-built which is 546.93.
