# **Town Creek Restoration Project – Option B Year 3 Monitoring Report**

**Stanly County, North Carolina**

**DMS Project ID Number – 95026; NC DEQ Contract No. 003990**

**Monitoring Year: 3 of 5**

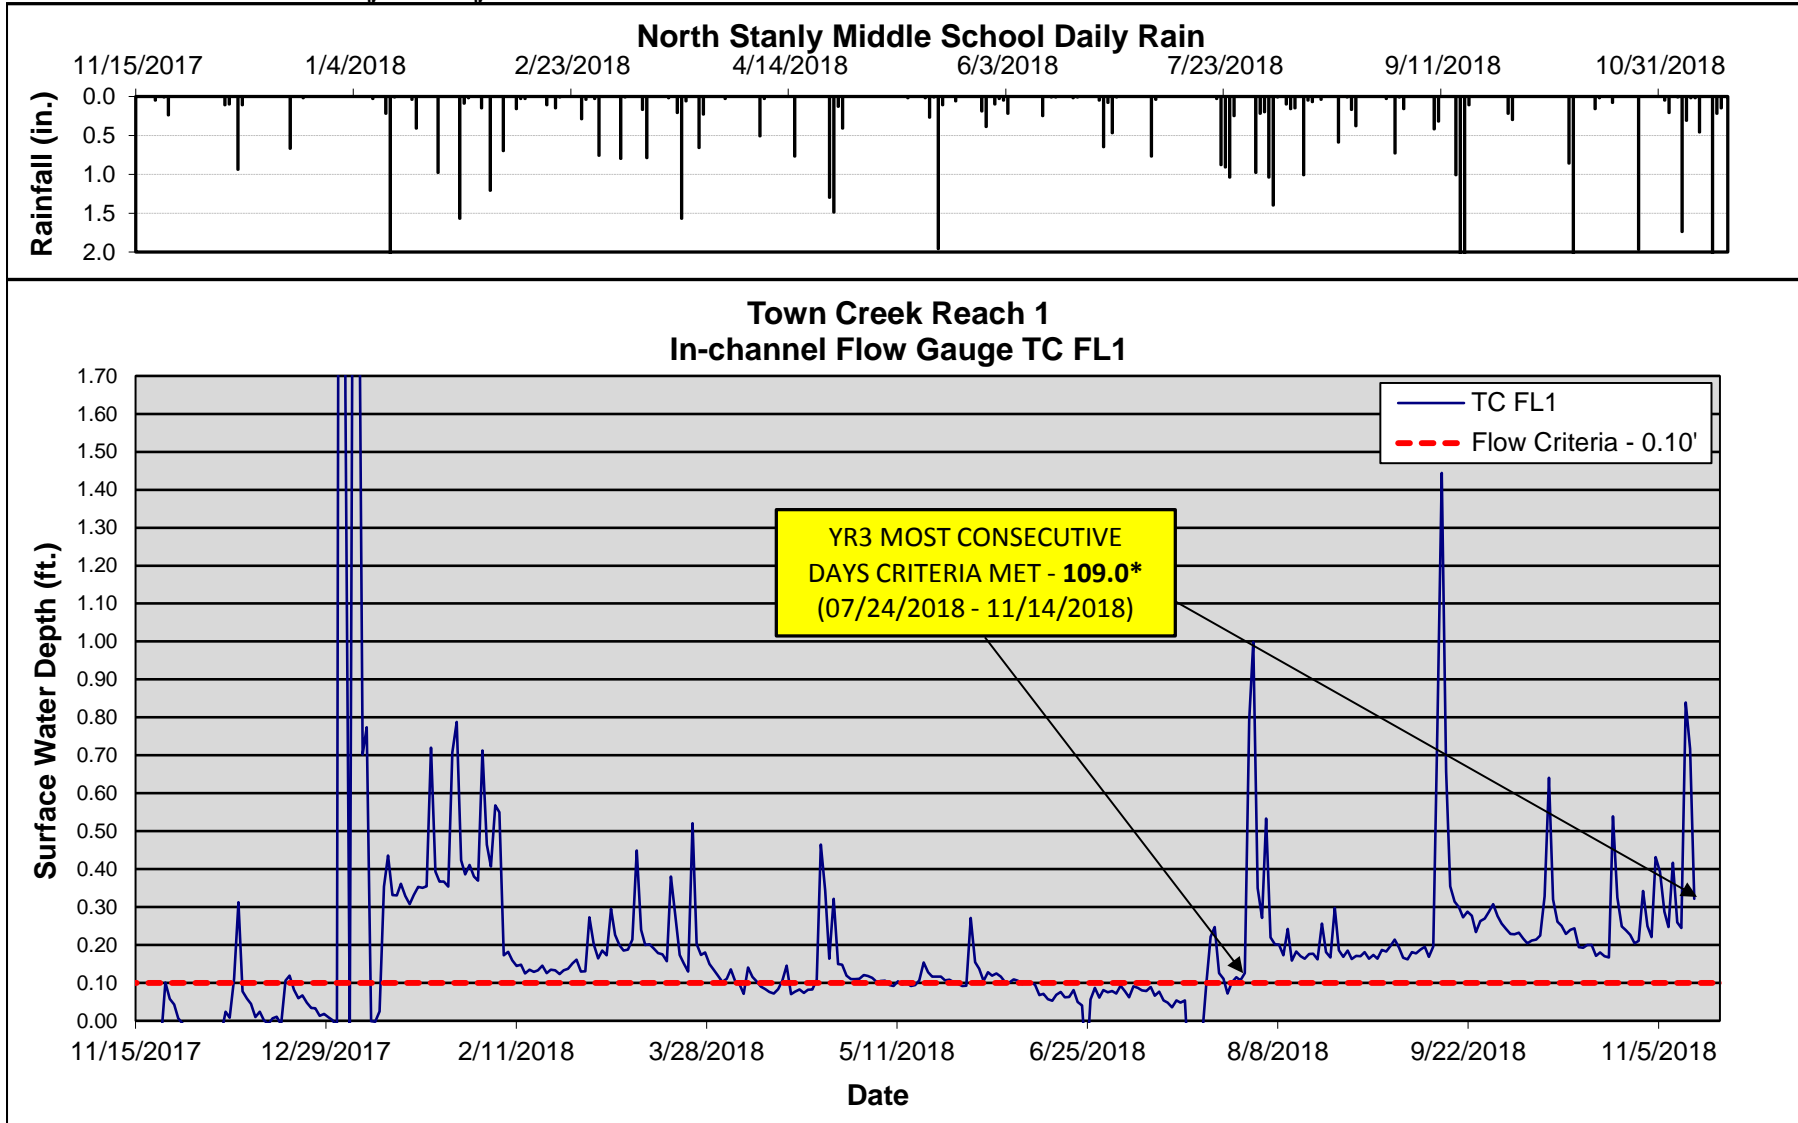
**Figure 5a. In-Stream Flow Gauge Graphs**  
**Town Creek Restoration Project: Project No. 95026**

\* Surface water flow is estimated to have occurred when the pressure transducer reading is equal to or above 0.1 feet in depth.

<b>Table 13. Verification of In-stream Flow Conditions</b>			
<b>Town Creek Restoration Project: DMS Project ID No. 95026</b>			
<b>Flow Gauge ID</b>	<b>Reach Location</b>	<b>Consecutive Days of Flow<sup>1</sup></b>	<b>Cumulative Days of Flow<sup>2</sup></b>
TCFL1	Reach 1 Station 11+05	109	248
TCFL2	Reach 2 Station 13+02	156	287

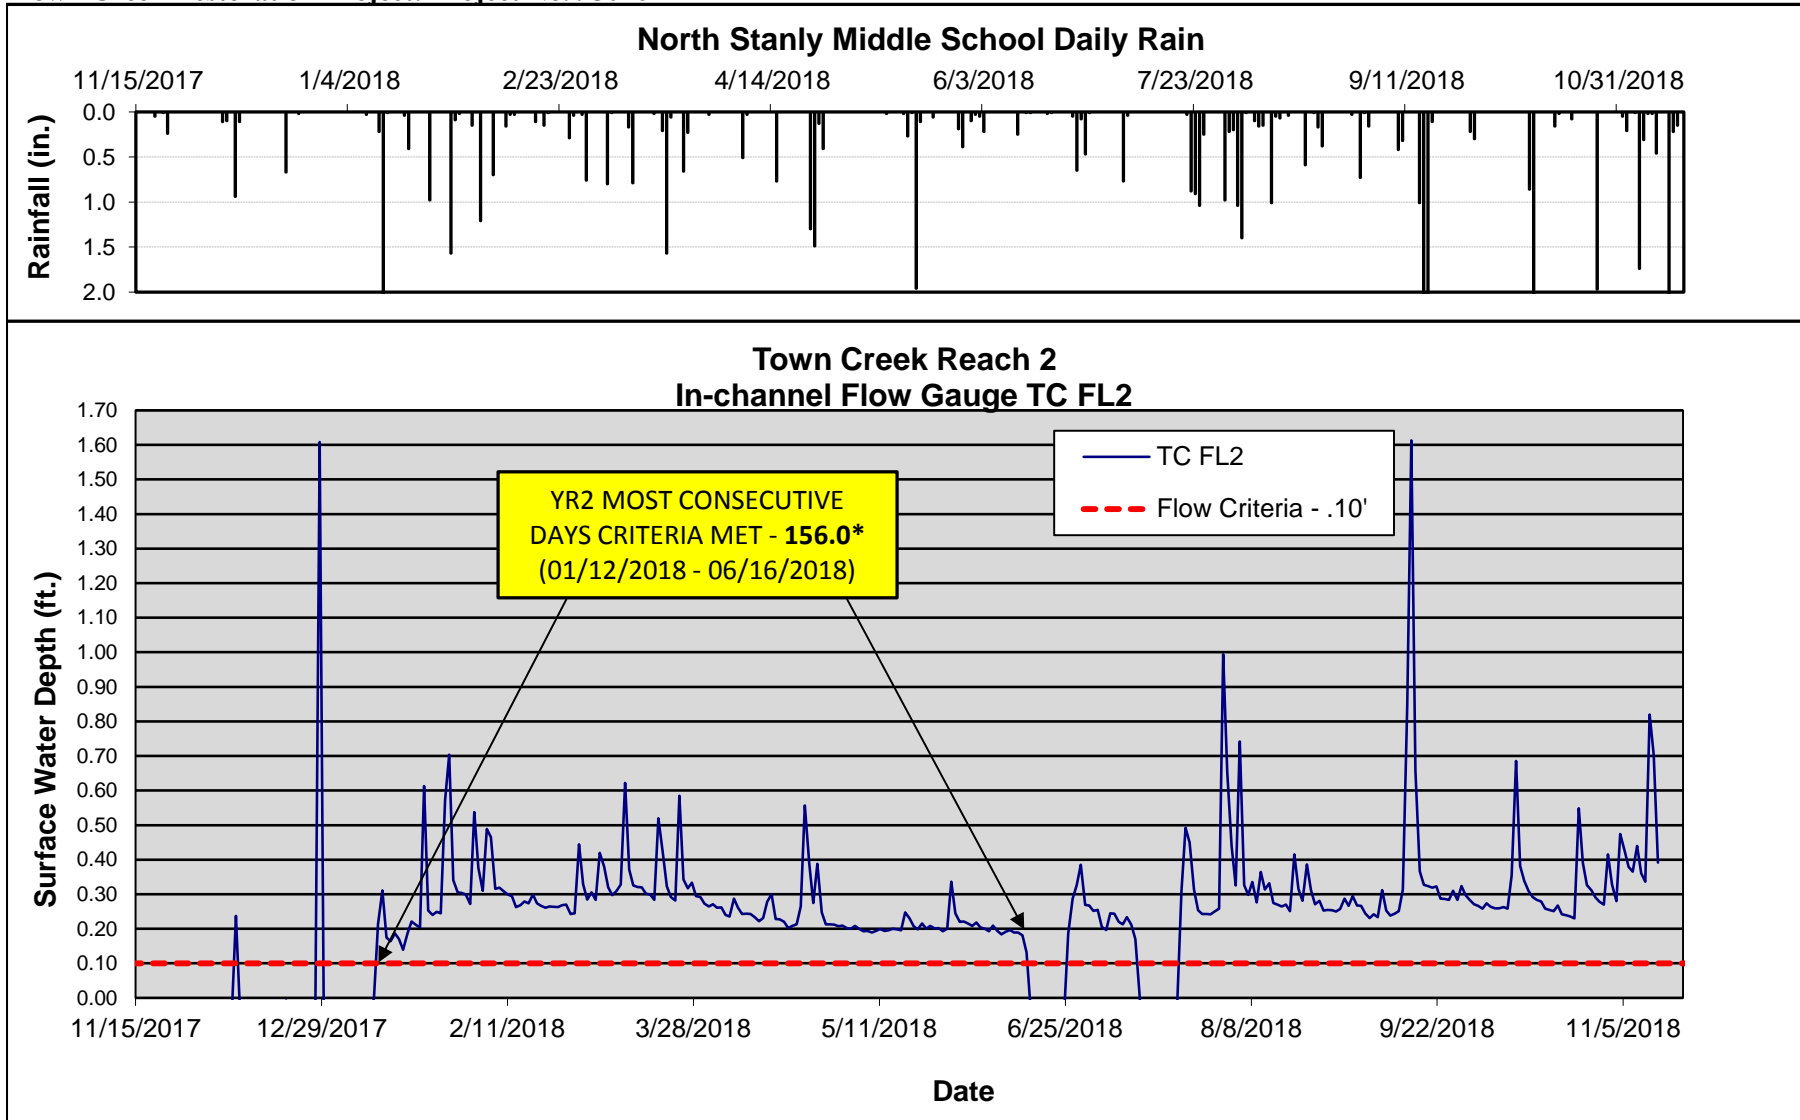
**Figure 5b. In-Stream Flow Gauge Graphs**  
**Town Creek Restoration Project: Project No. 95026**

\* Surface water flow is estimated to have occurred when the pressure transducer reading is equal to or above 0.1 feet in depth.
