Town Creek Restoration Project – Option B Year 4 Monitoring Report

Stanly County, North Carolina

DMS Project ID Number – 95026; NC DEQ Contract No. 003990

Report Prepared and Submitted by Michael Baker Engineering, Inc.

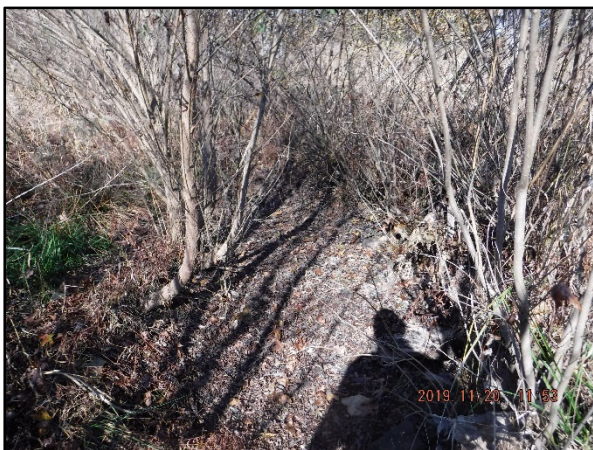
PID 39: Station 45+50 – Upstream (11/20/19)

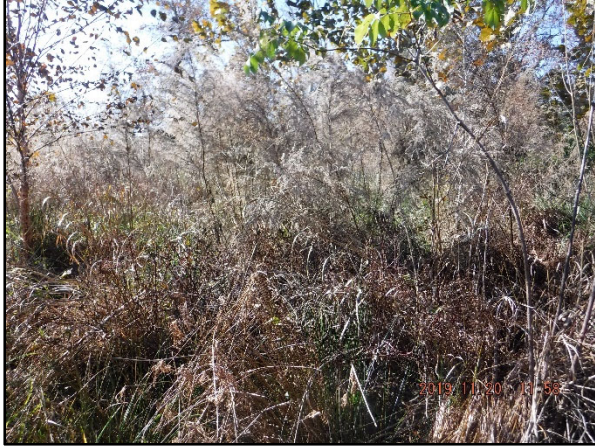
PID 41: Station 47+00 – Right Floodplain Rock Lined Channel from Wetland (11/20/19)

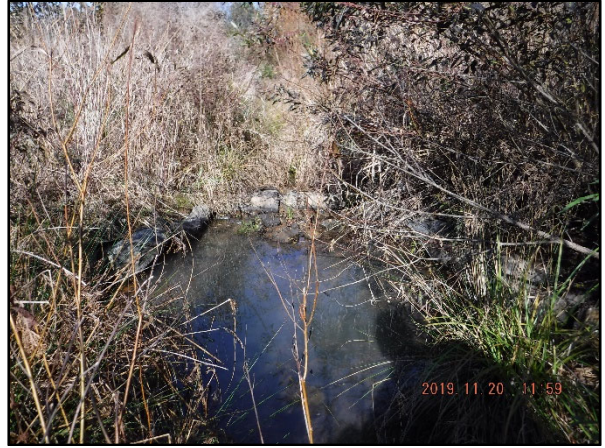
PID 42: Station 47+75 – Upstream (11/20/19)

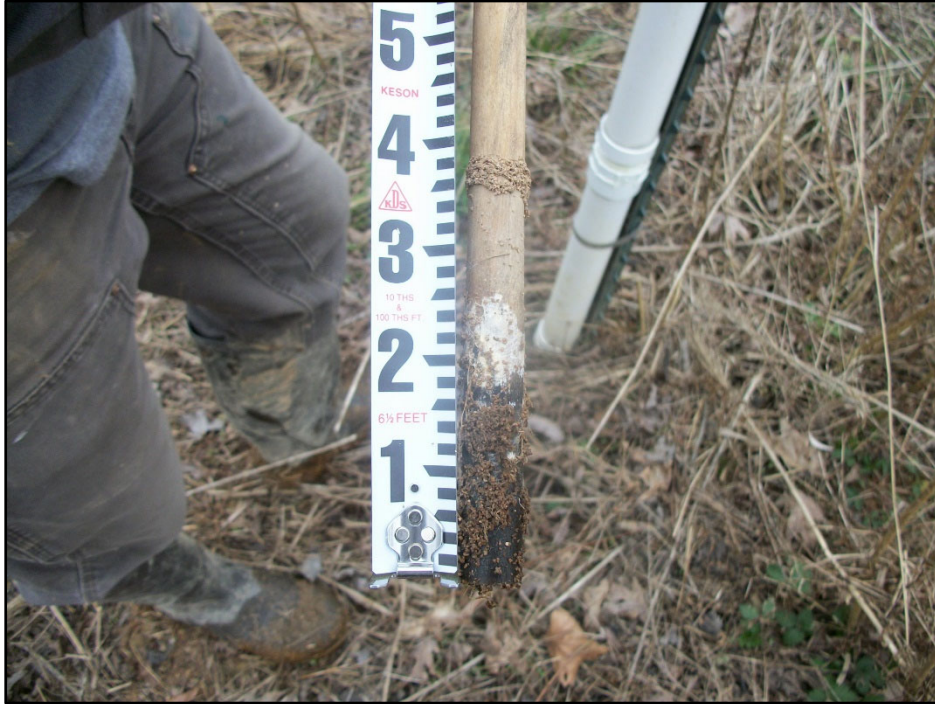
Crest Gauge Photo 1– 6 (3/20/2019)

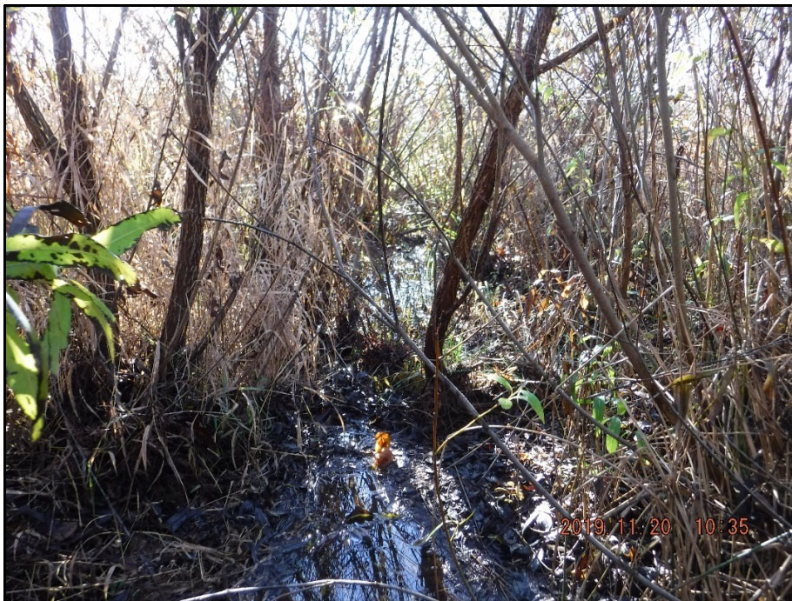
Flow Documentation Photo – Facing upstream of TCFL 2 (11/20/2019)
